CONTRACT NO: KL/2009/01

**SITE FORMATION FOR
KAI TAK CRUISE TERMINAL DEVELOPMENT**

**QUARTERLY ENVIRONMENTAL MONITORING & AUDIT
REPORT**

- JUNE TO AUGUST 2012 -

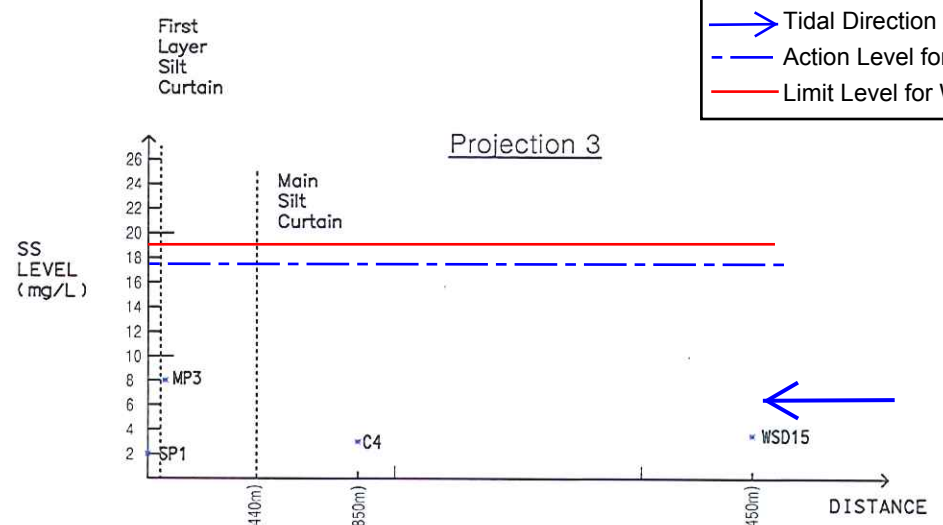
Description: WSD15 was located at upstream which was well within the Action Level.

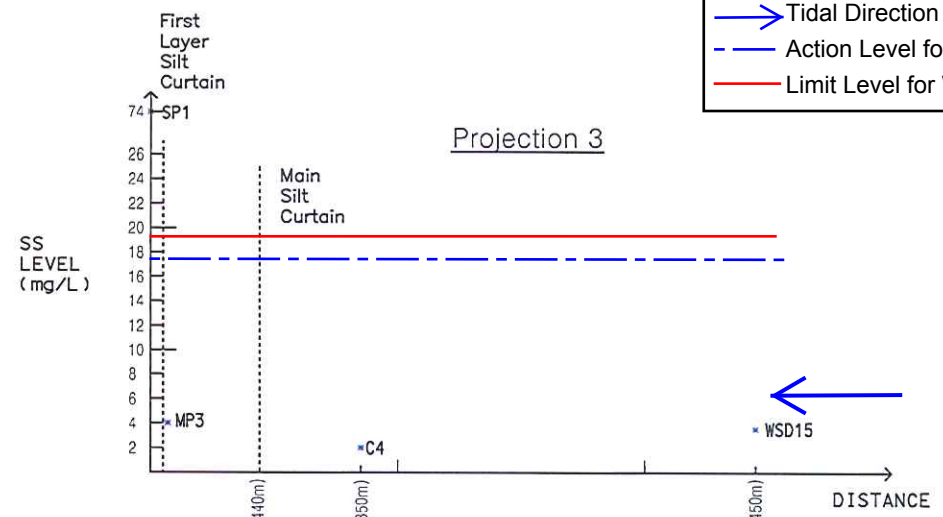
Description: WSD15 was located at upstream which was well within the Action Level.

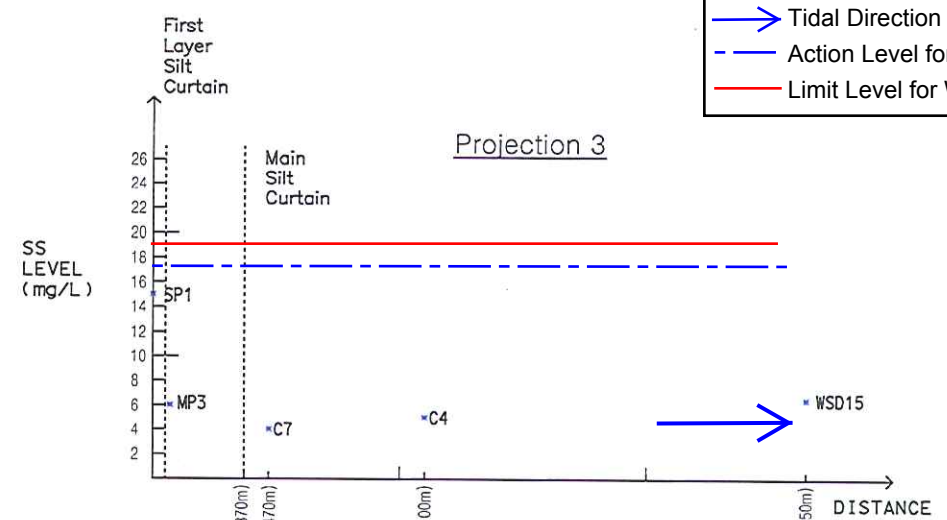
Description: WSD15 was located at upstream which was well within the Action Level.

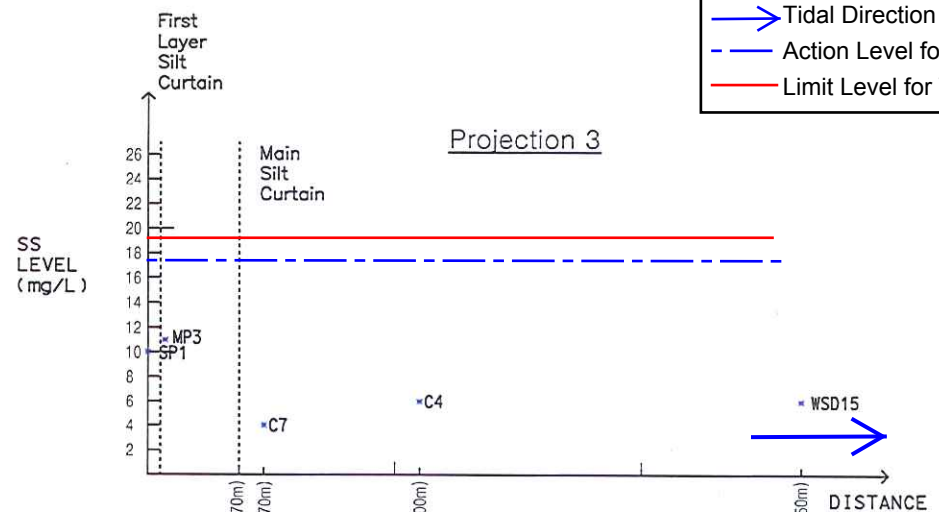
Description: WSD15 was located at downstream which was well within the Action Level.

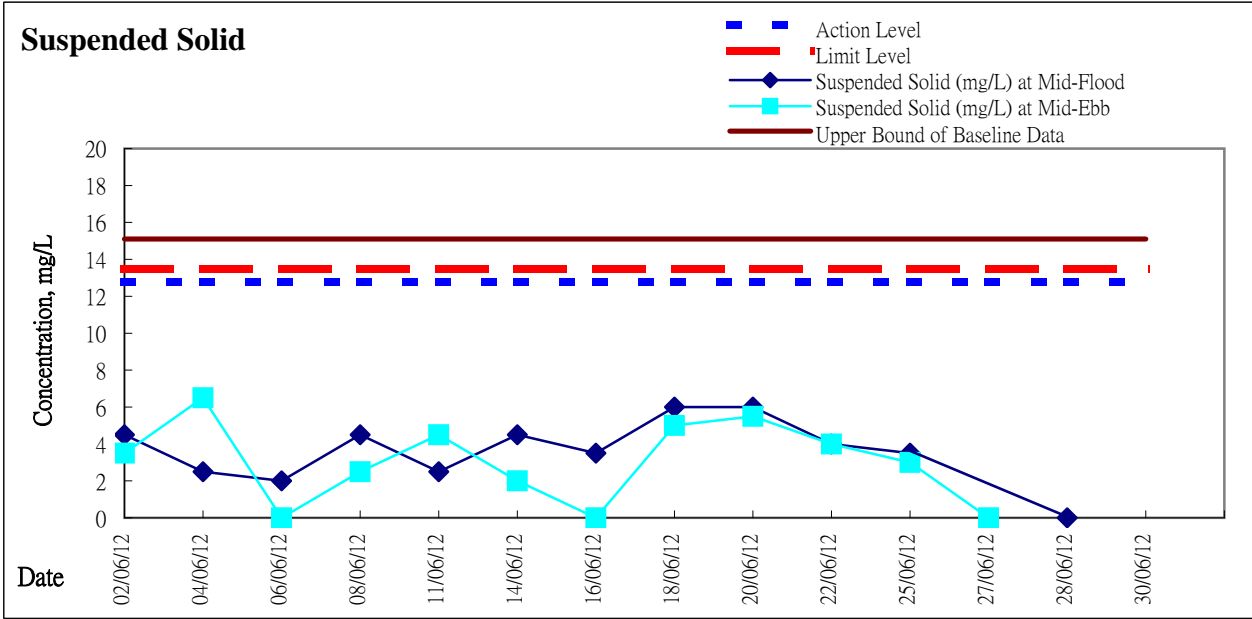
Graphic Presentation of Water Quality Result of WSD9 - Tai Wan with respect to Local Variation

Remarks: WSD9 is located at upstream during the ebb tides while at downstream during flood tides.

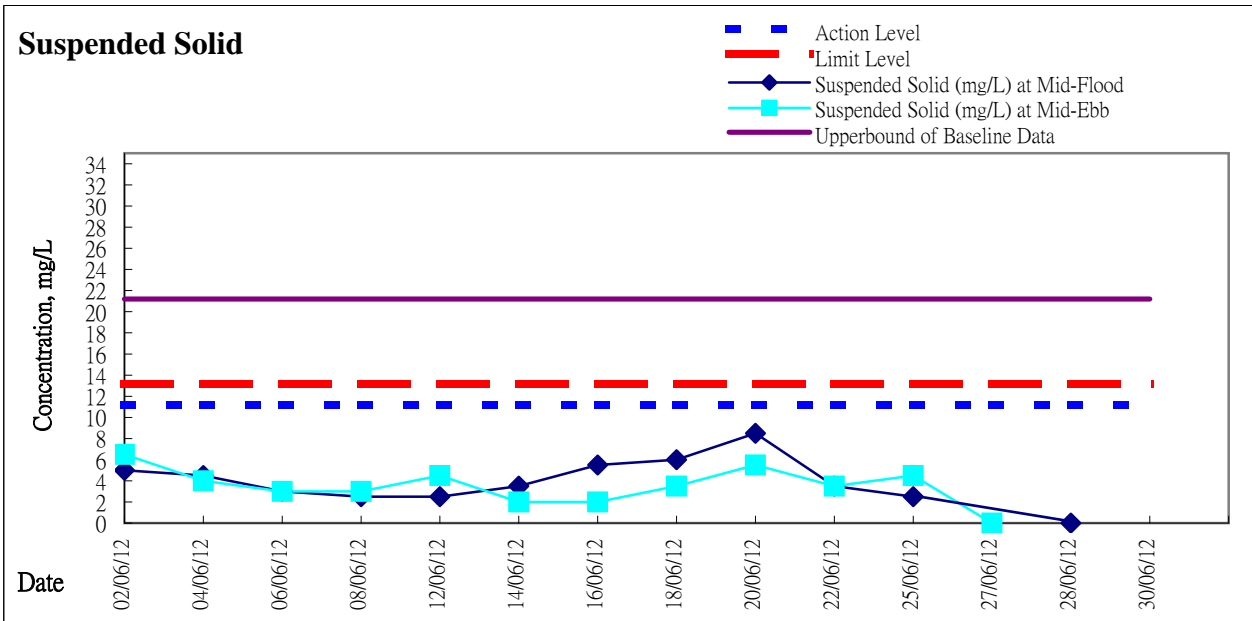
Graphic Presentation of Water Quality Result of WSD10 - Cha Kwo Ling with respect to Local Variation

Remarks: WSD10 is located at upstream during the flood tides while at downstream during ebb tides.

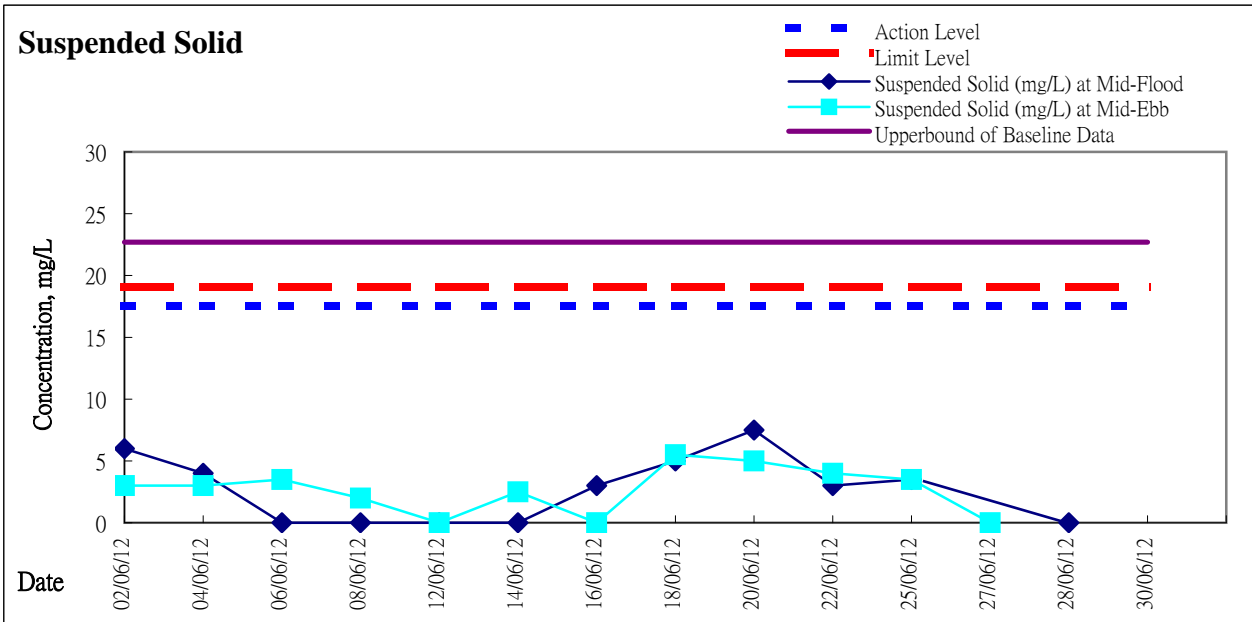
Graphic Presentation of Water Quality Result of WSD15 - Sai Wan Ho with respect to Local Variation

Remarks: WSD15 is located at upstream during the flood tides while at downstream during ebb tides.

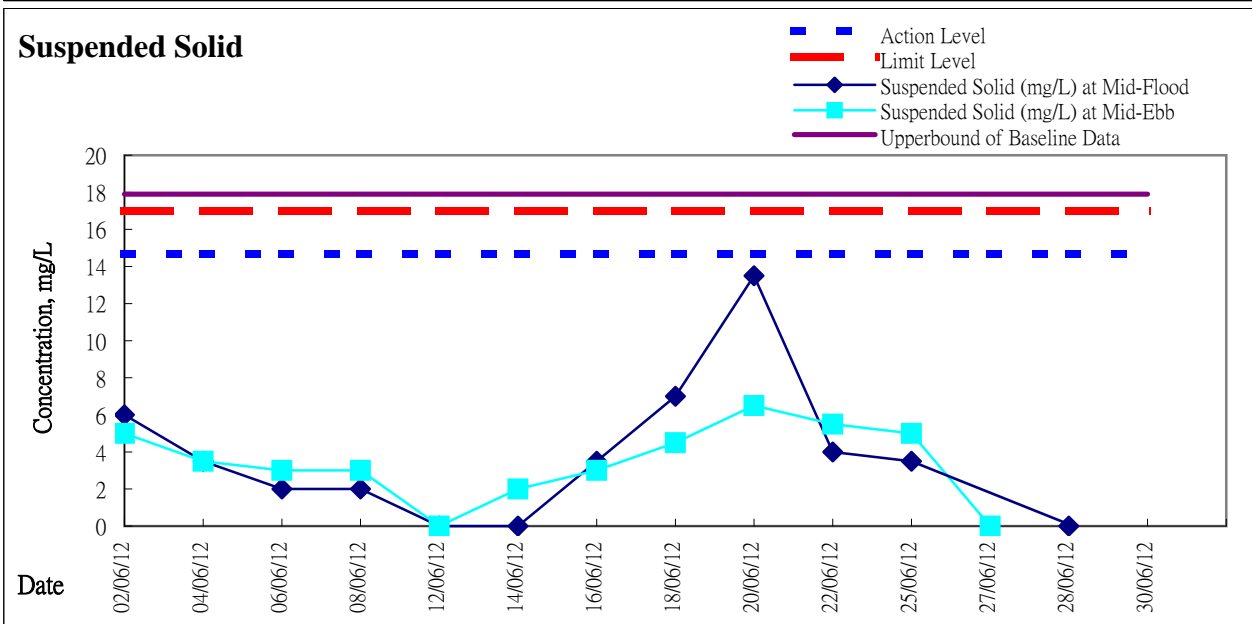
Graphic Presentation of Water Quality Result of WSD17 - Quarry Bay with respect to Local Variation

Remarks: WSD17 is located at upstream during the flood tides while at downstream during ebb tides.

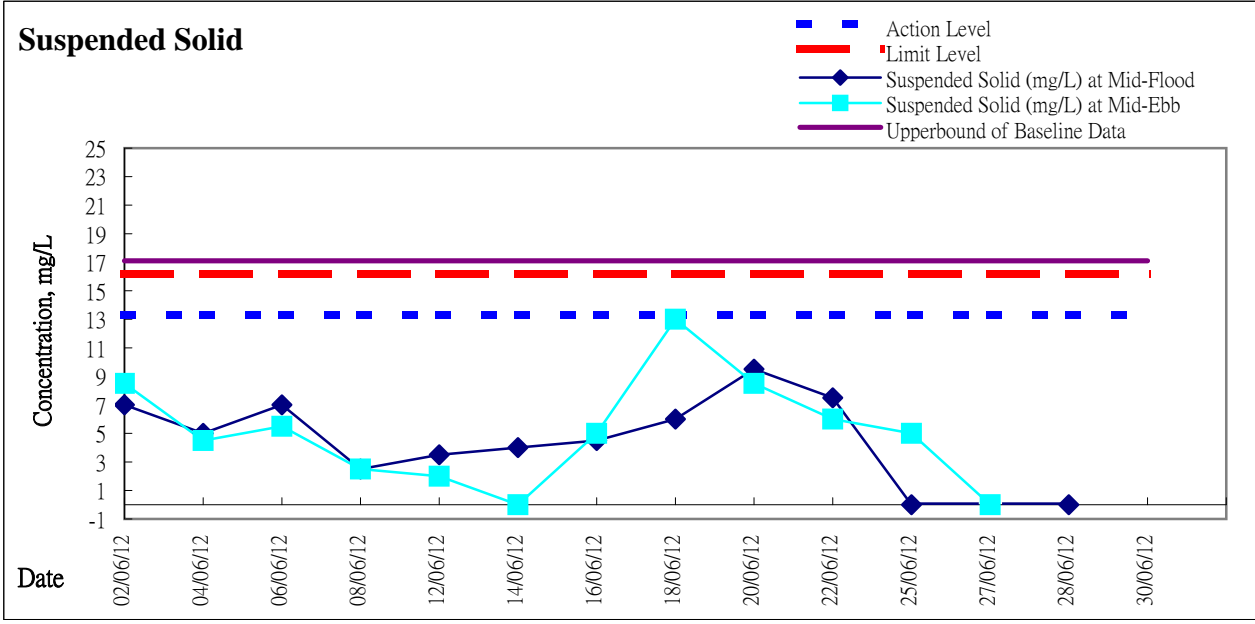
Graphic Presentation of Water Quality Result of WSD19 - Sheung Wan with respect to Local Variation

Remarks: WSD19 is located at upstream during the ebb tides while at downstream during flood tides.

- xi. For the SS exceedance recorded at WSD19 on 4 August 2012, no rising of SS level at downstream stations of WSD9 and WSD21, which are closer to Project site than WSD19. The rise in SS level might have been caused by localized impact or changes in ambient conditions. It is concluded that no adverse water quality impact was arising from the Project works.

- xii. For the SS exceedance recorded at WSD19 on 17 August 2012, no rising of SS level at downstream stations of WSD9 and WSD21, which are closer to Project site than WSD19. Heavy rainfall from the influence of typhoon Kai Tak was observed on 17 Aug 2012, this could have caused substantial urban runoff causing rise in SS level. It is concluded that no adverse water quality impact was arising from the Project works.

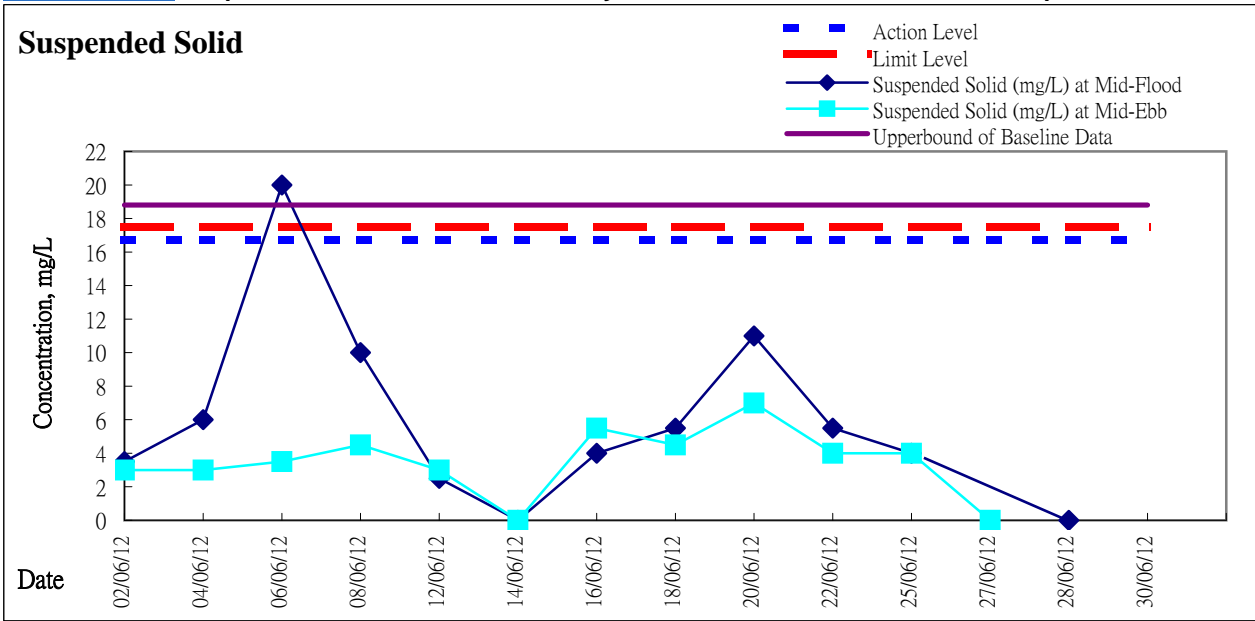
Graphic Presentation of Water Quality Result of WSD21 - Wan Chai with respect to Local Variation

Remarks: WSD21 is located at upstream during the ebb tides while at downstream during flood tides.
