**CONTRACT NO: KL/2009/01**  
**SITE FORMATION FOR**  
**KAI TAK CRUISE TERMINAL DEVELOPMENT**

**QUARTERLY ENVIRONMENTAL MONITORING & AUDIT**  
**REPORT**

- SEPTEMBER TO NOVEMBER 2012 -

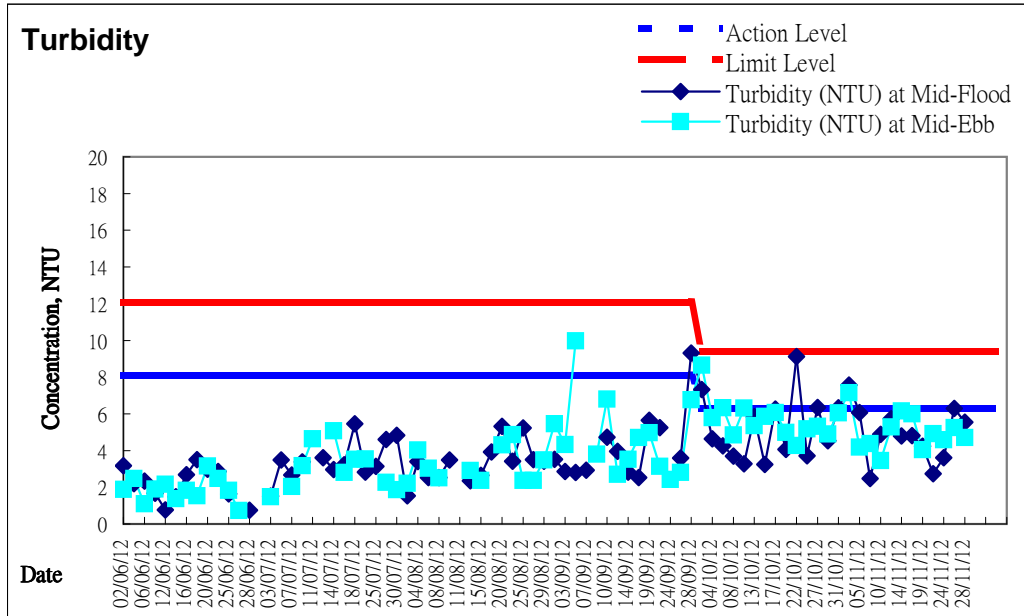
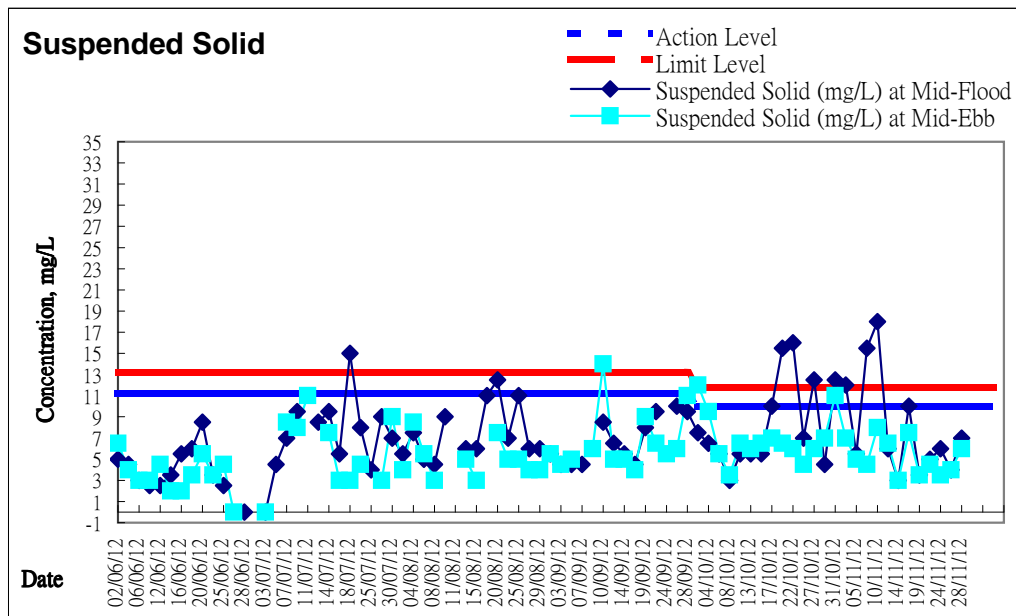
**Graphic Presentation of Water Quality Result of WSD10 - Cha Kwo Ling**

- Two sets of Suspended Solid Action and Limit levels for the dry season (the period from October to March) and wet season (the period from April to September).
- New sets Turbidity and SS Action Level and Limit Level for dry and wet season were approved by EPD on 19 Oct 2011

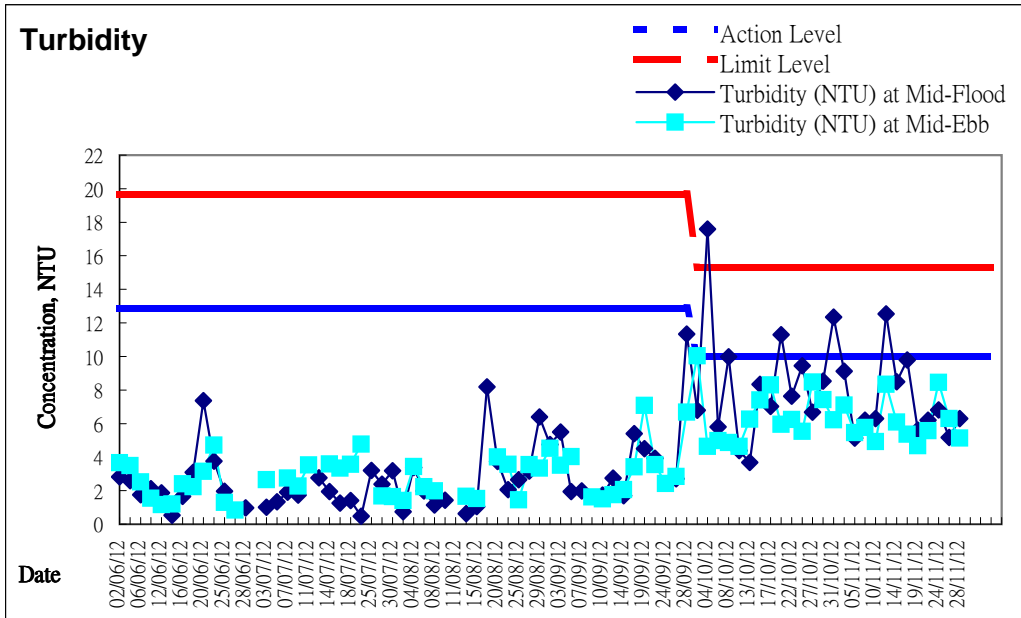
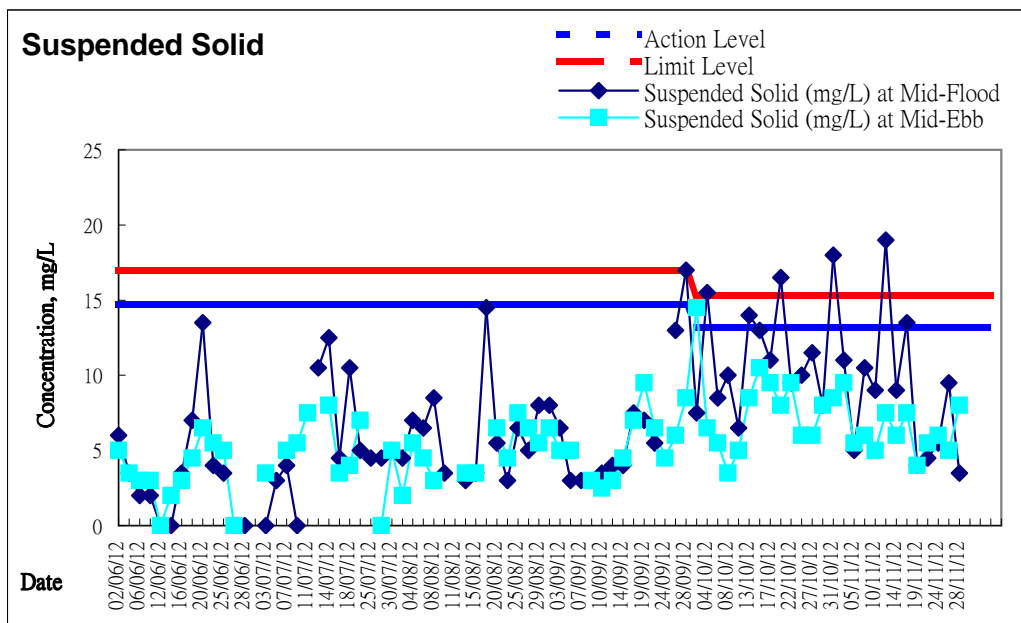
**Graphic Presentation of Water Quality Result of WSD17 - Quarry Bay**

- Two sets of Suspended Solid Action and Limit levels for the dry season (the period from October to March) and wet season (the period from April to September).
- New sets Turbidity and SS Action Level and Limit Level for dry and wet season were approved by EPD on 19 Oct 2011

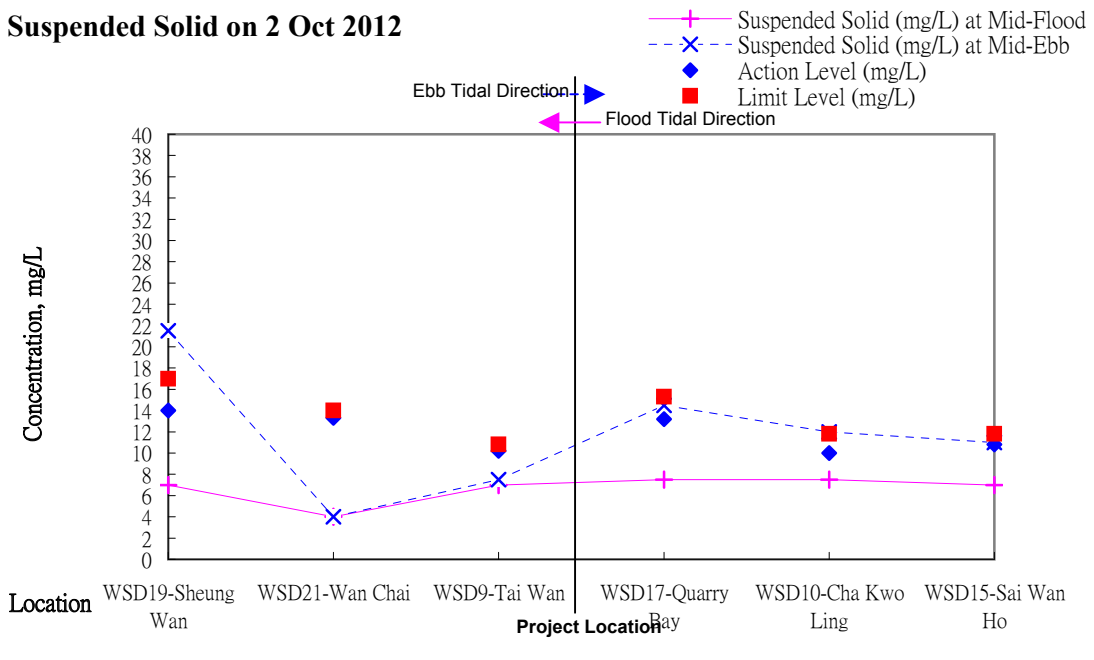
### Suspended Solid on 2 Oct 2012

- xi. For the SS exceedance recorded on 2 Oct 2012 at WSD10 (Mid-ebb), WSD15 (Mid-ebb) and WSD17(Mid-ebb) revealed that no apparent rise of SS after passing the project site. The rise in SS level might be caused by accumulation of filling materials from nearby transferral of filling materials activities or changes at upstream, as relatively SS concentration were recorded at WSD19, the furthest upstream station.

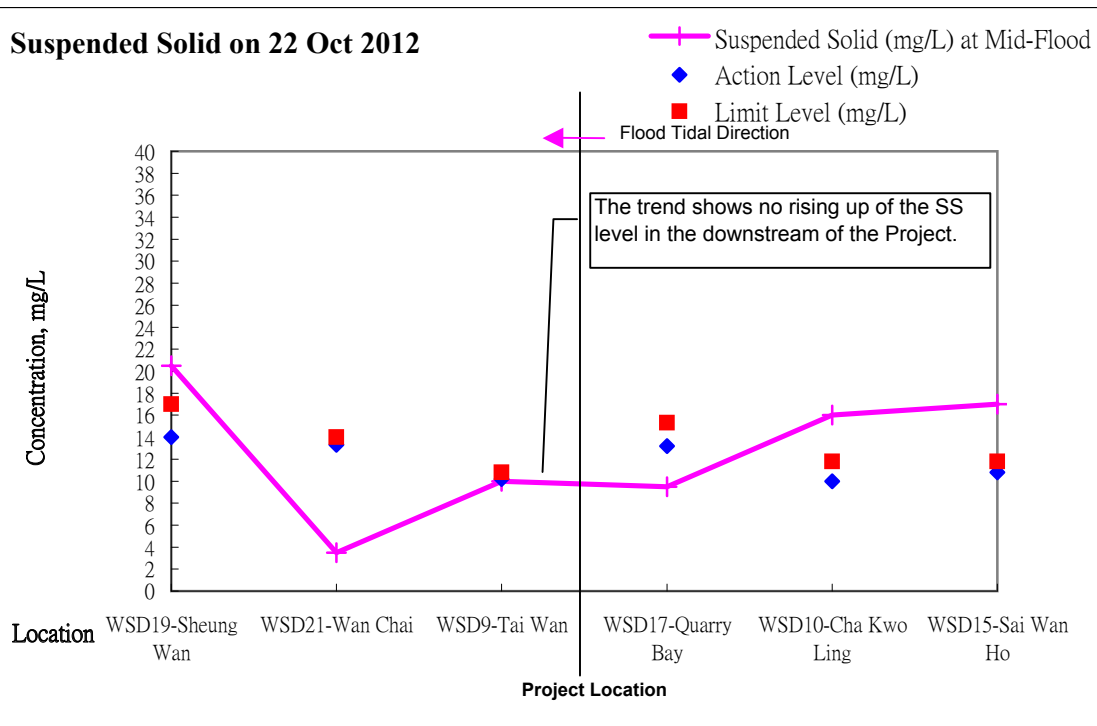
### Suspended Solid on 22 Oct 2012

- xii. For the SS exceedance recorded on 22 Oct 2012 at WSD19 (Mid-flood) revealed that no apparent rise of SS after passing the project site. The rise in SS level might be caused by accumulation of filling materials from nearby transferral of filling materials activities or changes at upstream, as relatively SS concentration were recorded at WSD10 and WSD15, the furthest upstream station.

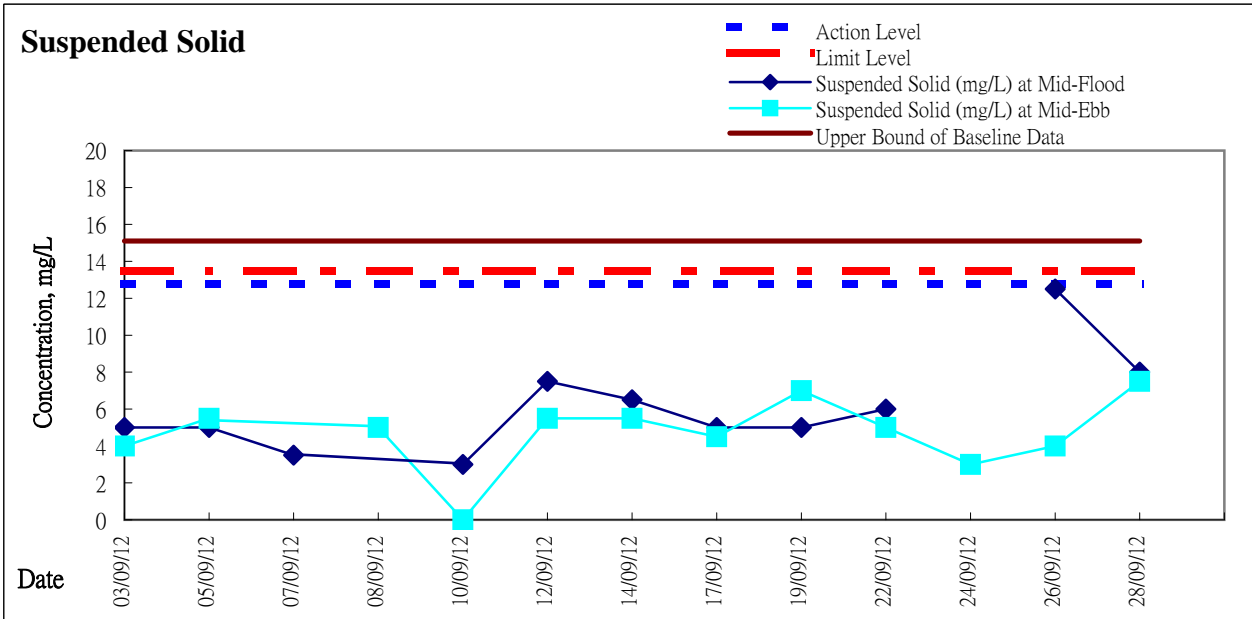
Graphic Presentation of Water Quality Result of WSD9 - Tai Wan with respect to Local Variation

Remarks: WSD9 is located at upstream during the ebb tides while at downstream during flood tides.

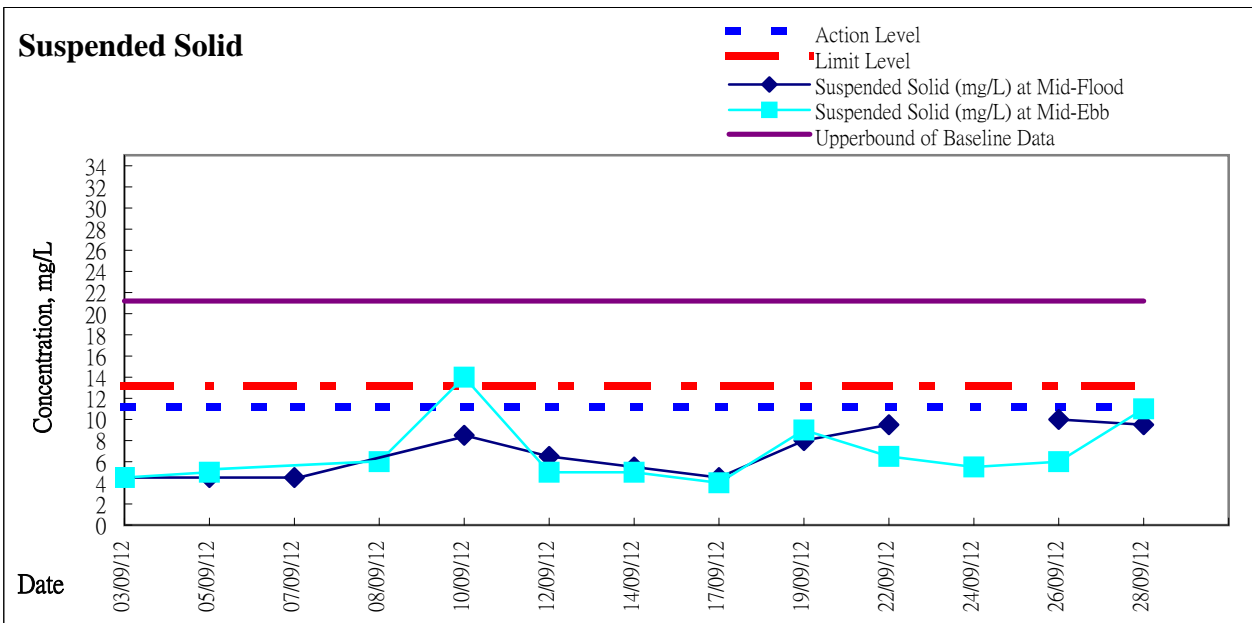
Graphic Presentation of Water Quality Result of WSD10 - Cha Kwo Ling with respect to Local Variation

Remarks: WSD10 is located at upstream during the flood tides while at downstream during ebb tides.

Remarks: Due to hoisting of amber rainstorm warning, the water quality monitoring for flood tide on 24 Sep 2012 was cancelled.

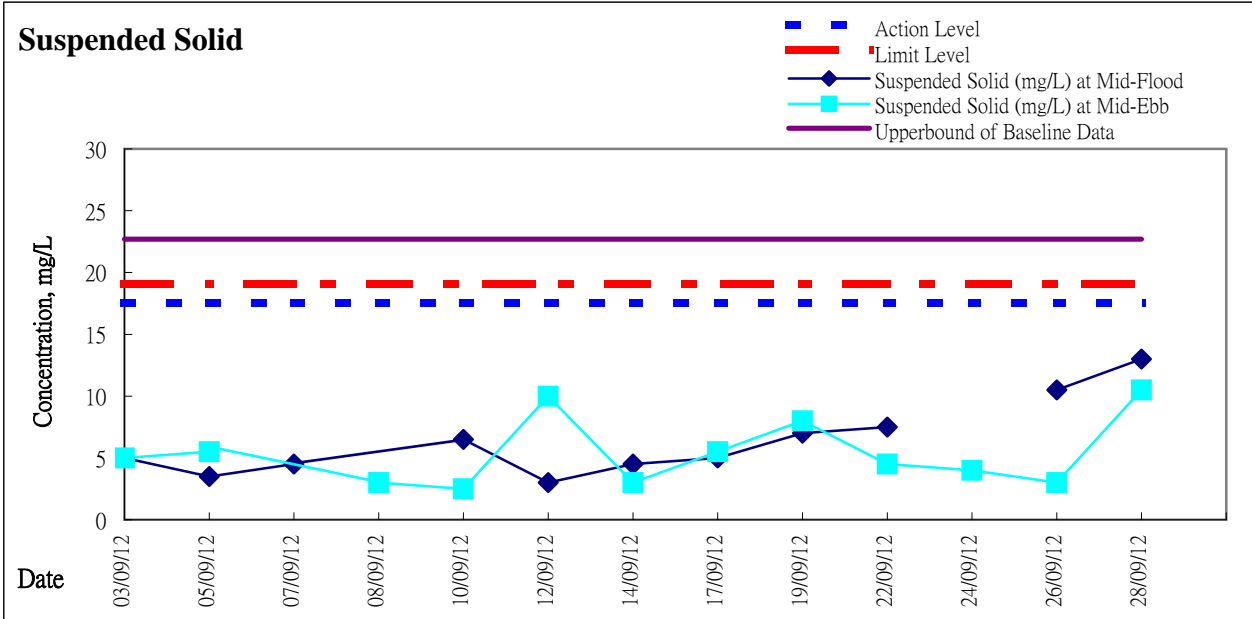
Graphic Presentation of Water Quality Result of WSD15 - Sai Wan Ho with respect to Local Variation

Remarks: WSD15 is located at upstream during the flood tides while at downstream during ebb tides.

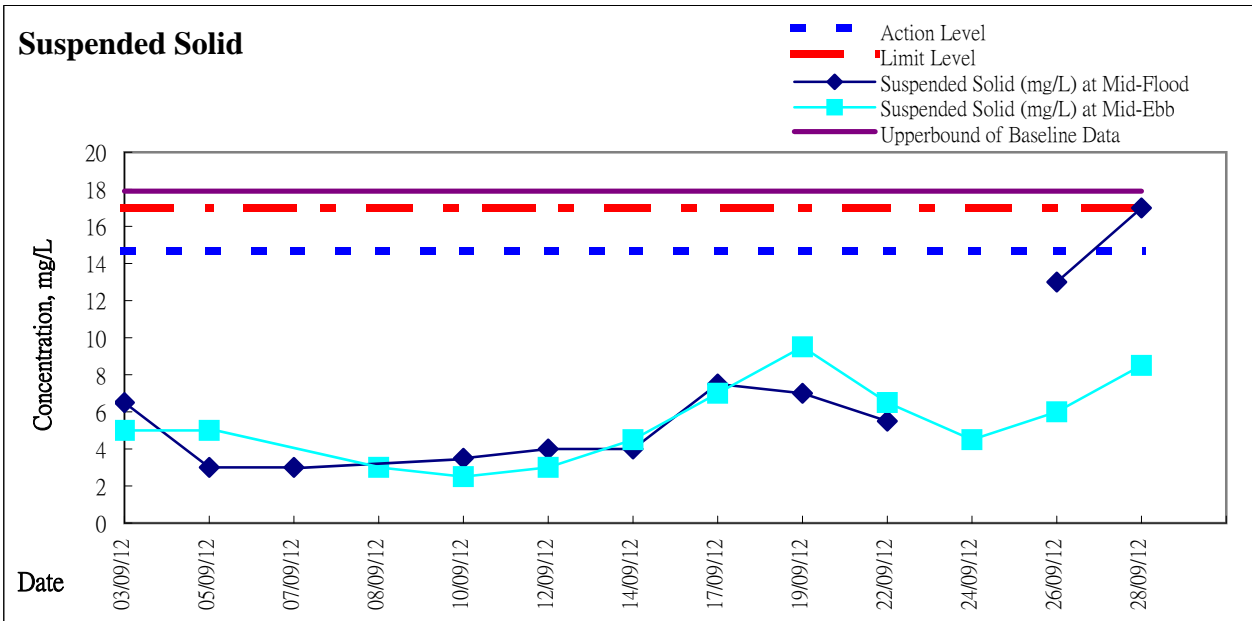
Graphic Presentation of Water Quality Result of WSD17 - Quarry Bay with respect to Local Variation

Remarks: WSD17 is located at upstream during the flood tides while at downstream during ebb tides.

Remarks: Due to hoisting of amber rainstorm warning, the water quality monitoring for flood tide on 24 Sep 2012 was cancelled.

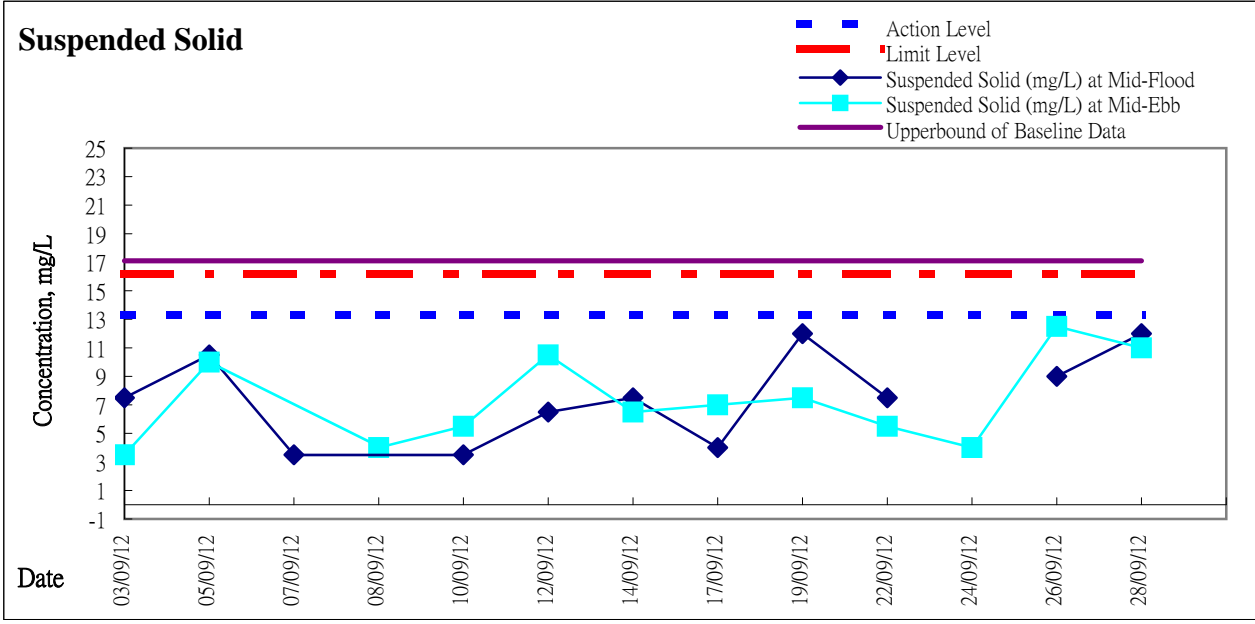
Graphic Presentation of Water Quality Result of WSD19 - Sheung Wan with respect to Local Variation

Remarks: WSD19 is located at upstream during the ebb tides while at downstream during flood tides.

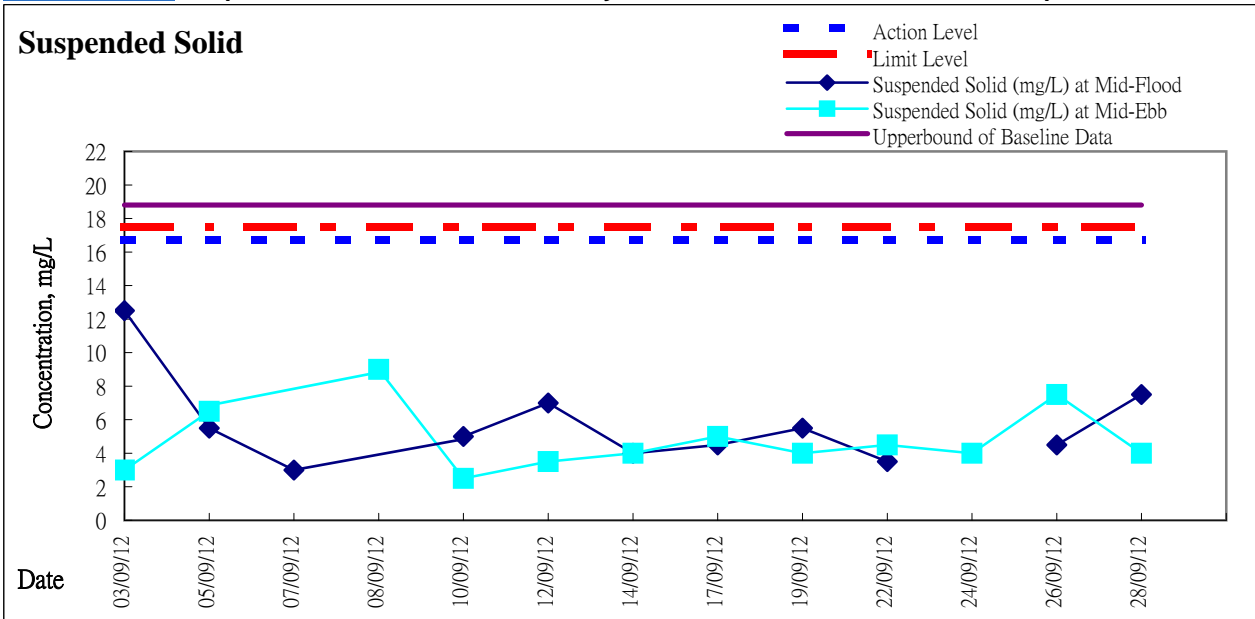
Graphic Presentation of Water Quality Result of WSD21 - Wan Chai with respect to Local Variation

Remarks: WSD21 is located at upstream during the ebb tides while at downstream during flood tides.

Remarks: Due to hoisting of amber rainstorm warning, the water quality monitoring for flood tide on 24 Sep 2012 was cancelled.
