**CONTRACT NO: KL/2009/01**

**SITE FORMATION FOR  
KAI TAK CRUISE TERMINAL DEVELOPMENT**

**QUARTERLY ENVIRONMENTAL MONITORING & AUDIT  
REPORT**

**- MARCH 2013 TO MAY 2013 -**

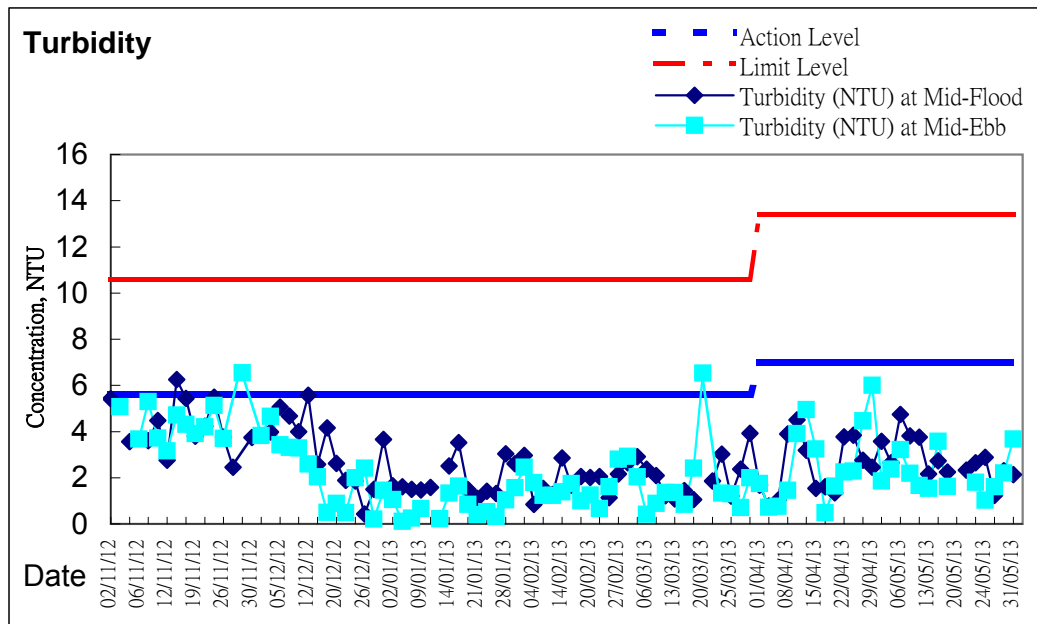
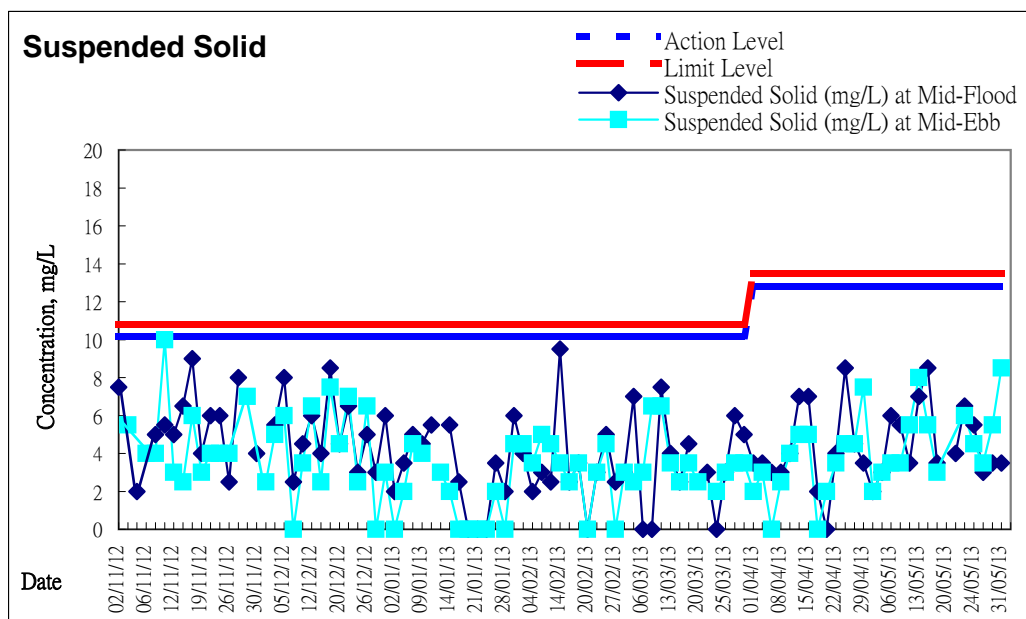
## Graphic Presentation of Water Quality Result of WSD9 - Tai Wan

- Two sets of Suspended Solid Action and Limit levels for the dry season (the period from October to March) and wet season (the period from April to September).
- New sets Turbidity and SS Action Level and Limit Level for dry and wet season were approved by EPD on 19 Oct 2011
- Due to hoisting of amber rainstorm warning, the water quality monitoring for ebb tide 20 May 2013 was cancelled.

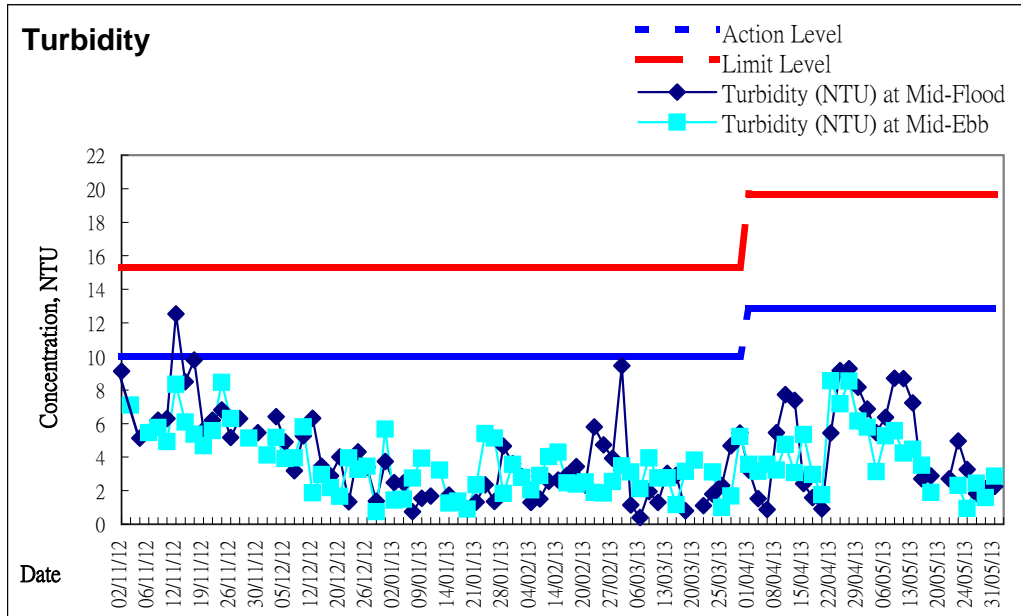
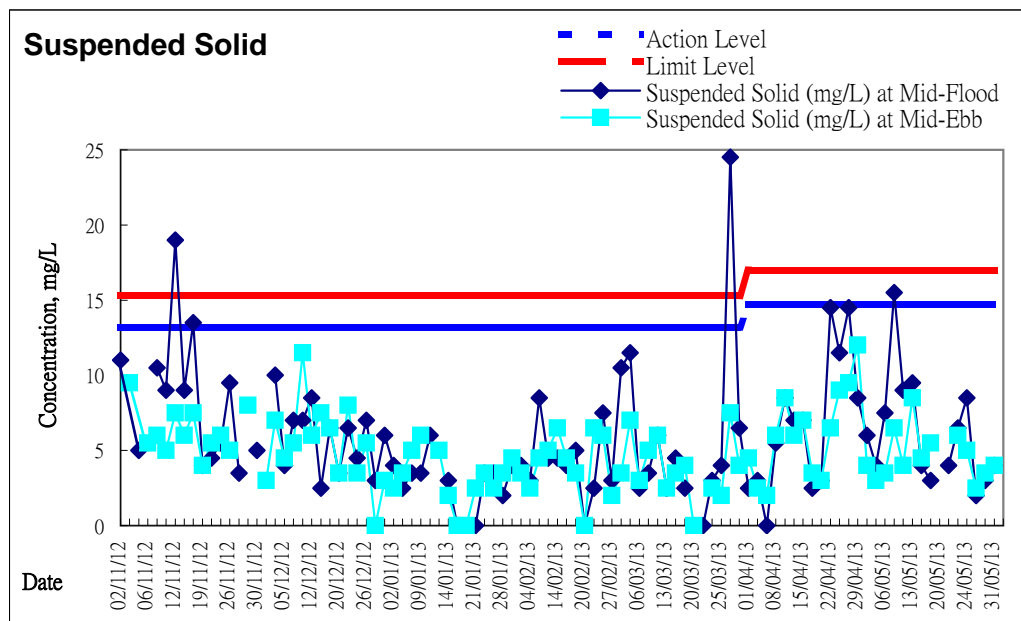
## Graphic Presentation of Water Quality Result of WSD17 - Quarry Bay

- Two sets of Suspended Solid Action and Limit levels for the dry season (the period from October to March) and wet season (the period from April to September).
- New sets Turbidity and SS Action Level and Limit Level for dry and wet season were approved by EPD on 19 Oct 2011
- Due to hoisting of amber rainstorm warning, the water quality monitoring for ebb tide 20 May 2013 was cancelled.

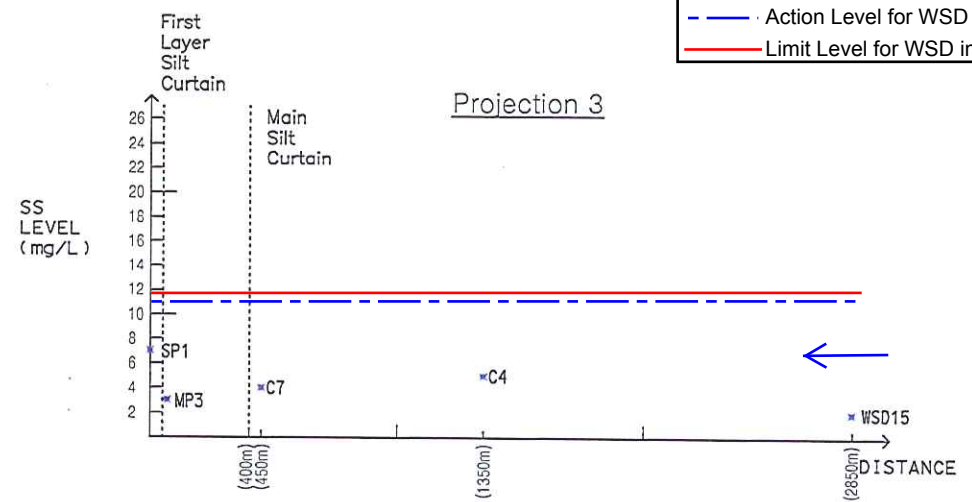
Description: WSD9 was located at downstream which was well within the Action Level.

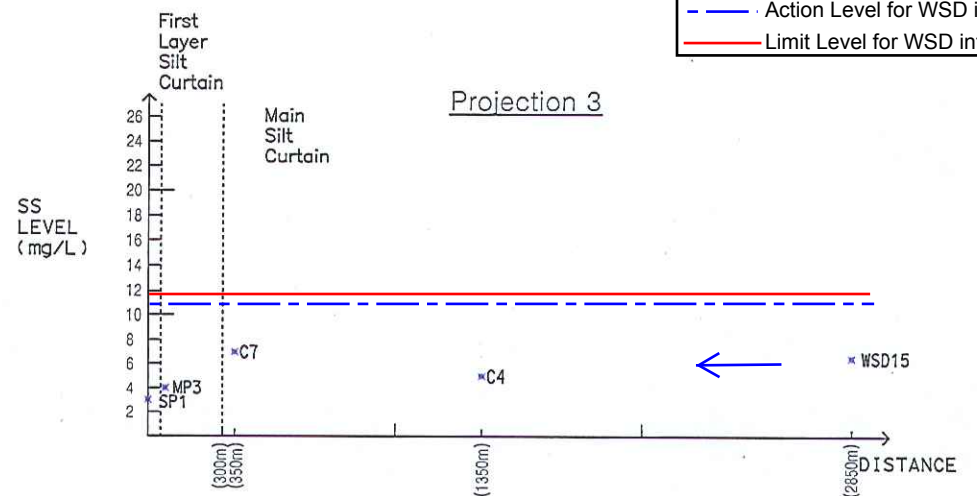
Description: WSD9 was located at upstream which was well within the Action Level.

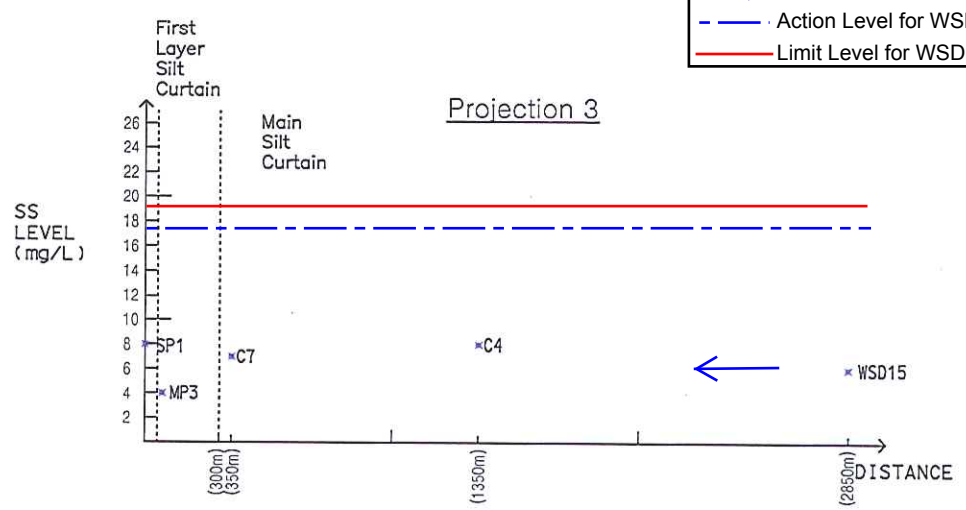
Description: WSD9 was located at downstream which was well within the Action Level.

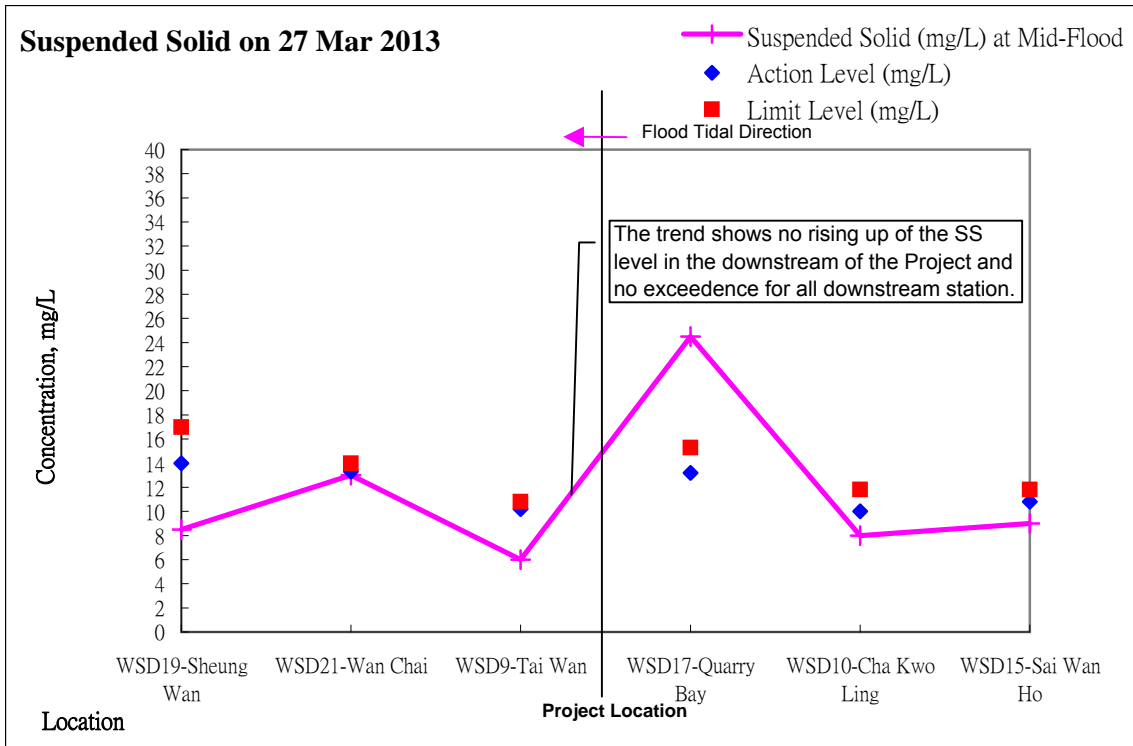
### Graphic Presentation of SS Results Against the Tidal Movement along Victoria Harbour

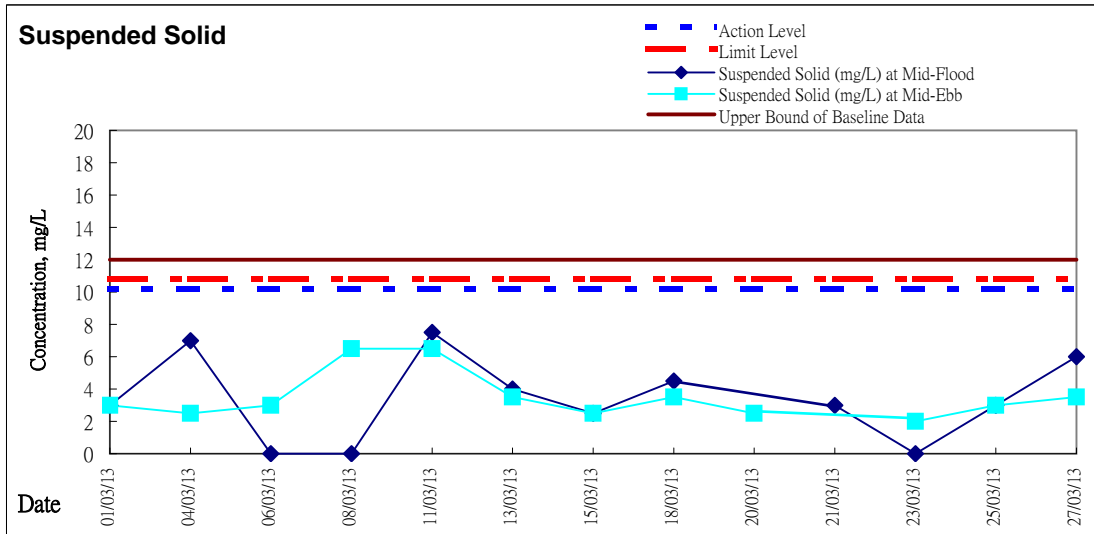
Graphic Presentation of Water Quality Result of WSD9 - Tai Wan with respect to Local Variation

Remarks: WSD9 is located at upstream during the ebb tides while at downstream during flood tides.

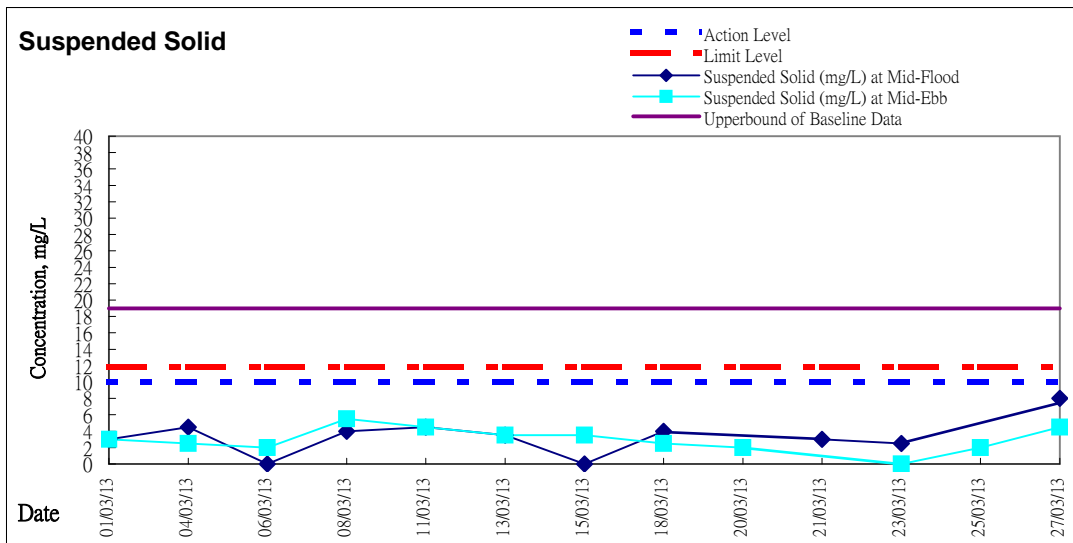
Graphic Presentation of Water Quality Result of WSD10 - Cha Kwo Ling with respect to Local Variation

Remarks: WSD10 is located at upstream during the flood tides while at downstream during ebb tides.

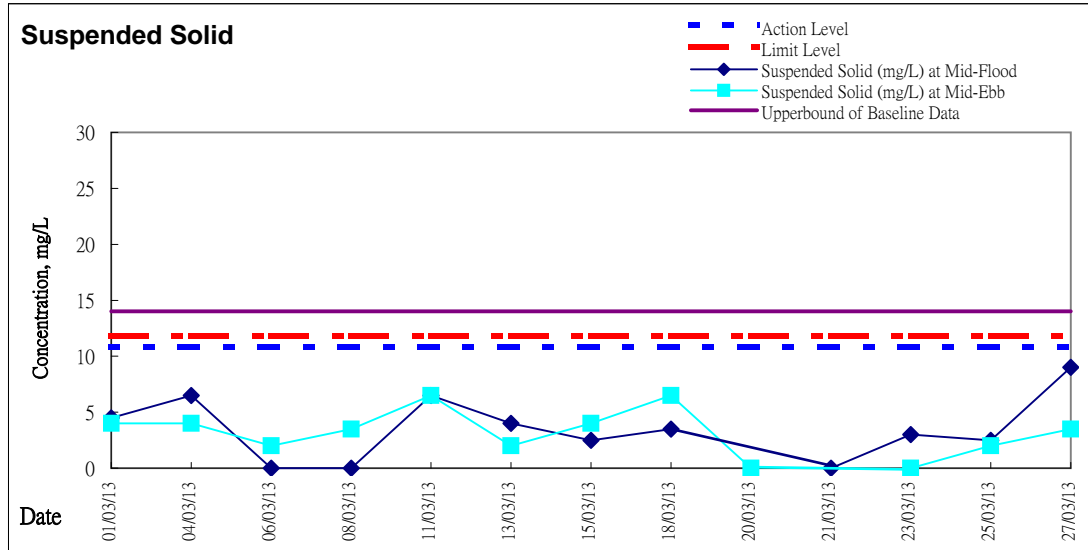
Graphic Presentation of Water Quality Result of WSD15 - Sai Wan Ho with respect to Local Variation

Remarks: WSD15 is located at upstream during the flood tides while at downstream during ebb tides.

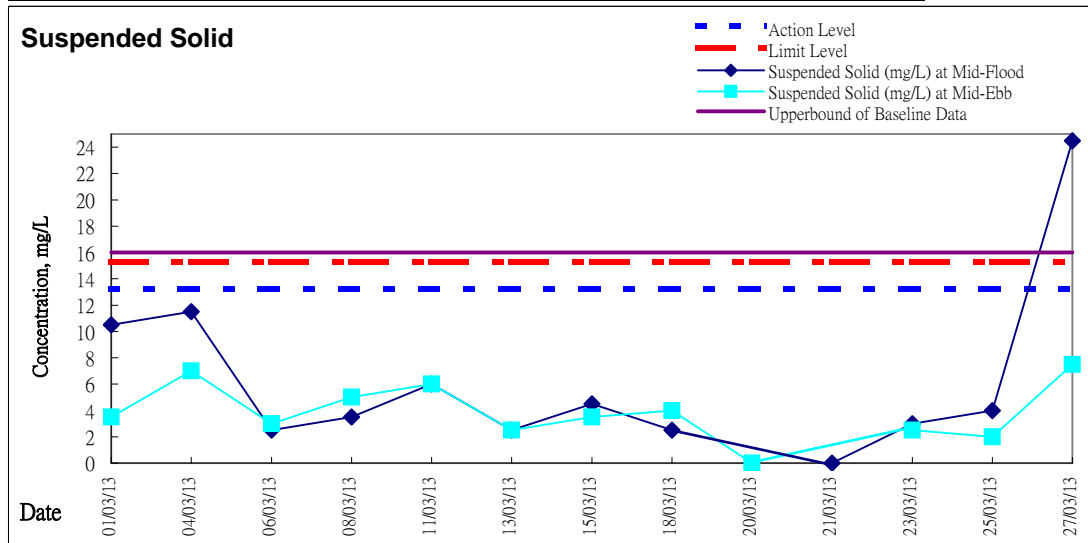
Graphic Presentation of Water Quality Result of WSD17 - Quarry Bay with respect to Local Variation

Remarks: WSD17 is located at upstream during the flood tides while at downstream during ebb tides.

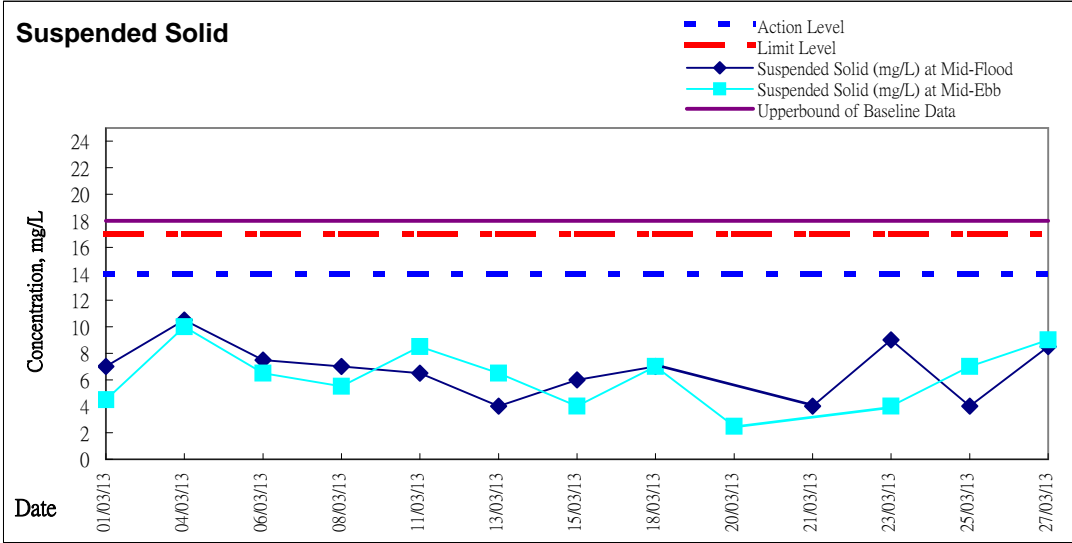
Graphic Presentation of Water Quality Result of WSD19 - Sheung Wan with respect to Local Variation

Remarks: WSD19 is located at upstream during the ebb tides while at downstream during flood tides.

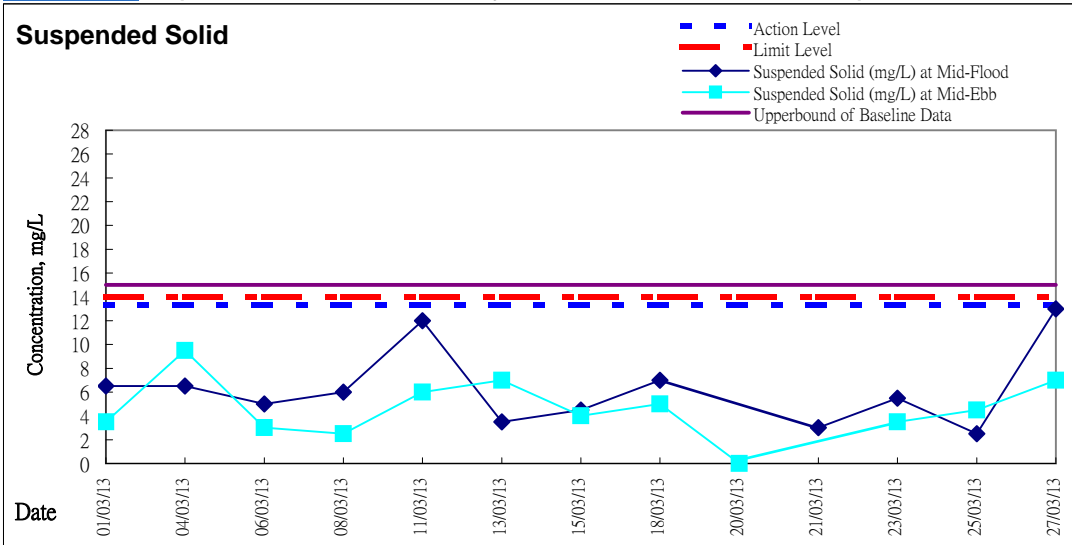
Graphic Presentation of Water Quality Result of WSD21 - Wan Chai with respect to Local Variation

Remarks: WSD21 is located at upstream during the ebb tides while at downstream during flood tides.
