CONTRACT NO: KL/2009/01
SITE FORMATION FOR
KAI TAK CRUISE TERMINAL DEVELOPMENT

QUARTERLY ENVIRONMENTAL
MONITORING & AUDIT REPORT

- SEPTEMBER TO NOVEMBER -

- 2013 -

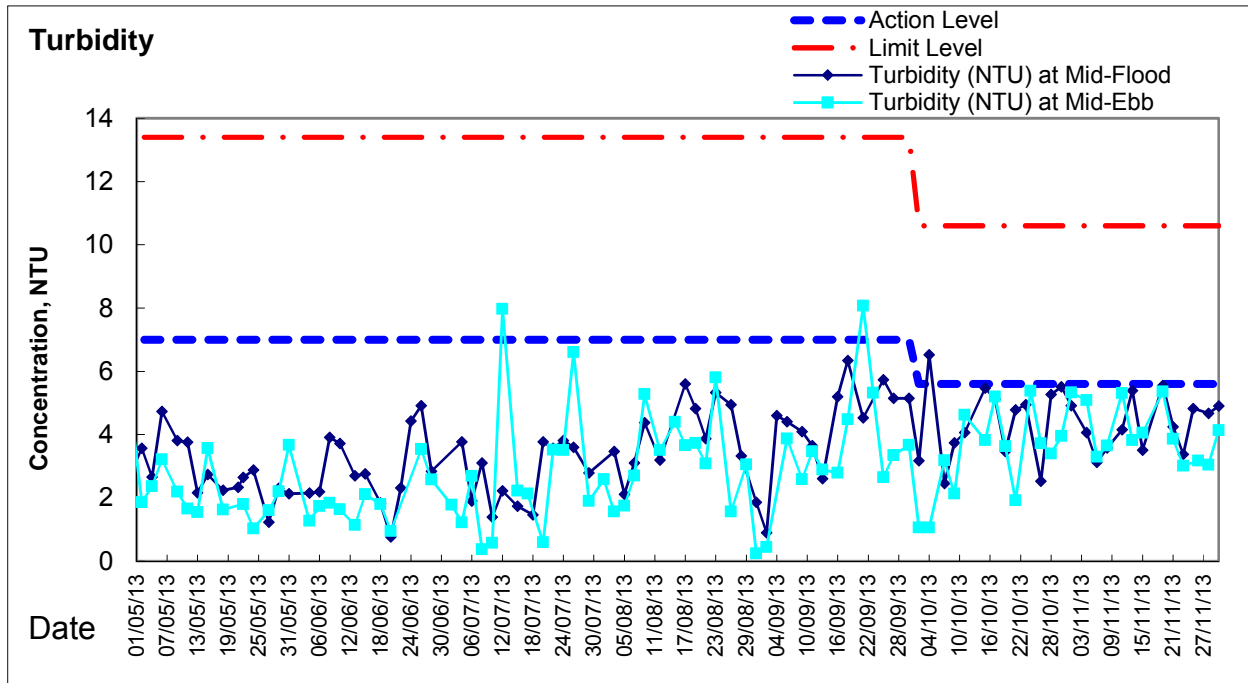
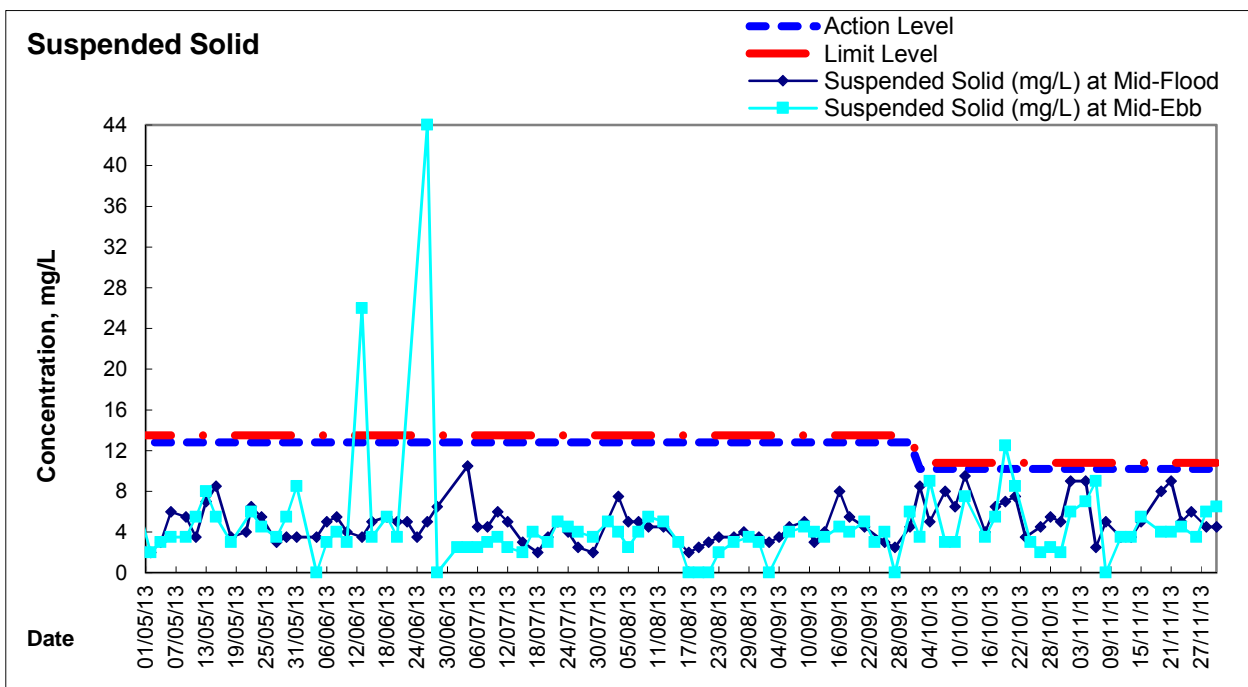
Graphic Presentation of Water Quality Result of WSD9 - Tai Wan

- Two sets of Suspended Solid Action and Limit levels for the dry season (October to March) and wet season (April to September).
- New sets of Turbidity and SS Action Level and Limit Level for dry and wet season were approved by EPD on 19 Oct 2011
- Due to hoisting of Amber Rainstorm Signal, the water quality monitoring on 4 Sep 2013 (ebb tide) was cancelled.
- Due to hoisting of No. 8 Southwest Gale or Storm Signal, the water quality monitoring on 23 Sep 2013 (flood tide) was cancelled.

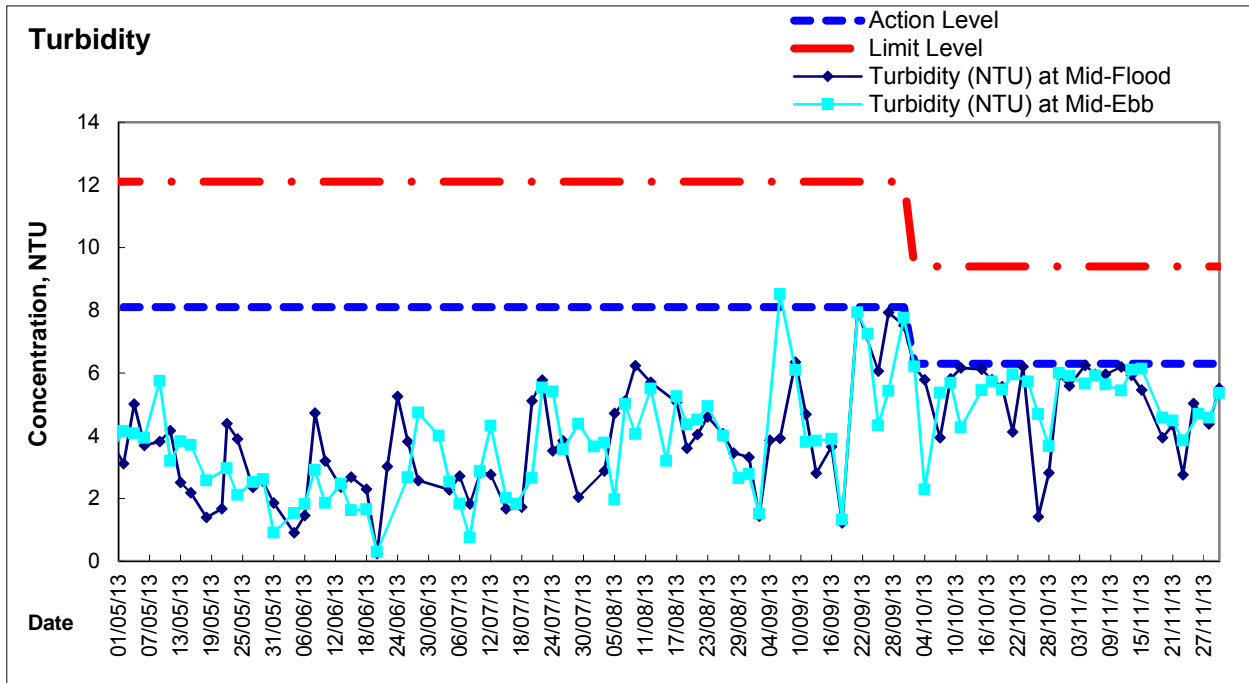
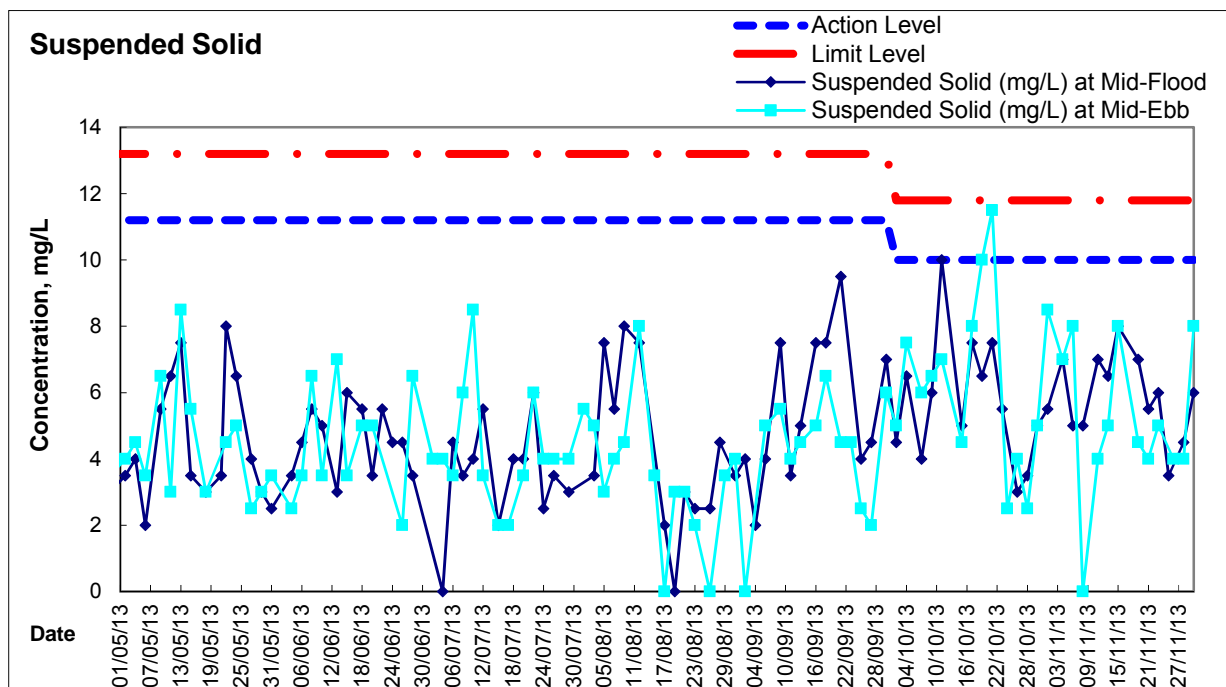
Graphic Presentation of Water Quality Result of WSD10 - Cha Kwo Ling

- Two sets of Suspended Solid Action and Limit levels for the dry season (October to March) and wet season (April to September).
- New sets of Turbidity and SS Action Level and Limit Level for dry and wet season were approved by EPD on 19 Oct 2011
- Due to hoisting of Amber Rainstorm Signal, the water quality monitoring on 4 Sep 2013 (ebb tide) was cancelled.
- Due to hoisting of No. 8 Southwest Gale or Storm Signal, the water quality monitoring on 23 Sep 2013 (flood tide) was cancelled.

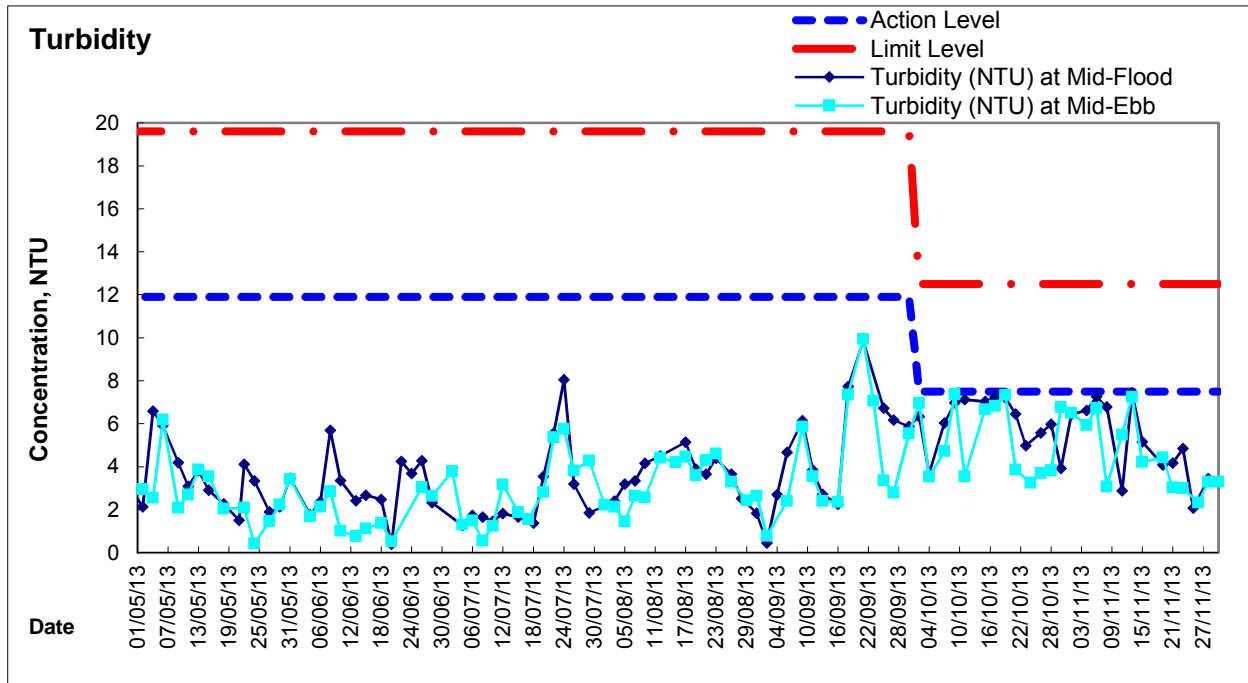
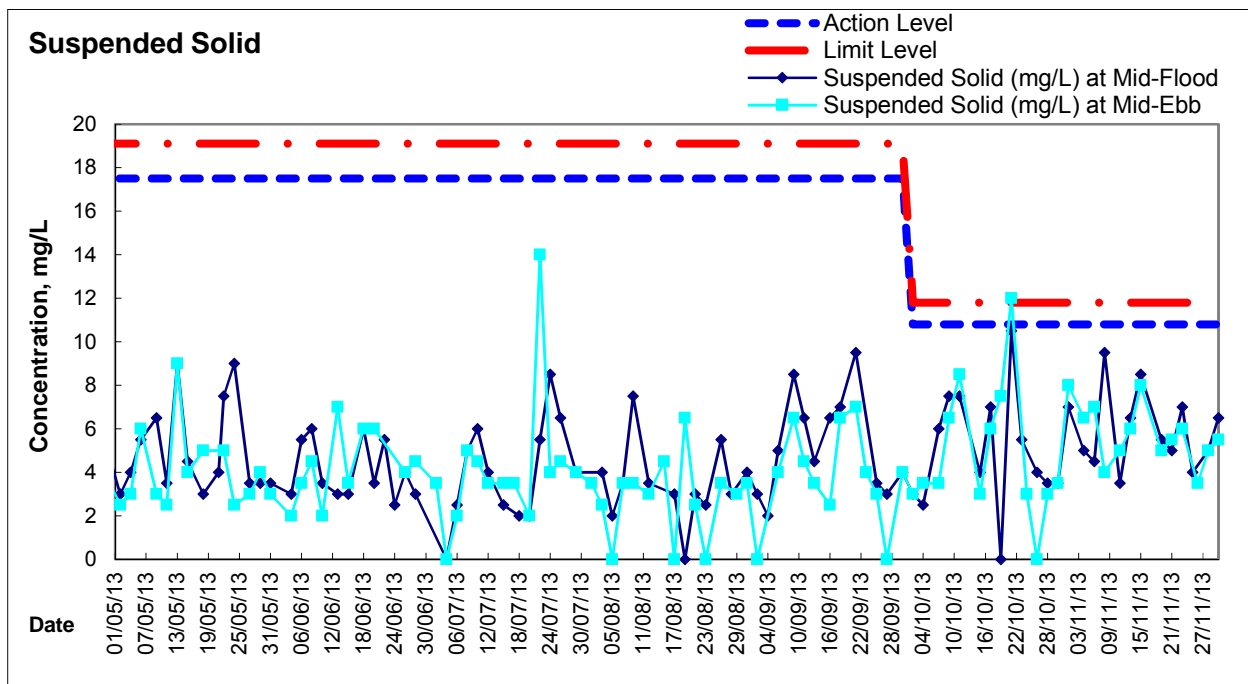
Graphic Presentation of Water Quality Result of WSD15 - Sai Wan Ho

- Two sets of Suspended Solid Action and Limit levels for the dry season (October to March) and wet season (April to September).
- New sets of Turbidity and SS Action Level and Limit Level for dry and wet season were approved by EPD on 19 Oct 2011
- Due to hoisting of Amber Rainstorm Signal, the water quality monitoring on 4 Sep 2013 (ebb tide) was cancelled.
- Due to hoisting of No. 8 Southwest Gale or Storm Signal, the water quality monitoring on 23 Sep 2013 (flood tide) was cancelled.

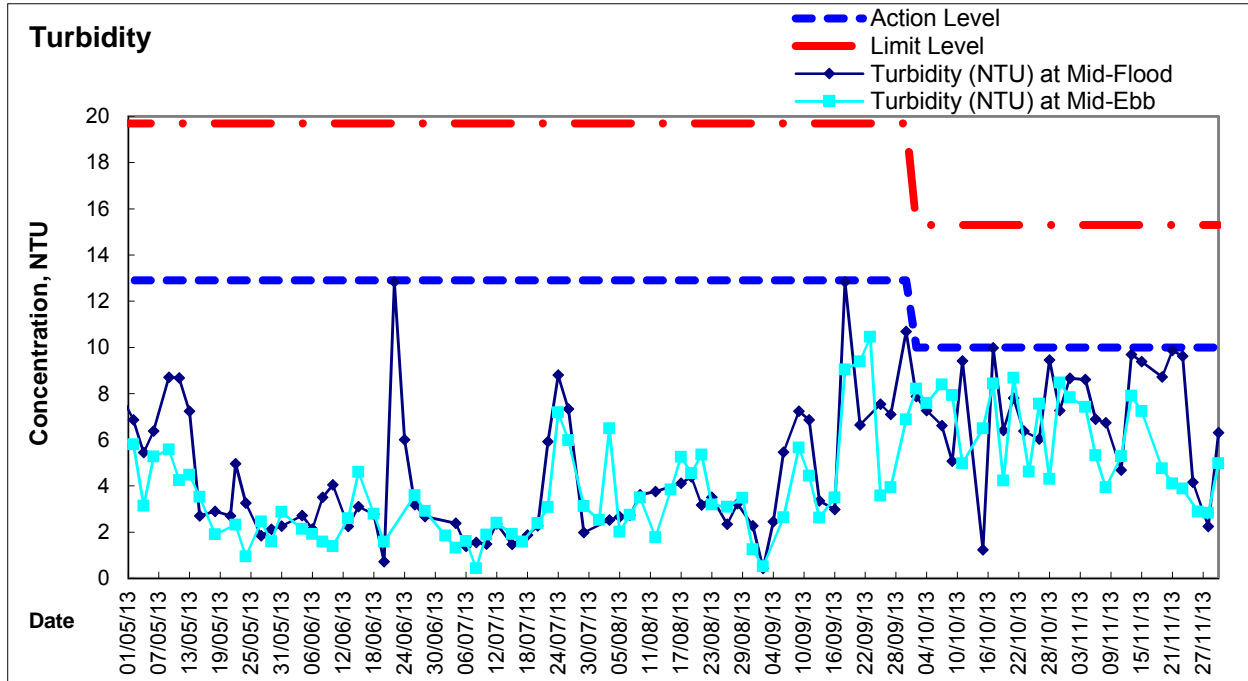
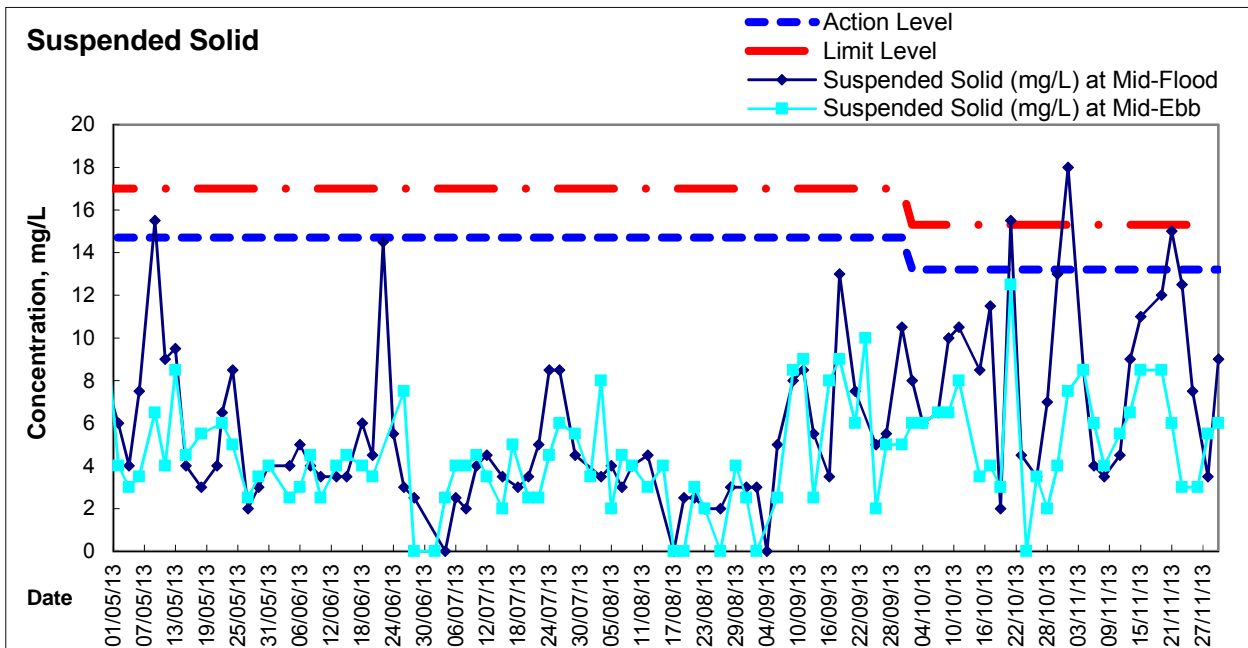
Graphic Presentation of Water Quality Result of WSD17 - Quarry Bay

- Two sets of Suspended Solid Action and Limit levels for the dry season (October to March) and wet season (April to September).
- New sets of Turbidity and SS Action Level and Limit Level for dry and wet season were approved by EPD on 19 Oct 2011
- Due to hoisting of Amber Rainstorm Signal, the water quality monitoring on 4 Sep 2013 (ebb tide) was cancelled.
- Due to hoisting of No. 8 Southwest Gale or Storm Signal, the water quality monitoring on 23 Sep 2013 (flood tide) was cancelled.

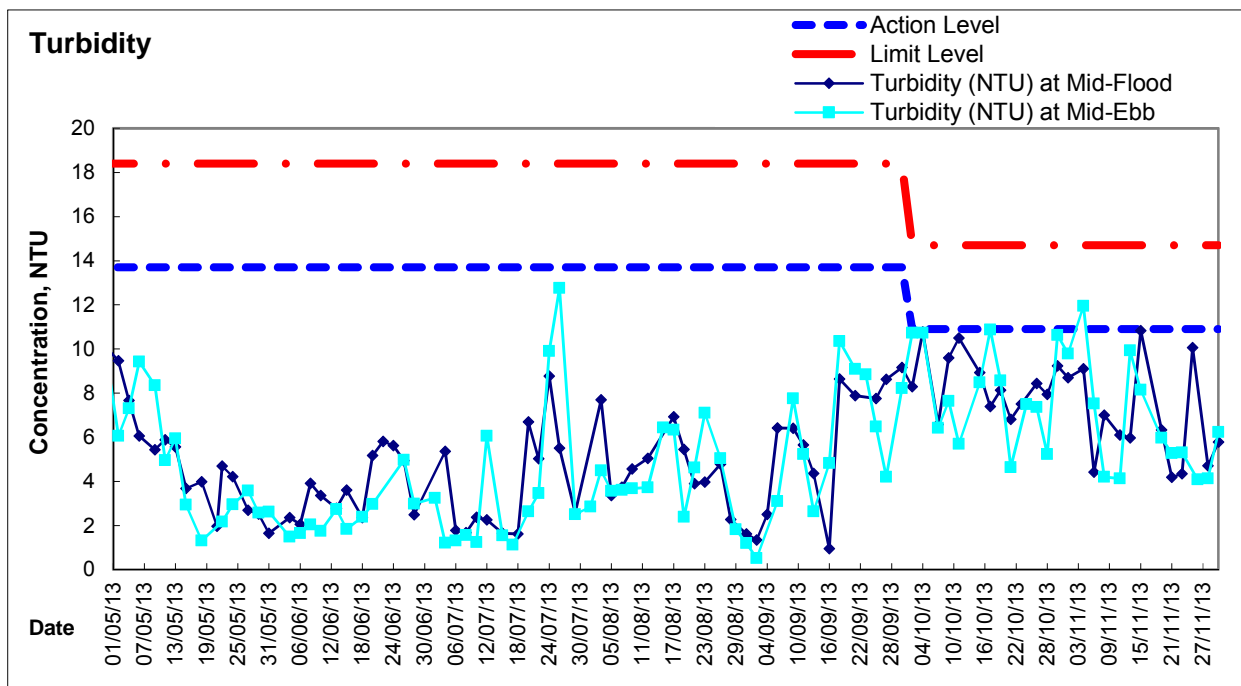
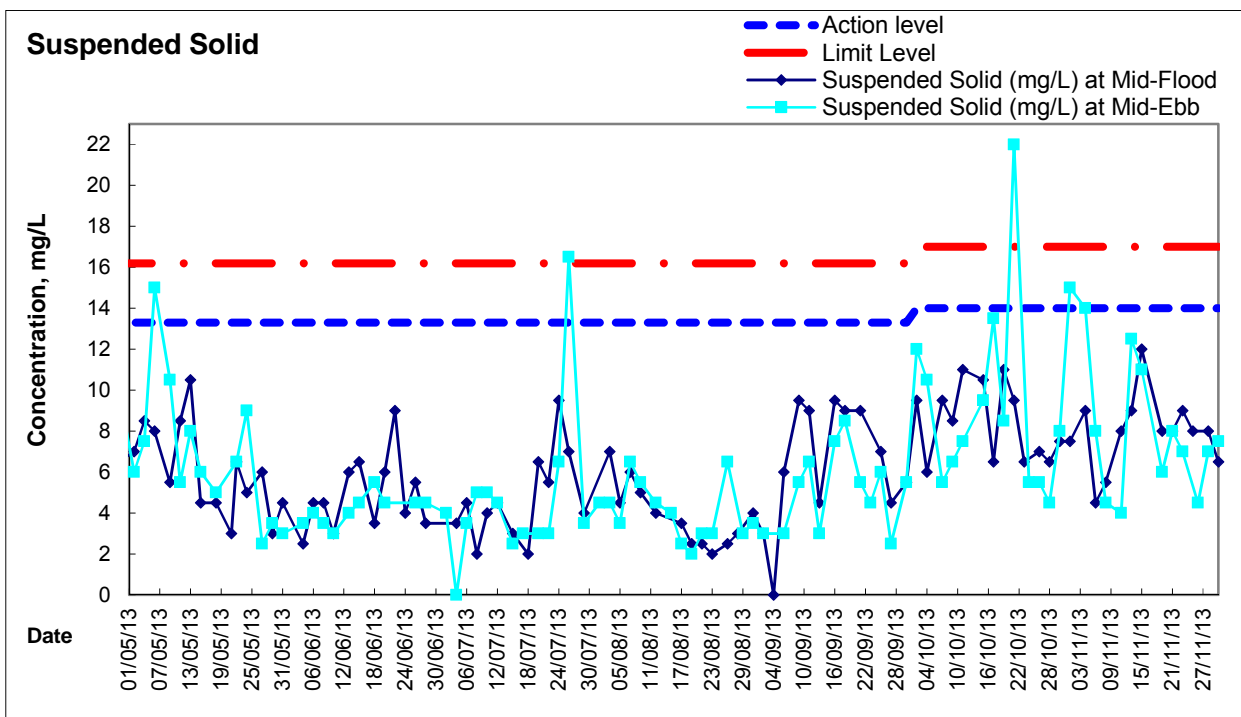
Graphic Presentation of Water Quality Result of WSD19 - Sheung Wan

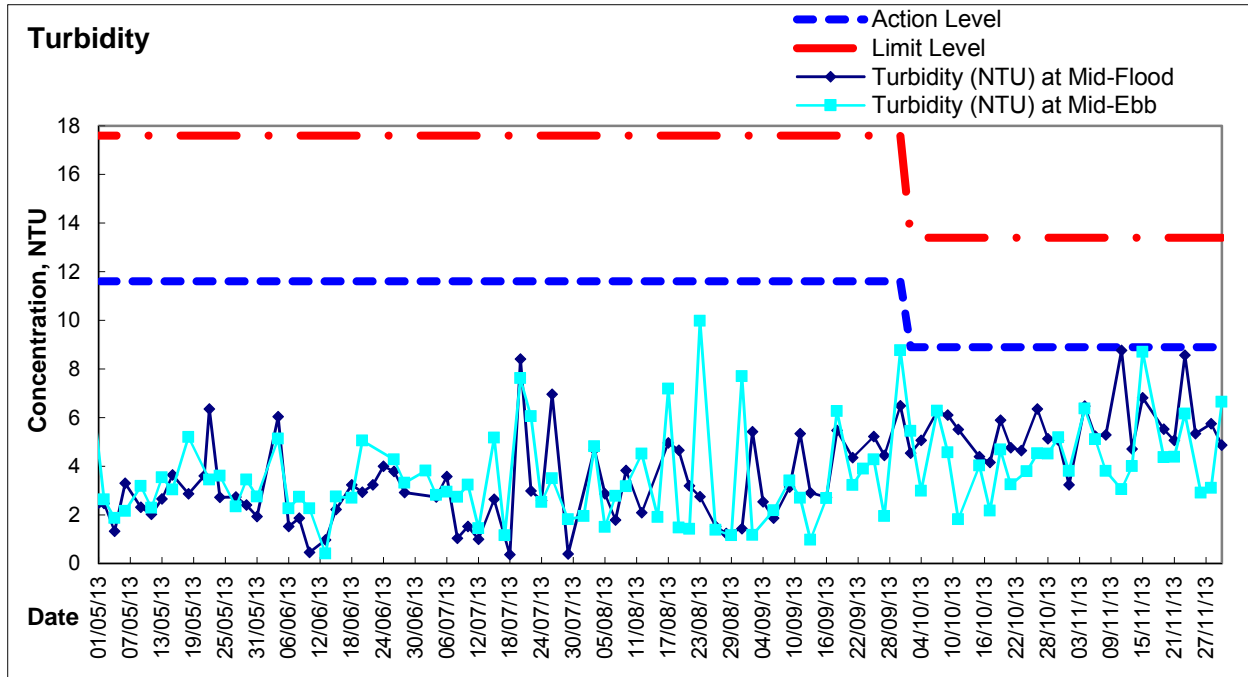
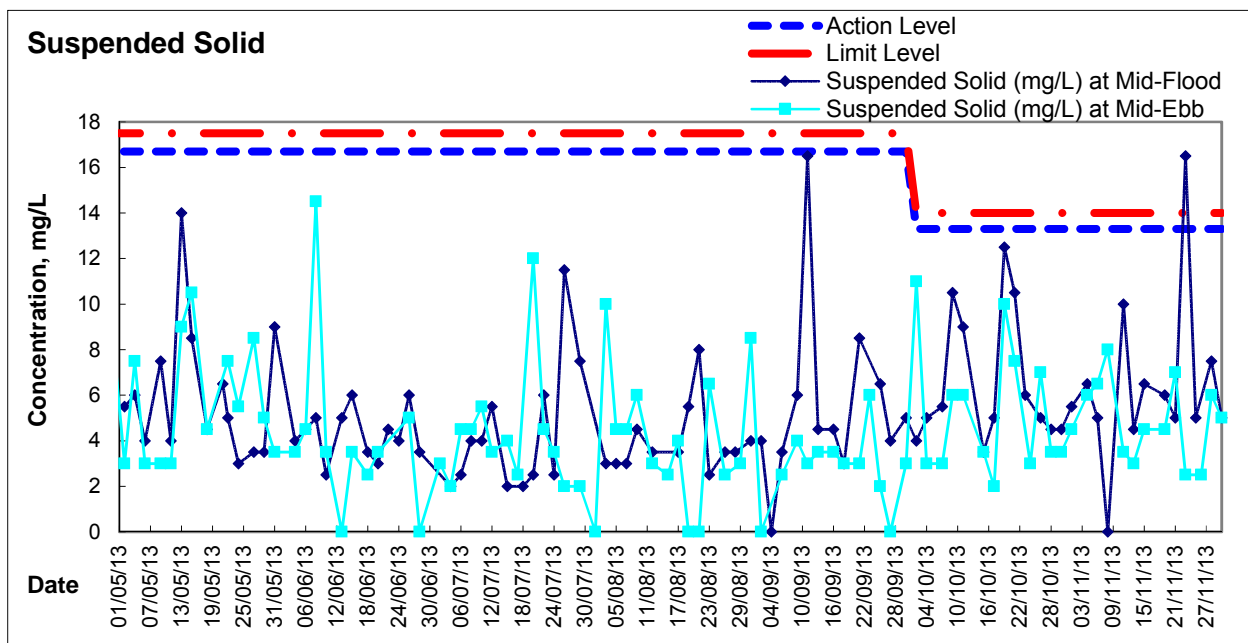
Graphic Presentation of Water Quality Result of WSD21 - Wan Chai

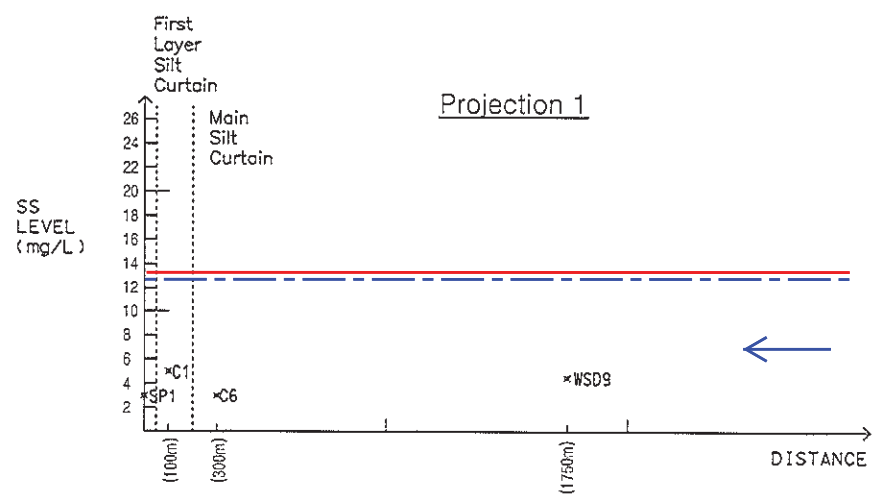
Description: WSD9 was located at upstream which was well within the action level.

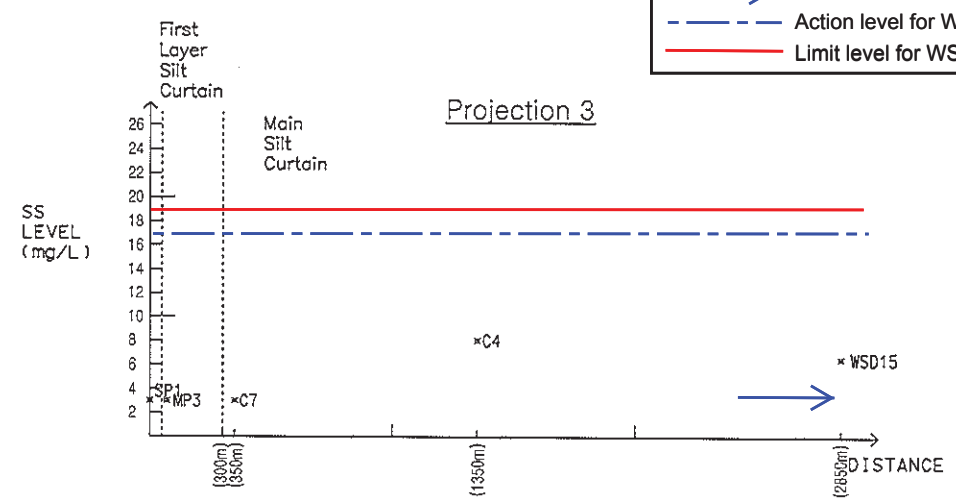
Description: WSD15 was located at downstream which was well within the action level.

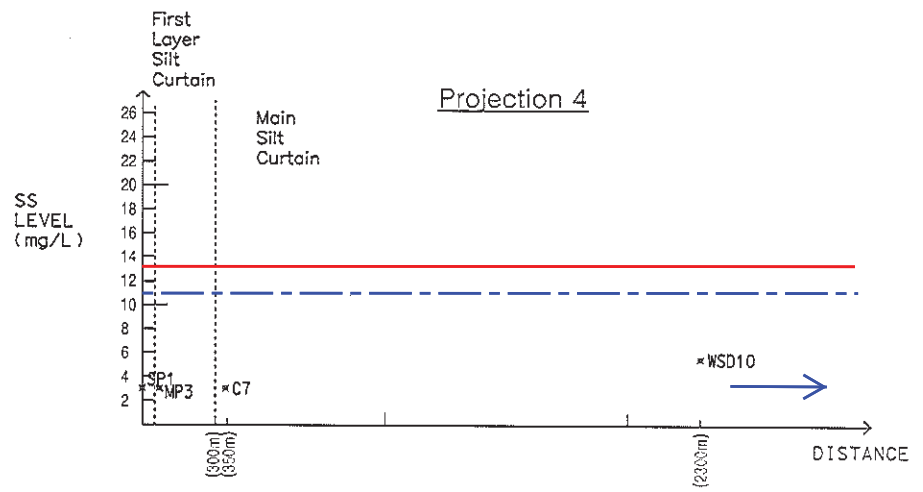
Description: WSD10 was located at downstream which was well within the action level.

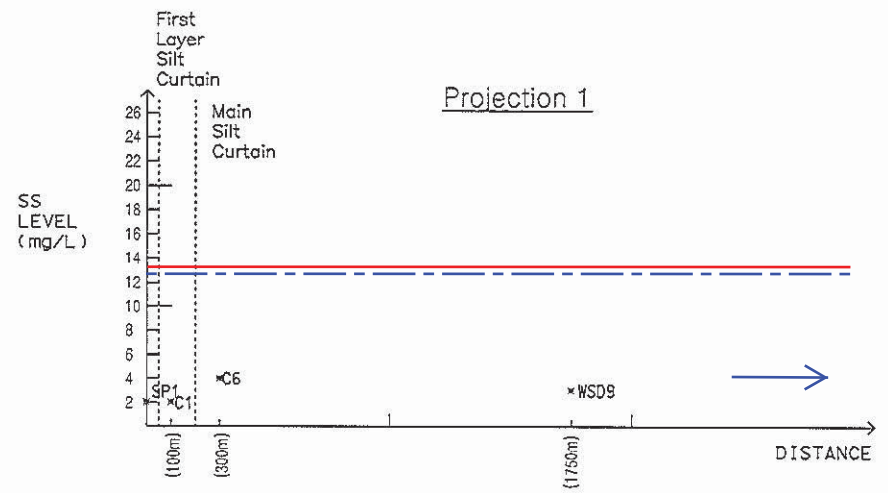
Description: WSD9 was located at downstream which was well within the action level.

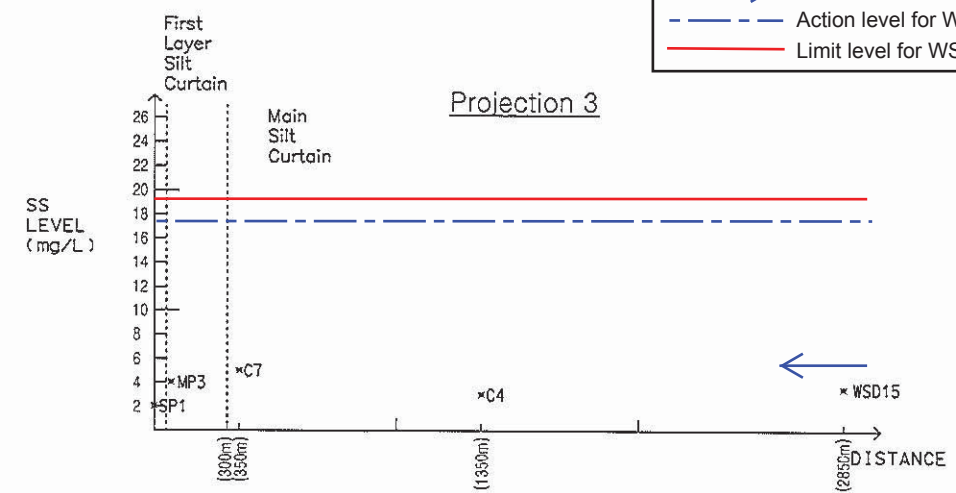
Description: WSD15 was located at upstream which was well within the action level.

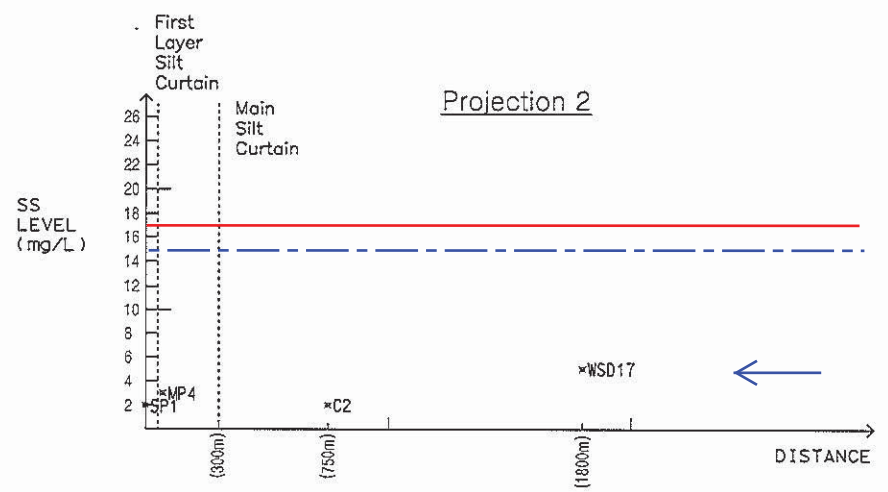
Description: WSD17 was located at upstream which was well within the action level.

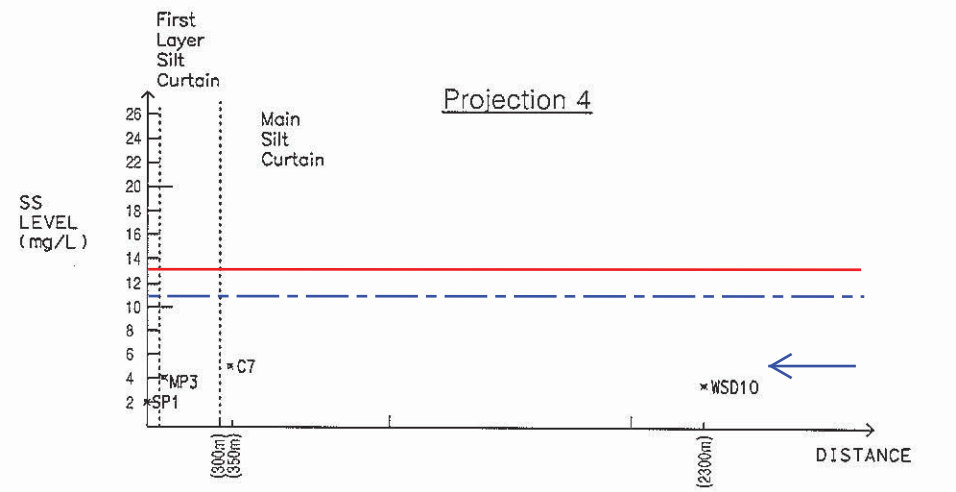
Description: WSD10 was located at upstream which was well within the action level.

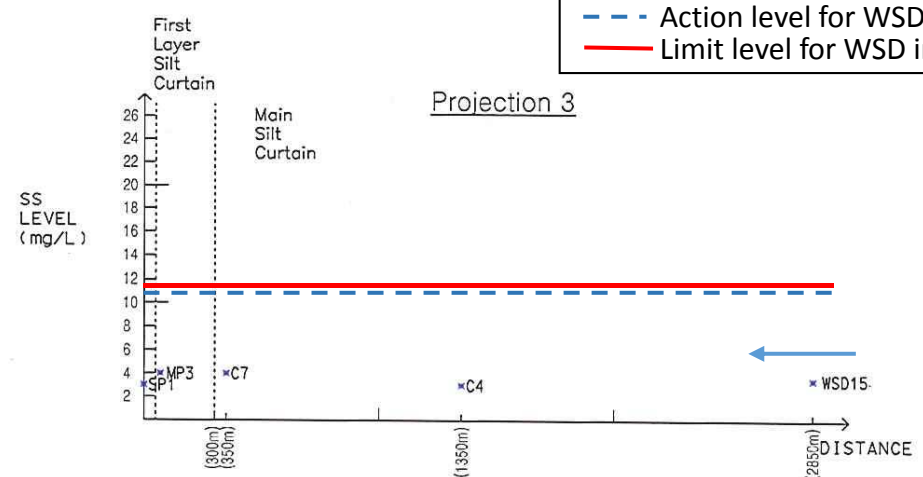
Description: WSD15 was located at upstream which was well within the Action Level.

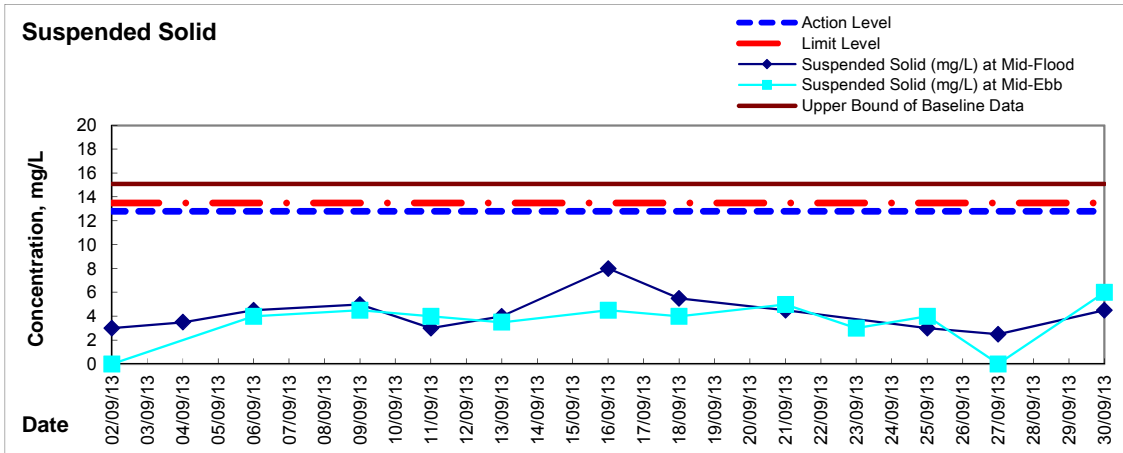
Graphic Presentation of Water Quality Result of WSD9 - Tai Wan with respect to Local Variation

Remarks: WSD9 is located at upstream during the ebb tides while at downstream during flood tides.
 - Due to hoisting of Amber Rainstorm Signal, the water quality monitoring on 4 Sep 2013 (ebb tide) was cancelled.
 - Due to hoisting of No. 8 Southwest Gale or Storm Signal, the water quality monitoring on 23 Sep 2013 (flood tide) was cancelled.

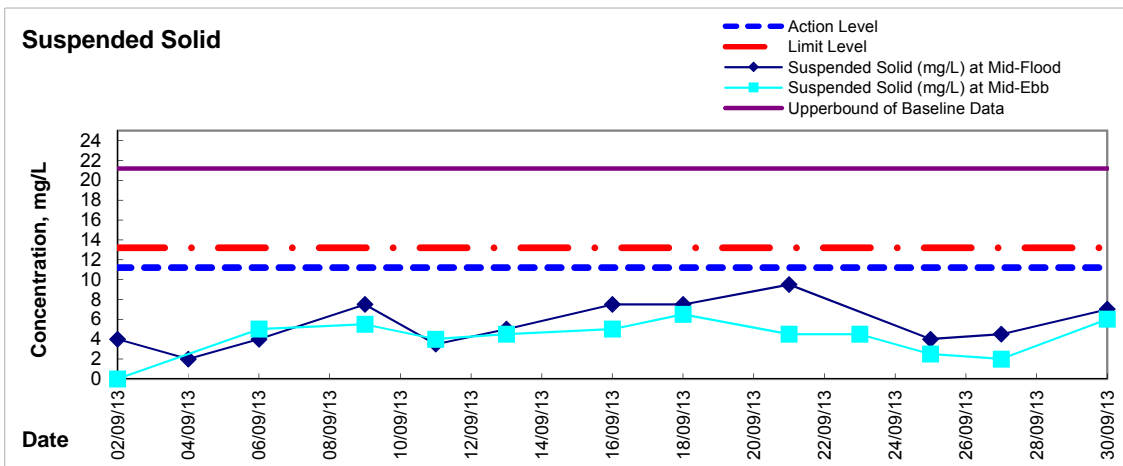
Graphic Presentation of Water Quality Result of WSD10 - Cha Kwo Ling with respect to Local Variation

Remarks: WSD10 is located at upstream during the flood tides while at downstream during ebb tides.
 - Due to hoisting of Amber Rainstorm Signal, the water quality monitoring on 4 Sep 2013 (ebb tide) was cancelled.
 - Due to hoisting of No. 8 Southwest Gale or Storm Signal, the water quality monitoring on 23 Sep 2013 (flood tide) was cancelled.

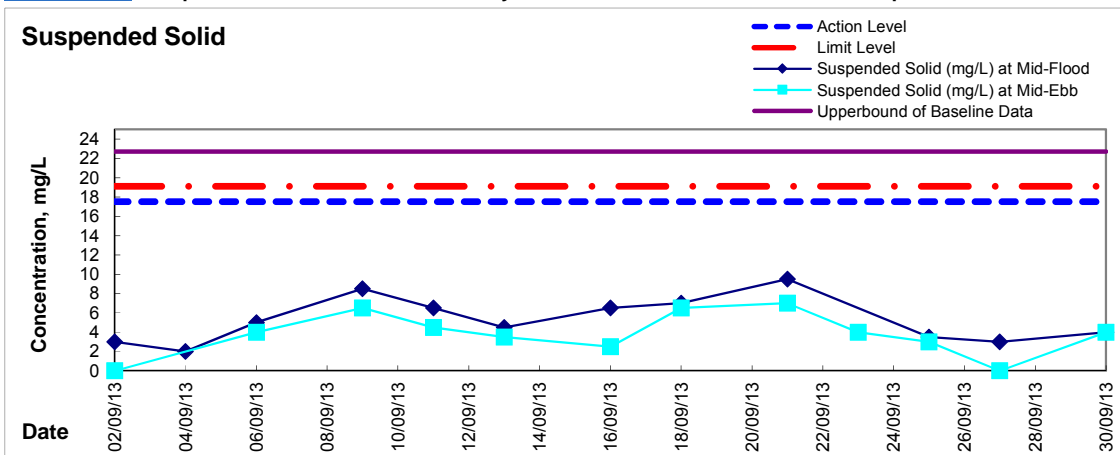
Graphic Presentation of Water Quality Result of WSD15 - Sai Wan Ho with respect to Local Variation

Remarks: WSD15 is located at upstream during the flood tides while at downstream during ebb tides.

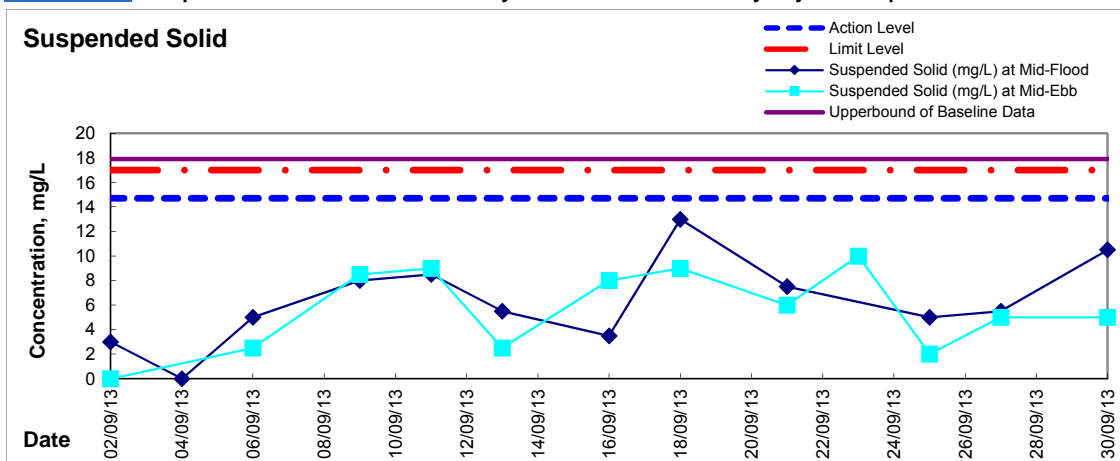
Graphic Presentation of Water Quality Result of WSD17 - Quarry Bay with respect to Local Variation

Remarks: WSD17 is located at upstream during the flood tides while at downstream during ebb tides.

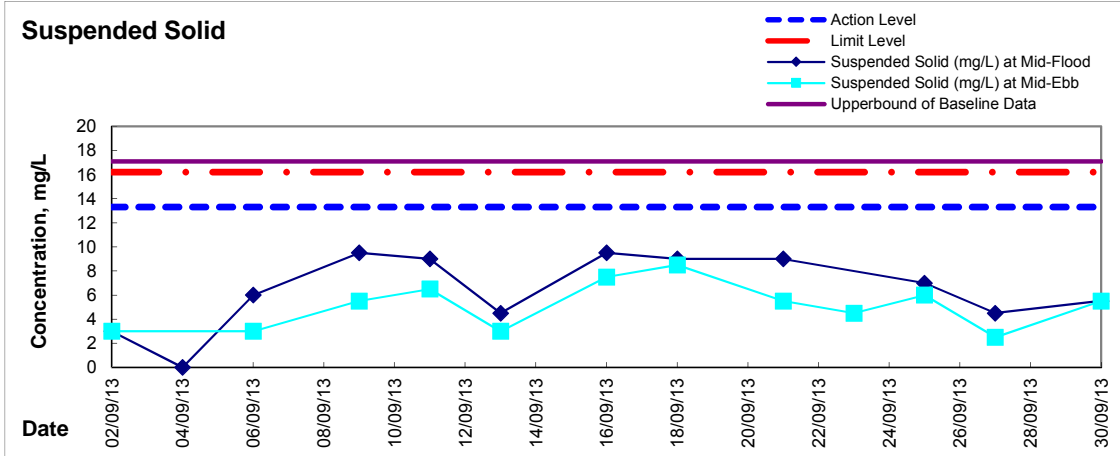
Graphic Presentation of Water Quality Result of WSD19 - Sheung Wan with respect to Local Variation

Remarks: WSD19 is located at upstream during the ebb tides while at downstream during flood tides.

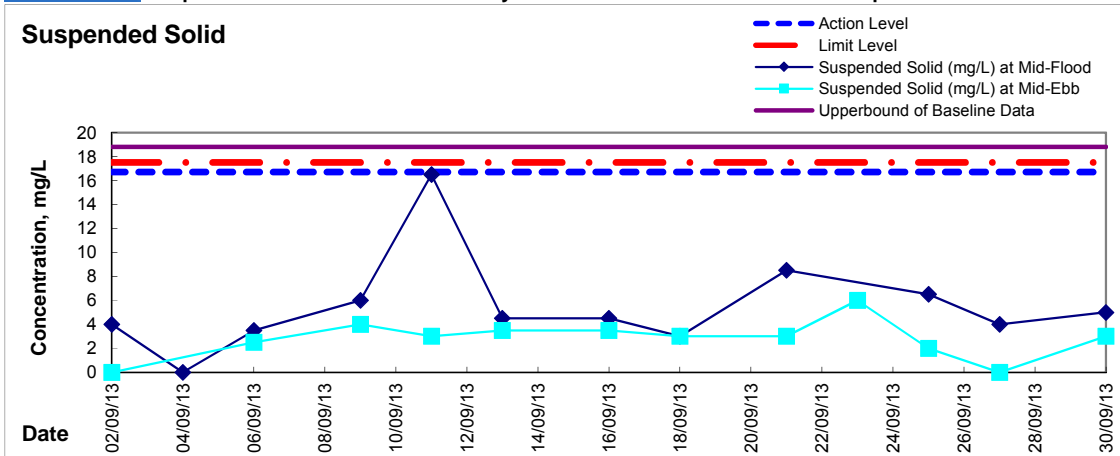
Graphic Presentation of Water Quality Result of WSD21 - Wan Chai with respect to Local Variation

Remarks: WSD21 is located at upstream during the ebb tides while at downstream during flood tides.

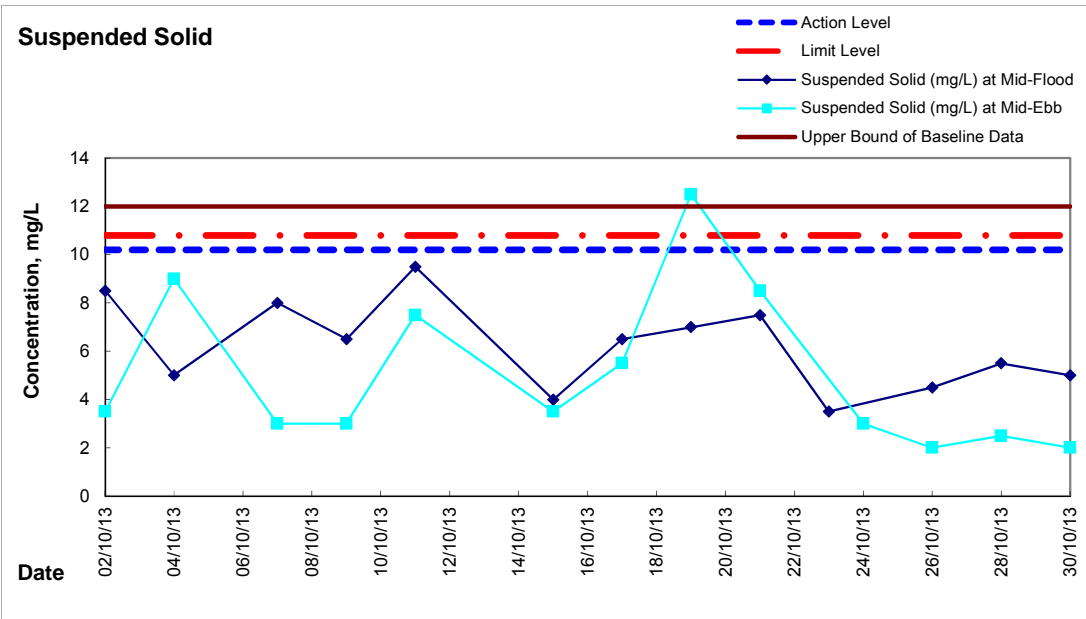
Graphic Presentation of Water Quality Result of WSD9 - Tai Wan with respect to Local Variation

Remarks: WSD9 is located at upstream during the ebb tides while at downstream during flood tides.

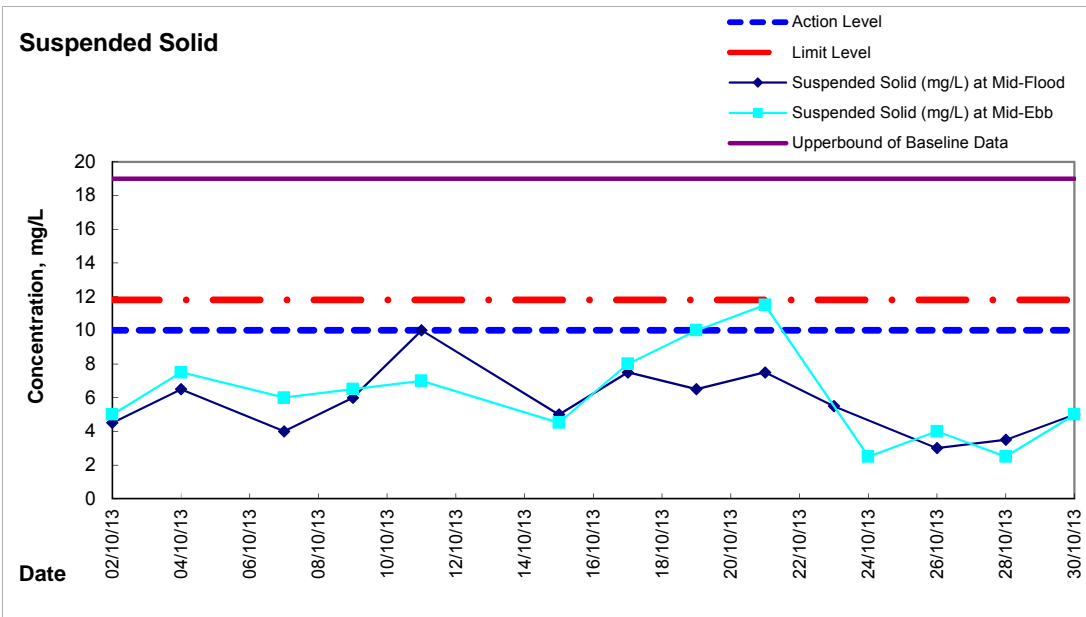
Graphic Presentation of Water Quality Result of WSD10 - Cha Kwo Ling with respect to Local Variation

Remarks: WSD10 is located at upstream during the flood tides while at downstream during ebb tides.

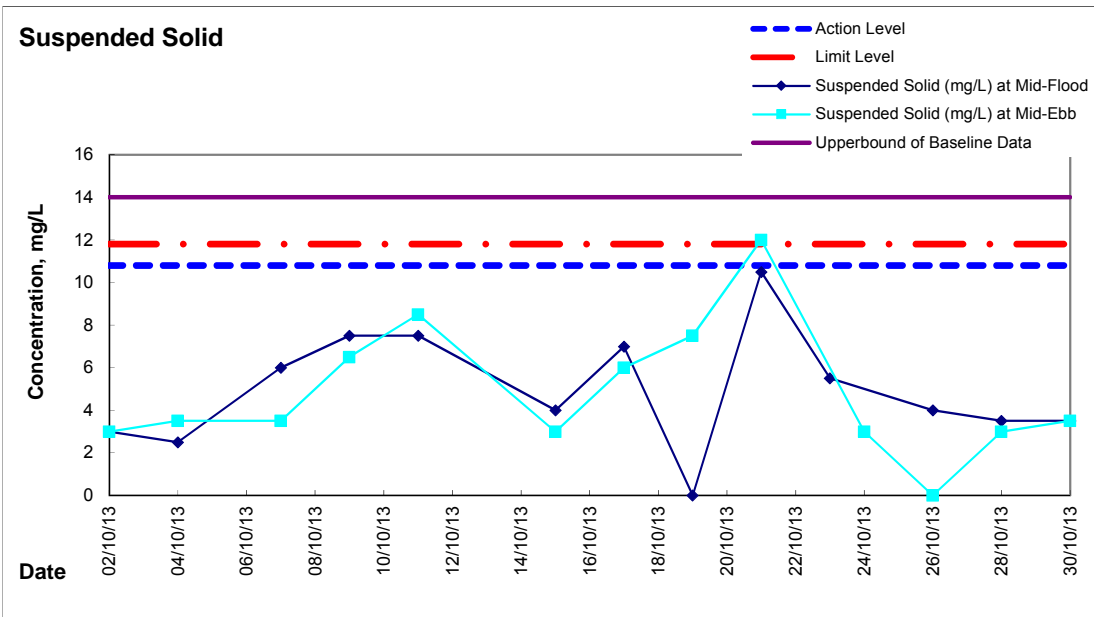
Graphic Presentation of Water Quality Result of WSD15 - Sai Wan Ho with respect to Local Variation

Remarks: WSD15 is located at upstream during the flood tides while at downstream during ebb tides.

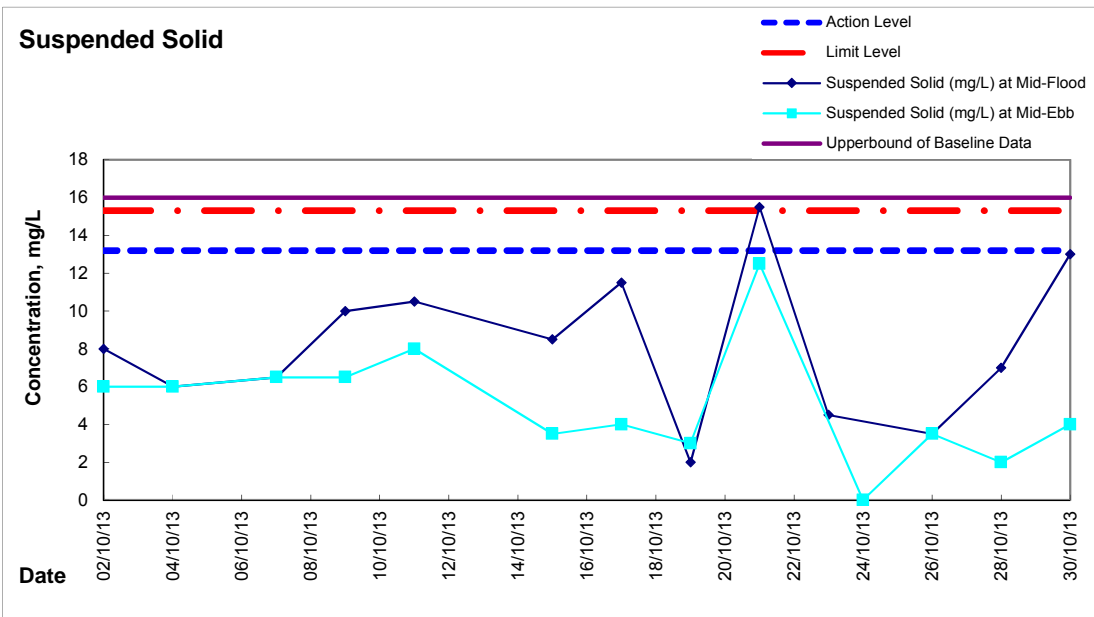
Graphic Presentation of Water Quality Result of WSD17 - Quarry Bay with respect to Local Variation

Remarks: WSD17 is located at upstream during the flood tides while at downstream during ebb tides.

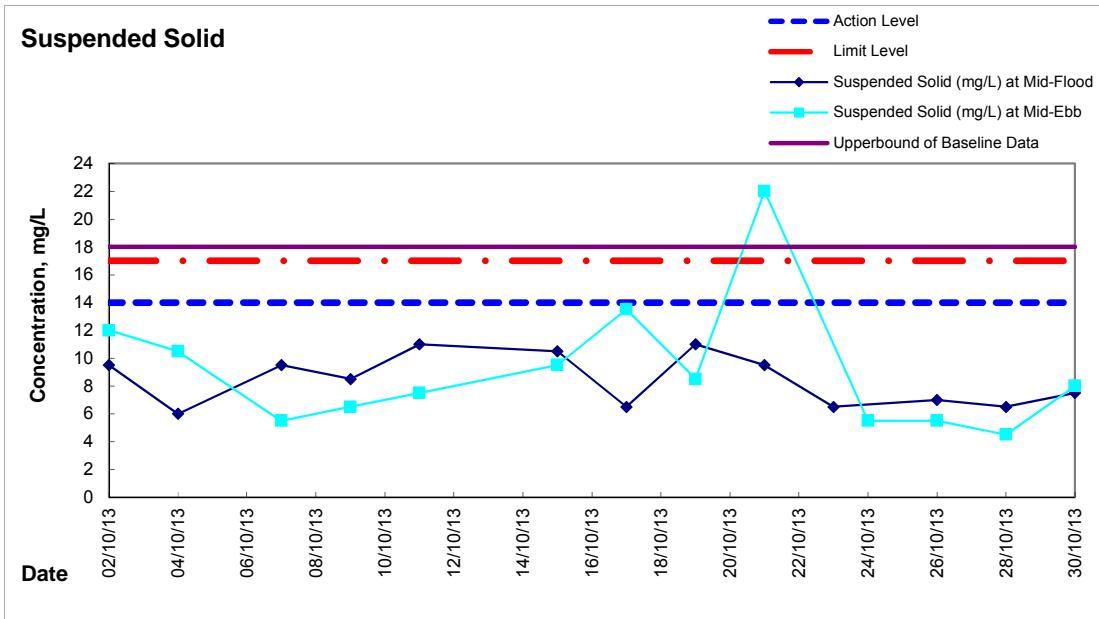
Graphic Presentation of Water Quality Result of WSD19 - Sheung Wan with respect to Local Variation

Remarks: WSD19 is located at upstream during the ebb tides while at downstream during flood tides.

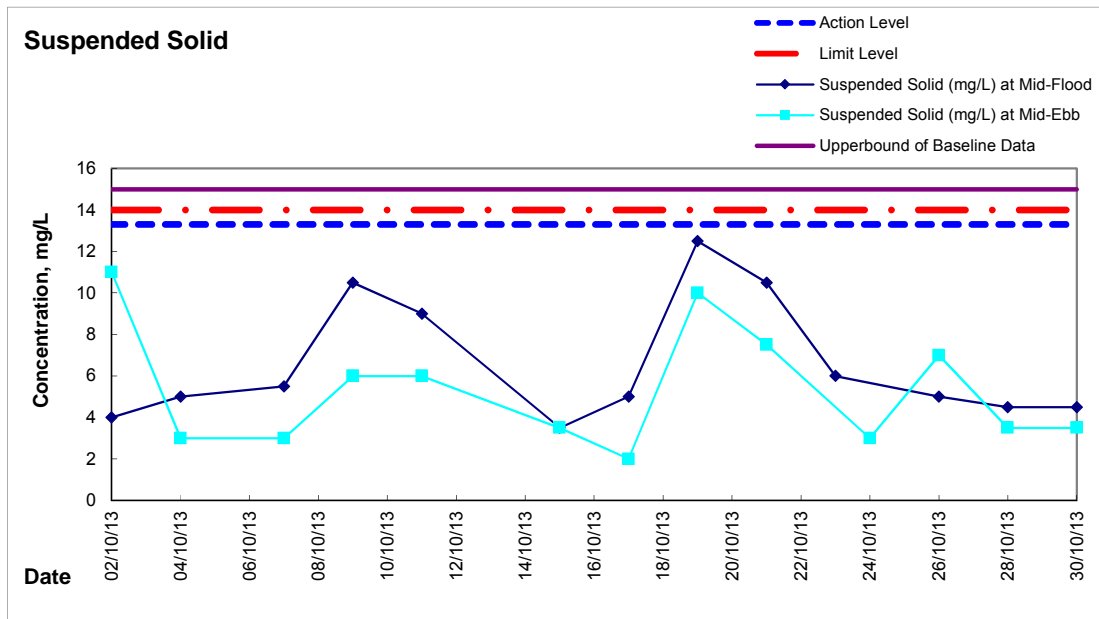
Graphic Presentation of Water Quality Result of WSD21 - Wan Chai with respect to Local Variation

Remarks: WSD21 is located at upstream during the ebb tides while at downstream during flood tides.
