CONTRACT NO: KL/2009/01
SITE FORMATION FOR
KAI TAK CRUISE TERMINAL DEVELOPMENT

QUARTERLY ENVIRONMENTAL
MONITORING & AUDIT REPORT

- SEPTEMBER TO NOVEMBER -

- 2013 -

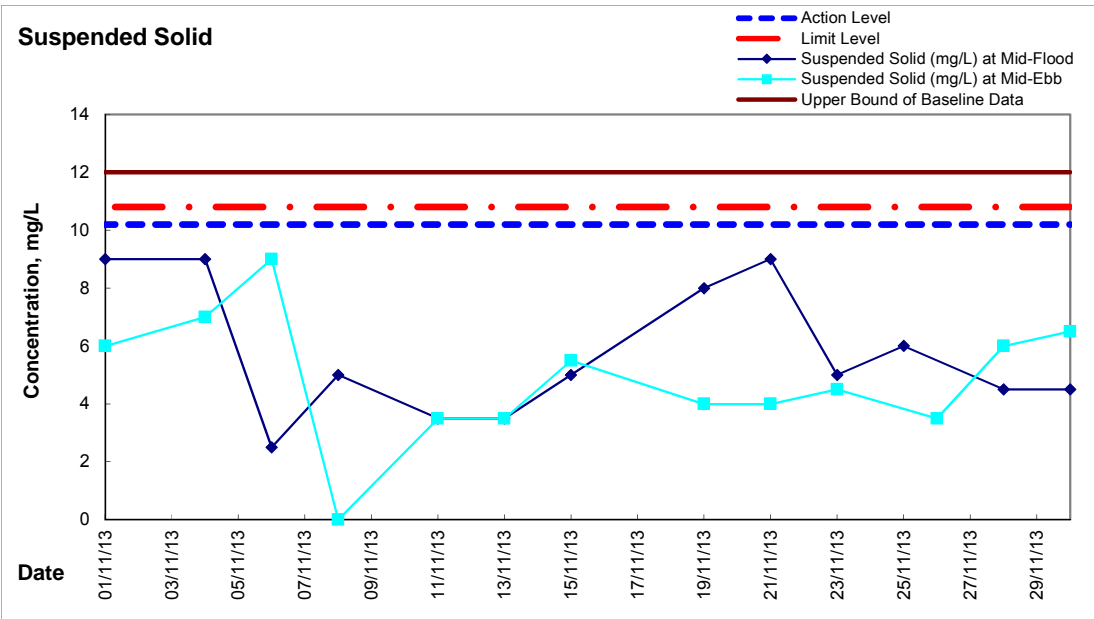
Graphic Presentation of Water Quality Result of WSD9 - Tai Wan with respect to Local Variation

Remarks: WSD9 is located at upstream during the ebb tides while at downstream during flood tides.

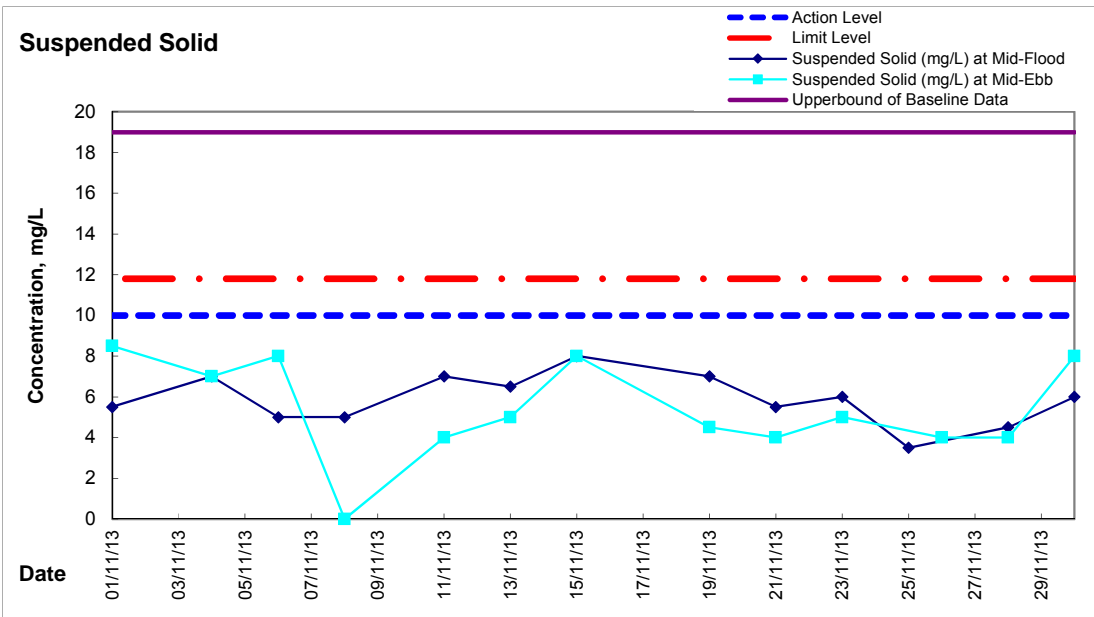
Graphic Presentation of Water Quality Result of WSD10 - Cha Kwo Ling with respect to Local Variation

Remarks: WSD10 is located at upstream during the flood tides while at downstream during ebb tides.

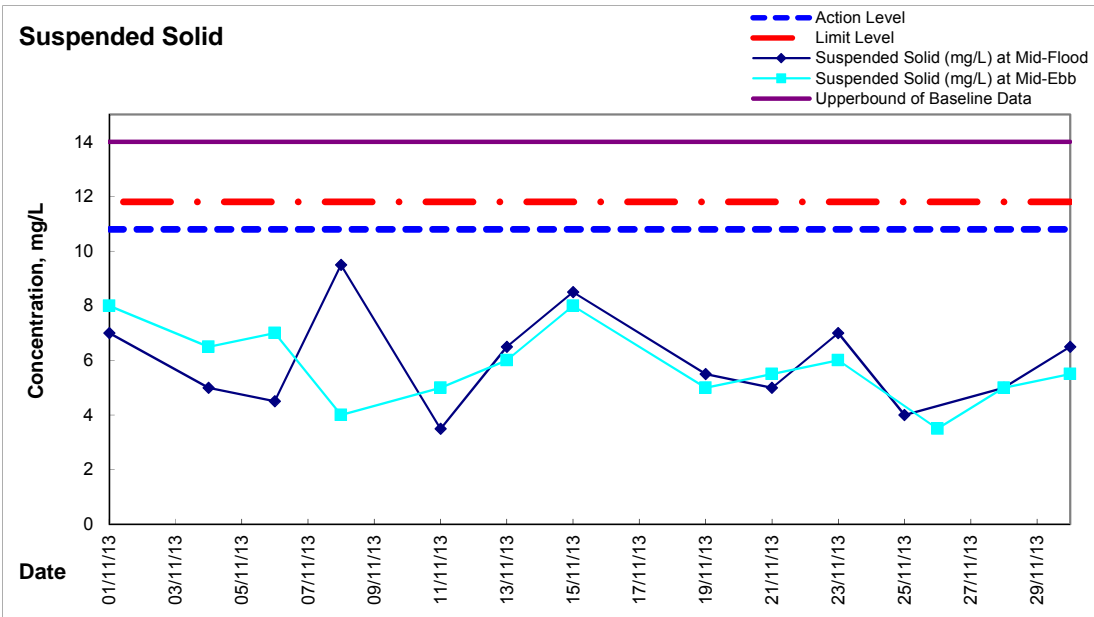
Graphic Presentation of Water Quality Result of WSD15 - Sai Wan Ho with respect to Local Variation

Remarks: WSD15 is located at upstream during the flood tides while at downstream during ebb tides.

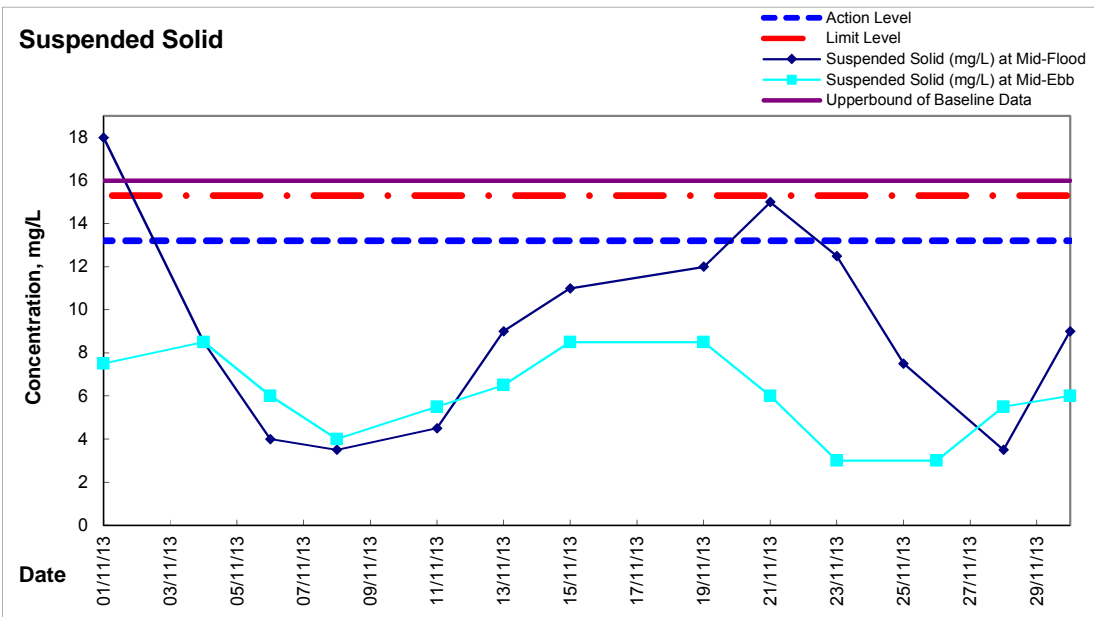
Graphic Presentation of Water Quality Result of WSD17 - Quarry Bay with respect to Local Variation

Remarks: WSD17 is located at upstream during the flood tides while at downstream during ebb tides.

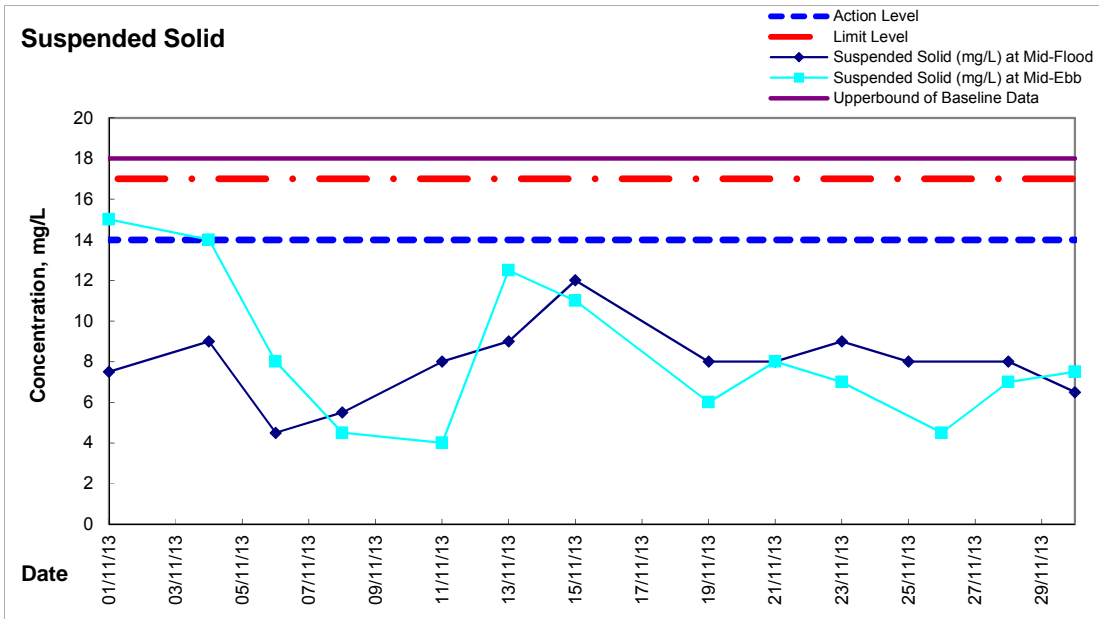
Graphic Presentation of Water Quality Result of WSD19 - Sheung Wan with respect to Local Variation

Remarks: WSD19 is located at upstream during the ebb tides while at downstream during flood tides.

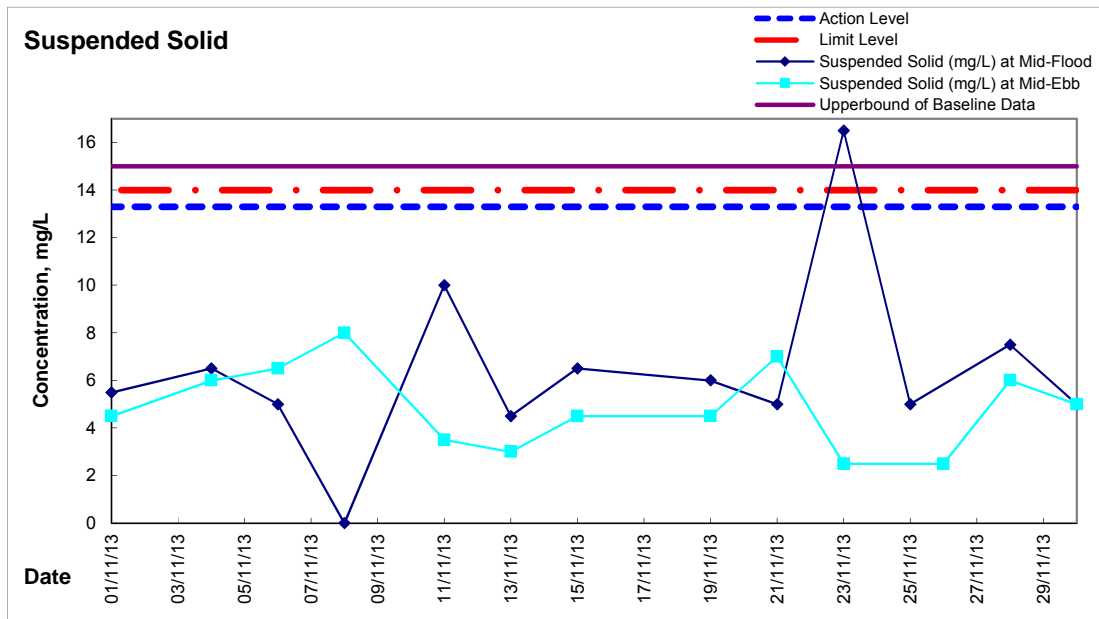
Graphic Presentation of Water Quality Result of WSD21 - Wan Chai with respect to Local Variation

Remarks: WSD21 is located at upstream during the ebb tides while at downstream during flood tides.
