CONTRACT NO: KL/2009/01
SITE FORMATION FOR
KAI TAK CRUISE TERMINAL DEVELOPMENT

QUARTERLY ENVIRONMENTAL
MONITORING & AUDIT REPORT

- DECEMBER 2013 TO FEBRUARY 2014 -

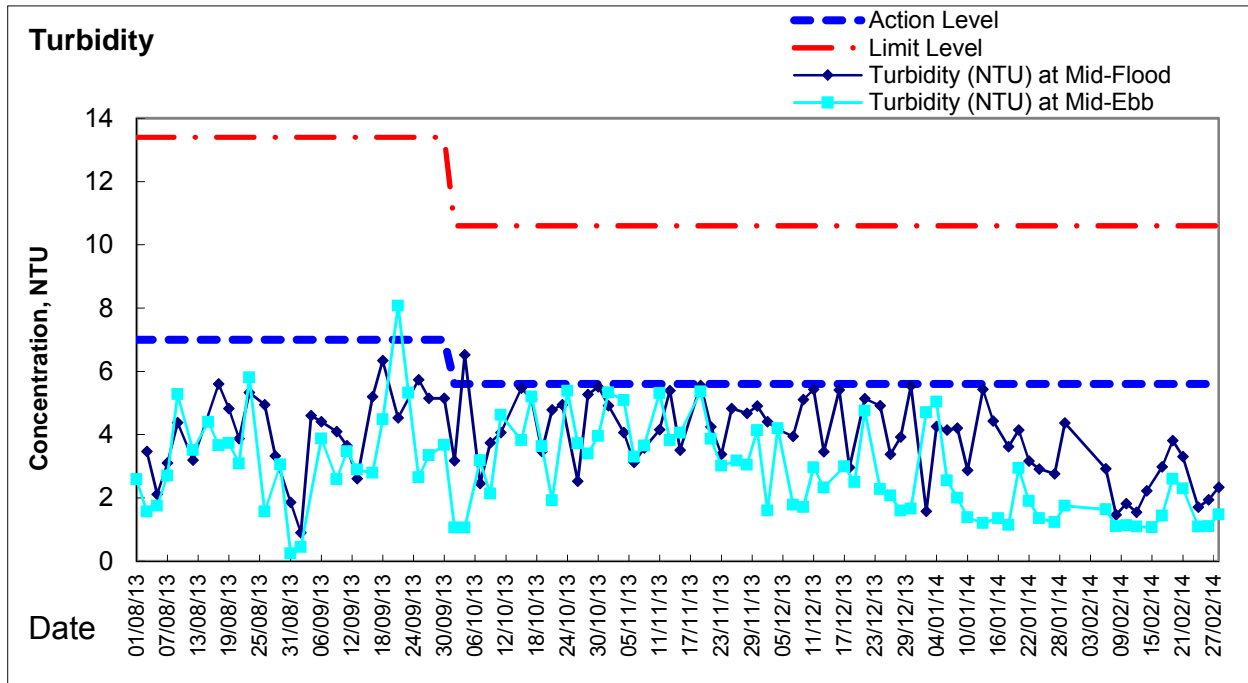
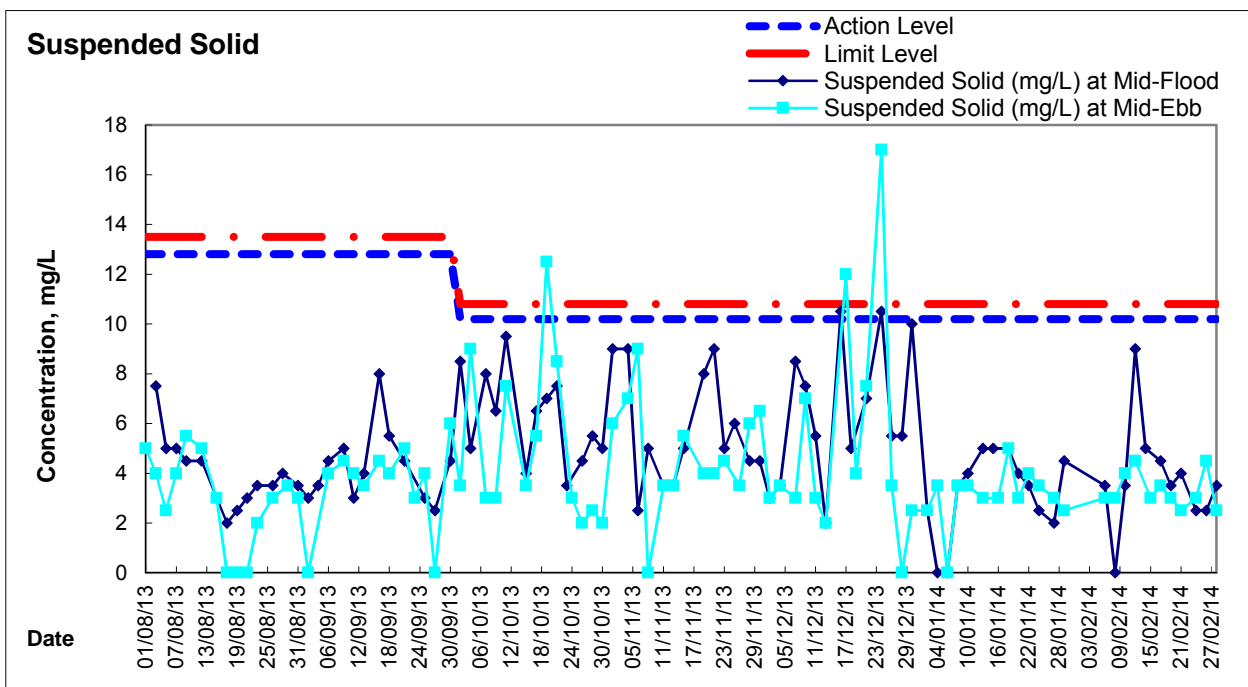
Graphic Presentation of Water Quality Result of WSD9 - Tai Wan

- Two sets of Suspended Solid Action and Limit levels for the dry season (October to March) and wet season (April to September).
- New sets of Turbidity and SS Action Level and Limit Level for dry and wet season were approved by EPD on 19 Oct 2011
- With respect to the Chinese New Year Holiday and the information provided by the Contractor, the construction site was closed from 31 Jan 2014 to 4 Feb 2014. The water quality monitoring event on 31 Jan 2014 and 4 Feb 2014 was temporarily suspended.

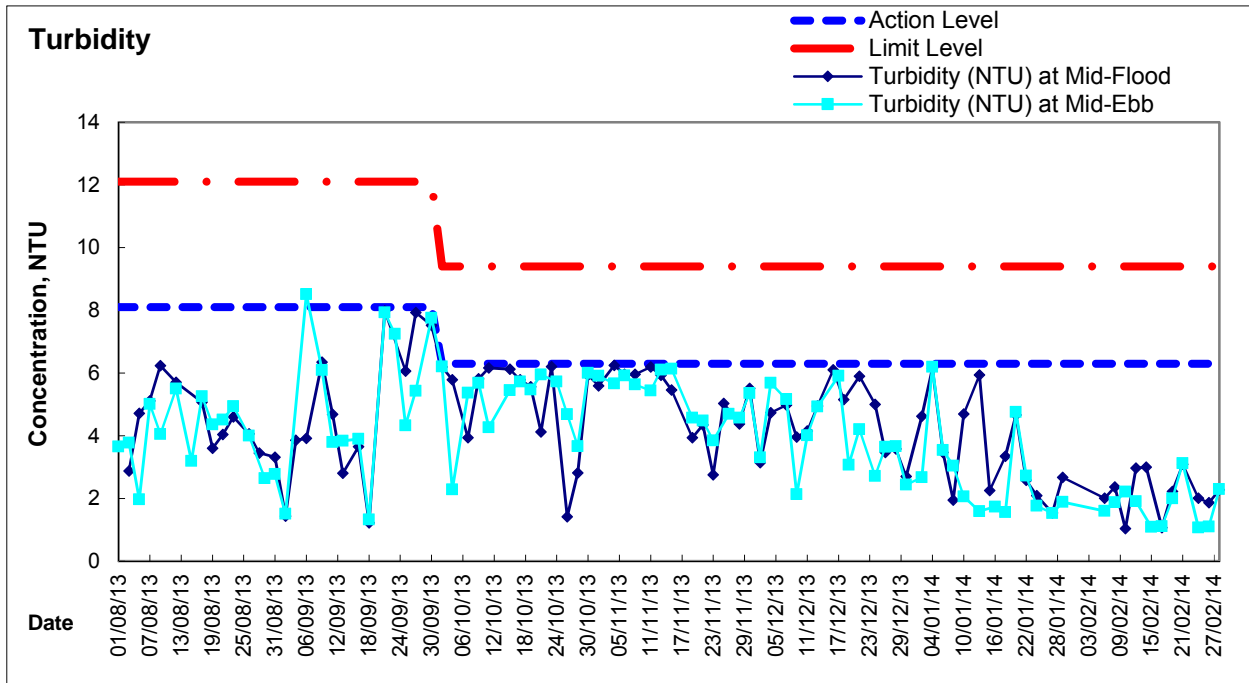
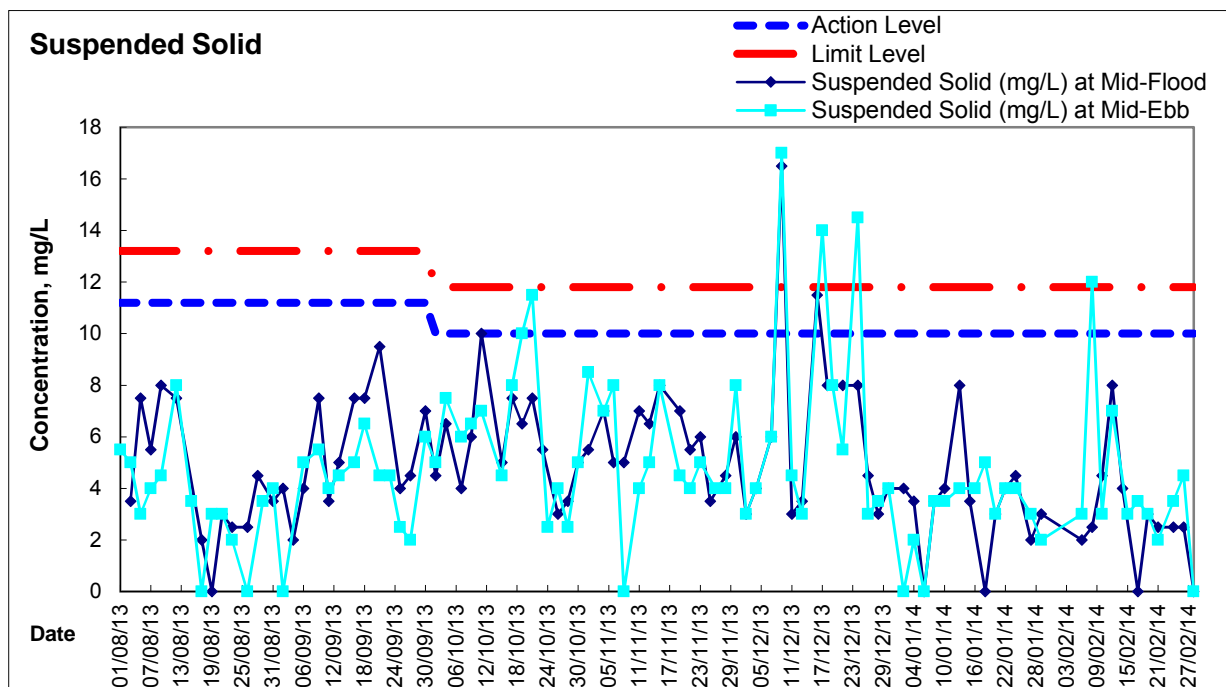
Graphic Presentation of Water Quality Result of WSD10 - Cha Kwo Ling

- Two sets of Suspended Solid Action and Limit levels for the dry season (October to March) and wet season (April to September).
- New sets of Turbidity and SS Action Level and Limit Level for dry and wet season were approved by EPD on 19 Oct 2011
- With respect to the Chinese New Year Holiday and the information provided by the Contractor, the construction site was closed from 31 Jan 2014 to 4 Feb 2014. The water quality monitoring event on 31 Jan 2014 and 4 Feb 2014 was temporarily suspended.

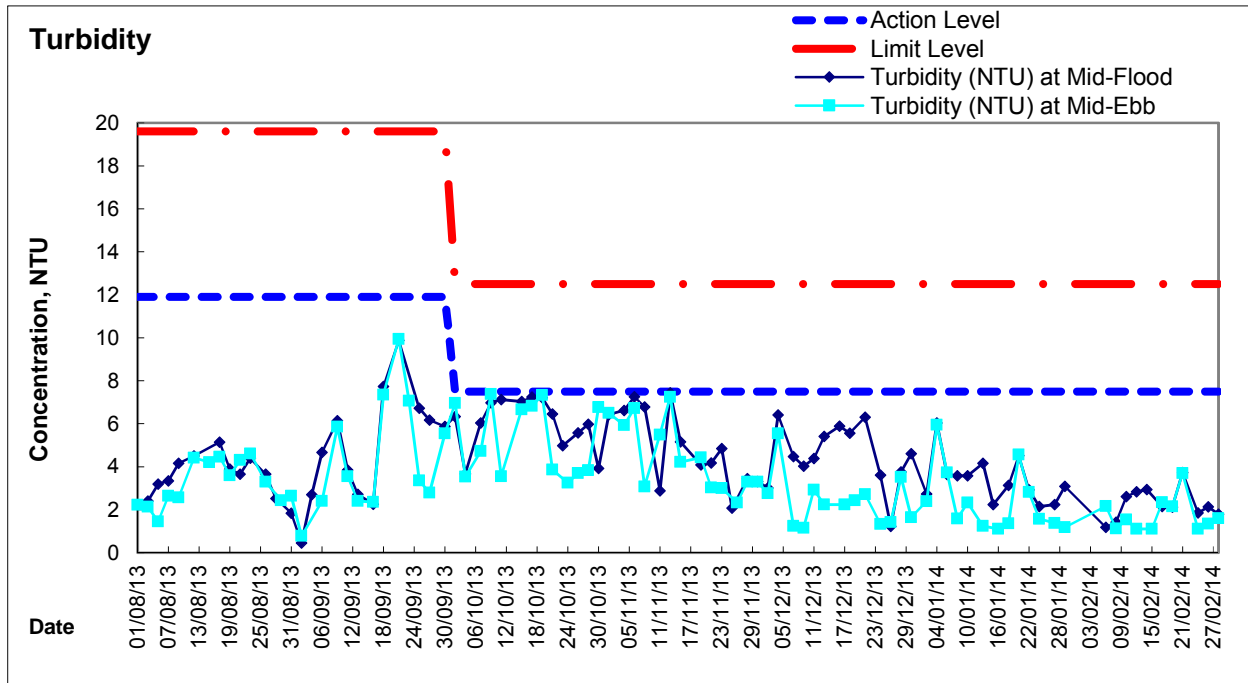
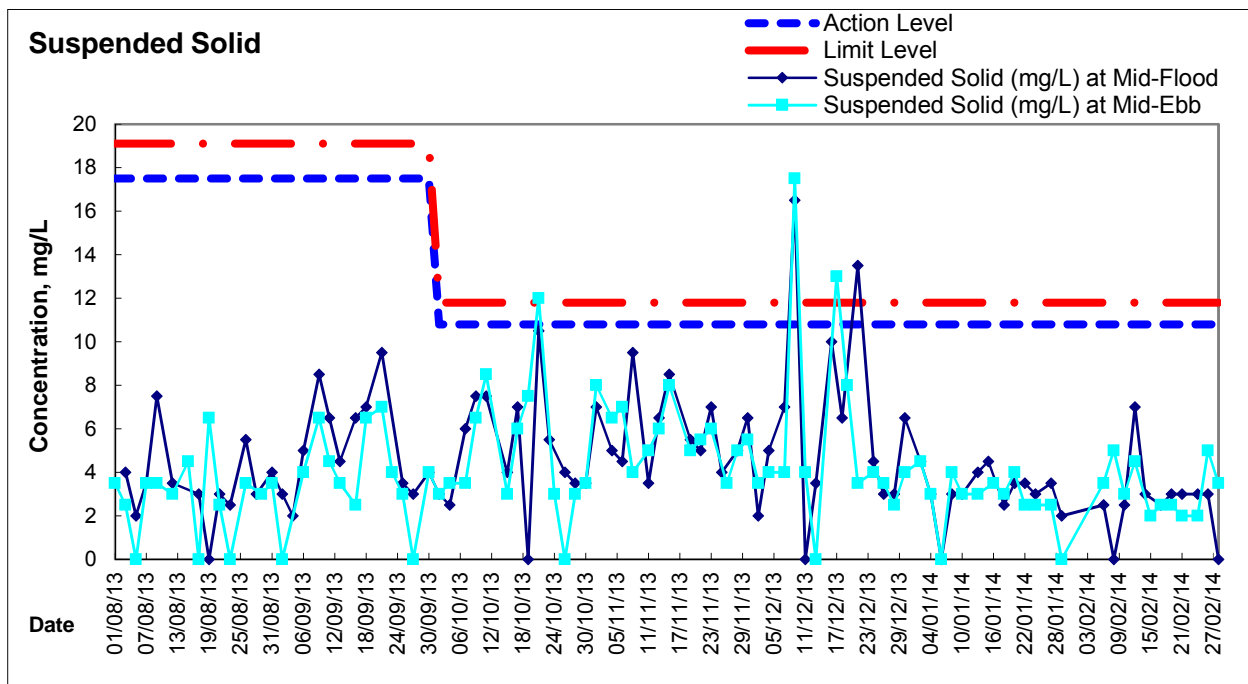
Graphic Presentation of Water Quality Result of WSD15 - Sai Wan Ho

- Two sets of Suspended Solid Action and Limit levels for the dry season (October to March) and wet season (April to September).
- New sets of Turbidity and SS Action Level and Limit Level for dry and wet season were approved by EPD on 19 Oct 2011
- With respect to the Chinese New Year Holiday and the information provided by the Contractor, the construction site was closed from 31 Jan 2014 to 4 Feb 2014. The water quality monitoring event on 31 Jan 2014 and 4 Feb 2014 was temporarily suspended.

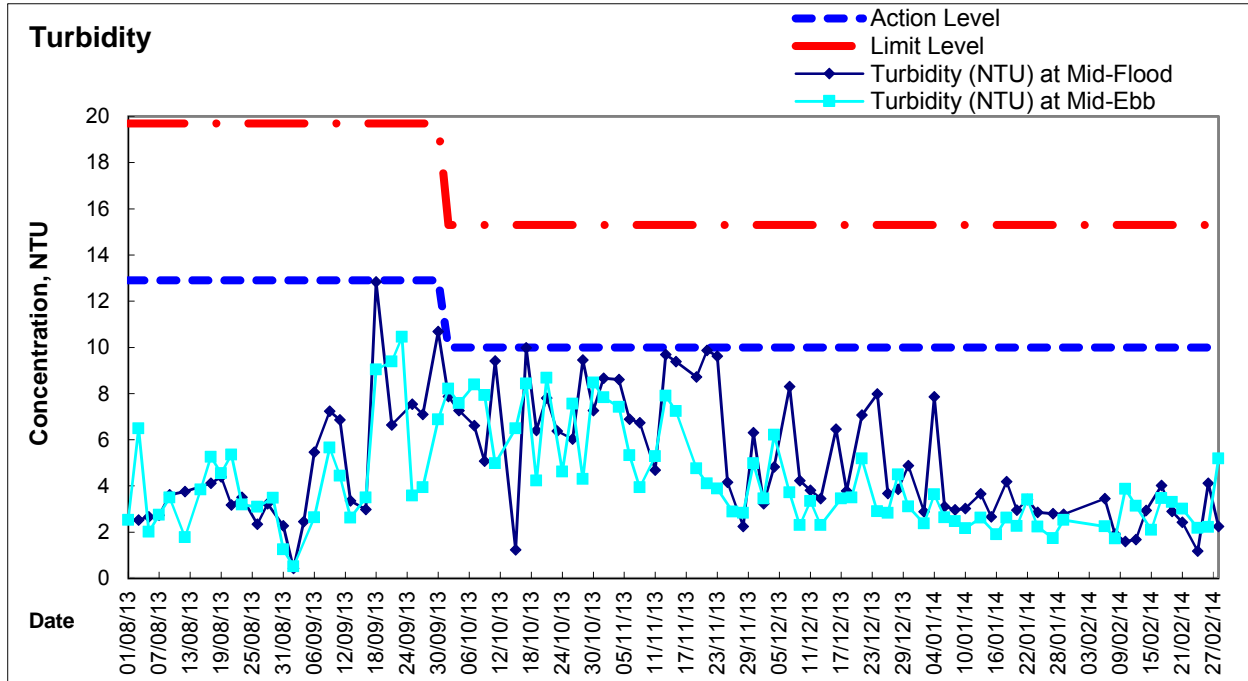
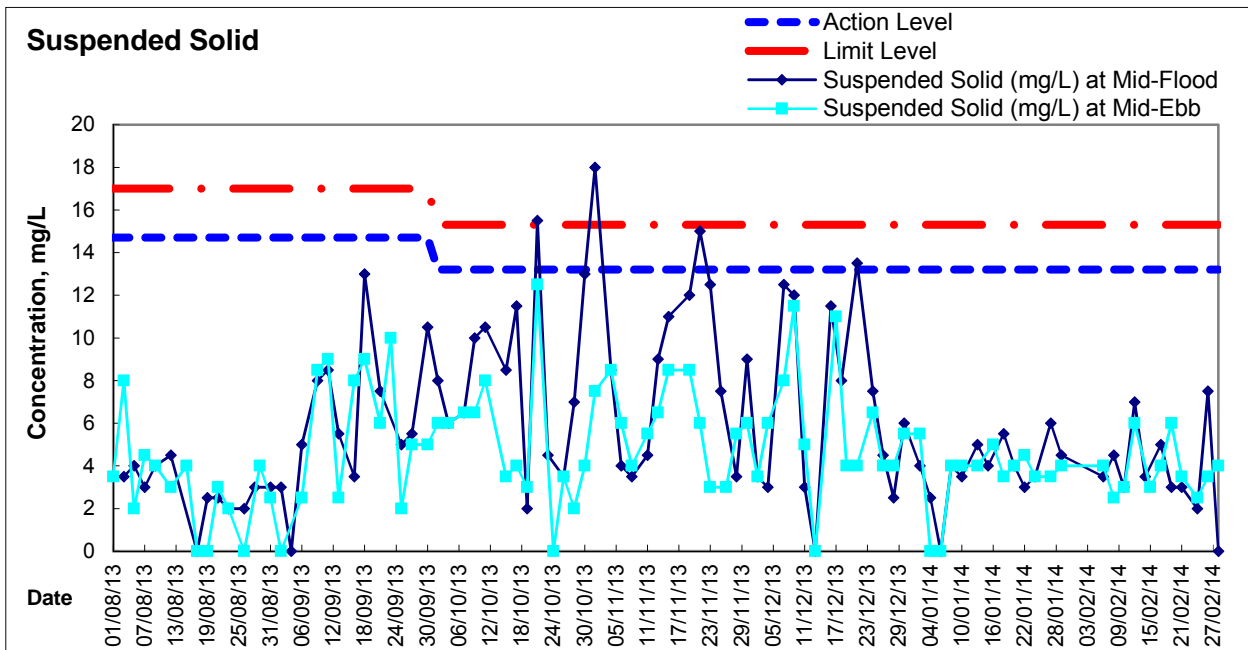
Graphic Presentation of Water Quality Result of WSD17 - Quarry Bay

- Two sets of Suspended Solid Action and Limit levels for the dry season (October to March) and wet season (April to September).
- New sets of Turbidity and SS Action Level and Limit Level for dry and wet season were approved by EPD on 19 Oct 2011
- With respect to the Chinese New Year Holiday and the information provided by the Contractor, the construction site was closed from 31 Jan 2014 to 4 Feb 2014. The water quality monitoring event on 31 Jan 2014 and 4 Feb 2014 was temporarily suspended.

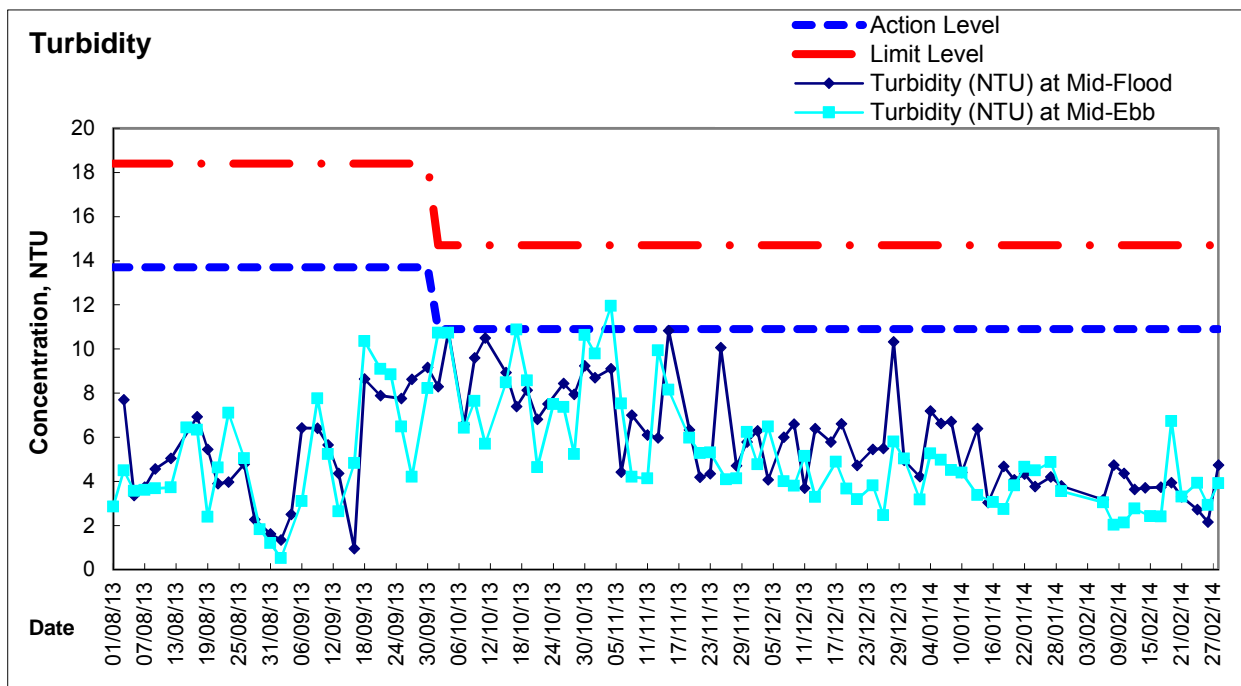
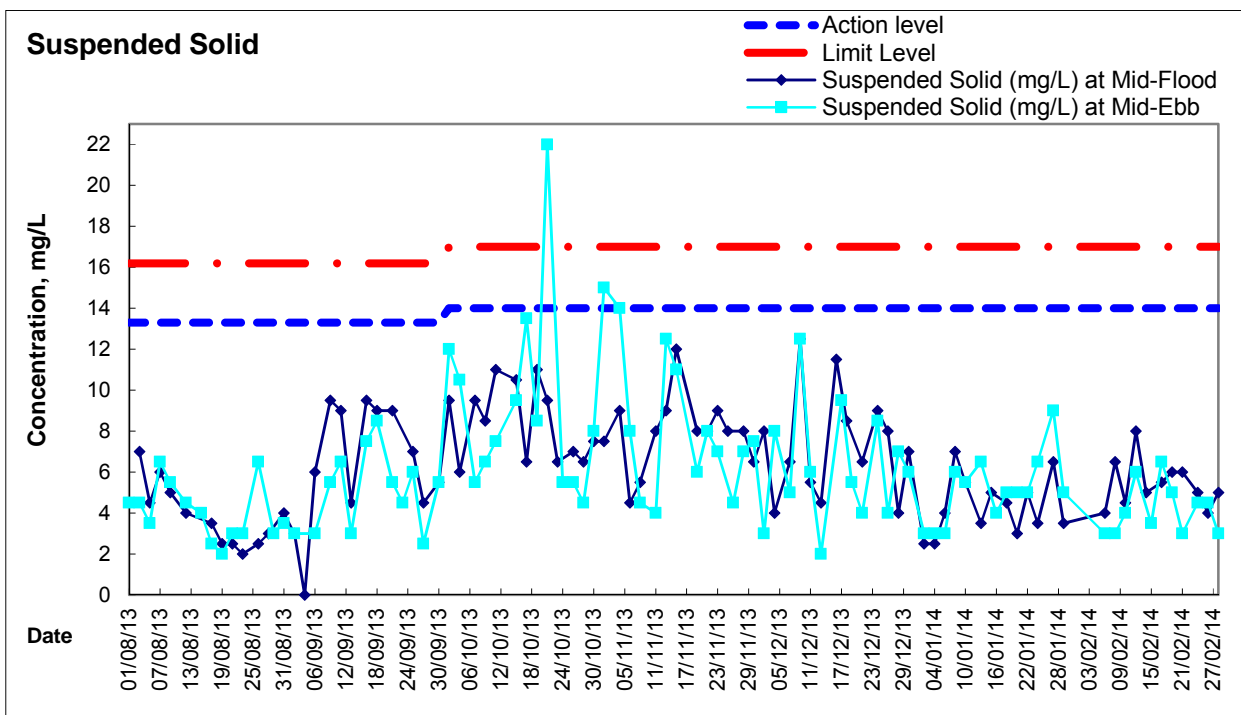
Graphic Presentation of Water Quality Result of WSD19 - Sheung Wan

- Two sets of Suspended Solid Action and Limit levels for the dry season (October to March) and wet season (April to September).
- New sets of Turbidity and SS Action Level and Limit Level for dry and wet season were approved by EPD on 19 Oct 2011
- With respect to the Chinese New Year Holiday and the information provided by the Contractor, the construction site was closed from 31 Jan 2014 to 4 Feb 2014. The water quality monitoring event on 31 Jan 2014 and 4 Feb 2014 was temporarily suspended.

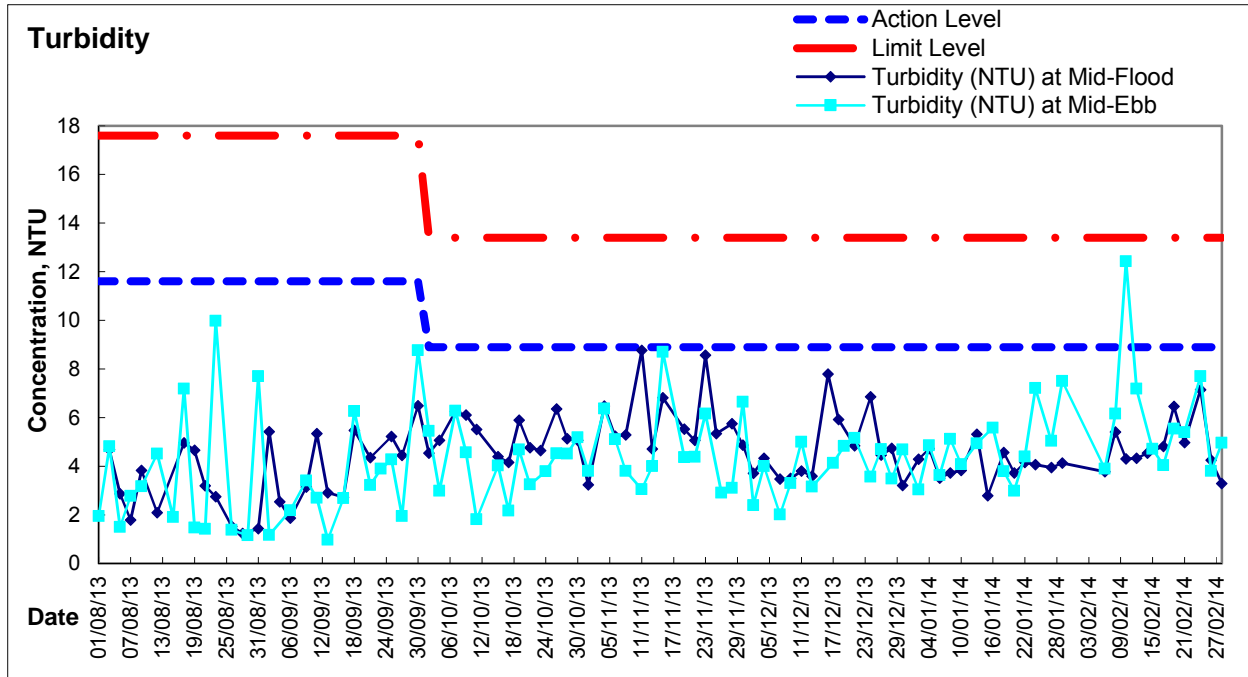
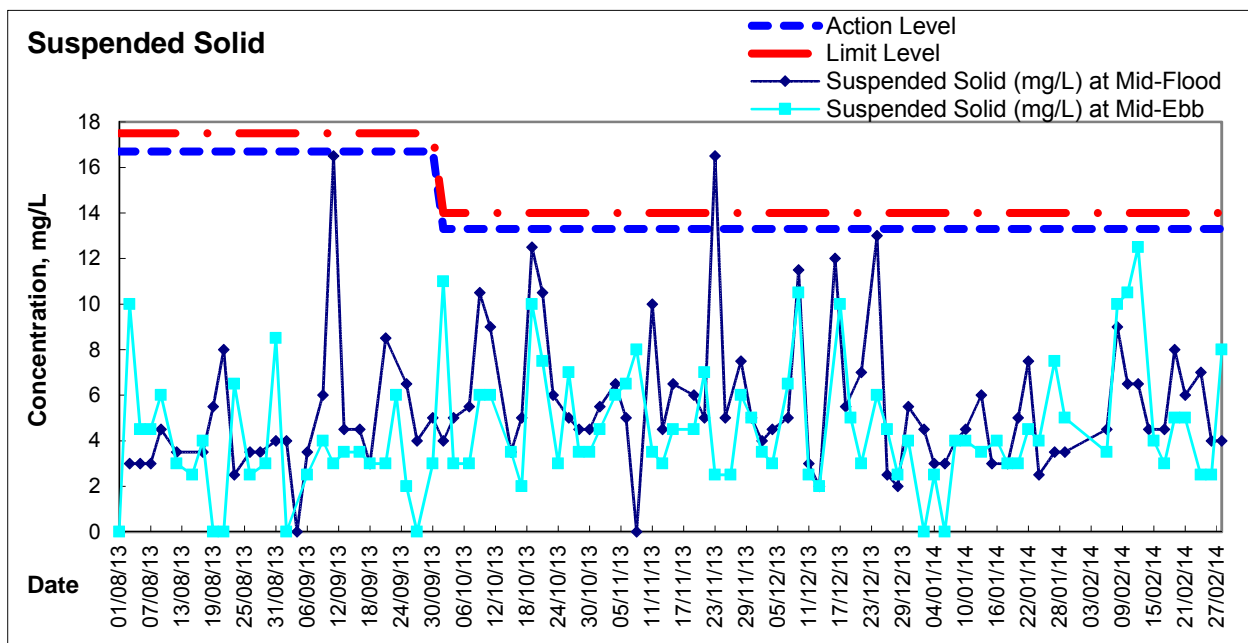
5.2.1. Turbidity exceedance was found on 10 Feb 2014 at WSD21 during ebb tide. Investigations found that all exceedance was not related to the Project works.

Graphic Presentation of Water Quality Result of WSD21 - Wan Chai

- Two sets of Suspended Solid Action and Limit levels for the dry season (October to March) and wet season (April to September).
- New sets of Turbidity and SS Action Level and Limit Level for dry and wet season were approved by EPD on 19 Oct 2011
- With respect to the Chinese New Year Holiday and the information provided by the Contractor, the construction site was closed from 31 Jan 2014 to 4 Feb 2014. The water quality monitoring event on 31 Jan 2014 and 4 Feb 2014 was temporarily suspended.

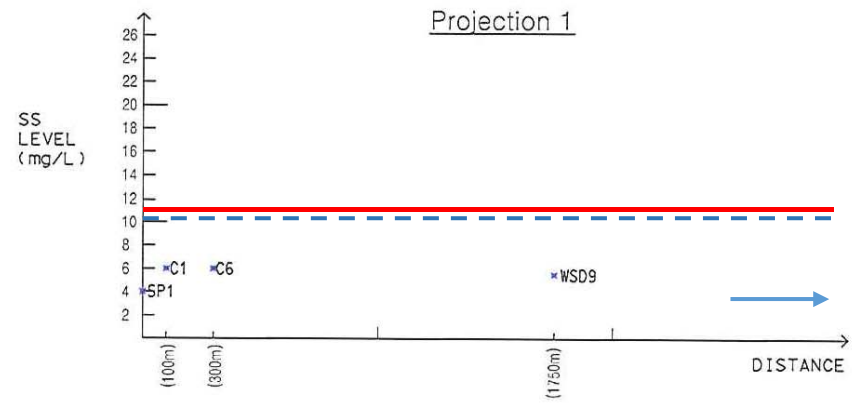
Description: WSD9 was located at downstream which was well within the Action Level.

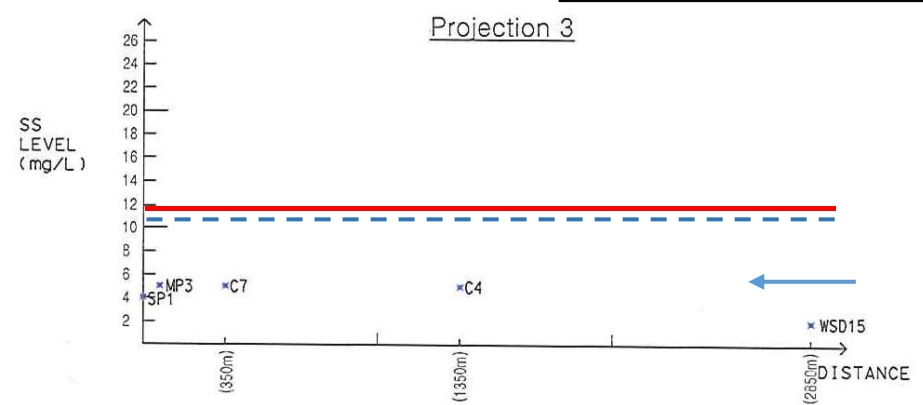
Description: WSD15 was located at upstream which was well within the Action Level.

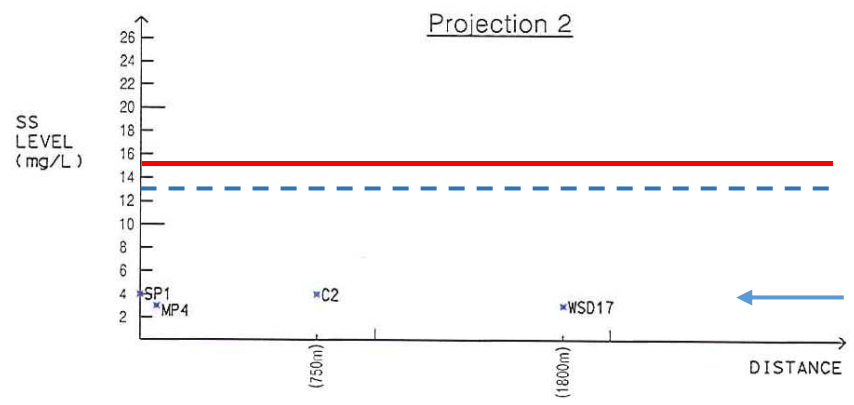
Description: WSD17 was located at upstream which was well within the Action Level.

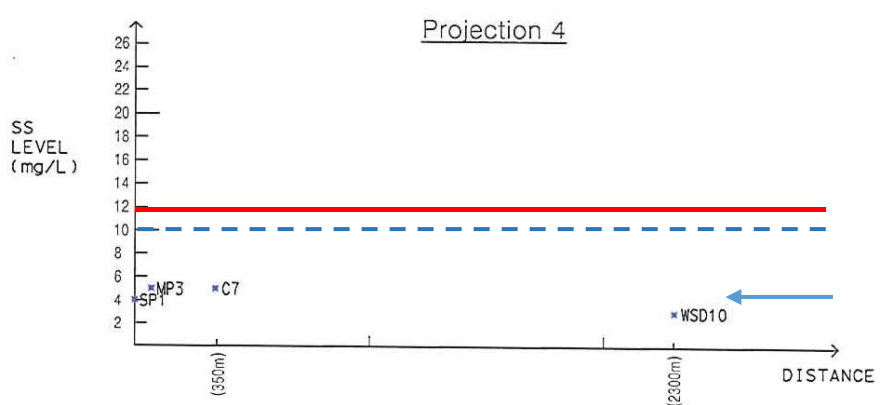
Description: WSD10 was located at upstream which was well within the Action Level.

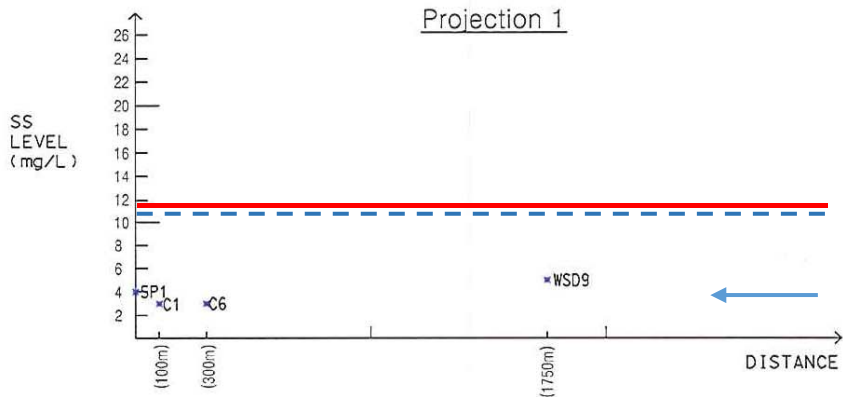
Description: WSD9 was located at upstream which was well within the Action Level.

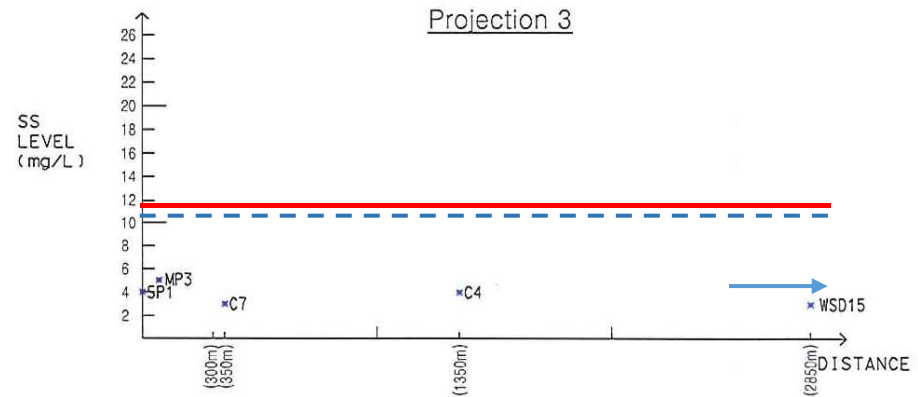
Description: WSD15 was located at downstream which was well within the Action Level.

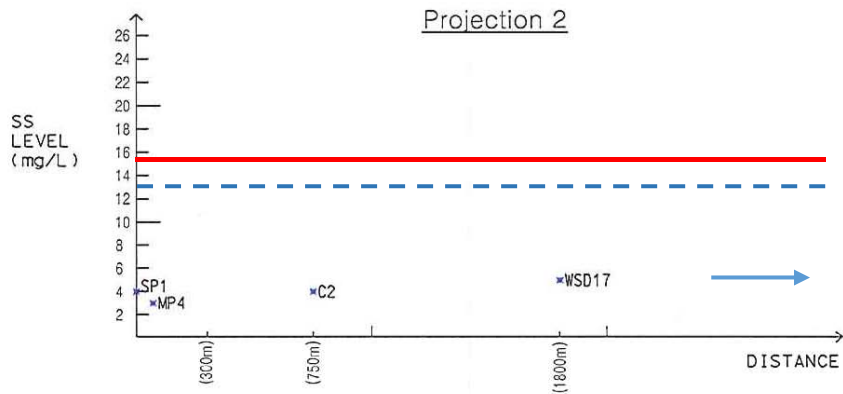
Description: WSD17 was located at downstream which was well within the Action Level.

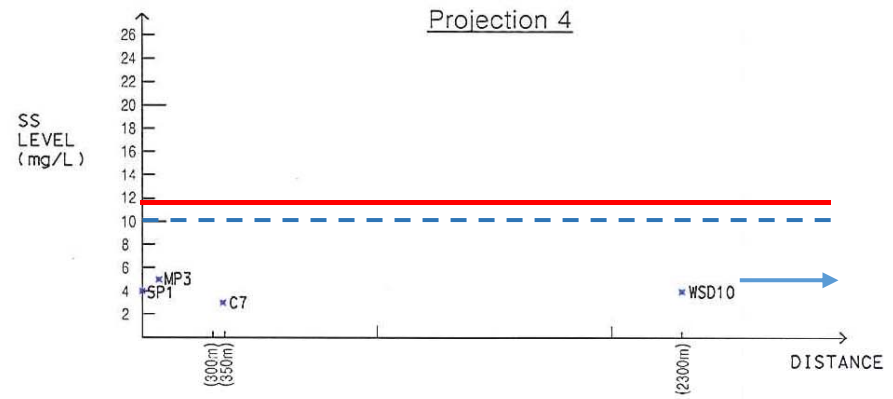
Description: WSD10 was located at downstream which was well within the Action Level.

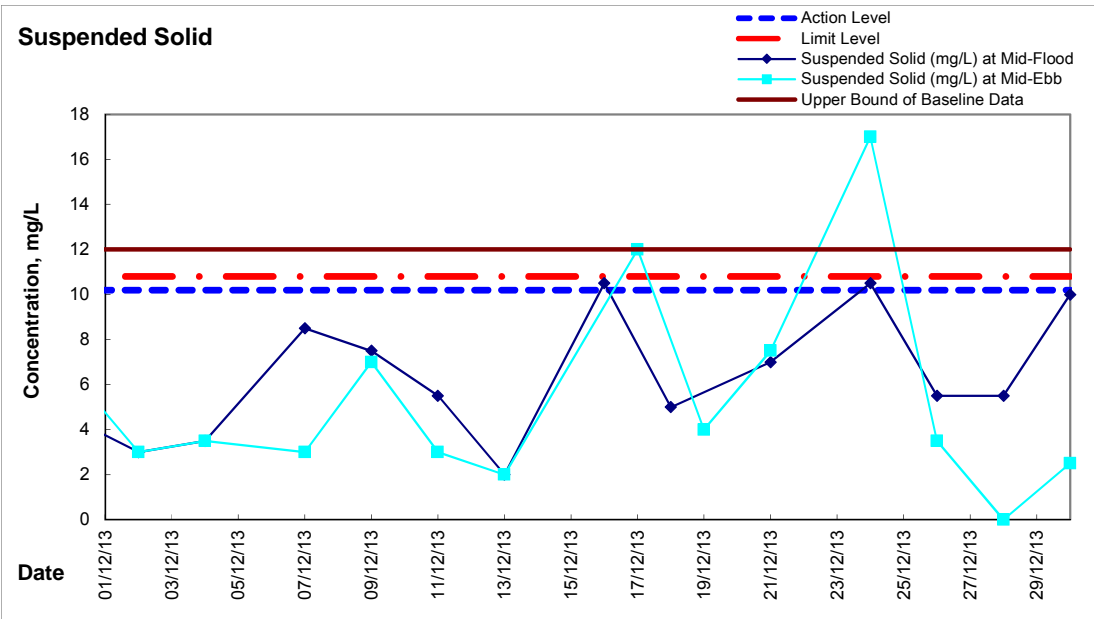
Graphic Presentation of Water Quality Result of WSD9 - Tai Wan with respect to Local Variation

Remarks: WSD9 is located at upstream during the ebb tides while at downstream during flood tides.

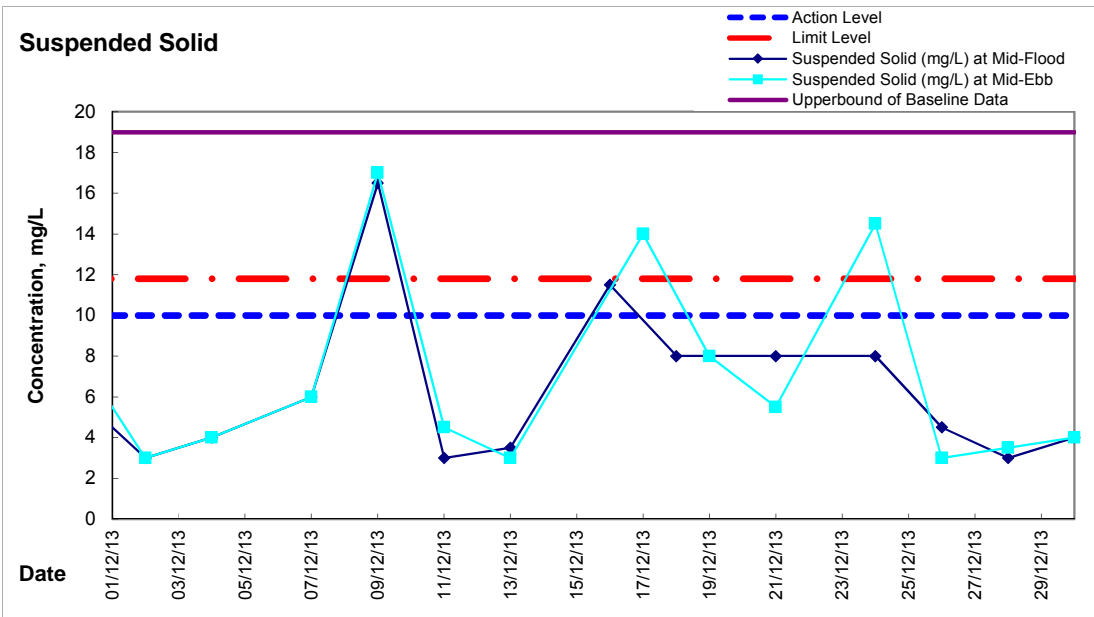
Graphic Presentation of Water Quality Result of WSD10 - Cha Kwo Ling with respect to Local Variation

Remarks: WSD10 is located at upstream during the flood tides while at downstream during ebb tides.

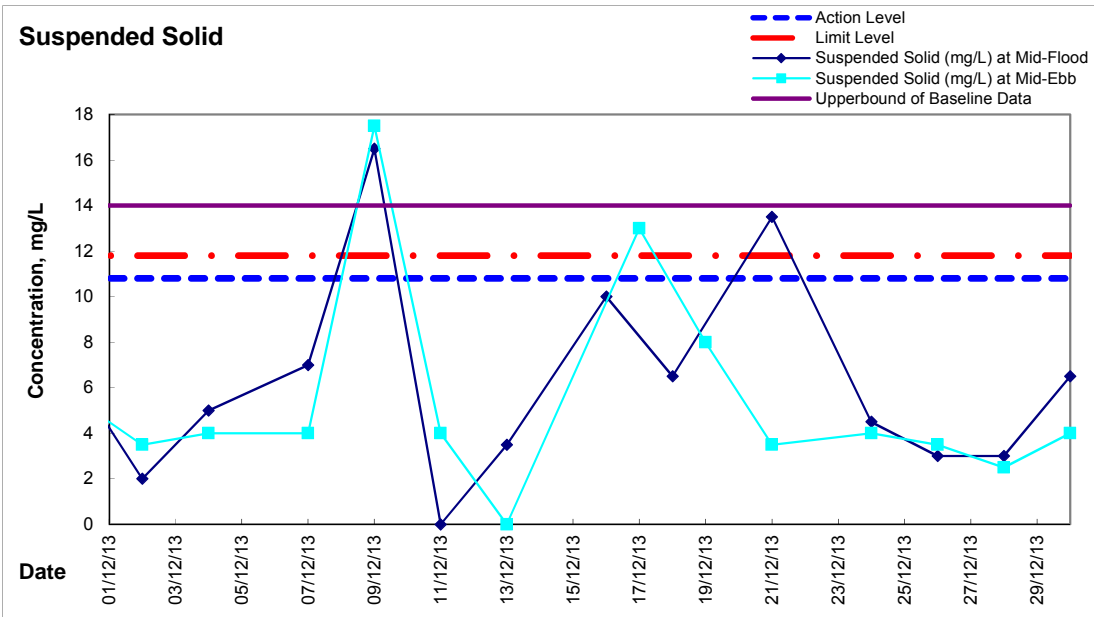
Graphic Presentation of Water Quality Result of WSD15 - Sai Wan Ho with respect to Local Variation

Remarks: WSD15 is located at upstream during the flood tides while at downstream during ebb tides.

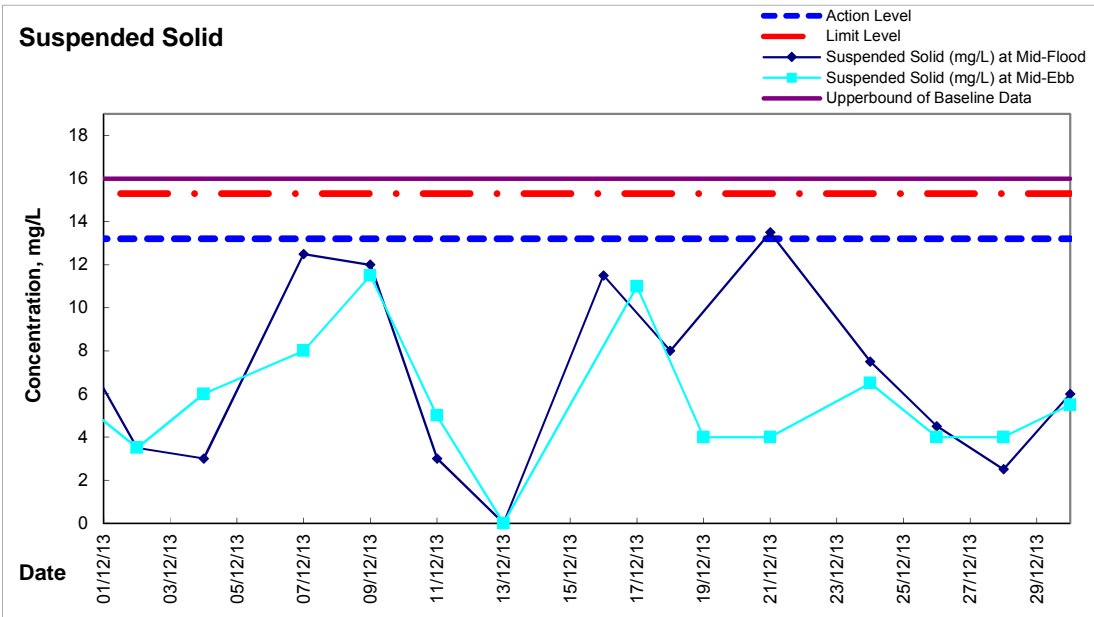
Graphic Presentation of Water Quality Result of WSD17 - Quarry Bay with respect to Local Variation

Remarks: WSD17 is located at upstream during the flood tides while at downstream during ebb tides.

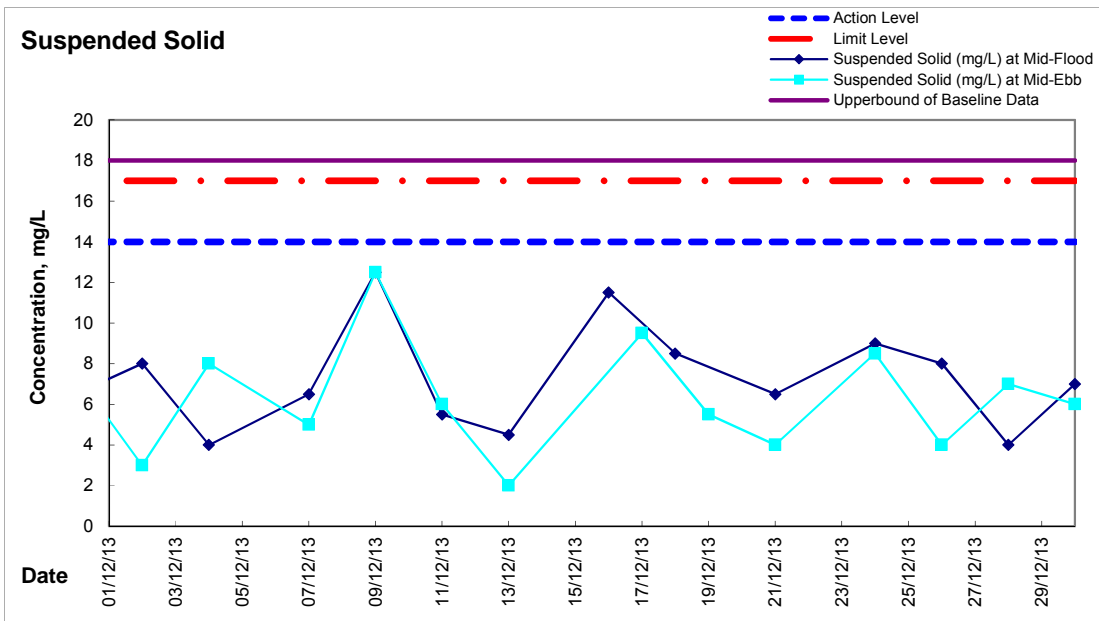
Graphic Presentation of Water Quality Result of WSD19 - Sheung Wan with respect to Local Variation

Remarks: WSD19 is located at upstream during the ebb tides while at downstream during flood tides.

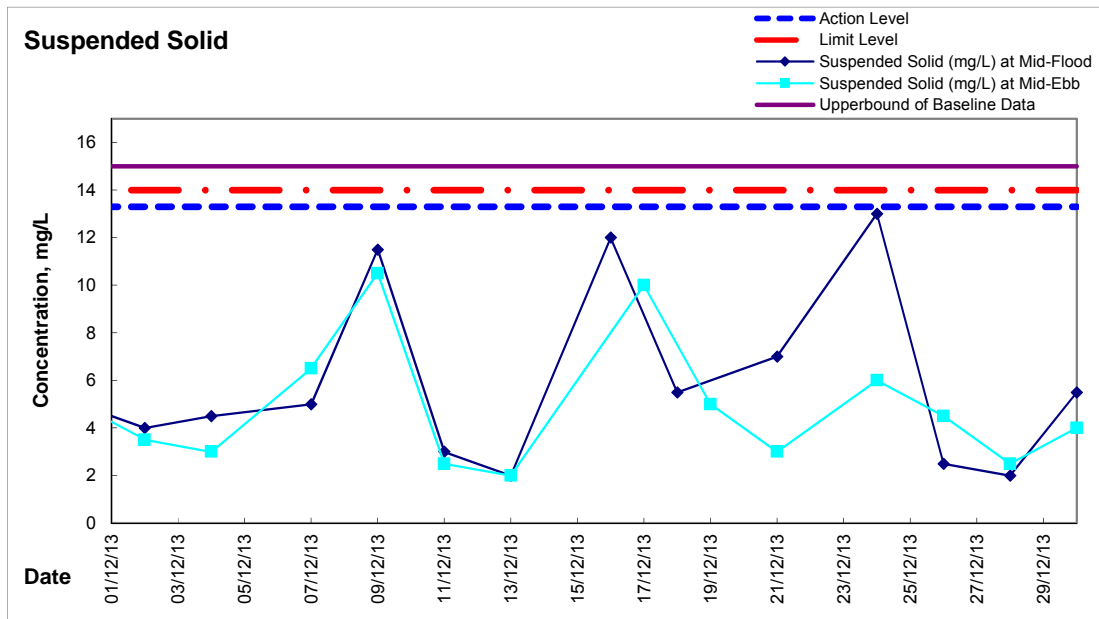
Graphic Presentation of Water Quality Result of WSD21 - Wan Chai with respect to Local Variation

Remarks: WSD21 is located at upstream during the ebb tides while at downstream during flood tides.
