TEST REPORT

CONTRACT NO. CV/2009/02
HANDLING OF SURPLUS PUBLIC FILL
TUEN MUN AREA 38 FILL BANK
MONTHLY EM&A REPORT NO.43
(JUNE 2013)

Report No.: ENA31338

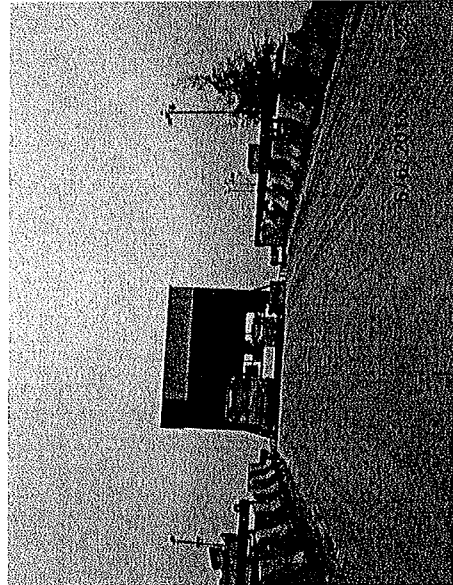
<p>Photo 130606_001 (Tipping Hall No.2)</p>

<i>Date</i>	<i>Key Findings</i>	<i>Action(s) Taken recommended by ET</i>	<i>Action(s) Taken by the Contractor during the site audit</i>	<i>Rectification Status by ET</i>
06 June 2013	The enclosure of tipping hall No.2 was found broken. (Previous item)	To repair the damaged part of the tipping hall properly.	---	Follow-up
	Mud and silt were noted accumulated inside the drainage channel near the CEDD's site office. (Previous item)	To clear the accumulated mud and silt in order to avoid any blockage.	---	Follow-up
	Standing water was found inside the drip tray for a generator near work shop. (Previous item)	To clear the standing water or apply pesticide to avoid mosquito breeding.	---	Follow-up
	No skirt curtain was provided for the drip tray for a generator near work shop. (Previous item)	To provide appropriate skirt curtain.	Skirt curtain was provided for the drip tray for a generator near work shop.	Closed

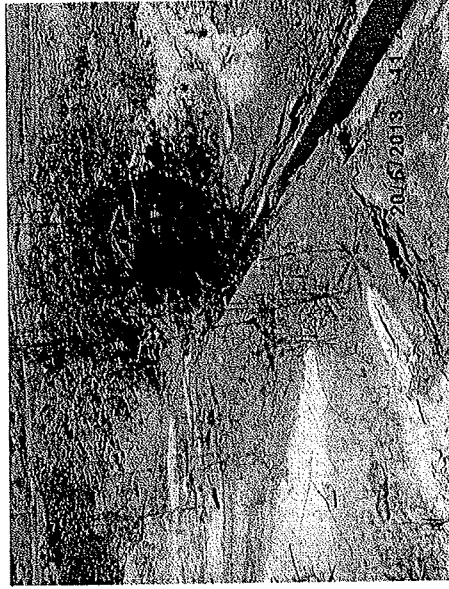
Photo 130620_005 (Tipping hall No.2)

Mud and silt were noted accumulated inside the drainage channel near the weighbridge at tipping hall No.2. (New item)	To clear the accumulated mud and silt in order to avoid any blockage.	---	Follow-up
27 June 2013	The enclosure of tipping hall No.2 was found broken. (Previous item)	To repair the damaged part of the tipping hall properly.	---	Follow-up
	Mud and silt were noted accumulated inside the drainage channel near the CEDD's site office. (Previous item)	To clear the accumulated mud and silt in order to avoid any blockage.	---	Follow-up
	Standing water was found inside the drip tray for a generator near work shop. (Previous item)	To clear the standing water or apply pesticide to avoid mosquito breeding.	No standing water was found inside the drip tray for a generator near work shop.	Closed
	Stagnant water was found accumulated inside the idle tyres at work shop. (Previous item)	To drain the stagnant water or apply pesticide to avoid mosquito breeding and covered the tyres properly.	No stagnant water was found accumulated inside the idle tyres at work shop.	Closed

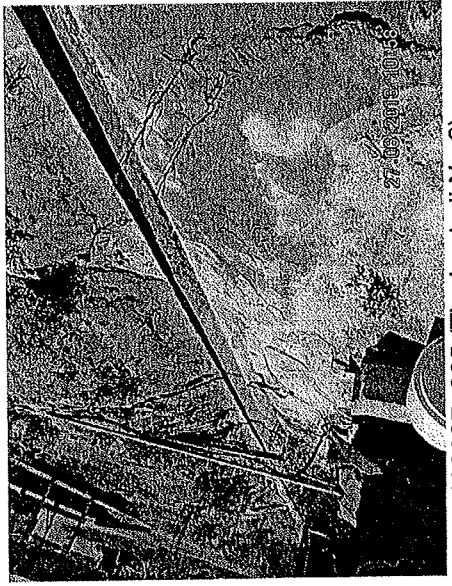
Photo 130627_005 (Tipping hall No.2)

Date	Key Findings	Action(s) Taken recommended by ET	Action(s) Taken by the Contractor during the site audit	Rectification Status by ET
27 June 2013	Mud and silt were noted accumulated inside the drainage channel near the weighbridge at tipping hall No.2. (New item)	To clear the accumulated mud and silt in order to avoid any blockage.	---	Follow-up
	Standing water was noted at dry soil deposition area. (New item)	To clear the standing water or apply pesticide to avoid mosquito breeding.	---	Follow-up
