DSD CONTRACT No. DC/2009/13 CONSTRUCTION OF SEWAGE TREATMENT WORKS AT YUNG SHUE WAN AND SOK KWU WAN

SOK KWU WAN PORTION AREA MONTHLY ENVIRONMENTAL MONITORING AND AUDIT (EM&A) REPORT (NO.57) – APRIL 2015

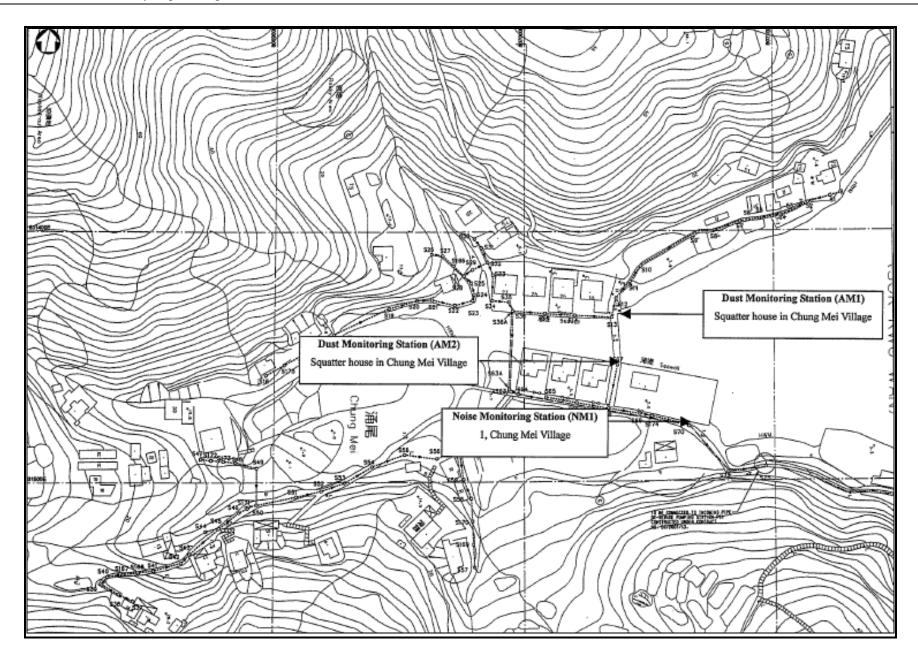
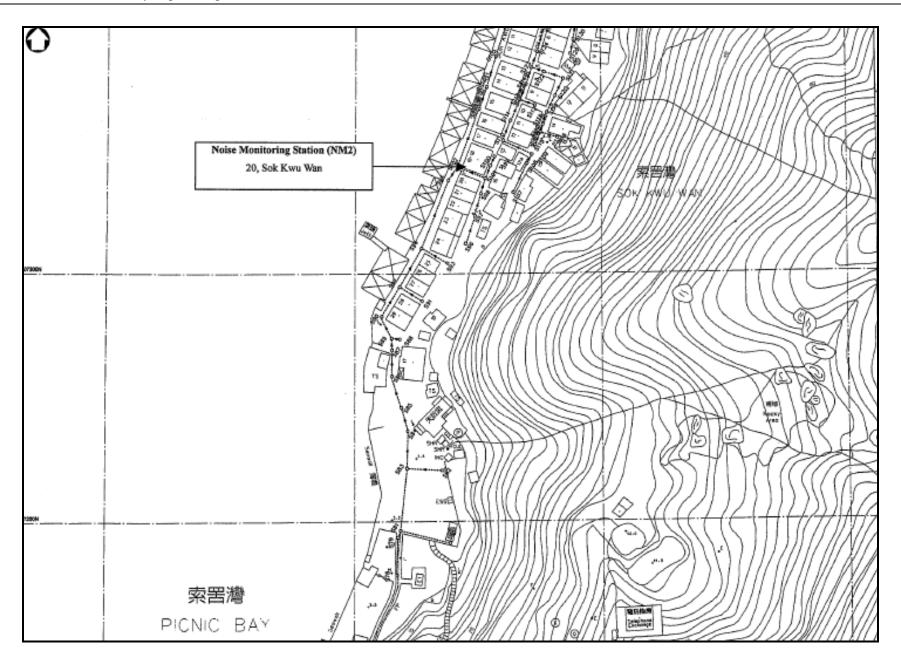
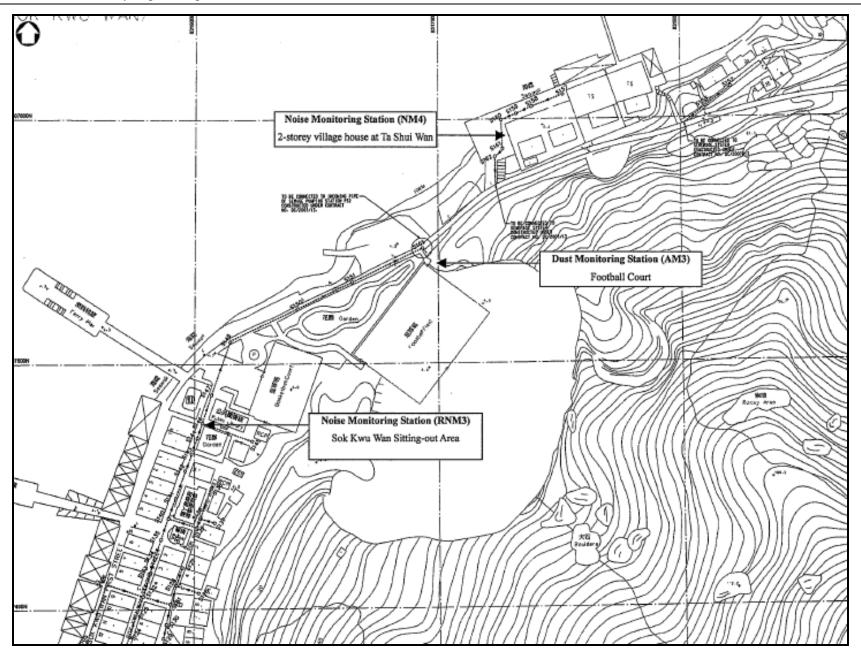
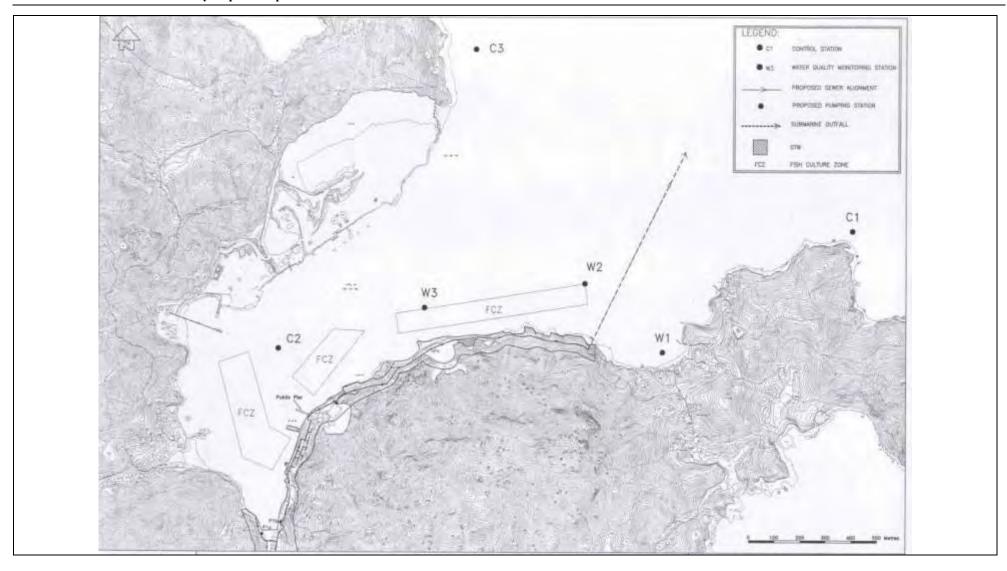
Location of Monitoring Stations(Air Quality / Construction Noise / Water Quality)

3.05 According to *EM&A Manual Section 3.4*, there were four noise sensitive receivers (NM1-NM4) designated for the construction noise monitoring. NM1, NM2 and NM4 of the three designated monitoring stations were identified and are monitored by the current DSD contract DC/2007/18. However, the premises monitoring station NM3 was rejected by the owner of 1B Sok Kwu Wan and an alternative noise monitoring station RNM3 replacement was proposed by the contract DC/2007/18 ET and accepted by the IEC and EPD before the baseline monitoring commencement in April 2008. The location RNM3 is located at Sok Kwu Wan Sitting-out area which just 3m width footpath away from the original location house 1B. The detailed construction noise monitoring stations to also under the Project is described in *Table 3-3* and graphical is shown in *Appendix D*.

3.06 Three control stations (C1-C3) and three impact stations (W1-W3) were recommended in the *EM&A Manual Section 4.5*. Impact stations W1-W3 identified at the sensitive receivers (FCZ and secondary contact recreation subzone) to monitor the impacts from the construction of the submarine outfall as well as the effluent discharge from the proposed STW on water quality. Three control stations: C1, C2 & C3 were specified at locations representative of the project site in its undisturbed condition and located at upstream and downstream of the works area. Detailed and co-ordnance of marine water quality monitoring stations is described in *Table 3-4* and the graphical is shown in *Appendix D* and would be performed for EM&A programme.

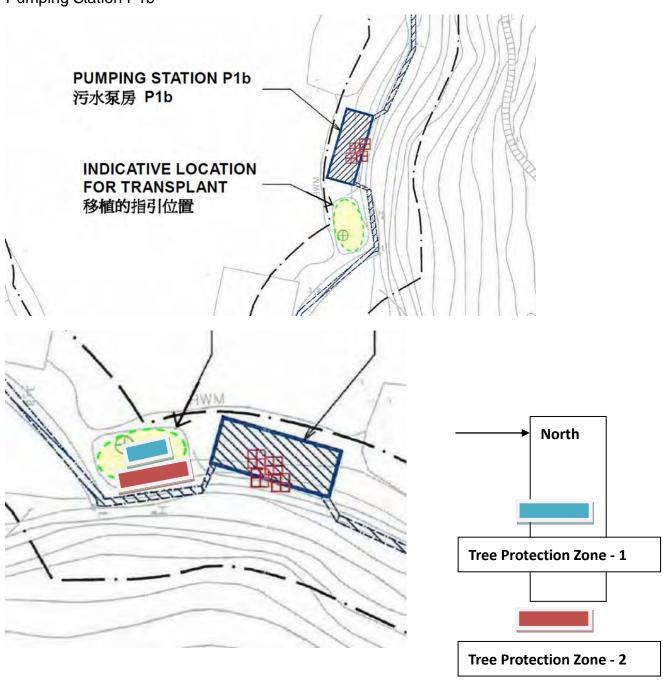
According to the requirement in the Environmental Permit EP-281/2007/A, the uncommon tree species, *Celtis timorensis*, found in the pumping station P1b area as shown in figure below shall be properly transplanted to the area immediately south of the Pumping Station P1b before commencement of construction of the Pumping Station P1b

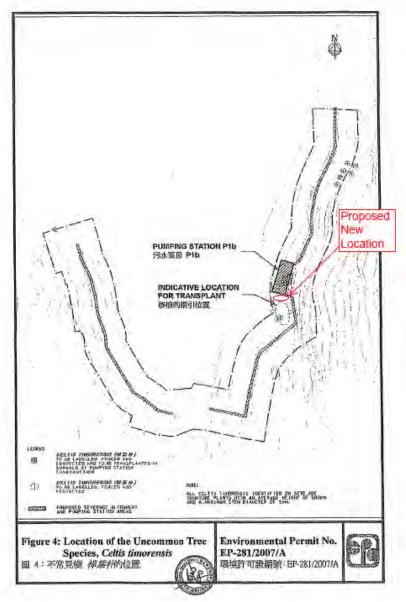
In March 2015, the *Celtis timorensis* were transplanted to the below area near PS1 as the new tree protection zone.

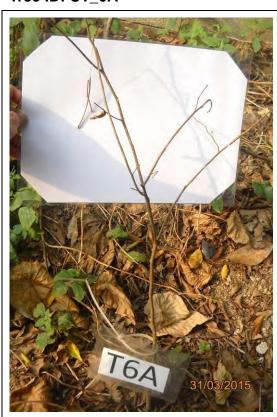
Tree ID: CT_6A

Current Status: Very Poor

Justification: No leaves. The bark was dry. No significant improvement in health. The plant was very weak.

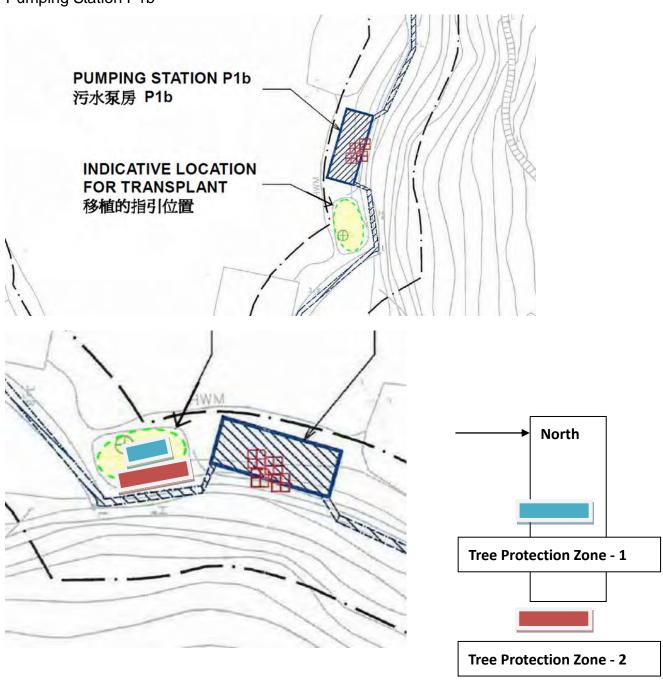
According to the requirement in the Environmental Permit EP-281/2007/A, the uncommon tree species, *Celtis timorensis*, found in the pumping station P1b area as shown in figure below shall be properly transplanted to the area immediately south of the Pumping Station P1b before commencement of construction of the Pumping Station P1b

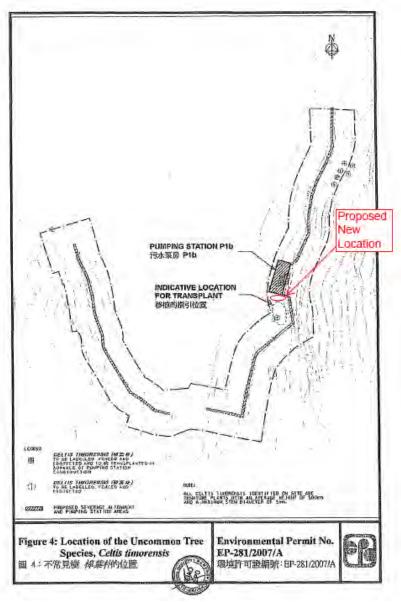
In March 2015, the *Celtis timorensis* were transplanted to the below area near PS1 as the new tree protection zone.
