**YUNG SHUE WAN AND
SOK KWU WAN VILLAGE SEWERAGE,
STAGE 1 WORKS**

**MONTHLY IMPACT MONITORING
REPORT NO.28**

(SEPTEMBER 2010)

Report No.: ENA00918

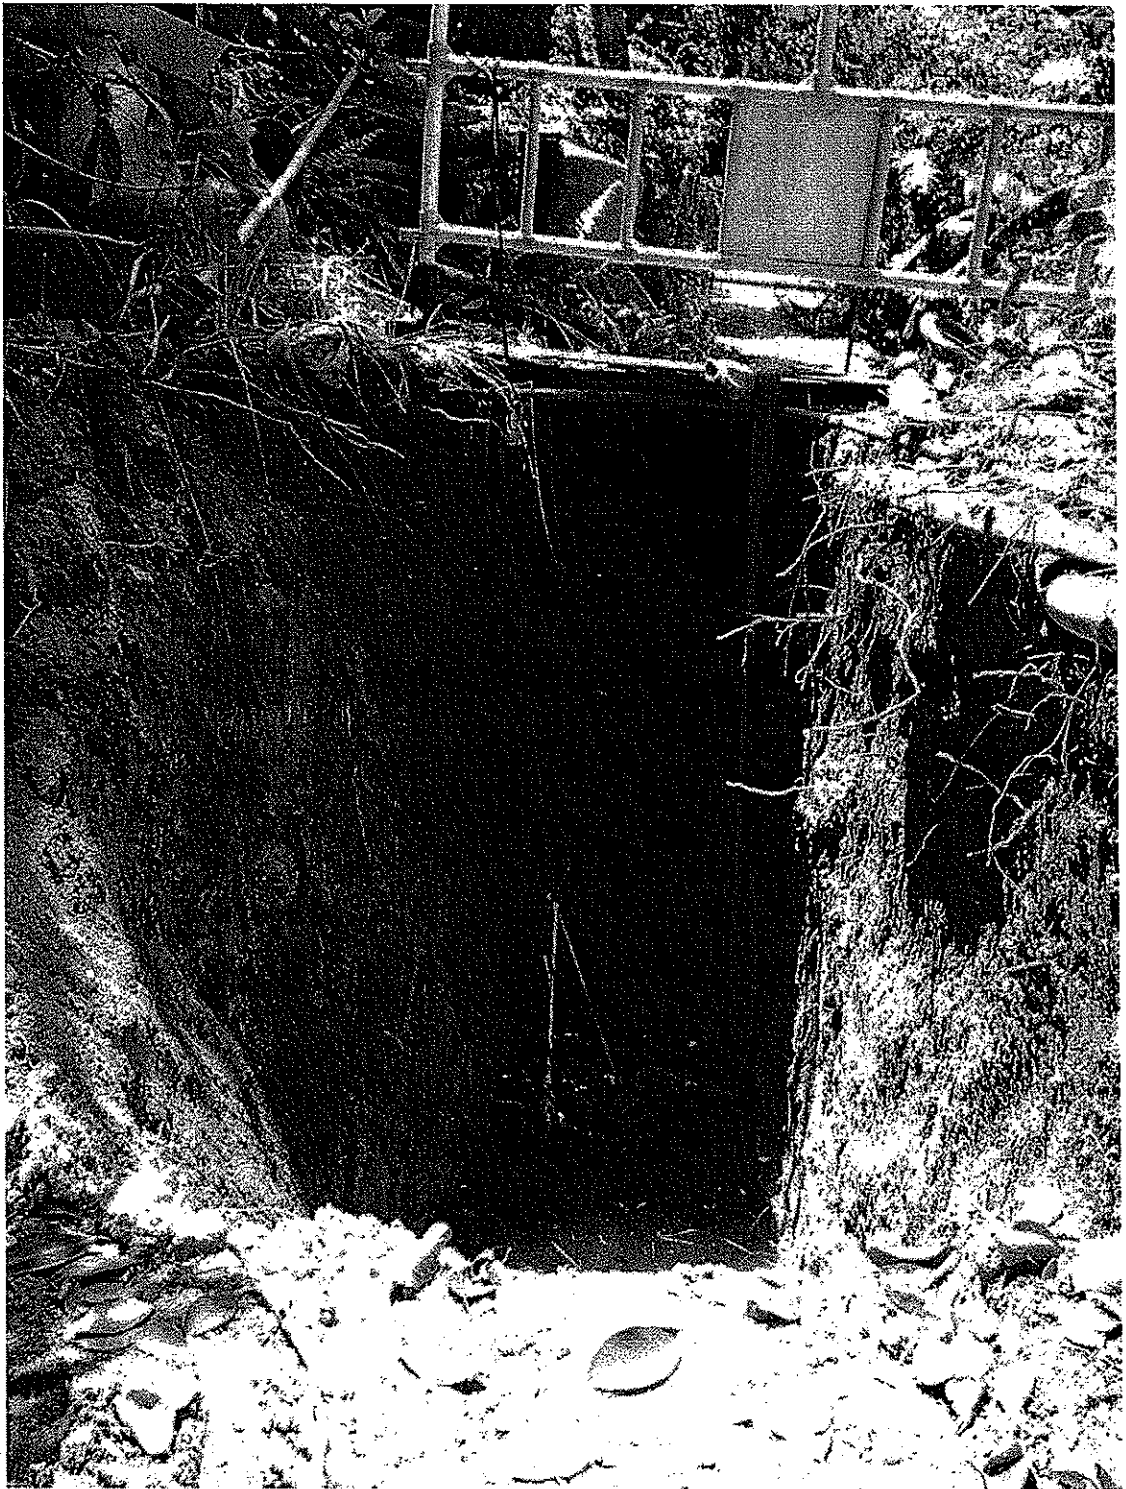
Plate 4: Deeper sondage excavated at MH S52 – looking south
