Kaden Construction Limited

**YUNG SHUE WAN AND
SOK KWU WAN VILLAGE SEWERAGE,
STAGE 1 WORKS**

**MONTHLY IMPACT MONITORING
REPORT NO.16**

(SEPTEMBER 2009)

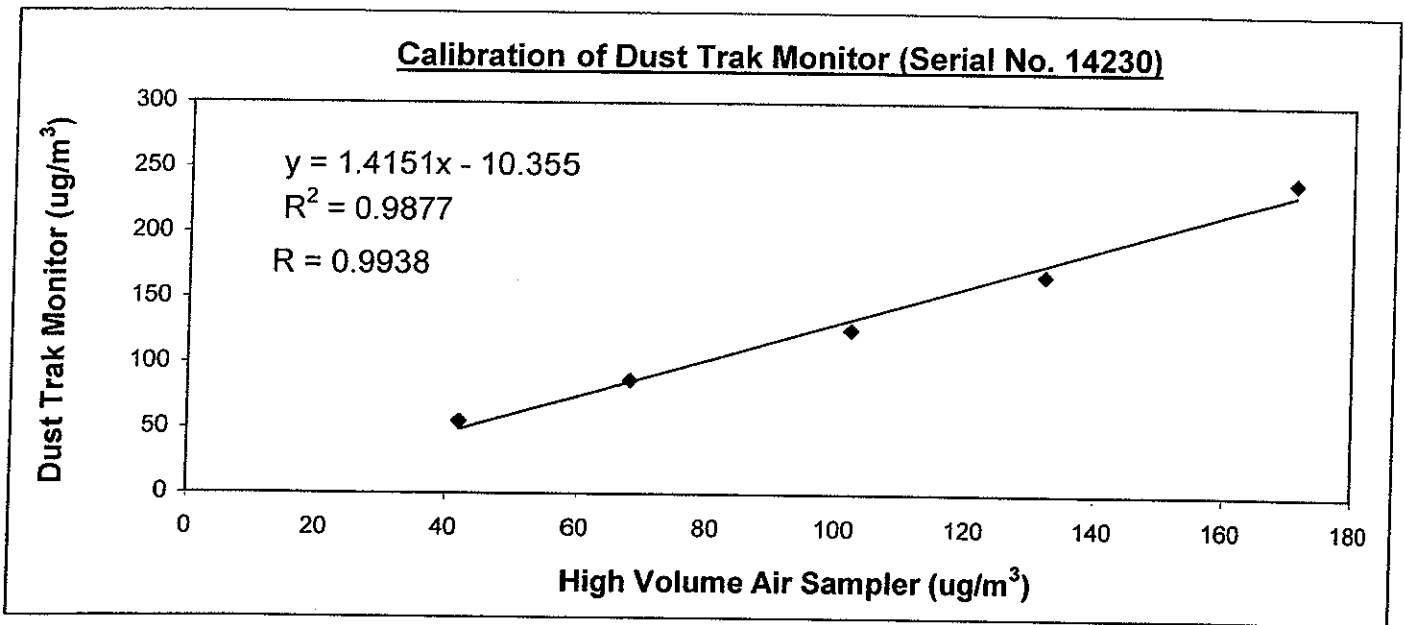
Method : Parallel measurement (five-point calibration) by placing the Dust Trak Monitor and High Volume Air Samper together under the same environmental condition

Results	Dust Trak Monitor (ug/m ³)	55	87	126	168	241
	High Volume Air Sampler (ug/m ³)	42	68	102	132	171
	High Volume Air Sampler Serial No.: 1178	Calibration Due Date: 29 August 2009

Acceptance Criteria : Correlation coefficient (r) of the calibration curve greater than 0.990 after a five point calibration

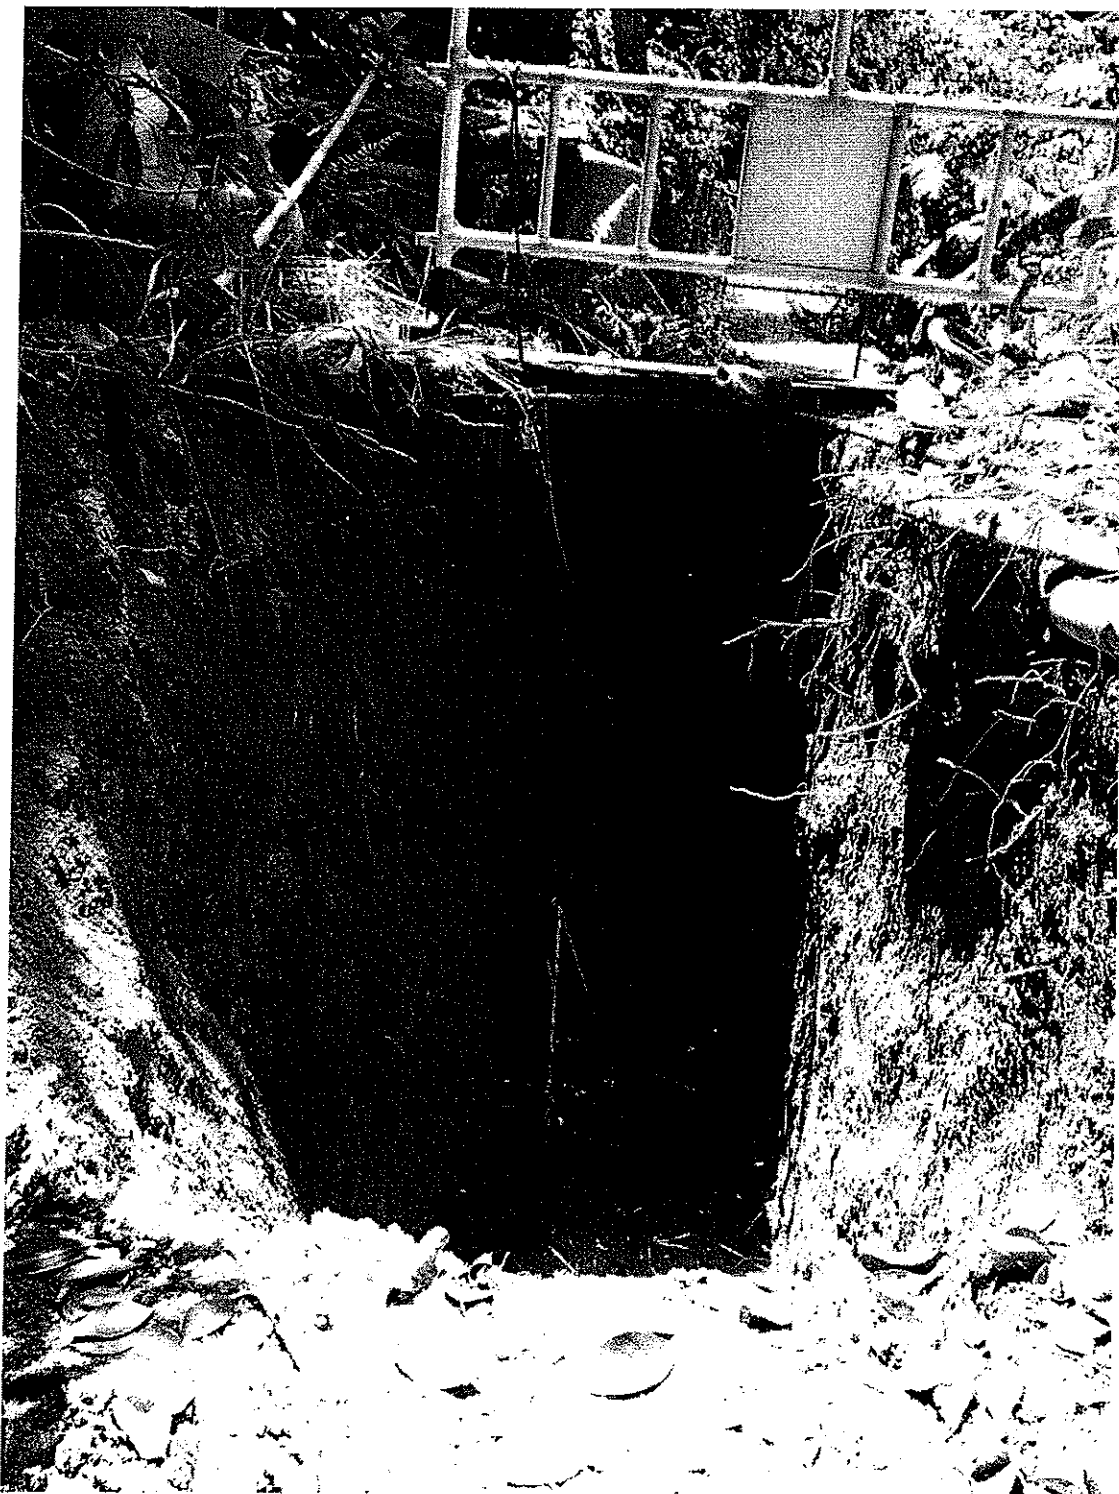
Plate 4: Deeper sondage excavated at MH S52 – looking south
