**CONTRACT NO. DC/2007/18**

**YUNG SHUE WAN AND  
SOK KWU WAN VILLAGE SEWERAGE,  
STAGE 1 WORKS**

**MONTHLY IMPACT MONITORING  
REPORT NO.17**

**(OCTOBER 2009)**

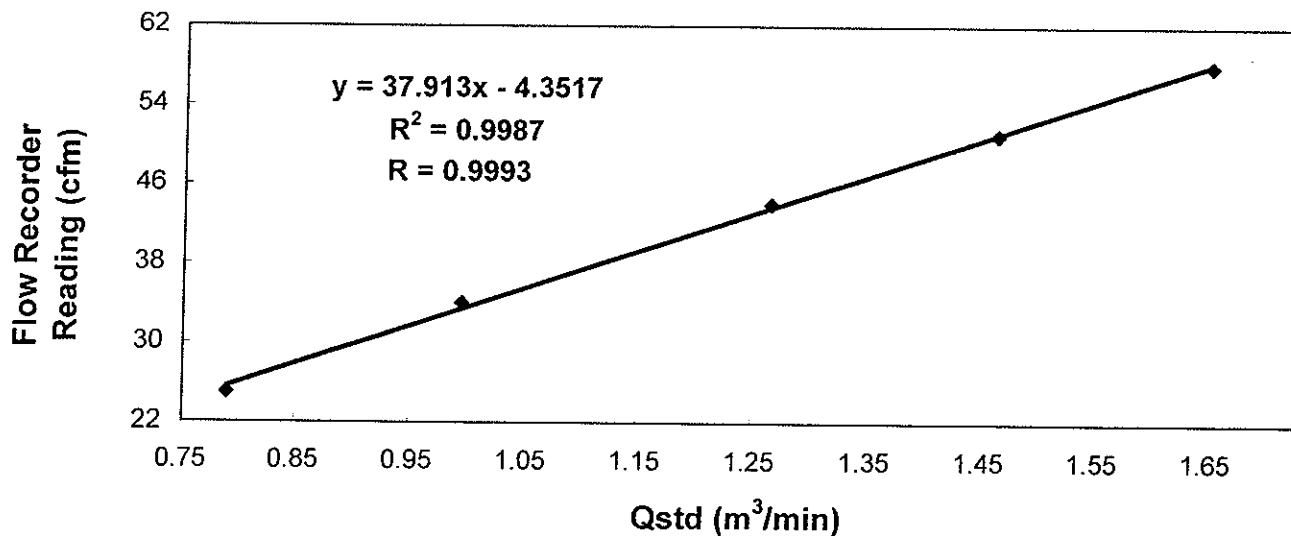
**Sampler 1173 Calibration Curve  
Site: Sok Kwu Wan (AM-1)**

Results	Flow recorder reading (cfm)	58	51	44	34	25
	Qstd (Actual flow rate, m <sup>3</sup> /min)	1.65	1.46	1.27	1.00	0.79
	Pressure : 753.06 mmHg	Temp. : 302 K

Acceptance Criteria : Correlation coefficient (r) of the calibration curve greater than 0.990 after 5-point calibration

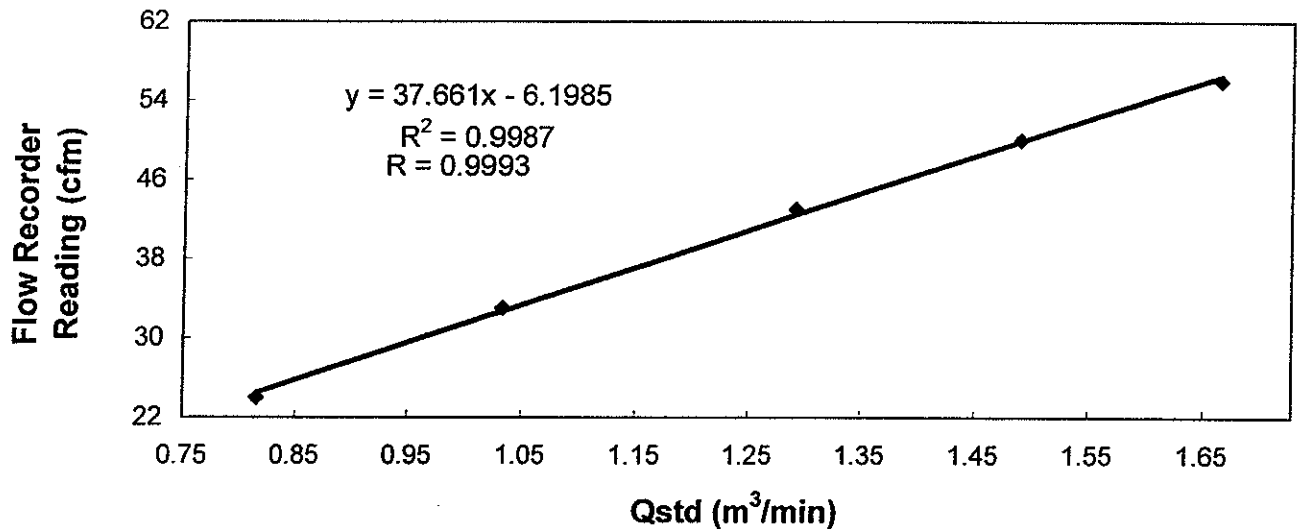
**Sampler 1173 Calibration Curve**  
Site: Sok Kwu Wan (AM-1)

<b>Results</b>	Flow recorder reading (cfm)	56	50	43	33	24
	Qstd (Actual flow rate, m <sup>3</sup> /min)	1.66	1.49	1.29	1.03	0.81
	Pressure : 764.31 mmHg	Temp. : 299 K

Acceptance Criteria : Correlation coefficient (r) of the calibration curve greater than 0.990 after 5-point calibration

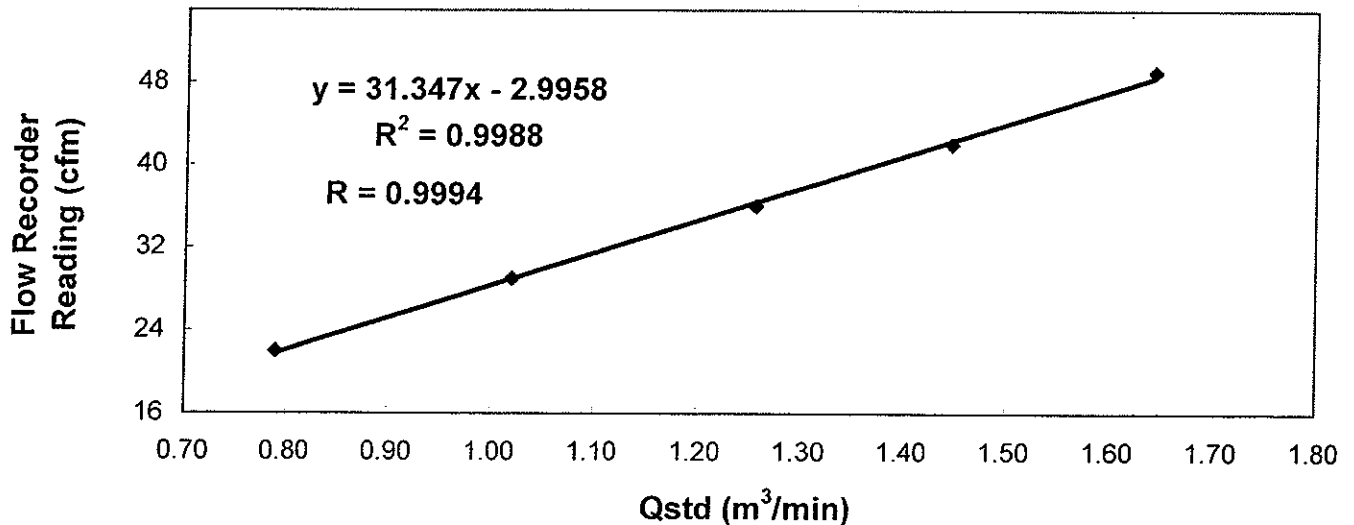
**Sampler 9865 Calibration Curve**  
Site: Sok Kwu Wan (AM-2)

Flow recorder reading (cfm)	49	42	36	29	22
Qstd (Actual flow rate, m <sup>3</sup> /min)	1.64	1.45	1.26	1.02	0.79
Pressure :	753.06 mm Hg		Temp. :	302 K

Acceptance Criteria : Correlation coefficient (r) of the calibration curve greater than 0.990 after a 5-point calibration

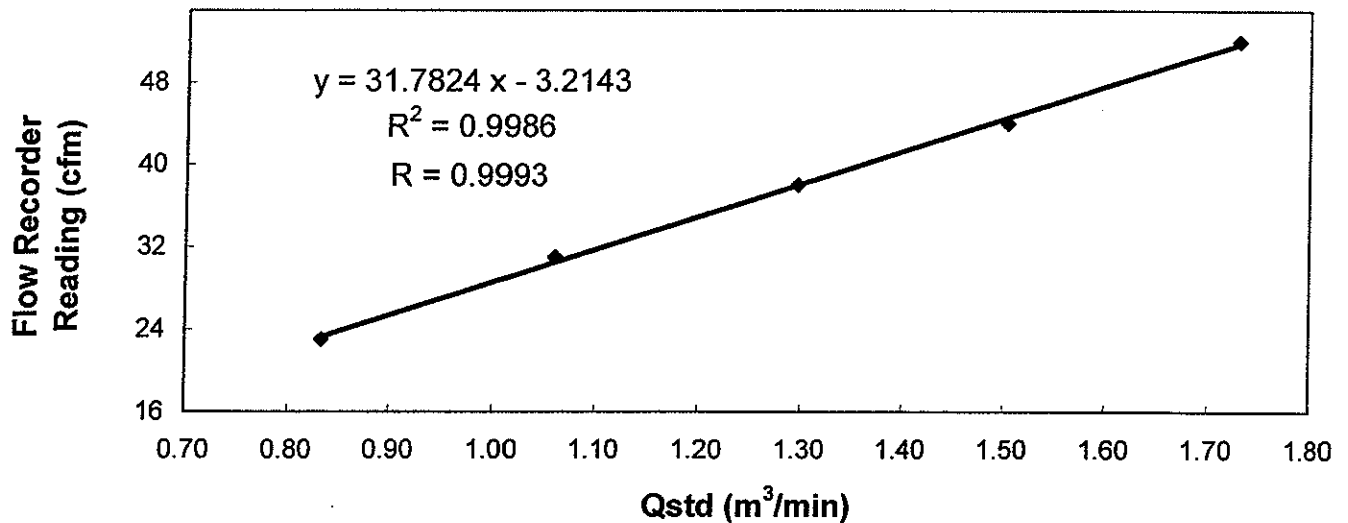
**Sampler 9865 Calibration Curve**  
Site: Sok Kwu Wan (AM-2)

<b>Results</b>	Flow recorder reading (cfm)	52	44	38	31	23
	Qstd (Actual flow rate, m <sup>3</sup> /min)	1.73	1.50	1.30	1.06	0.83
	Pressure : 764.31 mm Hg	Temp. : 297 K

Acceptance Criteria : Correlation coefficient (r) of the calibration curve greater than 0.990 after a 5-point calibration

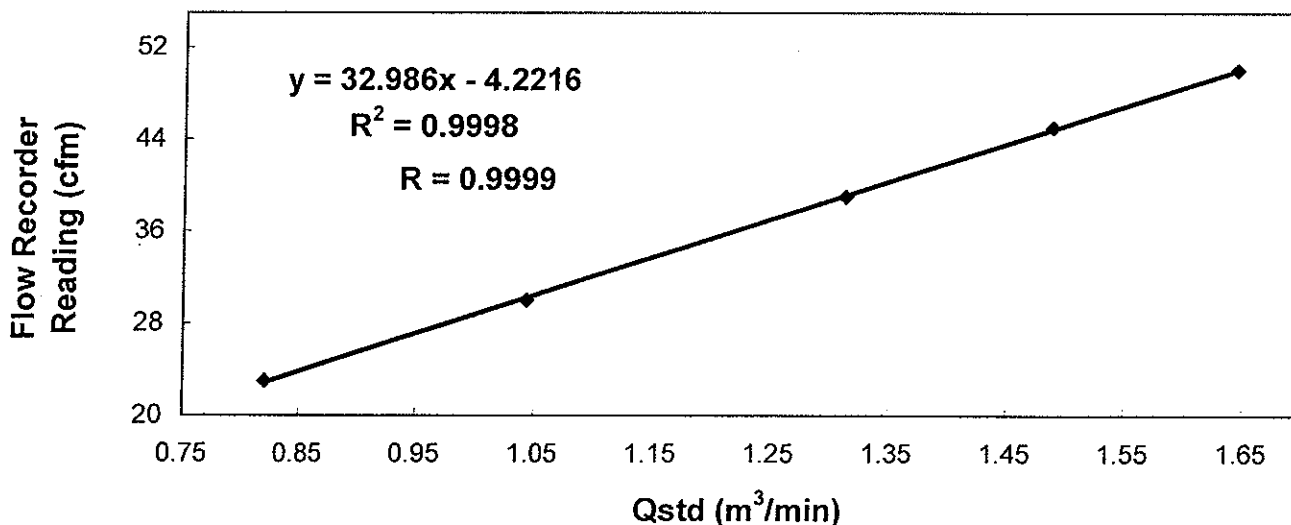
**Sampler 9912 Calibration Curve**  
Site: Sok Kwu Wan (AM-3)

Flow recorder reading (cfm)	50	45	39	30	23
Qstd (Actual flow rate, m <sup>3</sup> /min)	1.64	1.49	1.31	1.04	0.82
Pressure :	753.06 mm Hg		Temp. :	302 K

Acceptance Criteria : Correlation coefficient (r) of the calibration curve greater than 0.990 after a 5-point calibration

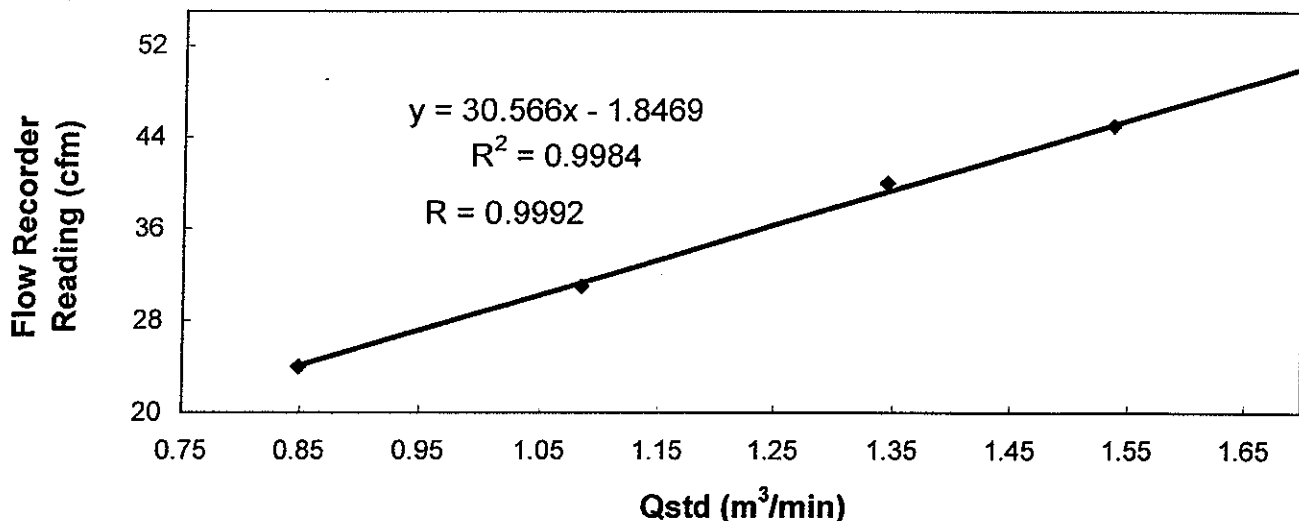
**Sampler 9912 Calibration Curve**  
**Site: Sok Kwu Wan (AM-3)**

Flow recorder reading (cfm)	51	45	40	31	24
Qstd (Actual flow rate, m <sup>3</sup> /min)	1.74	1.54	1.34	1.08	0.85
Pressure :	765.06 mm Hg		Temp. :	297 K

Acceptance Criteria : Correlation coefficient (r) of the calibration curve greater than 0.990 after a 5-point calibration

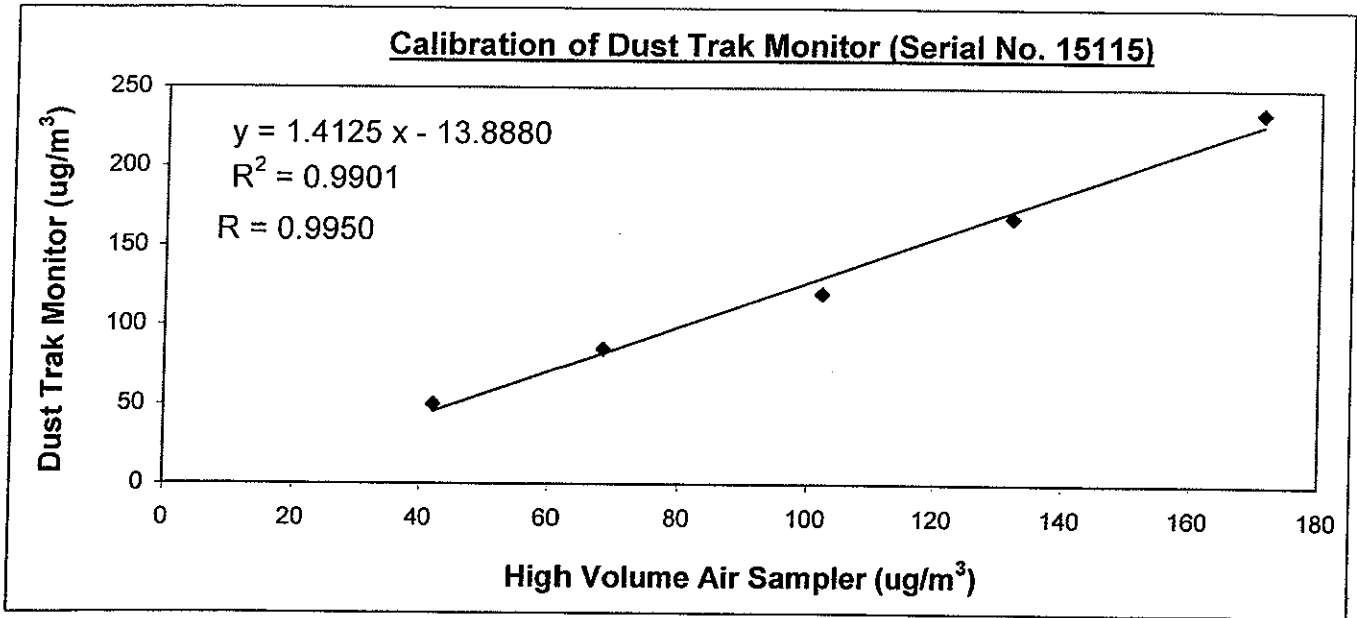
Method : Parallel measurement (five-point calibration) by placing the Dust Trak Monitor and High Volume Air Samper together under the same environmental condition

Results	Dust Trak Monitor ( $\mu\text{g}/\text{m}^3$ )	50	85	120	168	235
	High Volume Air Sampler ( $\mu\text{g}/\text{m}^3$ )	42	68	102	132	171
Serail No of High Volume Air Sampler : 1178		Calibration Due Date: 29 August 2009

Correlation coefficient (r) of the calibration curve greater than 0.990 after a five point calibration

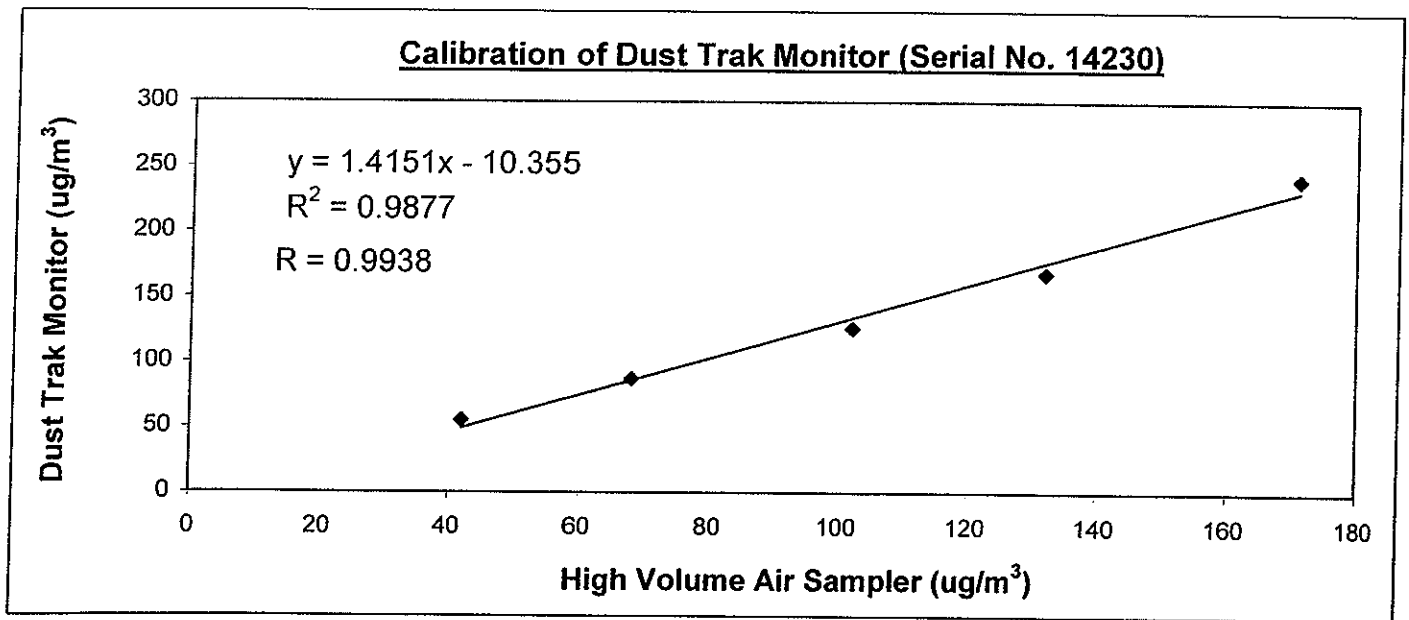
**Manufacturer** : TSI - 8520 Dust Trak **Date of Calibration** : 10 July 2009  
**Serial No.** : 14230 ( ET/EA/001/04 ) **Due Date** : 09 January 2010  
**Method** : Parallel measurement (five-point calibration) by placing the Dust Trak Monitor and High Volume Air Sampler together under the same environmental condition

Dust Trak Monitor ( $\mu\text{g}/\text{m}^3$ )	55	87	126	168	241
High Volume Air Sampler ( $\mu\text{g}/\text{m}^3$ )	42	68	102	132	171
High Volume Air Sampler Serial No.: 1178			Calibration Due Date: 29 August 2009

Acceptance Criteria : Correlation coefficient (r) of the calibration curve greater than 0.990 after a five point calibration

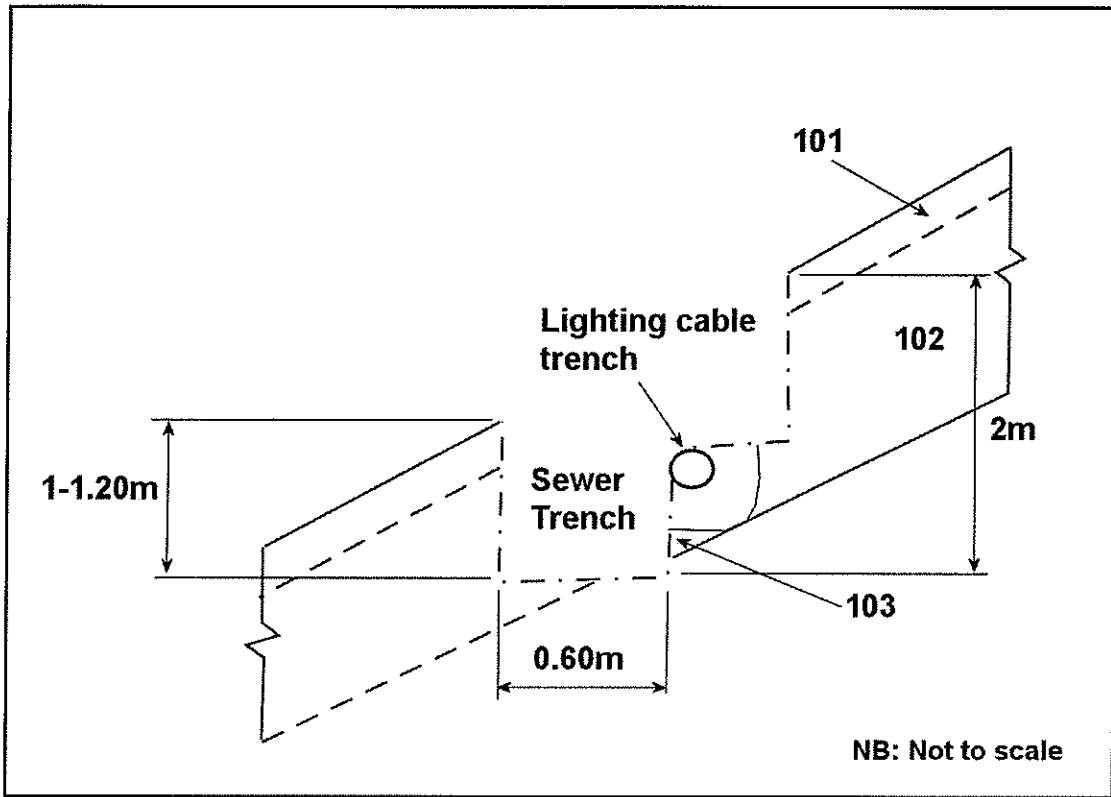
Figure 4: Transverse sketch section of sewer trench in environs of MH S53 – looking north

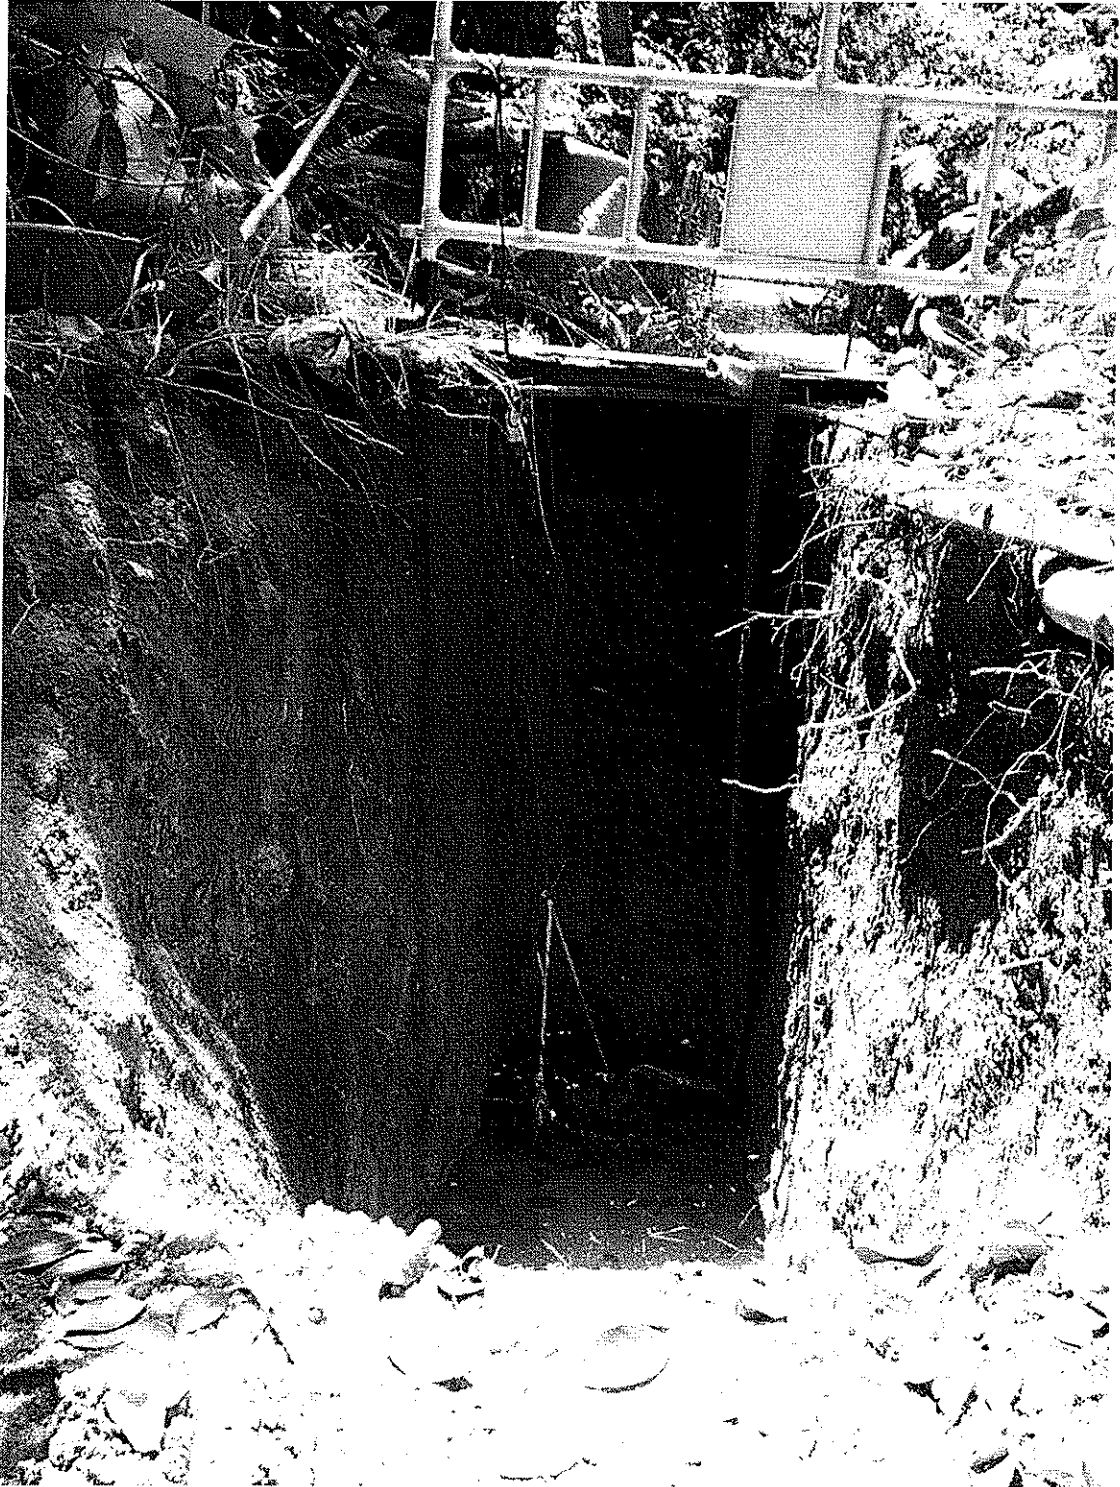
Plate 4: Deeper sondage excavated at MH S52 – looking south

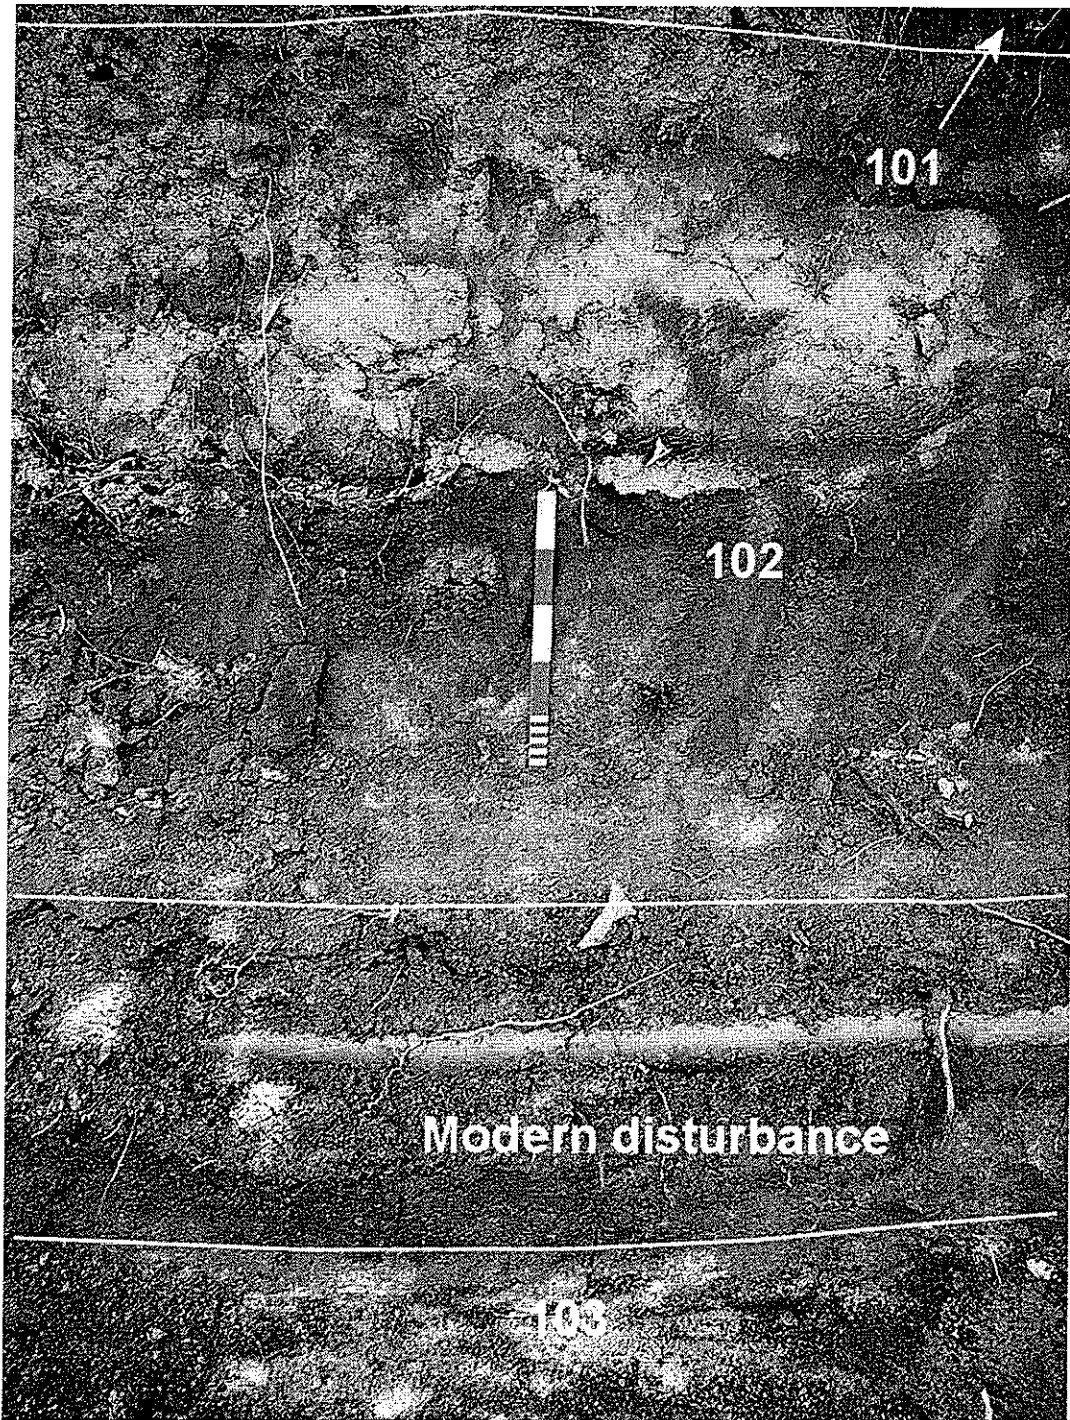
Plate 5: West facing section at MH S53 – trench stepped at base of 0.5m scale

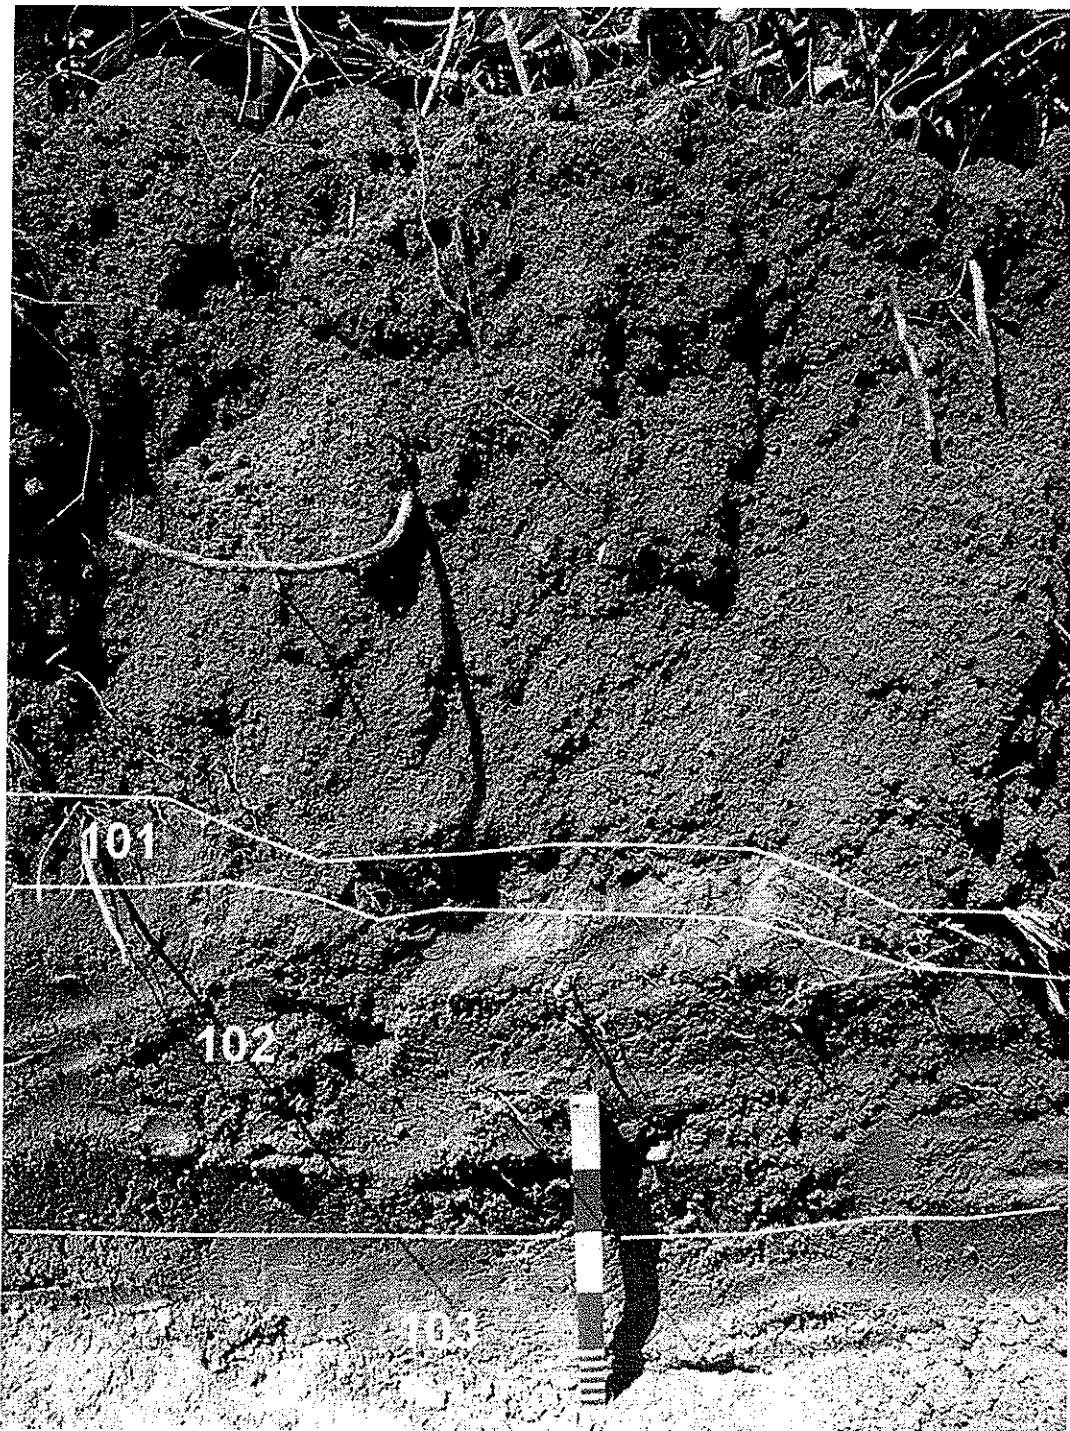
Plate 6: East facing section at MH S54

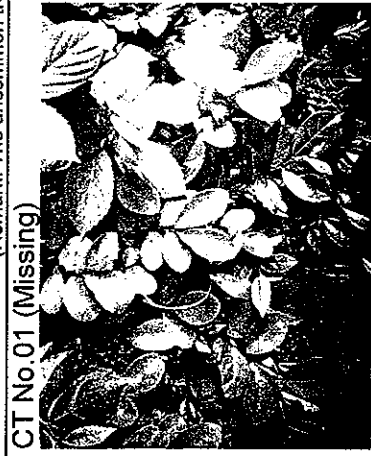
(Remark: The uncommon tree species at location No. 1, 2 & 12 were removed by Food & Environmental Hygiene Department (FEHD) as confirmed on 10 Sept. 2009)

CT No.01 (Missing)

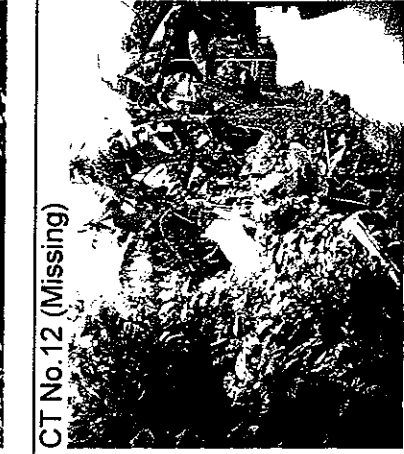
CT No.12 (Missing)

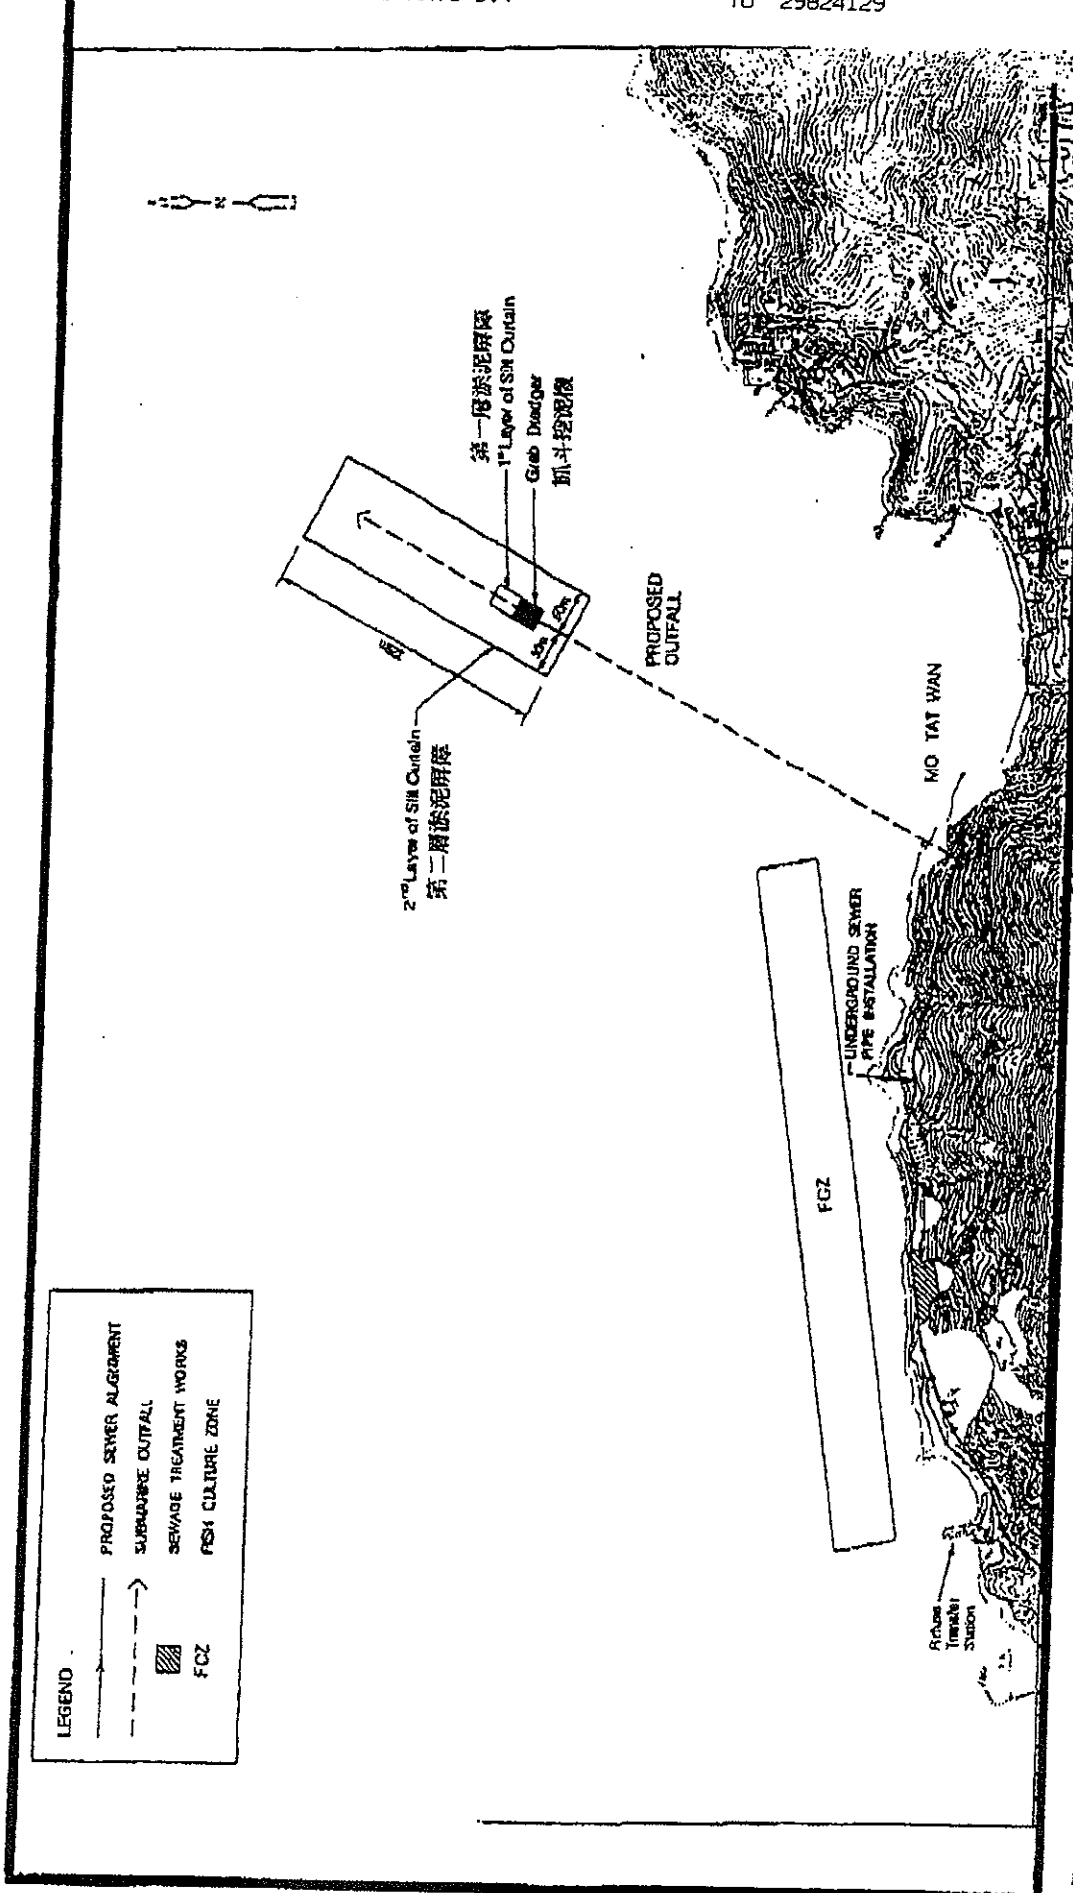
Figure 3: Arrangement of Silt Curtain during Construction  
 圖 3: 建造期間設置淤泥屏障的安排
