CONTRACT NO. DC/2007/18

**YUNG SHUE WAN AND
SOK KWU WAN VILLAGE SEWERAGE,
STAGE 1 WORKS**

**MONTHLY IMPACT MONITORING
REPORT NO.22**

(MARCH 2010)

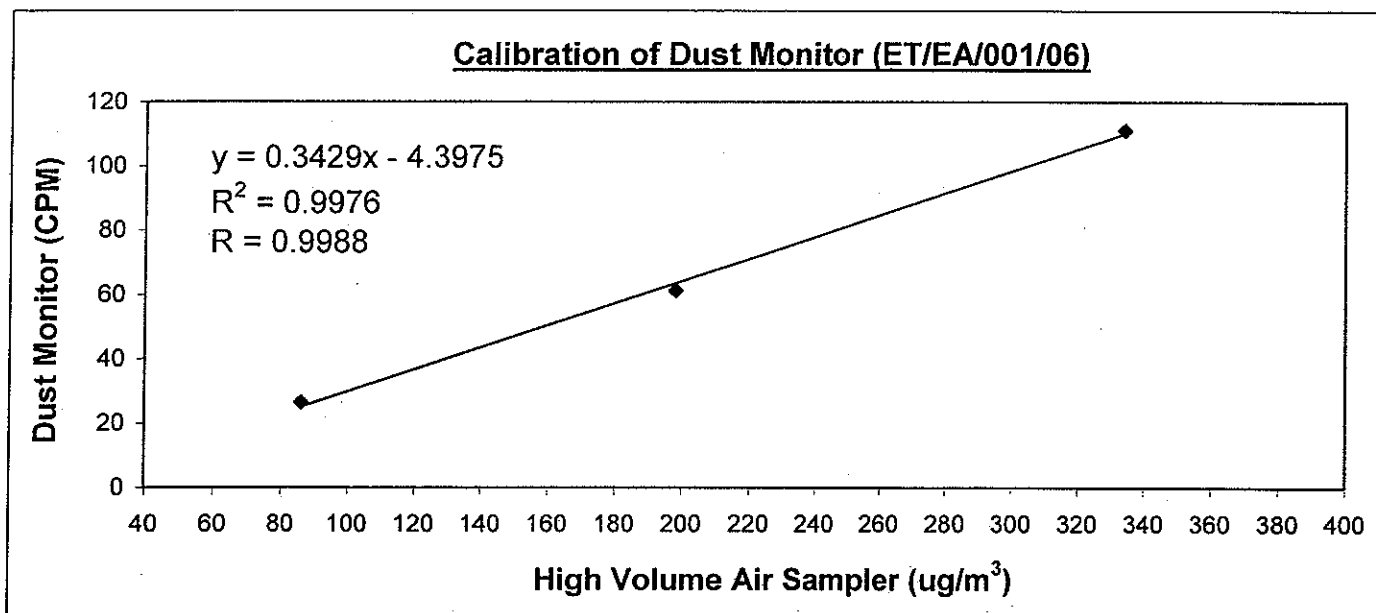
Manufacturer : SIBATA Date of Calibration : 09 February 2010
Serial No. : 014746 (ET/EA/001/06) Calibration Due Date : 08 August 2010
Method : Parallel measurement (^{three HSA} ~~five~~-point calibration) by placing the Dust Monitor and High Volume Air Sampler together under the same environmental condition

Acceptance Criteria : Correlation coefficient (r) of the calibration curve greater than 0.990 after a five point calibration

The Dust Trak Monitor complies * / ~~does not comply~~ * with the internal calibration procedures and is deemed acceptable * / unacceptable * for use.

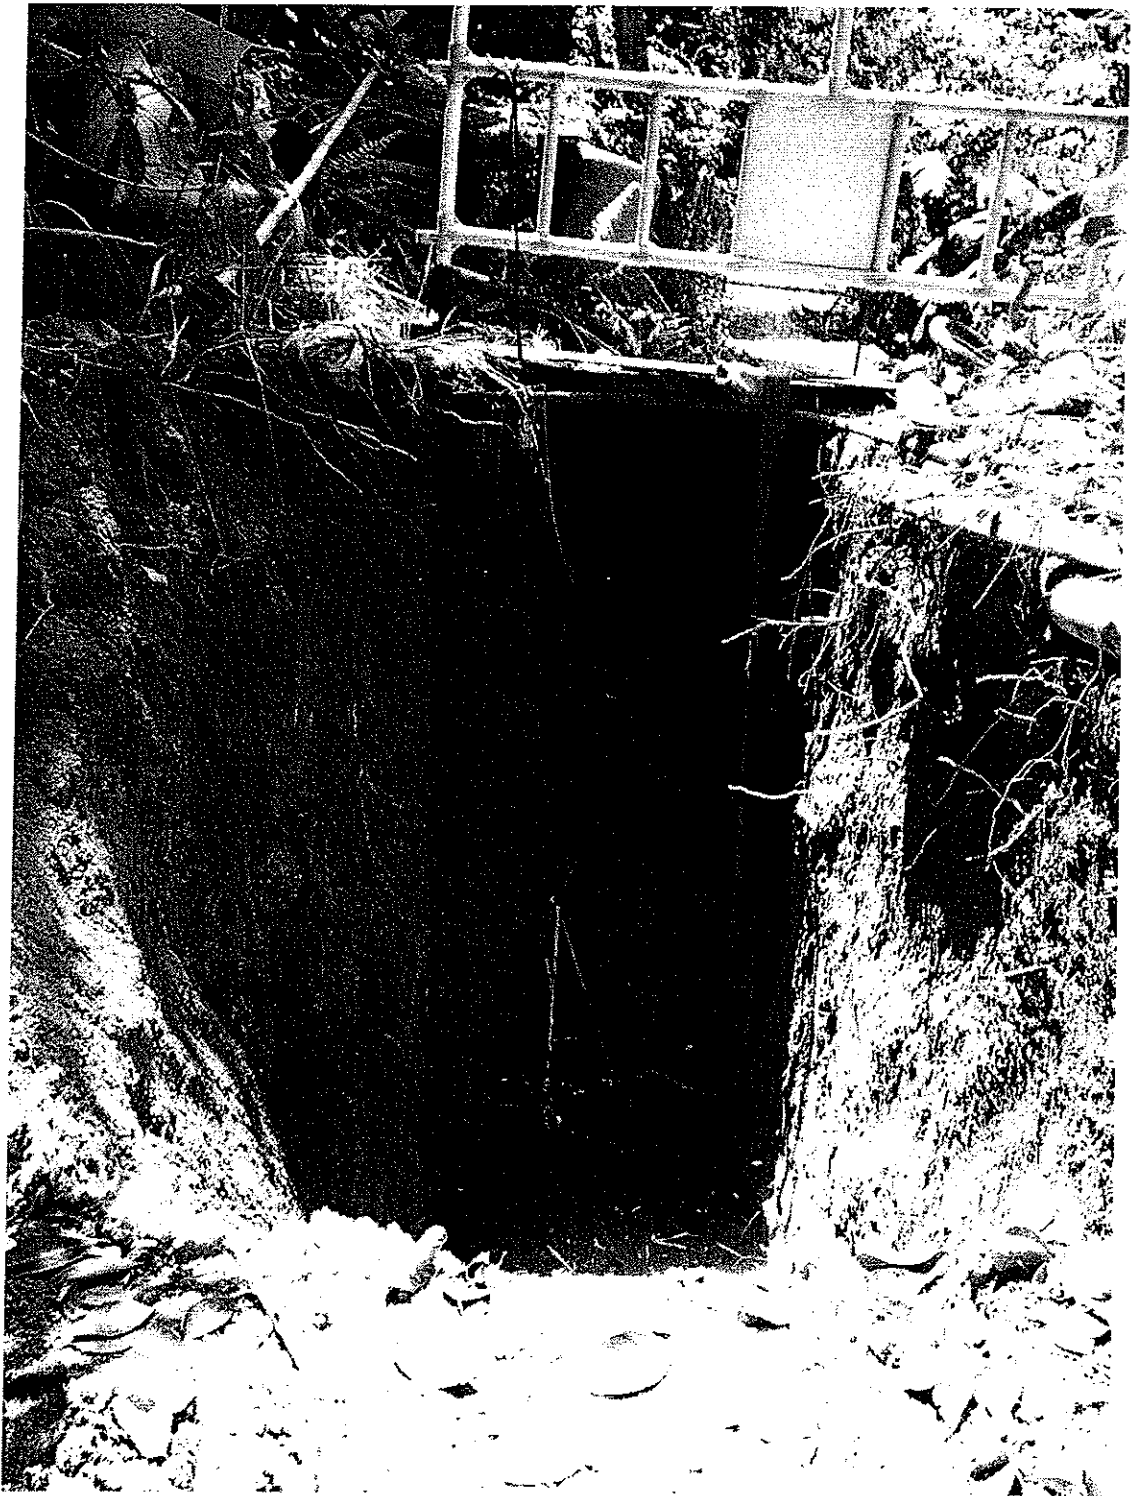
Plate 4: Deeper sondage excavated at MH S52 – looking south
