**YUNG SHUE WAN AND
SOK KWU WAN VILLAGE SEWERAGE,
STAGE 1 WORKS**

**MONTHLY IMPACT MONITORING
REPORT NO.24**

(MAY 2010)

Report No.: ENA00470

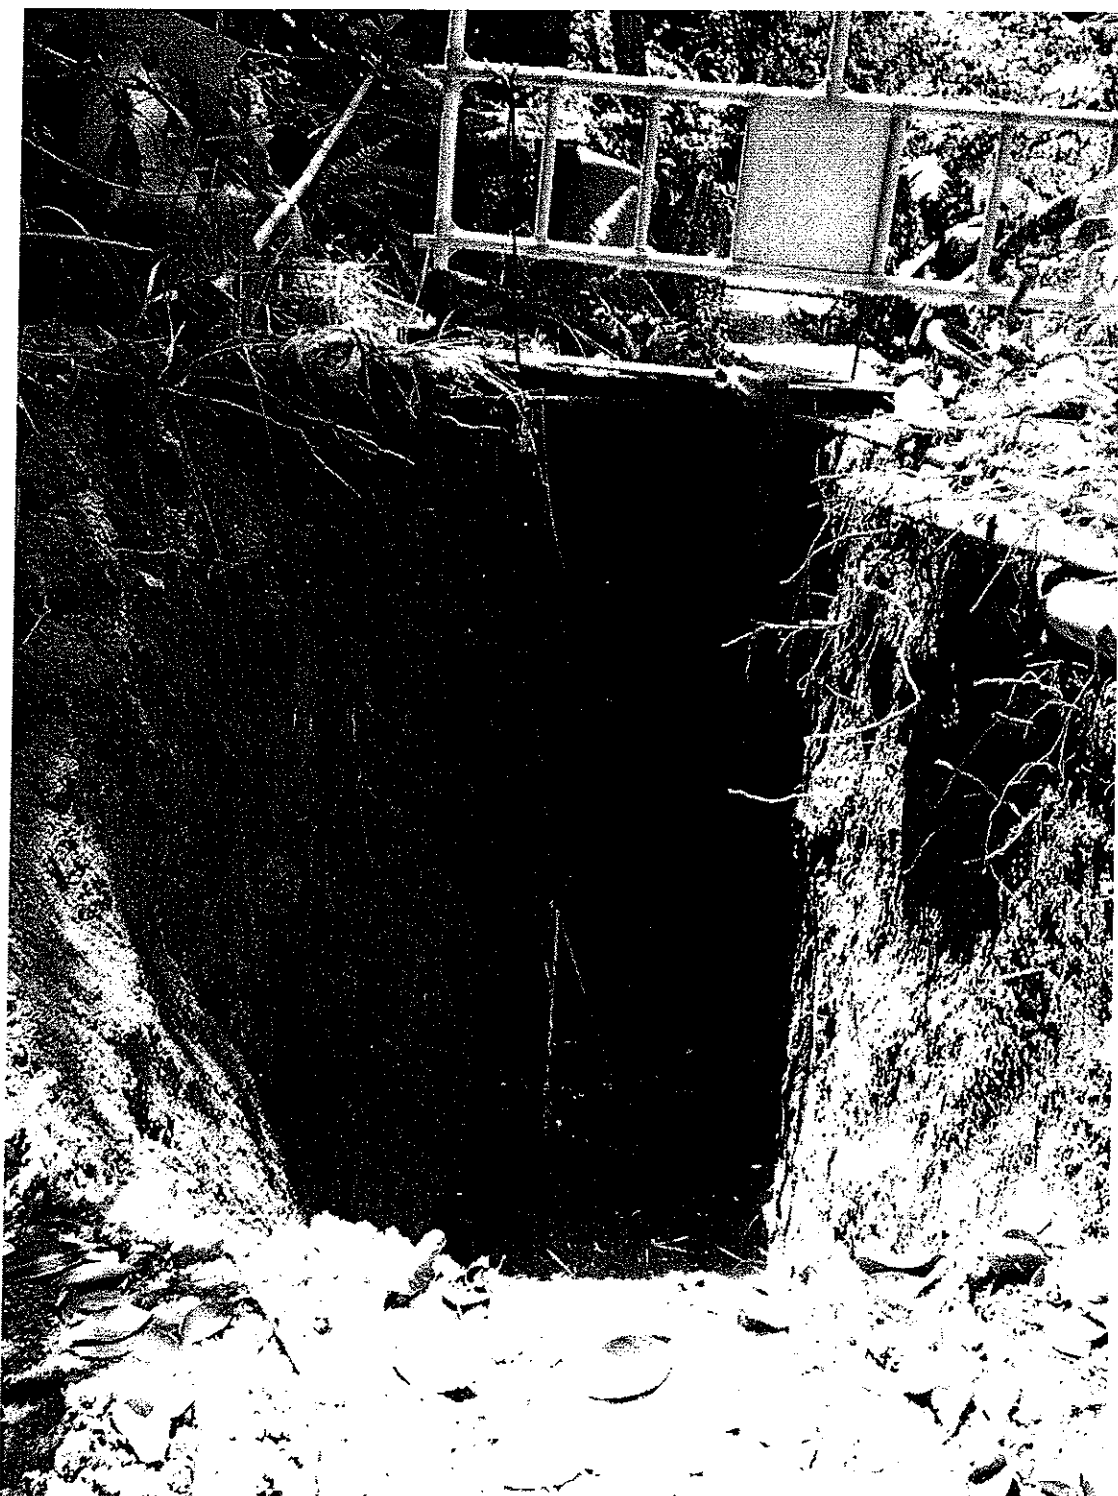
Plate 4: Deeper sondage excavated at MH S52 – looking south
