**CONTRACT NO. DC/2007/18**

**YUNG SHUE WAN AND  
SOK KWU WAN VILLAGE SEWERAGE,  
STAGE 1 WORKS**

**MONTHLY IMPACT MONITORING  
REPORT NO.26**

**(JULY 2010)**

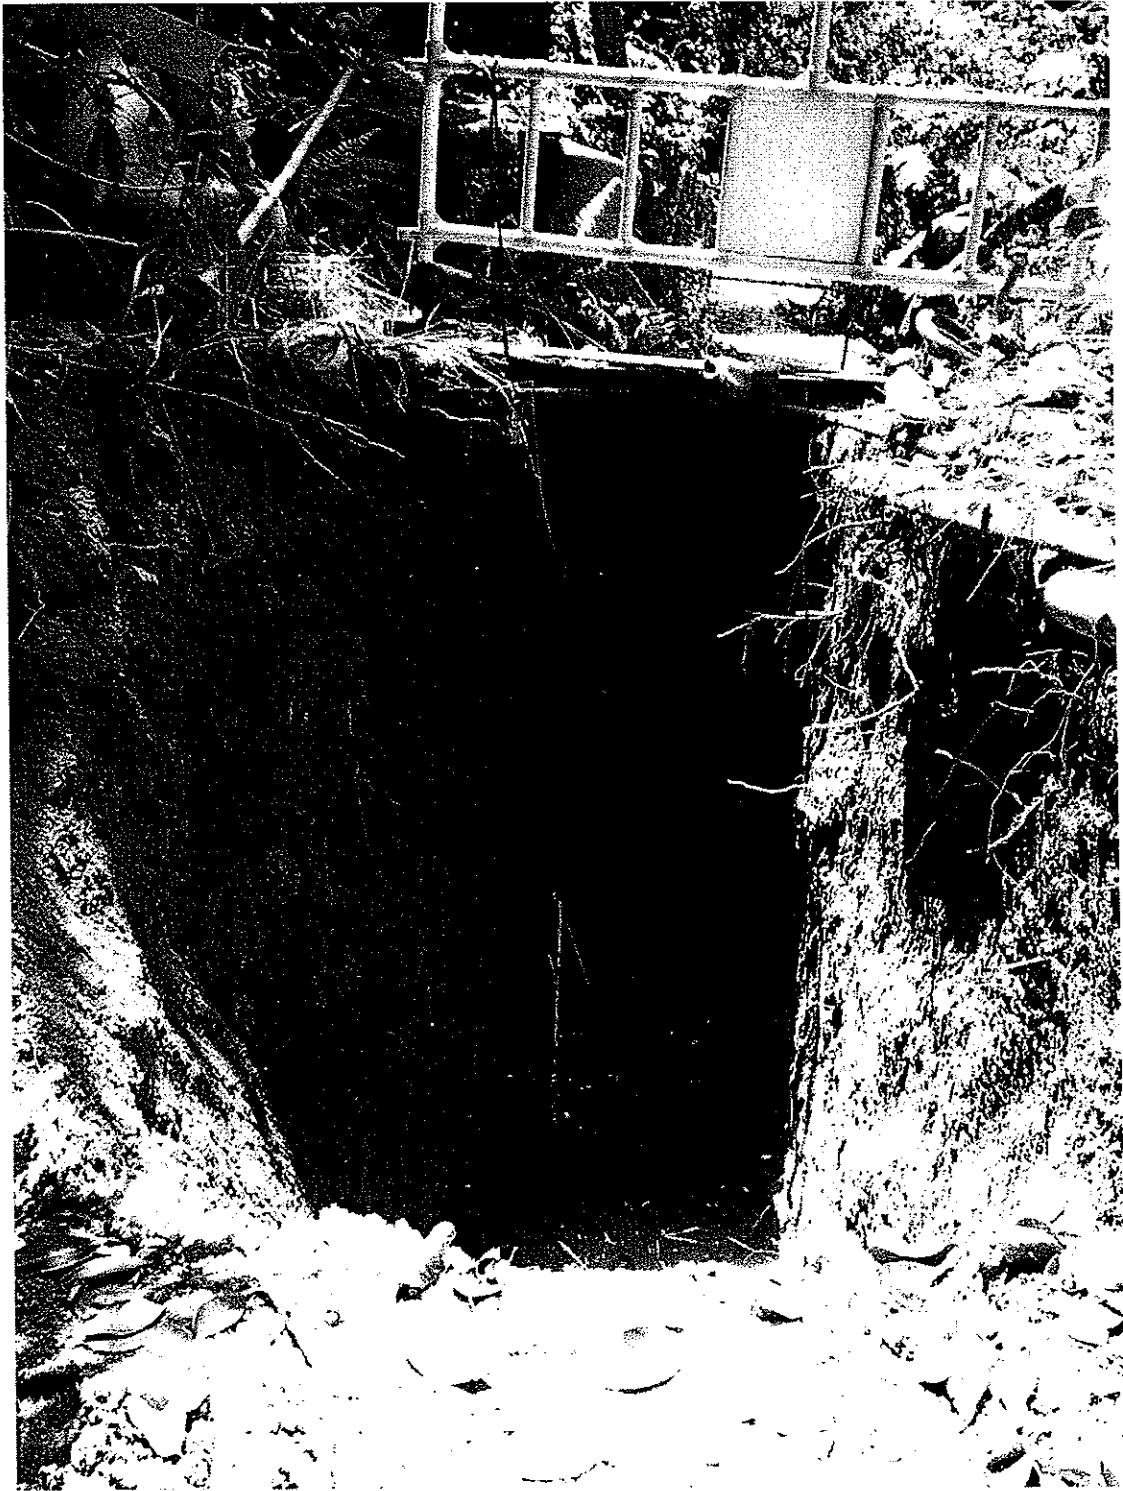
Plate 4: Deeper sondage excavated at MH S52 – looking south
