**Contract No. DC/2008/09**  
**Harbour Area Treatment Scheme**  
**Stage 2A**  
**Construction of Sewage Conveyance**  
**System from Ap Lei Chau to Aberdeen**

**Report for Post-translocation Coral Monitoring (1<sup>st</sup>)**  
**(Version 2.0)**

March 2010

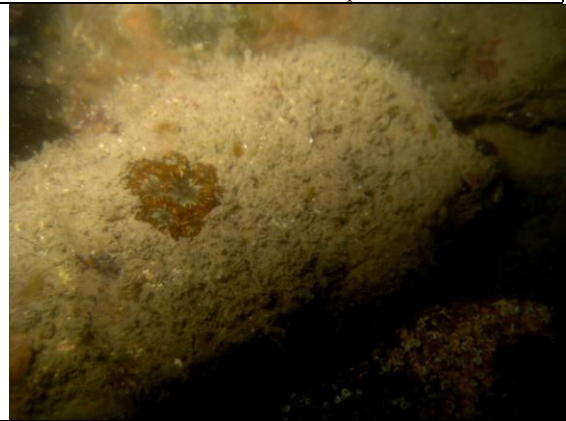
T2 *Oulastrea crispata*

3.1.3 When compared with baseline data immediate after translocation (30<sup>th</sup> January 2010), there was minor change in the health parameters in both Translocated and Reference Coral Colonies. Increased sedimentation was recorded in T03, R02 and R03 with <3%; while decreased in sedimentation level was observed in T02 and R01 by 1%. Bleaching and mortality was not recorded in any of the colonies.
