Contract No. DC/2008/09
Harbour Area Treatment Scheme
Stage 2A
Construction of Sewage Conveyance
System from Ap Lei Chau to Aberdeen
Report for Post-translocation Coral Monitoring (2nd)
(Version 1.0)

April 2010

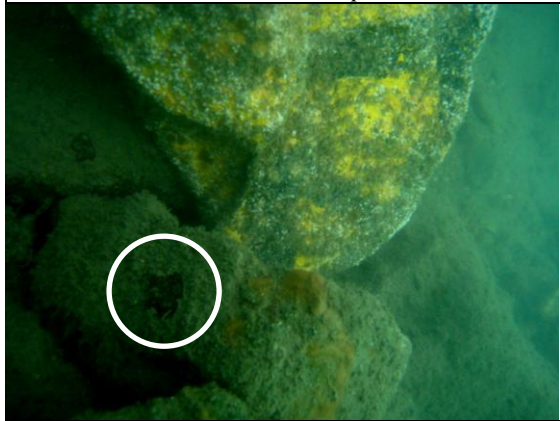
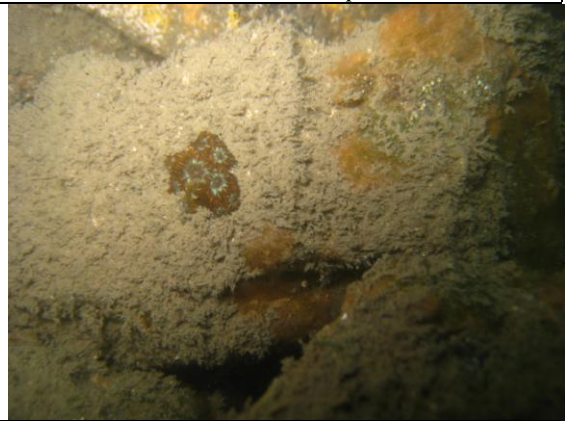
T2 *Oulastrea crispata*

3.1.3 When compared with baseline data immediate after translocation (30th January 2010), there was minor change in the health parameters in both Translocated and Reference Coral Colonies. Increased sedimentation was recorded in T03, R02, R03 and R04 with <3%; while decreased in sedimentation level was observed in T02 and R01 by 1%. Bleaching and mortality was not recorded in any of the colonies.

3.1.4 Measures on geometric diameter showed increases in colonies T02, T03 and R04 by 0.1 mm implied observable growth in the colonies when compared with baseline data.
