Contract No. DC/2008/09
Harbour Area Treatment Scheme
Stage 2A
Construction of Sewage Conveyance
System from Ap Lei Chau to Aberdeen

Report for Post-translocation Coral Monitoring (3rd)
(Version 1.0)

June 2010

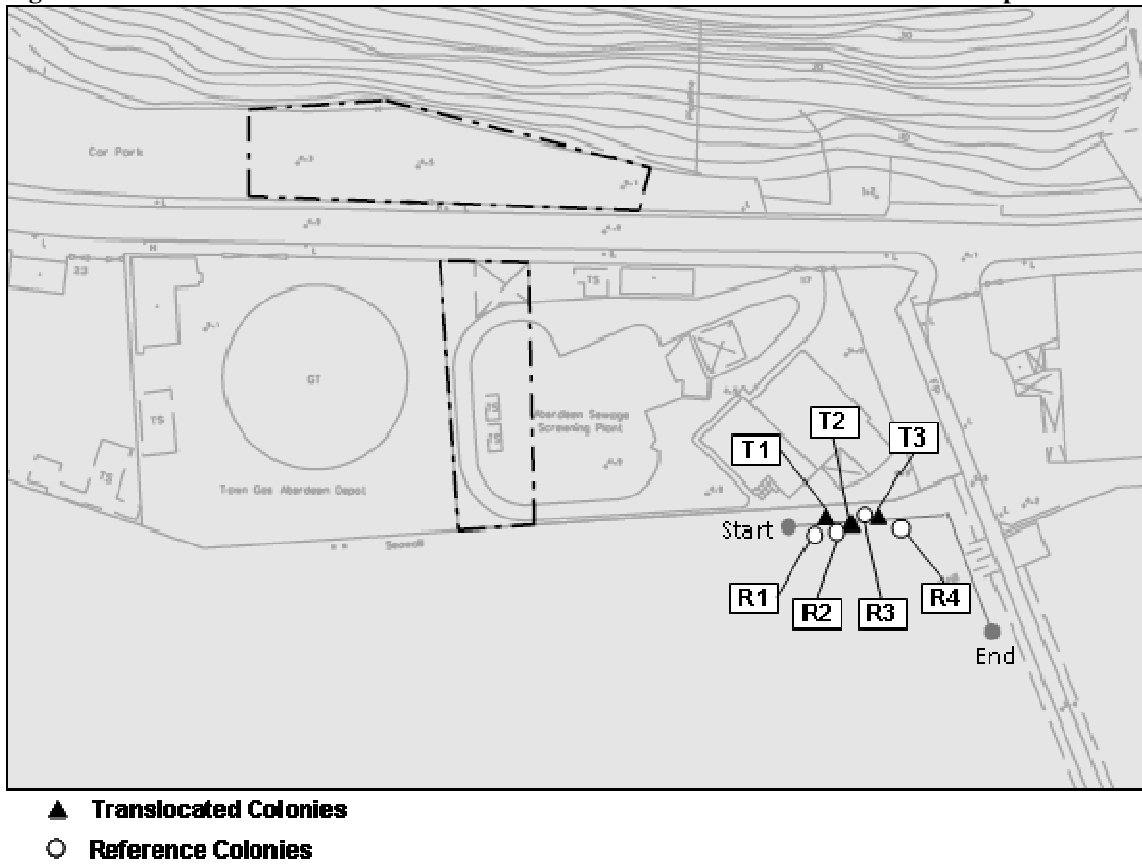
Figure 2.1 Schematic Position of Translocated and Reference Coral Colonies at the Recipient Site.

2.1.1 Coral monitoring was conducted at the Recipient Site (**Fig. 2.1**). In order to identify background environmental perturbations that are not associated with the translocation, four colonies originated at the Recipient Site were tagged as the Reference Colonies. Location (GPS coordinates) of the Recipient Site and conditions during the survey are summarized in Table 3.1.

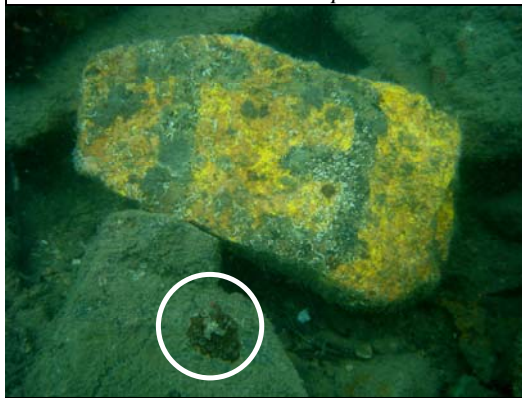
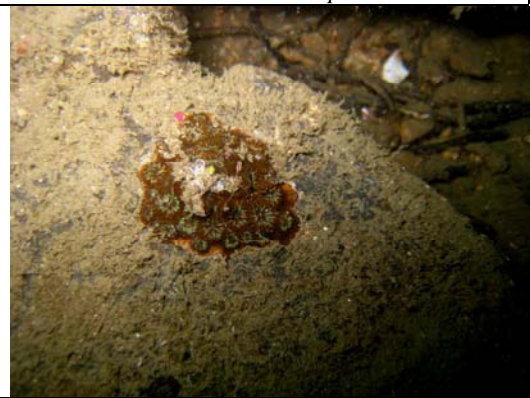
T3 *Oulastrea crispata*

3.1.3 When compared with baseline data immediate after translocation (30th January 2010), there was generally minor increase in sedimentation in both Translocated and Reference Coral Colonies for 1 to 6%. No Bleaching was recorded across all colonies. New partially mortality was recorded in T3 for 2%, which was likely to be caused by abrasion.

- 4.1.2 Record of mortality was recorded in T03, which was likely caused physically by abrasion as indicated by the damage of the underlying skeleton. The mortality led to sedimentation around the damaged area. Further observation is necessary to monitor if the mortality remain stable or further increase.
