**Paul Y. Construction Co. Limited**

**Contract No. DC/2008/09**  
**Harbour Area Treatment Scheme**  
**Stage 2A**  
**Construction of Sewage Conveyance**  
**System from Ap Lei Chau to Aberdeen**  
**Report for Post-translocation Coral Monitoring (4<sup>th</sup>)**  
**(Version 2.0)**

October 2010

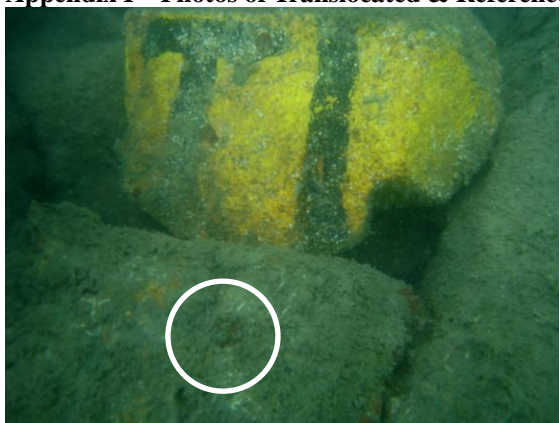
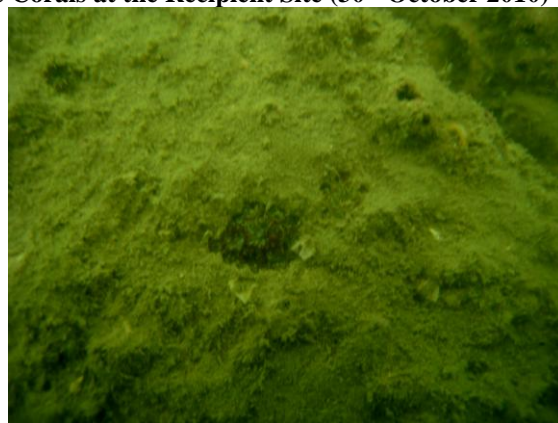
T1 *Oulastrea crispata*

3.1.3 When compared with baseline data immediate after translocation (30<sup>th</sup> January 2010), there was generally minor increase in sedimentation in both Translocated and Reference Coral Colonies for 1 to 4%. No bleaching was recorded across all colonies. The mortality rate recorded in T3 during the June 2010 survey (2%) showed no further increase in the present monitoring; a decrease in value to 1.8% was attributed to the growth of the colonies. No other partial mortality was observed in other tagged or reference colonies.

3.1.4 Measures on geometric diameter review increases in all colonies. For the Translocated Colonies, growth ranged from 2.2 to 3.0 mm since June 2010; while for the Reference Colonies, growth ranged from 1.3 to 6.1 mm over the past 4 months.

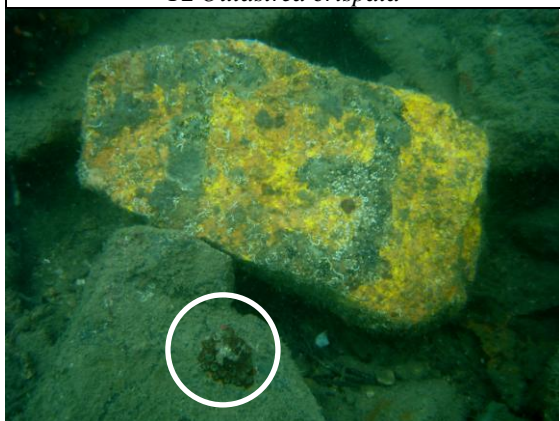
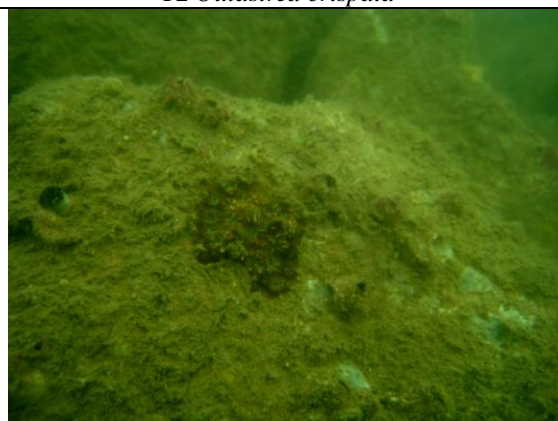
T3 *Oulastrea crispata*

- 4.1.2 The partial mortality in T03 was recorded in June 2010, which was likely caused by physical abrasion. A decrease in percentage mortality was recorded due to the growth of the colonies, as well as no further increase in the mortality area. The observation suggested that the recorded damage did not pose further impact on the colony. The general health of the colony was also reflected by the similar growth rate as compared with the other colonies.
