Contract No. HY/2010/02

**Hong Kong – Zhuhai – Macao Bridge  
Hong Kong Boundary Crossing  
Facilities –  
Reclamation Works****Monthly EM&A Report for November 2012**

[12/2012]

Version:	Rev. 0	Date:	14 December 2012
----------	--------	-------	------------------

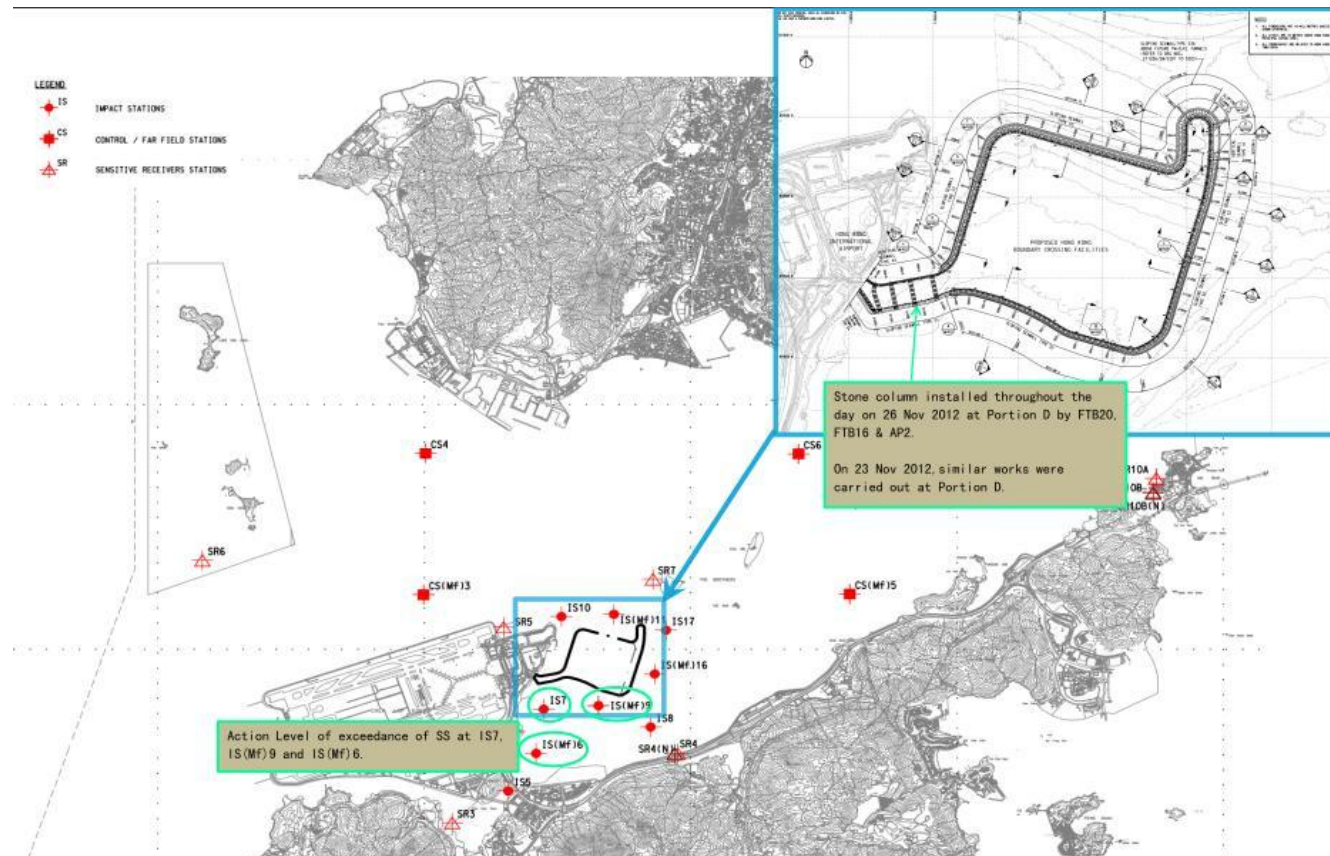
4.7.5 Three (3) where recorded on 26th Nov 2012 during mid-ebb tide at Impact Station IS(Mf)9 and IS7 and during mid-flood tide at Impact Station IS(Mf)6. For Action Level exceedances at measured Suspended Solids (mg/L), 23.8 mg/L, 24.2 mg/L and 28.1mg/L were recorded at Impact Station IS(Mf)9, IS7 and IS(Mf)6 respectively.

4.7.5.1 For Action Level Exceedances of SS at IS(Mf)9 and IS7 at Mid-Ebb tide, IS(Mf)6 at Mid-Flood tide on 26 November 2012, Stone column installation was carried out throughout the day at Portion D by FTB 16, FTB20 and AP2 on 26 Nov 2012.

4.7.5.2 Same work at same portion was carried out on the day on 23 November 2012 while no exceedance was recorded on 23 November 2012 at the same tide.

4.7.5.3 Rough sea condition and strong wind was noted during both Mid-Ebb tide and Mid-Flood tide. Shallow water condition at IS(Mf)9, IS7 and IS(Mf)6, water quality was likely to be affected up by rough sea condition and strong wind.

4.7.5.4 The exceedances was considered as Non-Project Related.

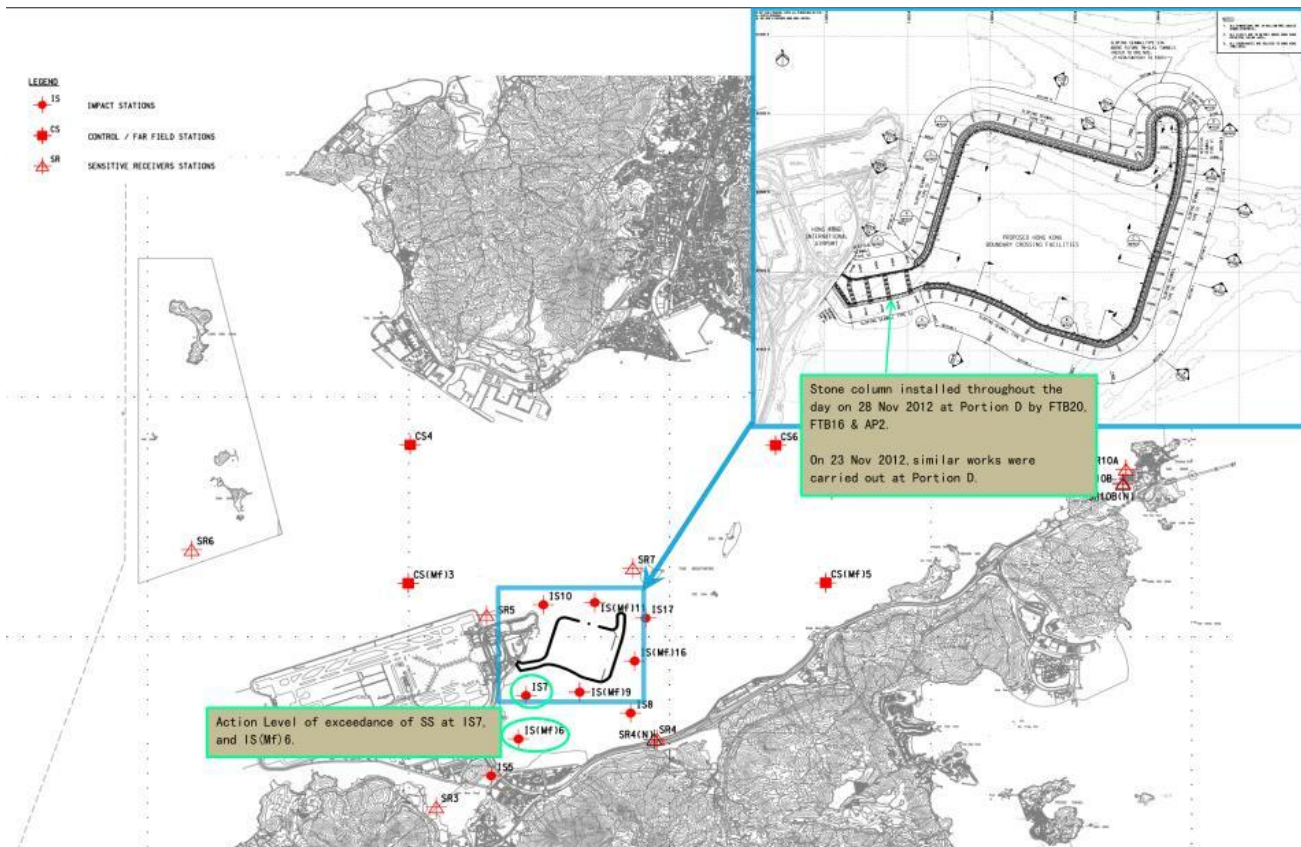
4.7.6 Two (2) where recorded on 28th Nov 2012 during mid-ebb tide at Impact Station IS(Mf)6 and IS7. For Action Level exceedances at measured Suspended Solids (mg/L), 31mg/L and 24.1mg/L were recorded at Impact Station IS(Mf)6 and IS7 respectively.

- 4.7.6.1 For Action Level Exceedances of SS at IS(Mf)6 and IS7 at Mid-Ebb tide on 28 November 2012, Stone column installation was carried out throughout the day at Portion D by FTB 16, FTB20 and AP2 on 28 Nov 2012.

- 4.7.6.2 Same work at same portion was carried out on the day on 23rd November 2012 while no exceedance was recorded on 23rd November 2012 at the same tide.

- 4.7.6.4 Bottom sediment might be stirred up by rough sea condition and strong wind at shallow water condition at Mid-Ebb tide at IS(Mf)6 and IS7 which in turn might contribute to the elevation in suspended solid.

- 4.7.6.5 In view of there is no damage can be observed from the silt curtain which deployed in the works area at Portion D.
- 4.7.6.6 The exceedances was considered as Non-Project Related.
