The Jockey Club CPS Limited

Central Police Station Conservation  
and Revitalisation Project:  
*Second Quarterly EM&A Report*  
*(1 February 2012 to 30 April 2012)*

Issue Date: June 2012

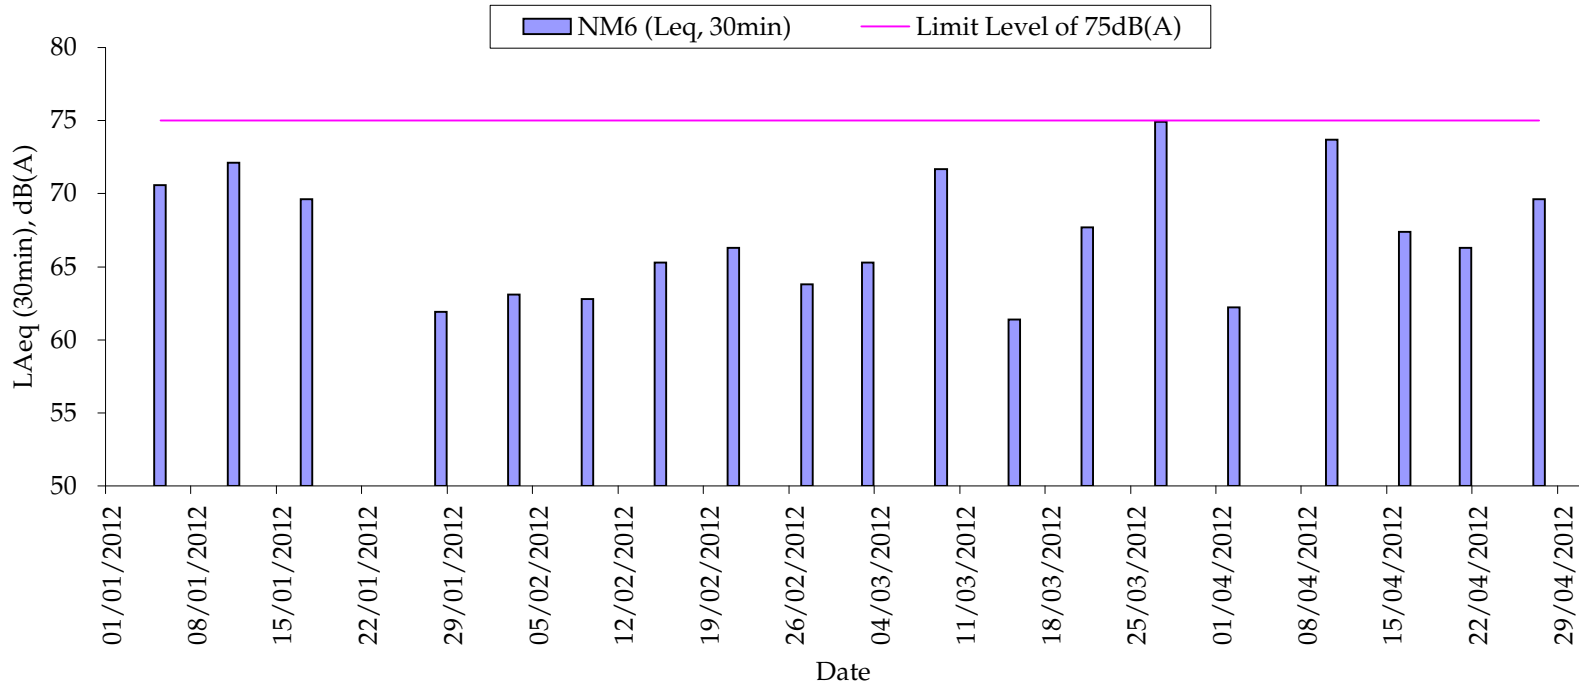
Normal Weekdays Noise Monitoring Results at NM6 - Chancery Mansion (Leq, 30min)

- 75dB(A) was adopted as the Limit Level during normal weekdays in the reporting period

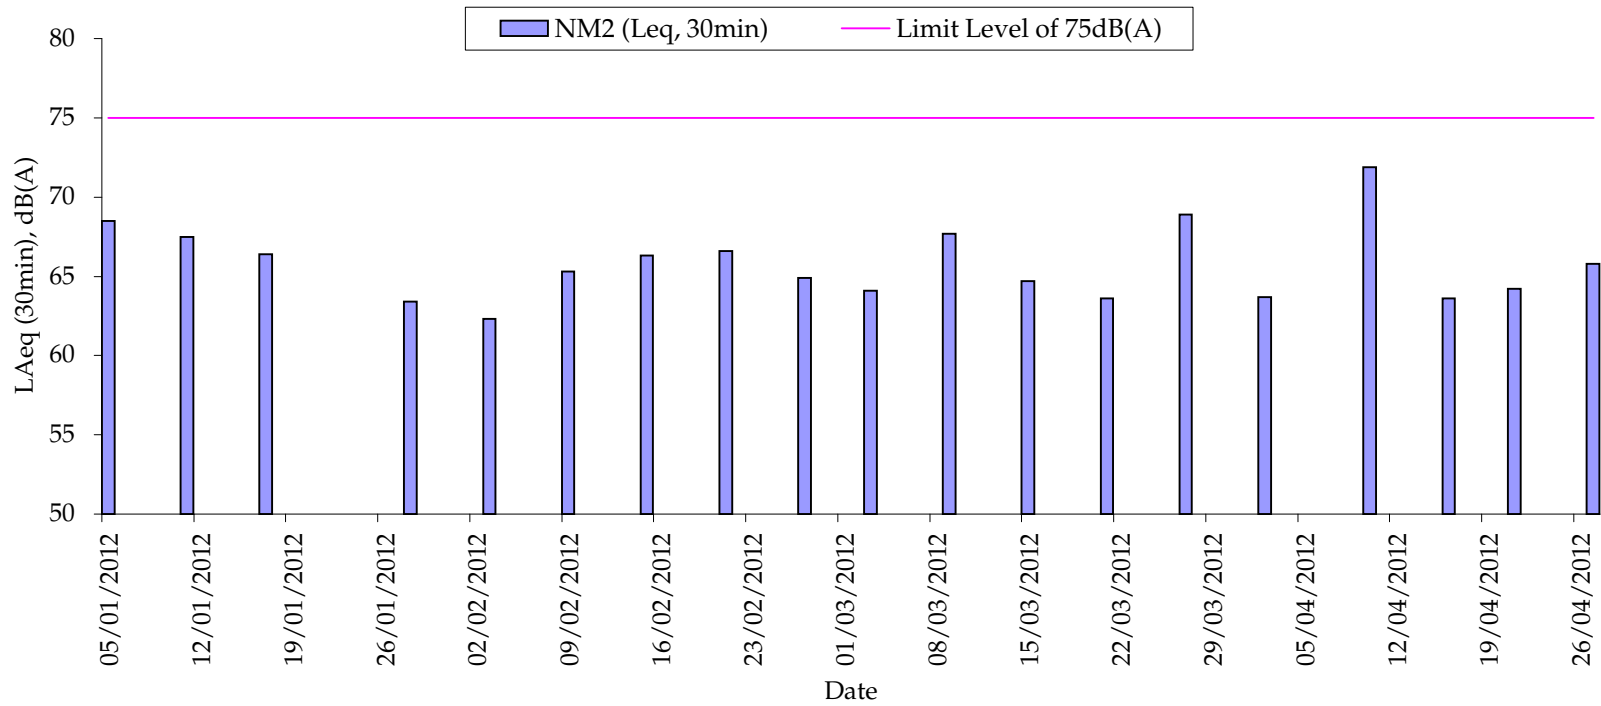
Normal Weekdays Noise Monitoring Results at NM2 - Ho Fook Building (Leq, 30min)

- 75dB(A) was adopted as the Limit Level during normal weekdays in the reporting period

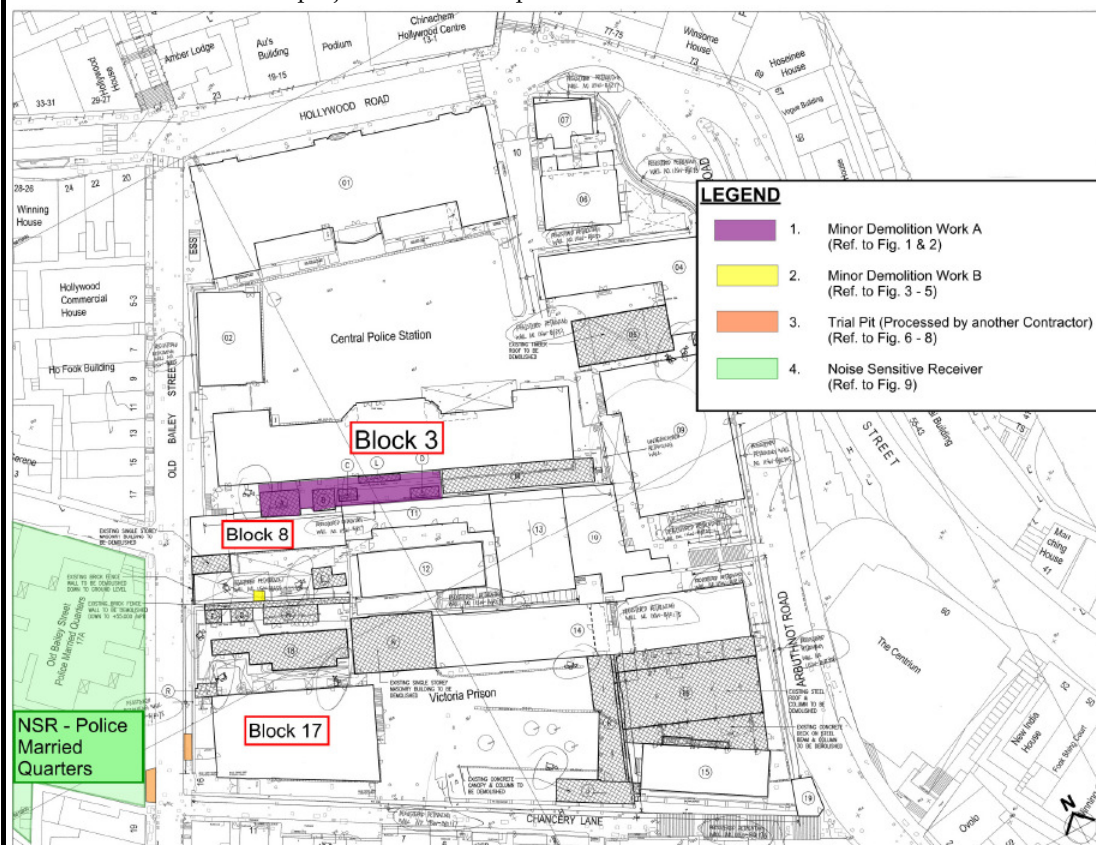
1. According to the works summary provided by the Contractor, construction work conducted included demolition works between Block 3 and Block 8, and nearby Block 8 and gantry entrance; and asbestos abatement work at Block 16. It was also noted that trial pit work for WSD's project was conducted by another contractor at Old Bailey Street.
2. It was noted that the location of the trial pit work is nearer to the residence of the complainant compared to the construction works of the project (see the figure below). Both the construction works by another contractor at Old Bailey Street and within the project site could be possible sources of noise nuisance.

Based on the above investigation, the following mitigation measures are proposed to the Contractor to further minimize the nuisance to the adjacent users:

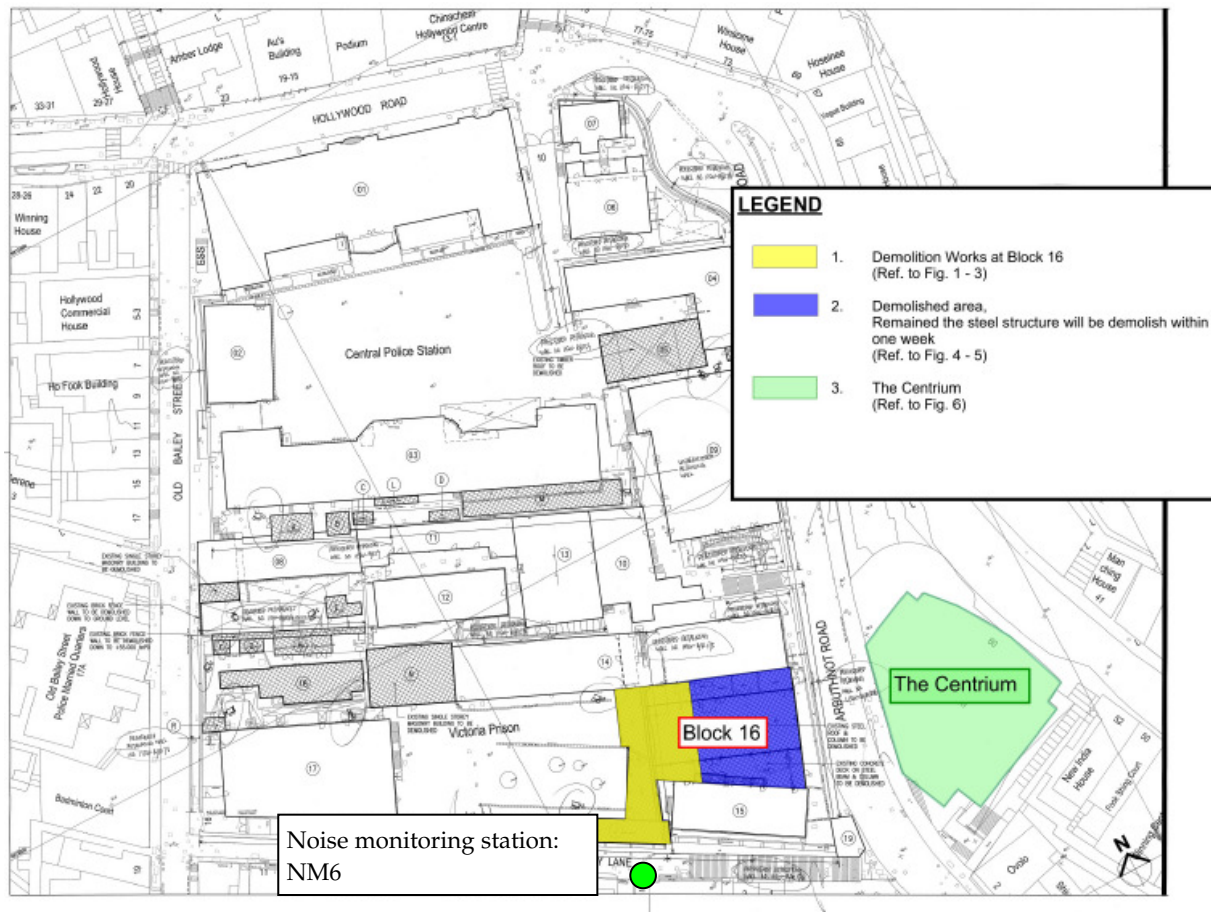
1. According to the works summary provided by the Contractor, construction work conducted during the week included demolition works at Block 16 which is located opposite the Centrum (see the figure below).

2. It was noted that the location of the demolition works at Building 16 is the nearest to the complainant. The construction noise from the demolition works at Building 16 could be possible sources of noise nuisance noted by the complainant.

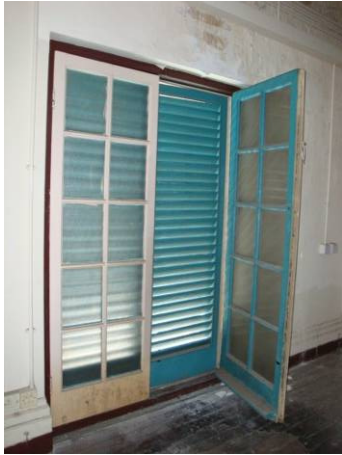
Element no.	Description	Photo ref	Significance
01.007	External shutters

High
01.008	External terraces at 1/F

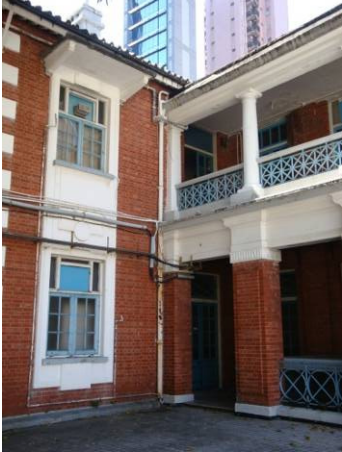
Low
01.012	Rainwater goods

Adverse

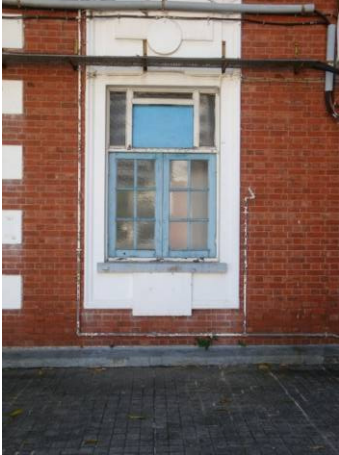
Element no.	Description	Photo ref	Significance
01.016	Altered doors and windows

Adverse
01.017	Mezzanine floor in room 01/LG1/13

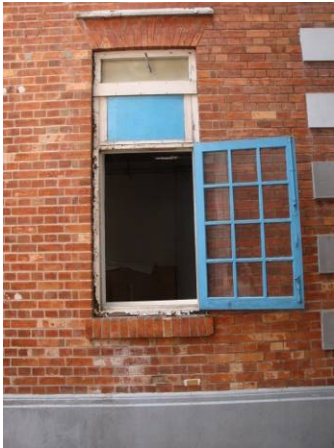
A close-up photograph of a brick wall featuring a window with a bright blue frame. The window is partially open, and the surrounding brickwork shows signs of wear and alteration.	Adverse
02.009	Concrete stairs

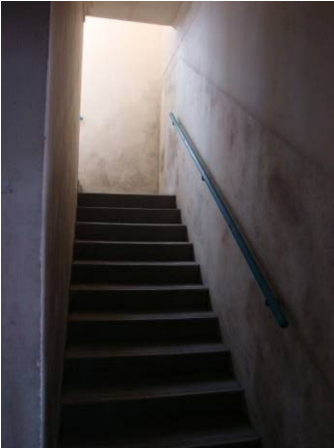
A photograph of a concrete staircase with a simple metal handrail. The stairs are set within a plain, light-colored wall, and the lighting is somewhat dim, highlighting the utilitarian nature of the space.	Adverse

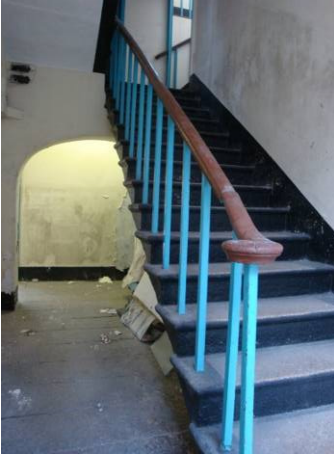
A photograph of a staircase with dark grey steps. The balustrade is painted a bright blue color with a dark wood handrail. The staircase is set against a light-colored wall with an arched opening in the background.	High
04.012	Stair from First to Second Floor

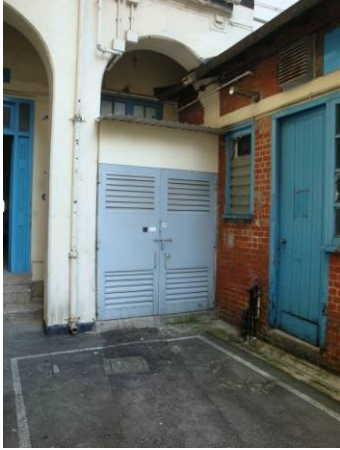
Element no.	Description	Photo ref.	Significance
04.019	Switchgear in old porch 04/G/13

Adverse
04.020	Flat plywood ceiling lining with plain rectangular cover battens

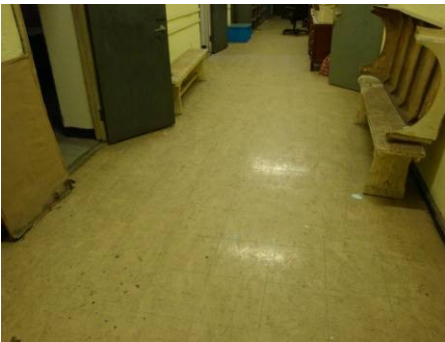
Low
14.015	Vinyl tile floor on suspended timber floor

Adverse
