Central Police Station Conservation  
and Revitalisation Project:  
*Eleventh Quarterly EM&A Report*  
*(1 May 2014 to 31 July 2014)*

Issue Date: September 2014

| <b>Annex N</b> | <b><i>A Summary of Current Condition of Character Defining Elements</i></b> |

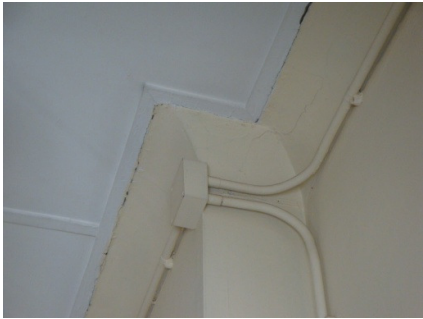
| Element no. | Description | Photo ref | Significance | Proposal | Mitigation | Impact |
|---|--|--|---|---|--|---|
| 01.002 | Plaster coving at abutments of walls and ceilings | | Low | Remove in exceptional cases eg, where adjacent new lift shaft | Cut back neatly to a square edge and ensure remaining section is secure. | Low |

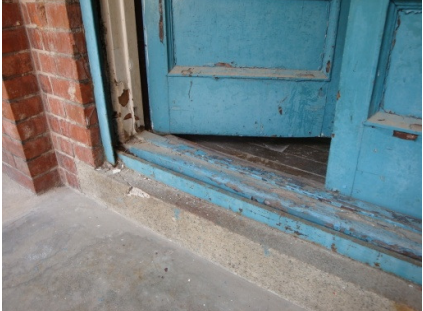
| Element no. | Description | Photo ref | Significance | Proposal | Mitigation | Impact |
|---|---|--|---|---|---|---|
| 01.004 | Timber thresholds at external doors and internal doors between main corridor and individual rooms | | Low | Remove to enable level access | Splice extensions to door jambs, extend width of bottom rail of doors to match existing | Low |

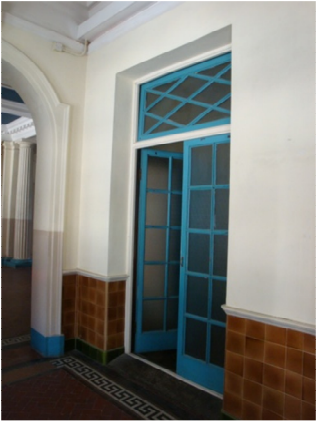
| Element no. | Description | Photo ref | Significance | Proposal | Mitigation | Impact |
|---|---|--|---|--|--|---|
| 01.006 | Panelled doors | | Moderate | Replace where necessary to achieve fire resistance to comply with Code | Re-use where possible. Record design on survey drawings where element cannot be re-used. | Moderate |

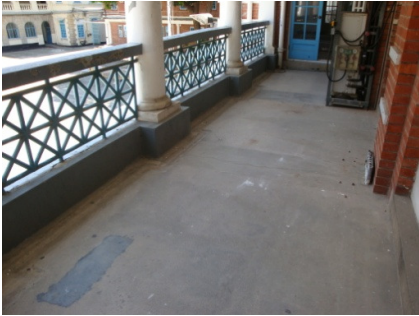
| Element no. | Description | Photo ref | Significance | Proposal | Mitigation | Impact |
|---|---|--|---|---|---|---|
| 01.008 | External terraces at 1/F | | High | Overlay existing concrete paving with timber deck to provide level access | New deck to be reversible | Low |

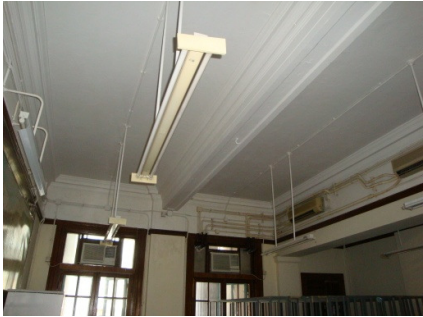
| Element no. | Description | Photo ref | Significance | Proposal | Mitigation | Impact |
|---|---|--|---|--|--|---|
| 01.009 | Plaster ceilings on GF and LG1 | | Moderate | Install cloud ceilings to accommodate new services | Install fixed grid to minimise damage to ceiling | High |

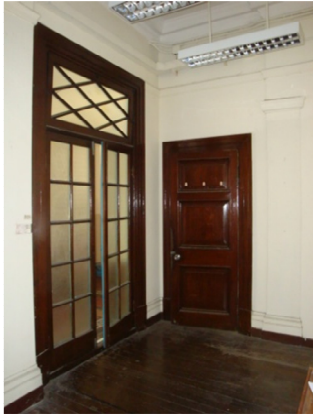
| Element no. | Description | Photo ref | Significance | Proposal | Mitigation | Impact |
|---|---|--|---|--|--|---|
| 01.010 | Timber door frames and architraves | | Moderate | Conceal in exceptional cases eg. where adjacent new lift shaft | Retain architrave and door frame in situ. Avoid damage to joinery. | High |

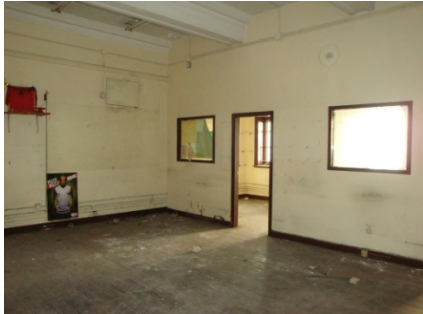
| Element no. | Description | Photo ref | Significance | Proposal | Mitigation | Impact |
|---|---|---|---|--|---|---|
| 01.011 | Concrete floor | | Low | Replace where new kitchens and plant rooms to be installed | Carefully remove and retain existing floorboards for re-use. Ensure controlled demolition of concrete structure and removal of debris from building to avoid damage to adjacent surfaces. Protect or carefully remove and set aside adjacent elements such as skirting boards | Low |

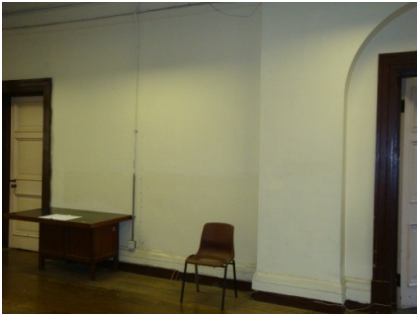
| Element no. | Description | Photo ref | Significance | Proposal | Mitigation | Impact |
|---|---|--|---|--|---|---|
| 01.015 | Existing walls | | Moderate | Form new opening as part of re-planning of interiors | New doors and frames to be of their time to avoid confusion about provenance | Moderate |

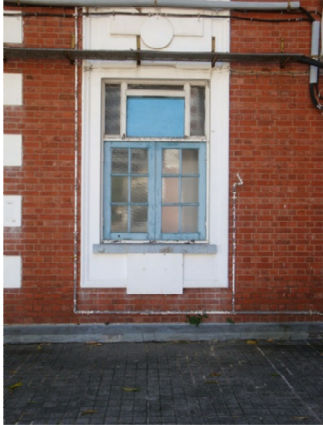
| Element no. | Description | Photo ref | Significance | Proposal | Mitigation | Impact |
|---|---|--|---|---|---|---|
| 01.016 | Altered doors and windows | | Adverse | Repair or renew as necessary existing frames to match original patterns | Not applicable | High |

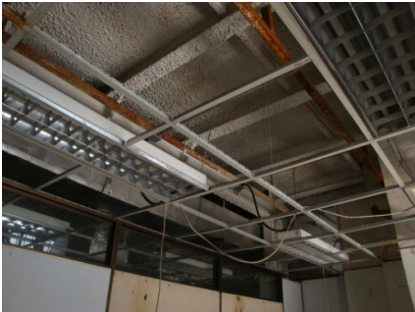
| Element no. | Description | Photo ref | Significance | Proposal | Mitigation | Impact |
|---|---|--|---|---|---|---|
| 01.017 | Mezzanine floor in room 01/LG1/13 | | Adverse | Remove floor and supporting columns to re-create original double-height space | Not applicable | High |

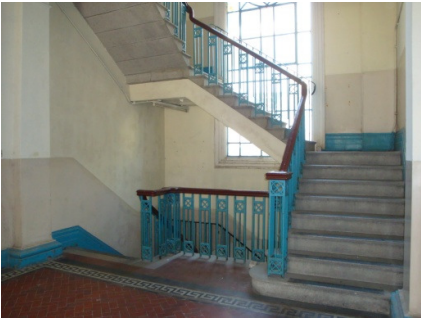
| Element no. | Description | Photo ref | Significance | Proposal | Mitigation | Impact |
|---|--|--|---|--|---|---|
| 01.021 | Stair balustrades | | High | Balustrades to be supplemented with additional handrails and supports to mitigate non-compliance with code | New fittings to be of their time and made reversible. Physical intervention to existing stairs and balustrades to be kept to the minimum. | Moderate |

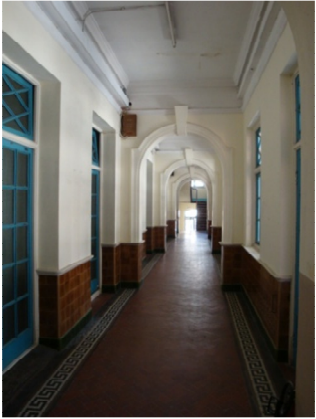
| Element no. | Description | Photo ref | Significance | Proposal | Mitigation | Impact |
|---|---|--|---|---|--|---|
| 01.022 | Main corridors | | High | Install new lighting, fire sprinklers, fire doors to comply with Fire Services Code | New fittings to be mounted in a manner that is of its time and reversible. Avoid physical intervention with existing plaster box cornices, architraves, dado rails | High |

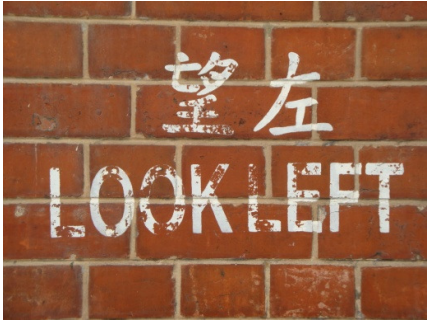
| Element no. | Description | Photo ref | Significance | Proposal | Mitigation | Impact |
|---|---|--|---|---|--|---|
| 01.023 | Painted signs | | High | Protect in situ | Not applicable | N/A |

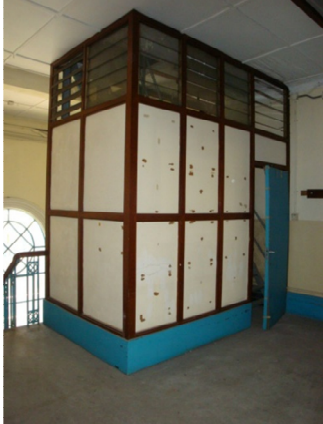
| Element no. | Description | Photo ref | Significance | Proposal | Mitigation | Impact |
|---|--|---|---|---|---|---|
| 01.026 | Enclosure at First Floor landing of main stair | | Adverse | Remove | Not applicable | Moderate |

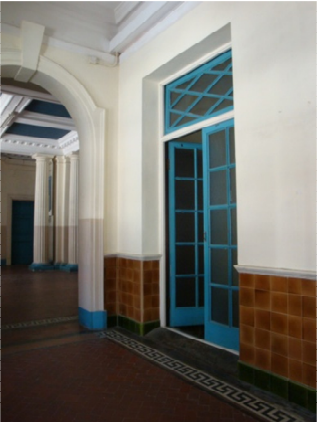
| Element no. | Description | Photo ref | Significance | Proposal | Mitigation | Impact |
|---|---|--|---|---|--|---|
| 01.030 | Tiled dado | | High | Cut away for enlargement of existing windows to form new doorways | Cut back to joint line and adjust tiling pattern to suit new opening. New tiles to match existing sizes and colours. | Moderate |

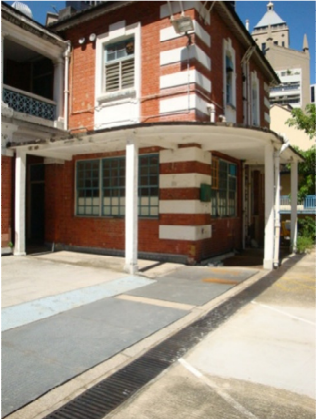
| Element no. | Description | Photo ref | Significance | Proposal | Mitigation | Impact |
|---|---|---|---|---|--|---|
| 01.031 | Reinforced concrete canopy and sash windows | | Moderate | Remove canopy and replace sash windows with new windows to match original | Make good brickwork where canopy removed, Reinstate rendered architraves around new window to match similar window facing on West wing | Moderate |

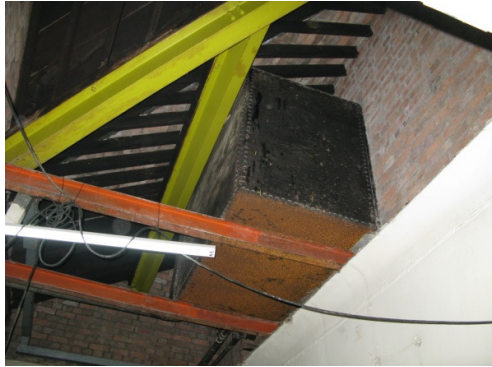
| Element no. | Description | Photo ref | Significance | Proposal | Mitigation | Impact |
|---|---|---|---|--|---|---|
| 01.033 | Ceiling void service installation (Cast Iron Water Tank and pipework) | | Low | Remove and make good adjacent surfaces | N/A | Low |

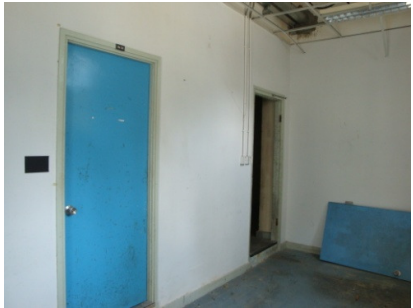
| Element no. | Description | Photo ref. | Significance | Proposal | Mitigation | Impact |
|---|---|--|---|---|---|---|
| 02.002 | Modern internal doors | | Adverse | Remove | Not applicable | High |

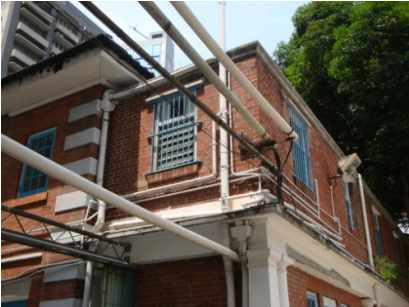
| Element no. | Description | Photo ref. | Significance | Proposal | Mitigation | Impact |
|---|--|--|---|---|---|---|
| 02.004 | External airconditioning units and other external services | | Adverse | Remove and make good brickwork | Not applicable | High |

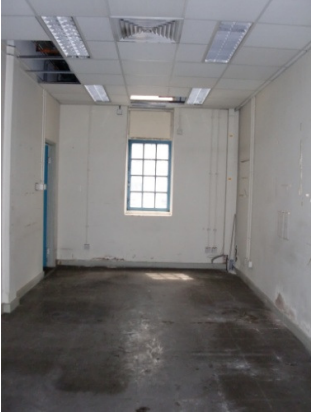
| Element no. | Description | Photo ref. | Significance | Proposal | Mitigation | Impact |
|---|--|--|---|---|--|---|
| 02.006 | Concrete floors | | Low | Selected removal to accommodate new stairs and lift shaft | Carefully form openings to ensure structural stability | Low |

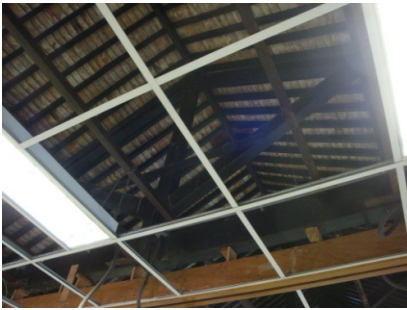
| Element no. | Description | Photo ref. | Significance | Proposal | Mitigation | Impact |
|---|---|--|---|---|---|---|
| 02.011 | Roof structure and tiled soffit | | High | Repair and retain. | N/A | Neutral |

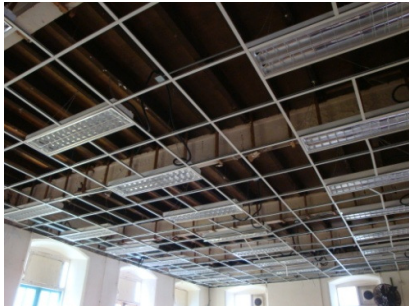
| Element no. | Description | Photo ref. | Significance | Proposal | Mitigation | Impact |
|---|---|--|---|---|---|---|
| 03.001 | Lay-in grid suspended ceiling | | Adverse | Remove | Not applicable | High |

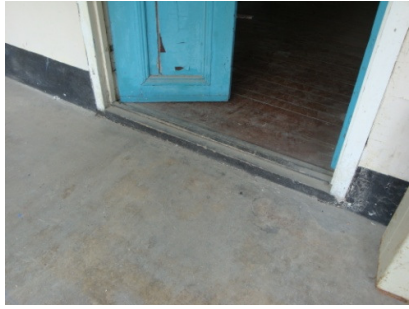
| Element no. | Description | Photo ref. | Significance | Proposal | Mitigation | Impact |
|---|---|--|---|---|---|---|
| 03.004 | Timber thresholds at external doors and internal doors between main corridor and individual rooms | | Low | Remove to enable level access | Splice extensions to door jambs, extend width of bottom rail of doors to match existing | Low |

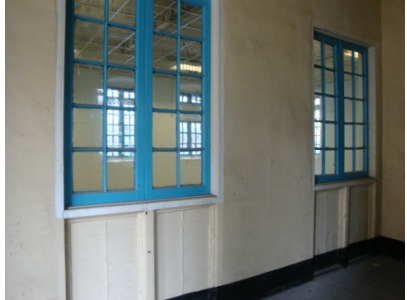
| Element no. | Description | Photo ref. | Significance | Proposal | Mitigation | Impact |
|---|---|--|---|--|--|---|
| 03.005 | Timber spandrel panels below windows | | Low | Conceal in exceptional cases eg. where adjacent new lift shaft | Retain frame and spandrel panel where possible. Remove only where necessary in connection with re-planning of interiors. Record on measured survey drawings. | Low |

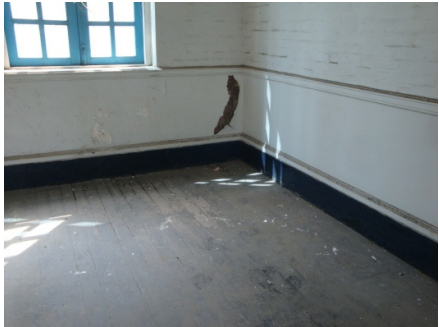
| Element no. | Description | Photo ref. | Significance | Proposal | Mitigation | Impact |
|---|---|--|---|--|--|---|
| 03.006 | Timber floors | | High | Replace where new kitchens and plant rooms to be installed | Limit extent of removal as much as possible. Carefully remove and retain existing floorboards for re-use. Ensure controlled dismantling of timber structure and set aside for possible re-use. Protect or carefully remove and set aside adjacent elements such as skirting boards | Medium |

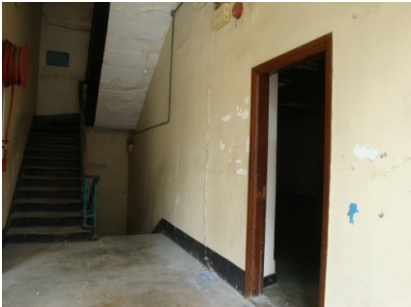
| Element no. | Description | Photo ref. | Significance | Proposal | Mitigation | Impact |
|---|---|--|---|--|---|---|
| 03.009 | Block existing door openings | | Low | Block opening as part of re-planning of interior | Retain existing door frame and architraves. Use framing and non-combustible sheet linings to block opening. | Low |

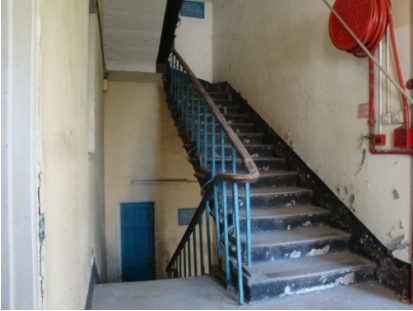
| Element no. | Description | Photo ref. | Significance | Proposal | Mitigation | Impact |
|---|--|--|---|--|---|---|
| 03.013 | Stair balustrades | | High | Balustrades to be supplemented with additional handrails and supports to mitigate non-compliance with code | New fittings to be of their time and made reversible. Physical intervention to existing stairs and balustrades to be kept to the minimum. | Moderate |

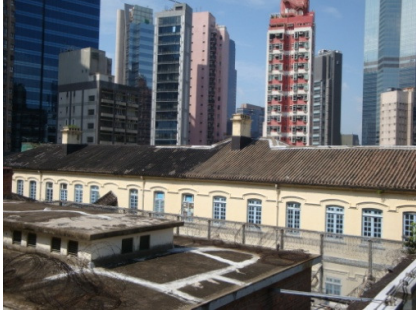
| Element no. | Description | Photo ref. | Significance | Proposal | Mitigation | Impact |
|---|---|--|---|---|---|---|
| 03.016 | Pitched roofs | | High | New penetrations through roofs for ventilation ducts and other services | Arrange new penetrations so that they conform with the geometry of the existing roof.<br>Model the size and shape of the new ducts so that the impact on the roofscape is minimised.<br>Finish the new ducts in a non-reflective material that is neutral in colour and mid-tone. | High |

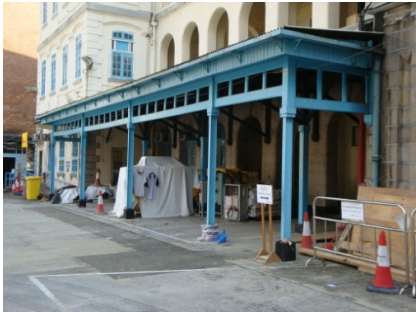
| Element no. | Description | Photo ref. | Significance | Proposal | Mitigation | Impact |
|---|---|--|---|---|---|---|
| 03.017 | Lean-to structure adjacent North wall | | Moderate | Remove | Record on measured survey drawings.<br>Make good walls where roof structure abuts | Moderate |

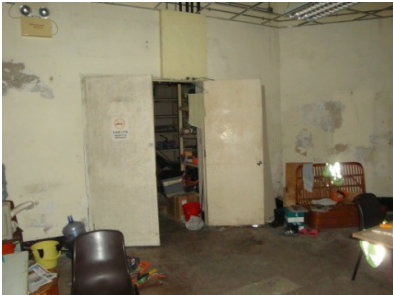
| Element no. | Description | Photo ref. | Significance | Proposal | Mitigation | Impact |
|---|--|--|---|---|--|---|
| 03.019 | Internal walls at Ground Floor level | | Moderate | Remove selected internal walls where strictly necessary as part of re-planning of interiors | Walls of early or original date to be retained in part eg. by leaving a "nib" where the wall is bonded to another wall. At the point where the wall is cut away, form the cut-line on the line of a vertical joint in alternate courses. Bricks in the remaining courses to be left "as cut", and not re-bonded. Record walls on measured survey dwgs. | Moderate |

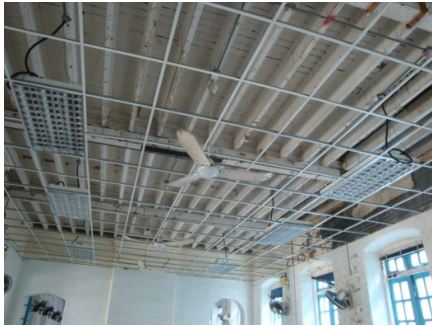
| Element no. | Description | Photo ref. | Significance | Proposal | Mitigation | Impact |
|---|---|--|---|---|--|---|
| 03.021 | Exposed soffits of timber floors | | Moderate | Underline existing floors to achieve specified fire resistance stated in Code | Avoid unnecessary damage to existing structure. New lining will reduce extent of intervention into existing structure. Keep level of new linings well clear of window heads. | Moderate |

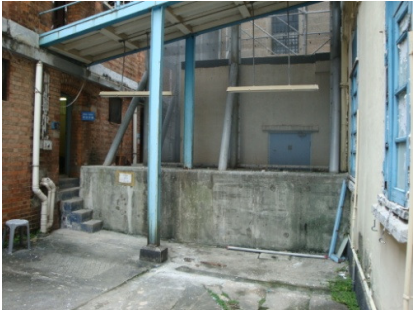
| Element no. | Description | Photo ref. | Significance | Proposal | Mitigation | Impact |
|---|--|--|---|---|---|---|
| 03.023 | Single storey outbuildings on south side | | Adverse | Demolish | Check for evidence of early route from Magistracy to Prison. | Low |

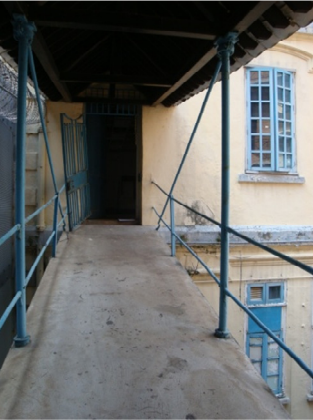
| Element no. | Description | Photo ref. | Significance | Proposal | Mitigation | Impact |
|---|---|---|---|---|---|---|
| 03.024 | Bridge at east end | | Moderate | Retain | Not applicable | Neutral |

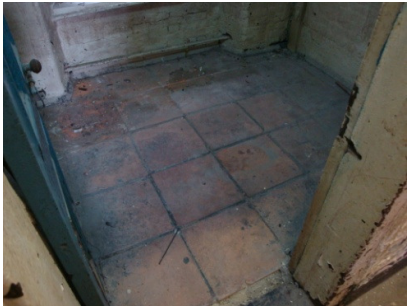
| Element no. | Description | Photo ref. | Significance | Proposal | Mitigation | Impact |
|---|--|---|---|--|---|---|
| 03.027 | Clay-tiled floor in store room adjacent stairs | | Low | Remove as part of re-planning of interiors | Record on measured survey drawings | Low |

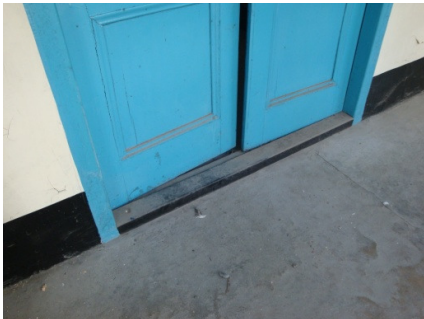
| Element no. | Description | Photo ref. | Significance | Proposal | Mitigation | Impact |
|---|---|--|---|---|---|---|
| 04.002 | Timber thresholds at external doors and internal doors between main corridor and individual rooms | | Low | Remove to enable level access | Splice extensions to door jambs, extend width of bottom rail of doors to match existing | Low |

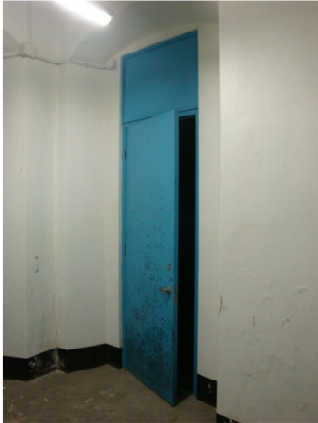
| Element no. | Description | Photo ref. | Significance | Proposal | Mitigation | Impact |
|---|---|---|---|--|---|---|
| 04.006 | Block existing door openings | | Moderate | Block opening as part of re-planning of interior | Retain existing door frame and architraves. Use framing and non-combustible sheet linings to block opening. | Moderate |

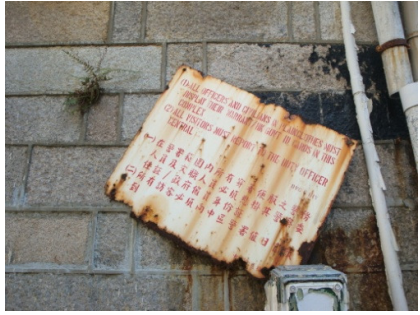
| Element no. | Description | Photo ref. | Significance | Proposal | Mitigation | Impact |
|---|---|--|---|--|---|---|
| 04.015 | Fixed signs | | Low-High | Remove and refix/display in visitors' centre/discard | Record each sign and assess significance individually and treat accordingly | N/A |

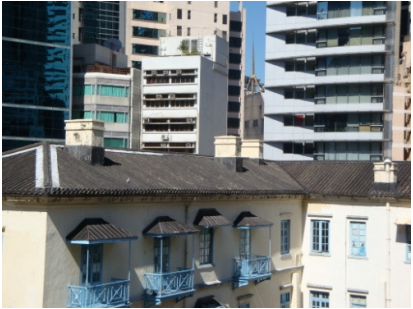
| Element no. | Description | Photo ref. | Significance | Proposal | Mitigation | Impact |
|---|---|---|---|---|---|---|
| 04.016 | Pitched roofs | | High | New penetrations through roofs for ventilation ducts and other services | <p>Arrange new penetrations so that they conform with the geometry of the existing roof.</p> <p>Model the size and shape of the new ducts so that the impact on the roofscape is minimised.</p> <p>Finish the new ducts in a non-reflective material that is neutral in colour.</p> | High |

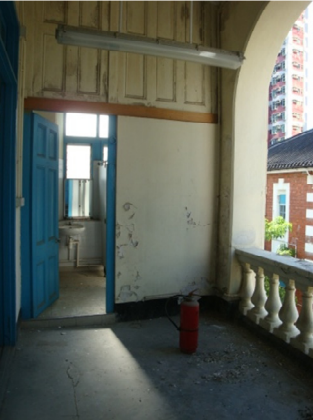
| Element no. | Description | Photo ref. | Significance | Proposal | Mitigation | Impact |
|---|---|---|---|---|---|---|
| 04.017 | Toilets at ends of verandahs | | Adverse | Remove and make good finishes | Not applicable | High |

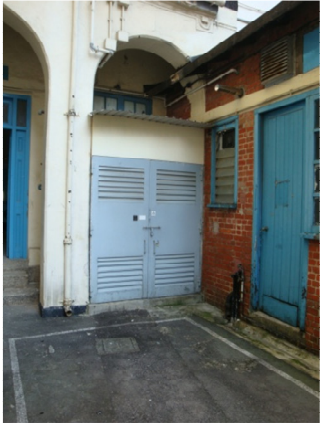
| Element no. | Description | Photo ref. | Significance | Proposal | Mitigation | Impact |
|---|---|---|---|---|---|---|
| 04.019 | Switchgear in old porch 04/G/13 | | Adverse | Open up porch, remove electrical switchgear and make good | Not applicable | High |

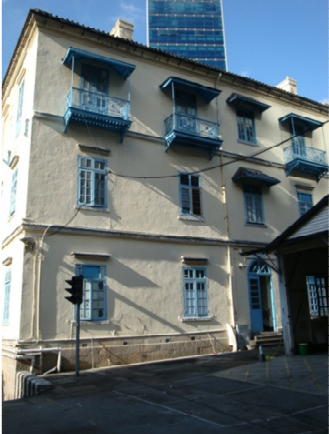
| Element no. | Description | Photo ref. | Significance | Proposal | Mitigation | Impact |
|---|---|---|---|--|--|---|
| 04.023 | Cantilever balconies | | High | <p>Retain and repair as necessary.</p> <p>Reinstate balcony on west elevation.</p> | <p>Avoid highly visible intervention to enhance structural integrity and/or compliance with building codes.</p> <p>Restrict access if necessary to achieve this objective.</p> | Low |

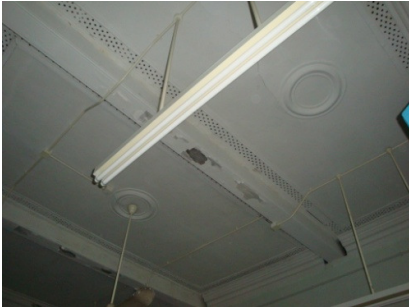
| Element no. | Description | Photo ref. | Significance | Proposal | Mitigation | Impact |
|---|---|---|---|---|---|---|
| 04.026 | Ceiling rose | | Low | Repair and retain insitu | Not applicable | Neutral |

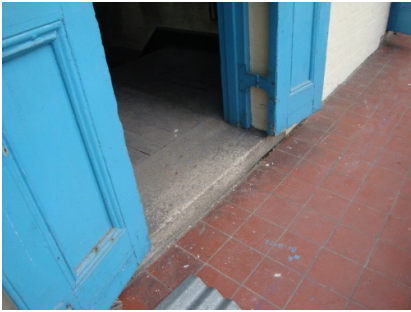
| Element no. | Description | Photo ref. | Significance | Proposal | Mitigation | Impact |
|---|---|--|---|---|---|---|
| 06.001 | Granite thresholds at external doors | | Low | Retain; install timber deck flush with level of step where necessary | Avoid alteration to step. | Low |

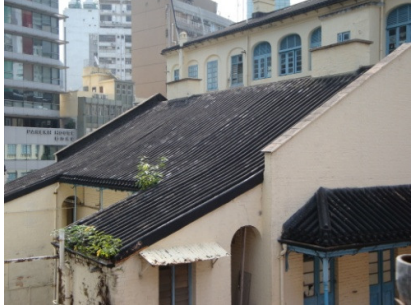
| Element no. | Description | Photo ref. | Significance | Proposal | Mitigation | Impact |
|---|---|--|---|---|---|---|
| 06.002 | Pitched roof | | High | New penetrations through roofs for ventilation ducts and other services | Arrange new penetrations so that they conform with the geometry of the existing roof.<br>Model the size and shape of the new ducts so that the impact on the roofscape is minimised.<br>Finish the new ducts in a non-reflective material that is neutral in colour and mid-tone. | High |

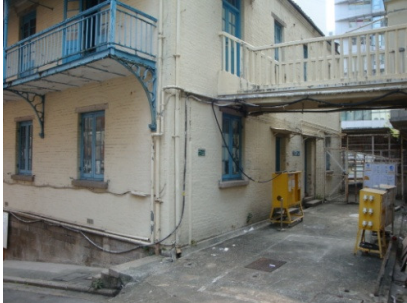
| Element no. | Description | Photo ref. | Significance | Proposal | Mitigation | Impact |
|---|---|--|---|--|--|---|
| 06.004 | Exterior decorations | | Adverse | Strip off and redecorate | Sample and analyse existing paint media; select new media to suit substrate and significance | Moderate |

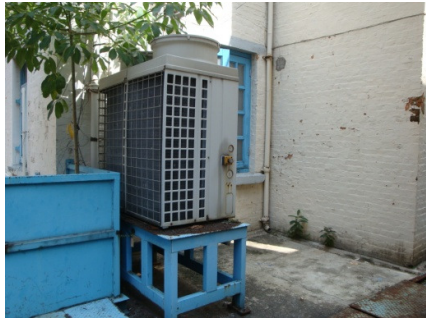
| Element no. | Description | Photo ref. | Significance | Proposal | Mitigation | Impact |
|---|--|--|---|---|---|---|
| 06.006 | External airconditioning units and other external services | | Adverse | Adverse | Remove and make good brickwork | Not applicable |

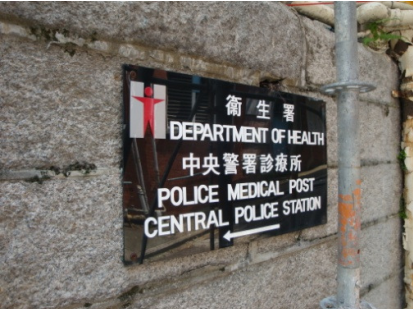
| Element no. | Description | Photo ref. | Significance | Proposal | Mitigation | Impact |
|---|---|--|---|--|---|---|
| 06.008 | Fixed signs | | Low-High | Remove and refix/display in visitors' centre/discard | Record each sign and assess significance individually and treat accordingly | N/A |

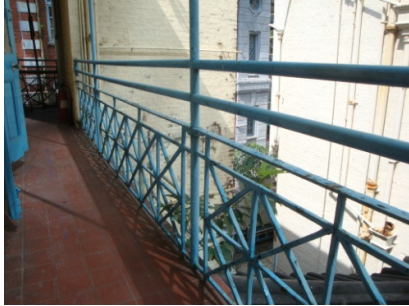
| Element no. | Description | Photo ref. | Significance | Proposal | Mitigation | Impact |
|---|---|--|---|---|--|---|
| 06.010 | Iron balustrades | | High | Retain and repair as necessary. | Avoid highly visible intervention to enhance structural integrity and/or compliance with building codes. Restrict access if necessary to achieve this objective. | Low |

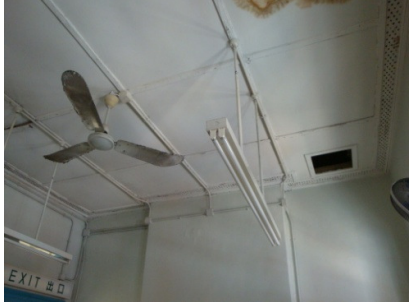
| Element no. | Description | Photo ref. | Significance | Proposal | Mitigation | Impact |
|---|---|--|---|--|---|---|
| 06.011 | Perforated margin at perimeter of ceiling | | Low | Repair and retain. | Where fire-proofing of floor is required, use a product that can be installed within the floor void, leaving the ceiling lining intact. | Low |

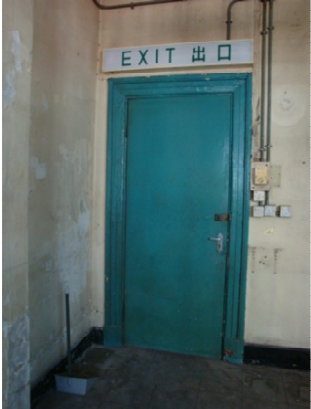
| Element no. | Description | Photo ref. | Significance | Proposal | Mitigation | Impact |
|---|---|--|---|--|---|---|
| 06.012 | Block existing door openings | | Moderate | Block opening as part of re-planning of interior | Retain existing door frame and architraves. Use framing and non-combustible sheet linings to block opening. | Moderate |

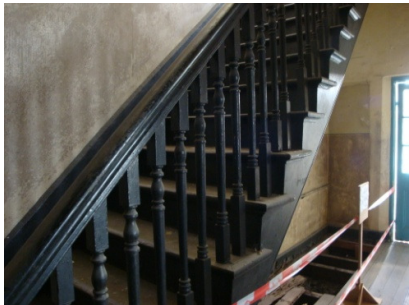
| Element no. | Description | Photo ref. | Significance | Proposal | Mitigation | Impact |
|---|---|--|---|--|---|---|
| 06.014 | Stair balustrades | | High | Balustrades to be supplemented with additional handrails and supports to mitigate non-compliance with code | New fittings to be of their time and made reversible. Physical intervention to existing stairs and balustrades to be kept to the minimum. | Moderate |

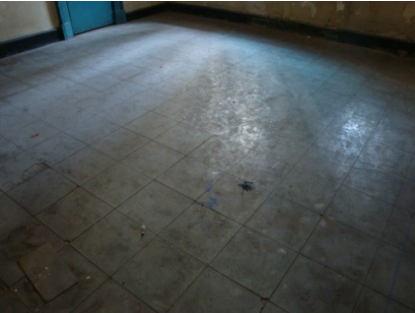
| Element no. | Description | Photo ref. | Significance | Proposal | Mitigation | Impact |
|---|---|--|---|---|--|---|
| 06.016 | Vinyl tile floor | | Adverse | Remove tiles; renew boarded floor boards if necessary | Not applicable | Moderate |

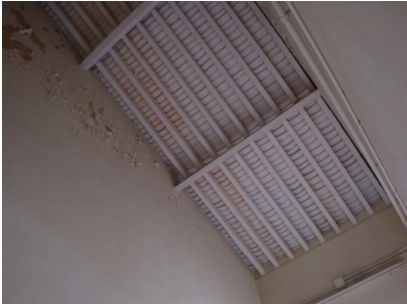
| Element no. | Description | Photo ref. | Significance | Proposal | Mitigation | Impact |
|---|---|--|---|---|---|---|
| 06.018 | Exposed roof covering | | Moderate | Retain as existing | Consider insulating between upper and lower layers of roof tiles to provide thermal insulation and vapour barrier | Low |

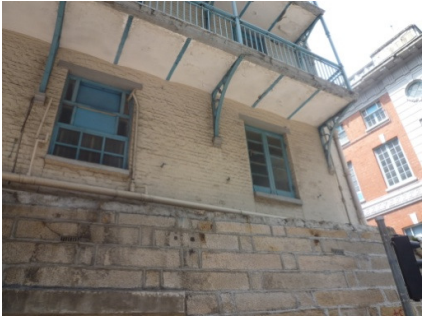
| Element no. | Description | Photo ref. | Significance | Proposal | Mitigation | Impact |
|---|---|--|---|---|--|---|
| 07.003 | Exterior decorations | | Adverse | Strip off and redecorate | Sample and analyse existing paint media; select new media to suit substrate and significance | High |

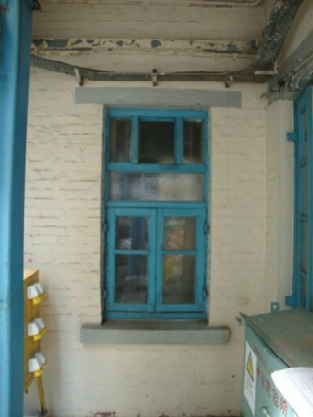
| Element no. | Description | Photo ref. | Significance | Proposal | Mitigation | Impact |
|---|---|--|---|---|--|---|
| 07.004 | Altered doors and windows | | Adverse | Repair or renew as necessary existing frames to match original patterns | Not applicable | High |

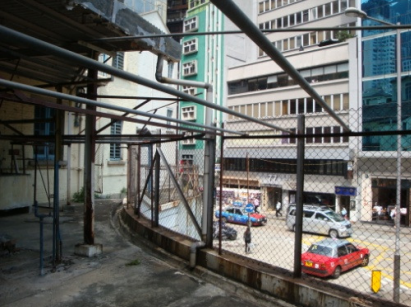
| Element no. | Description | Photo ref. | Significance | Proposal | Mitigation | Impact |
|---|--|--|---|---|---|---|
| 07.006 | Clothes drying racks | | Adverse | Remove | Not applicable | Low |

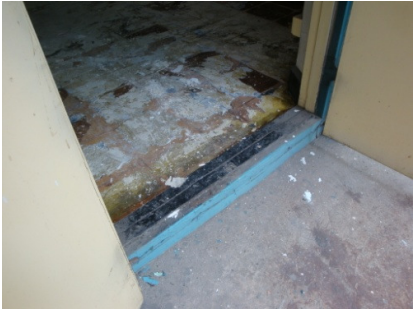
| Element no. | Description | Photo ref. | Significance | Proposal | Mitigation | Impact |
|---|---|--|---|---|---|---|
| 07.011 | Timber thresholds at external doors and internal doors between main corridor and individual rooms | | Low | Remove to enable level access | Splice extensions to door jambs, extend width of bottom rail of doors to match existing | Low |

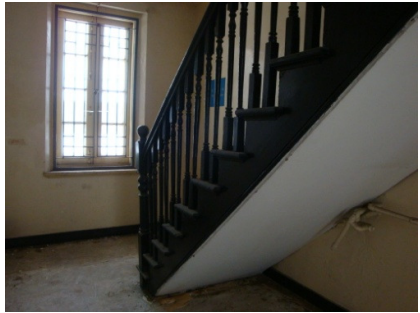
| Element no. | Description | Photo ref. | Significance | Proposal | Mitigation | Impact |
|---|---|--|---|--|---|---|
| 07.013 | Stair balustrades | | High | Balustrades to be supplemented with additional handrails and supports to mitigate non-compliance with code | New fittings to be of their time and made reversible. Physical intervention to existing stairs and balustrades to be kept to the minimum. | Moderate |

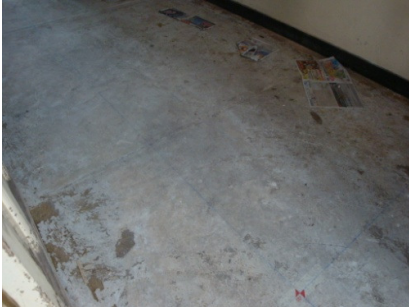
| Element no. | Description | Photo ref. | Significance | Proposal | Mitigation | Impact |
|---|---|--|---|---|---|---|
| 07.016 | Concrete floor | | Adverse | Overlay with hardwood floor boards | Not applicable | Moderate |

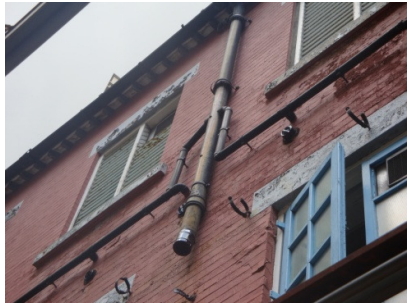
| Element no. | Description | Photo ref. | Significance | Proposal | Mitigation | Impact |
|---|---|--|---|--|--|---|
| 08.002 | Rainwater goods | | Adverse | Replace with cast iron in pattern to match original and in correct locations | No applicable | High |

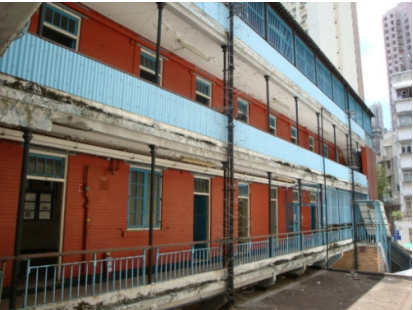
| Element no. | Description | Photo ref. | Significance | Proposal | Mitigation | Impact |
|---|---|--|---|--|---|---|
| 08.004 | Block existing door openings | | Moderate | Block opening as part of re-planning of interior | Retain existing door frame and architraves. Use framing and non-combustible sheet linings to block opening. | Moderate |

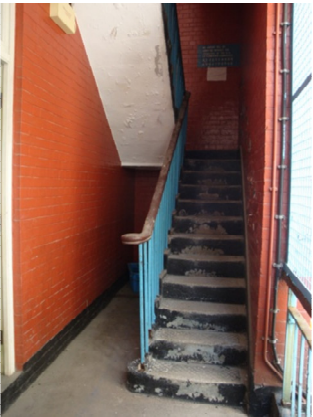
| Element no. | Description | Photo ref. | Significance | Proposal | Mitigation | Impact |
|---|---|--|---|---|--|---|
| 08.006 | External stair at west end | | Moderate | Retain | Repair as necessary.<br><br>Alter balustrade to achieve reasonable level of operational safety.<br><br>Restrict access to repairs and maintenance and means of escape. | Low |

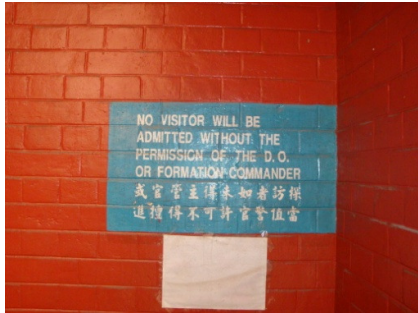
| Element no. | Description | Photo ref. | Significance | Proposal | Mitigation | Impact |
|---|--|--|---|---|---|---|
| 08.008 | Painted signs | | High | Protect in situ | Not applicable | N/A |

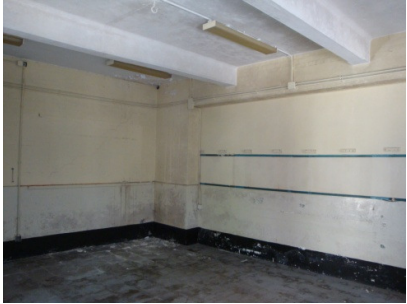
| Element no. | Description | Photo ref. | Significance | Proposal | Mitigation | Impact |
|---|---|--|---|---|--|---|
| 08.010 | Internal walls and concrete floors | | Low | Remove and rebuild in new configuration to suit new use | Ensure retained facades are fully supported during construction operations. Protect retained walls against damage during demolition works. Install new walls and floors to respect fenestration; avoid | Low |

| Element no. | Description | Photo ref. | Significance | Proposal | Mitigation | Impact |
|---|---|--|---|---|---|---|
| | | | | | clashes. | |

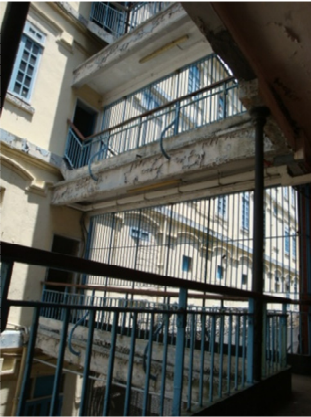
| Element no. | Description | Photo ref. | Significance | Proposal | Mitigation | Impact |
|---|---|--|---|--|--|---|
| 08.012 | Bridge access to Barrack Block | | Moderate | Retain | Repair as necessary.<br><br>Alter balustrade to achieve reasonable level of operational safety.<br><br>Restrict access to repairs and maintenance and means of escape. | Low |

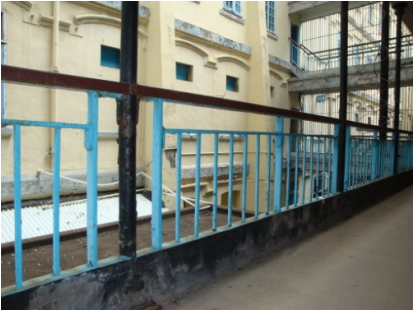
| Element no. | Description | Photo ref. | Significance | Proposal | Mitigation | Impact |
|---|---|--|---|--|--|---|
| 08.013 | Balcony balustrades | | Low | Repair as necessary and retain.<br><br>Remove selected sections to enable installation of new bridge connections to Barrack Block. | Avoid removal of associated iron columns.<br><br>Form interventions at selected positions so as to maintain the rhythm of the balustrades and ensure proper support at ends. | Low |

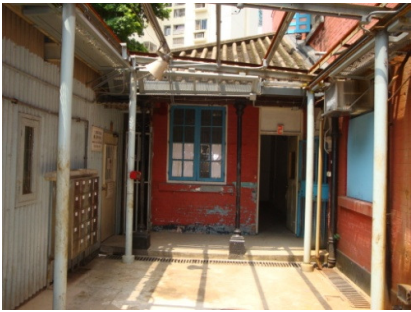
| Element no. | Description | Photo ref. | Significance | Proposal | Mitigation | Impact |
|---|--|--|---|---|--|---|
| 08.014 | Single-storey outbuilding with pitched roof over | | Low | Demolish to make way for new loading bay. | <p>Record on measured survey drawings.</p> <p>Infill existing internal opening leaving reveals exposed.</p> <p>Tooth-in new brickwork at abutments after existing walls removed.</p> <p>Salvage cast iron columns for possible re-use.</p> | Low |

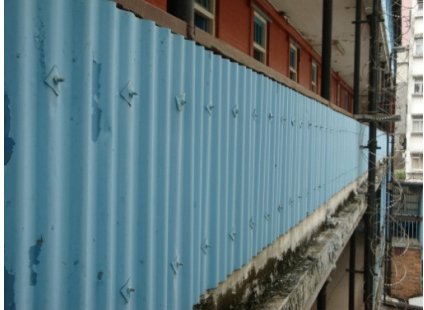
| Element no. | Description | Photo ref. | Significance | Proposal | Mitigation | Impact |
|---|--|--|---|---|--|---|
| 08.015 | Corrugated steel sheet on balcony balustrades | | Adverse | Remove | Not applicable | Low |

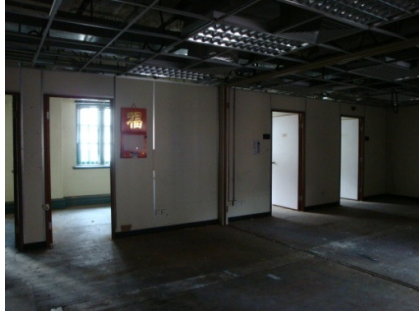
| Element no. | Description | Photo ref. | Significance | Proposal | Mitigation | Impact |
|---|---|--|---|---|---|---|
| 09.002 | Modern partitions | | Adverse | Remove | Not applicable | N/A |

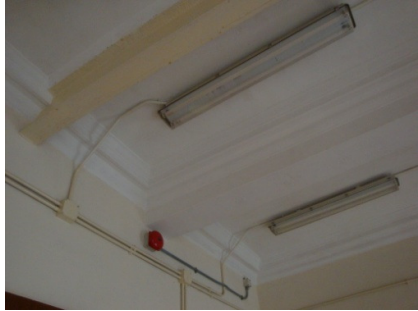
| Element no. | Description | Photo ref. | Significance | Proposal | Mitigation | Impact |
|---|---|--|---|---|--|---|
| 09.004 | Plaster box cornice | | Moderate | Remove in exceptional cases eg. Where adjacent new lift shafts | Cut back neatly to a square edge and ensure remaining section is secure. | Moderate |

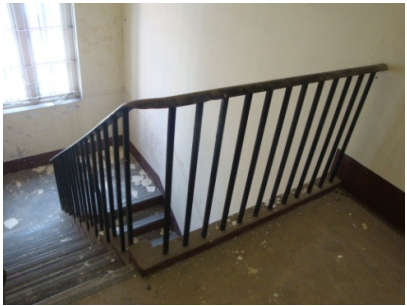
| Element no. | Description | Photo ref. | Significance | Proposal | Mitigation | Impact |
|---|---|--|---|--|---|---|
| 09.008 | Stair balustrades | | High | Balustrades to be supplemented with additional handrails and supports to mitigate non-compliance with code | New fittings to be of their time and made reversible. Physical intervention to existing stairs and balustrades to be kept to the minimum. | Moderate |

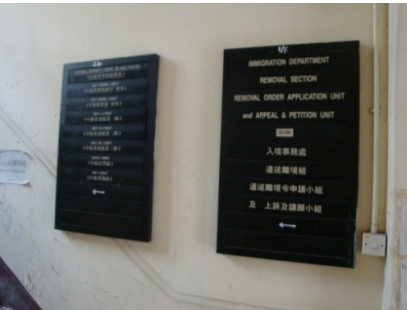
| Element no. | Description | Photo ref. | Significance | Proposal | Mitigation | Impact |
|---|---|--|---|--|---|---|
| 09.009 | Fixed signs | | Low-High | Remove and refix/display in visitors' centre/discard | Record each sign and assess significance individually and treat accordingly | N/A |

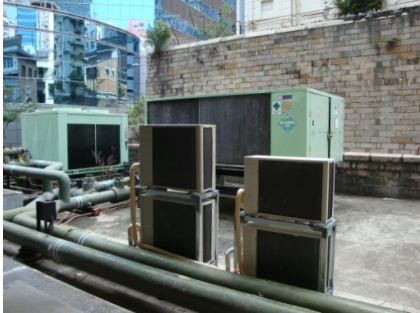
| Element no. | Description | Photo ref. | Significance | Proposal | Mitigation | Impact |
|---|--|--|---|---|---|---|
| 09.010 | External airconditioning units and other external services | | Adverse | Remove and make good brickwork | Not applicable | High |

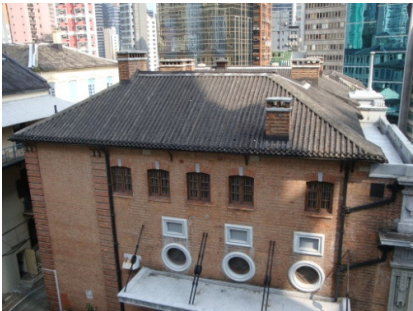
| Element no. | Description | Photo ref. | Significance | Proposal | Mitigation | Impact |
|---|--|--|---|---|---|---|
| 09.011 | Pitched roofs | | High | New penetrations through roofs for ventilation ducts and other services | Arrange new penetrations so that they conform with the geometry of the existing roof.<br>Model the size and shape of the new ducts so that the impact on the roofscape is minimised.<br>Finish the new ducts in a non-reflective material that is neutral in colour and mid-tone. | High |

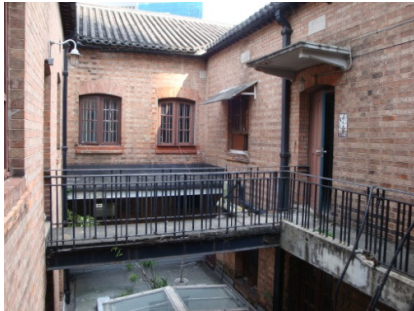
| Element no. | Description | Photo ref. | Significance | Proposal | Mitigation | Impact |
|---|---|--|---|---|---|---|
| 09.013 | Metal walkways across lightwell | | Adverse | Remove walkways and make good brickwork at abutments | Not applicable | High |

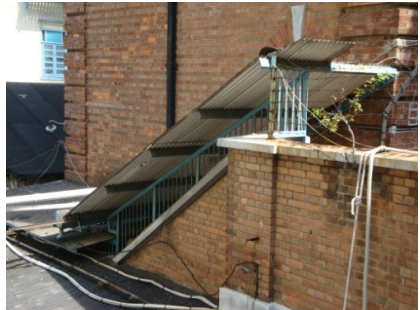
| Element no. | Description | Photo ref. | Significance | Proposal | Mitigation | Impact |
|---|---|--|---|---|---|---|
| 09.015 | Sloping canopy over external stair on west side | | Adverse | Remove canopy and supporting structure | Not applicable | Moderate |

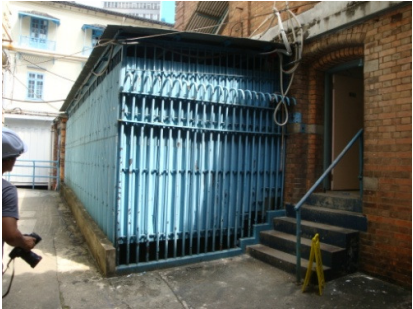
| Element no. | Description | Photo ref. | Significance | Proposal | Mitigation | Impact |
|---|---|--|---|--|---|---|
| 09.017 | Iron railing adjacent south side of item 09.016 above | | Moderate | Retain; including remains of bars (now removed) between existing railings and east side of Barracks Block. | Not applicable | Neutral |

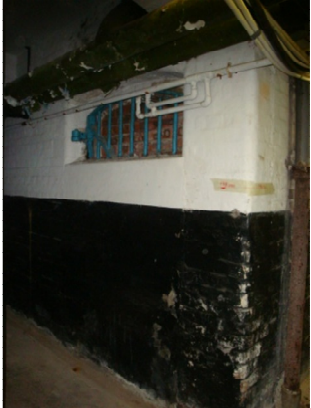
| Element no. | Description | Photo ref. | Significance | Proposal | Mitigation | Impact |
|---|---|--|---|---|--|---|
| 09.019 | Cell doors | | High | Re-open to provide access to Retail space | Retain existing iron gate | Low |

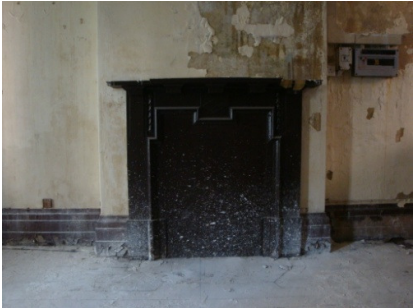
| Element no. | Description | Photo ref. | Significance | Proposal | Mitigation | Impact |
|---|---|--|---|---|---|---|
| 09.023 | Chimney piece | | Moderate | Retain | Not applicable | Neutral |

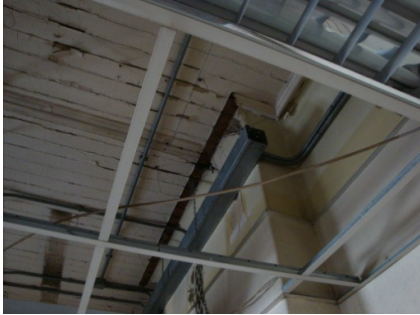
| Element no. | Description | Photo ref. | Significance | Proposal | Mitigation | Impact |
|---|---|--|---|---|---|---|
| 09.025 | Boarded ceilings on Second Floor | | High | Repair and retain where possible | Limit extent of penetrations as far as practicable. Record on measured survey drawings where ceilings have exceptionally to be removed. | Low |

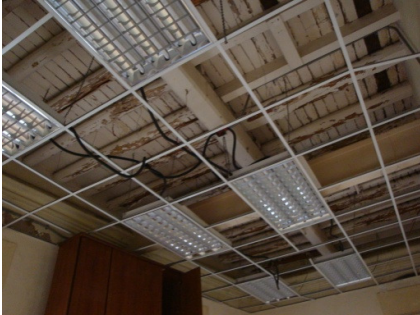
| Element no. | Description | Photo ref. | Significance | Proposal | Mitigation | Impact |
|---|---|--|---|--|--|---|
| 10.001 | Lay-in grid suspended ceiling | | Adverse | Remove | Not applicable | High |

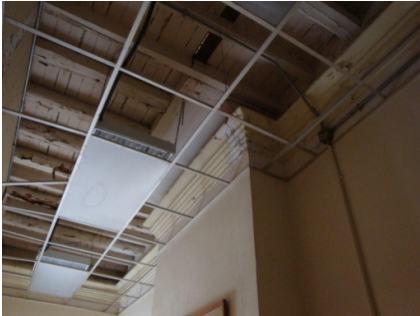
| Element no. | Description | Photo ref. | Significance | Proposal | Mitigation | Impact |
|---|---|--|---|--|--|---|
| 10.002 | Plaster box cornice | | Moderate | Remove in exceptional cases eg. Where adjacent new lift shafts | Cut back neatly to a square edge and ensure remaining section is secure. | Moderate |

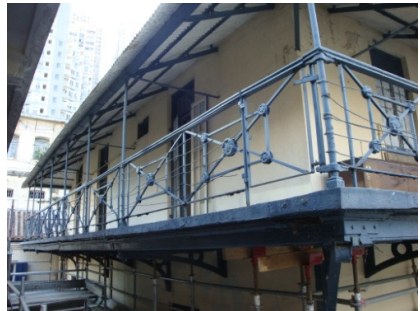
| Element no. | Description | Photo ref. | Significance | Proposal | Mitigation | Impact |
|---|---|--|---|---|--|---|
| 10.005 | Exterior decorations | | Adverse | Strip off and redecorate | Sample and analyse existing paint media; select new media to suit substrate and significance | High |

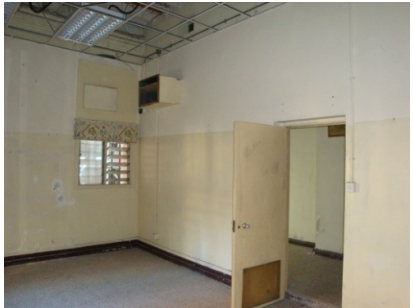
| Element no. | Description | Photo ref. | Significance | Proposal | Mitigation | Impact |
|---|---|--|---|--|---|---|
| 10.007 | Form new door openings | | Moderate | Form new opening as part of re-planning of interiors | New doors and frames to be of their time to avoid confusion about provenance | Moderate |

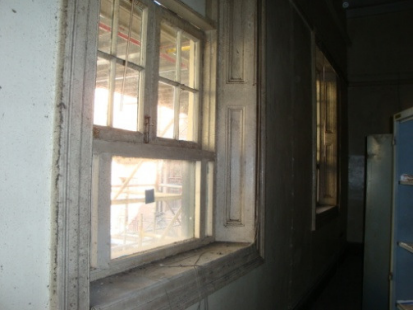
| Element no. | Description | Photo ref. | Significance | Proposal | Mitigation | Impact |
|---|--|--|---|---|---|---|
| 10.008 | Altered doors and windows | | Adverse | Repair or renew as necessary existing frames to match original patterns | Not applicable | High |

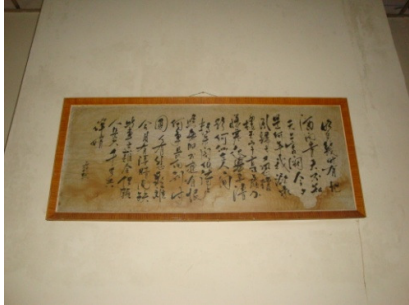
| Element no. | Description | Photo ref. | Significance | Proposal | Mitigation | Impact |
|---|---|--|---|---|---|---|
| 10.011 | Fixed signs | | Low-High | Remove and refix/display in visitors' centre/discard | Record each sign and assess significance individually and treat accordingly | N/A |

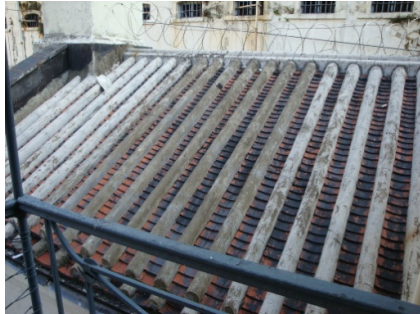
| Element no. | Description | Photo ref. | Significance | Proposal | Mitigation | Impact |
|---|---|--|---|---|---|---|
| 10.012 | Pitched roofs | | High | New penetrations through roofs for ventilation ducts and other services | Arrange new penetrations so that they conform with the geometry of the existing roof.<br>Model the size and shape of the new ducts so that the impact on the roofscape is minimised.<br>Finish the new ducts in a non-reflective material that is neutral in colour and mid-tone. | High |

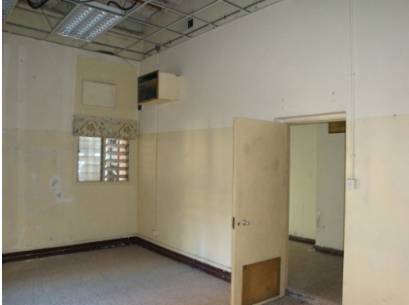
| Element no. | Description | Photo ref. | Significance | Proposal | Mitigation | Impact |
|---|---|---|---|---|--|---|
| 10.013 | Internal walls | | Moderate | Remove selected internal walls where strictly necessary as part of re-planning of interiors | Walls or early or original date to be retained in part eg. By leaving a “nib” where the wall is bonded to another wall. At the point where the wall is cut away, form the cut-line on the line of a vertical joint in alternate courses. Bricks in the remaining courses to be left “as cut”, and not re-bonded, as evidence of the current condition. | Moderate |

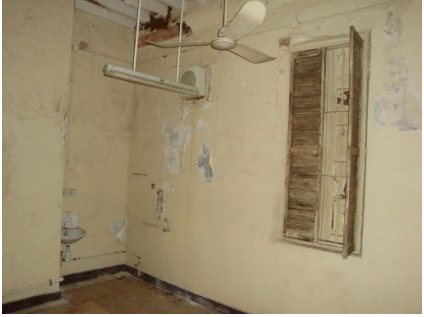
| Element no. | Description | Photo ref. | Significance | Proposal | Mitigation | Impact |
|---|---|--|---|---|--|---|
| 10.015 | Blocked windows on south elevation of south-east wing | | Adverse | Re-open window openings and reinstate window frames and glazing | Not applicable | Moderate |

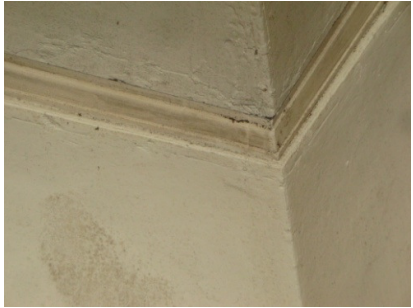
| Element no. | Description | Photo ref. | Significance | Proposal | Mitigation | Impact |
|---|---|--|---|---|--|---|
| 10.017 | Moulded timber picture rail | | Low | Repair and retain | Not applicable | Neutral |

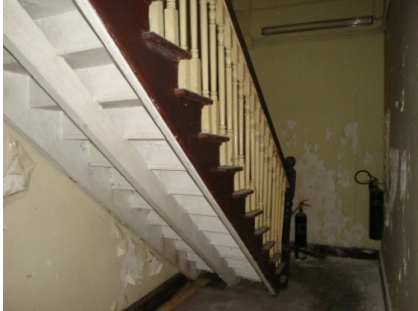
| Element no. | Description | Photo ref. | Significance | Proposal | Mitigation | Impact |
|---|---|--|---|---|--|---|
| 10.019 | Timber stair | | Moderate | Underline with fire-resisting lining | Repair as necessary and retain. | Low |

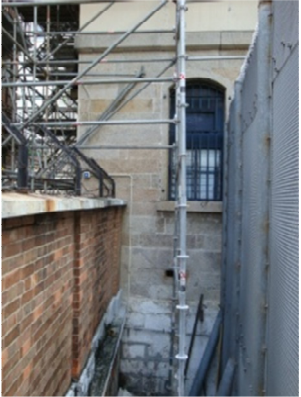
| Element no. | Description | Photo ref. | Significance | Proposal | Mitigation | Impact |
|---|--|--|---|---|---|---|
| 10.024 | Granite wall on North elevation | | High | Construct new external steps adjacent wall | Keep new stair clear of wall; avoid any physical connection between steps and wall. | Low |

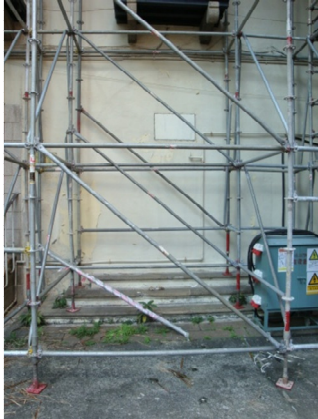
| Element no. | Description | Photo ref. | Significance | Proposal | Mitigation | Impact |
|---|--|--|---|---|--|---|
| 10.026 | Blocked archway on East elevation | | Adverse | Demolish infilling and re-open archway | Protect original arch and jambs against damage during demolition | Moderate |

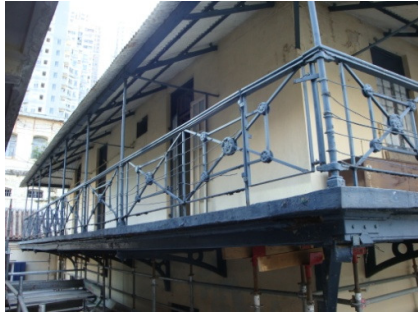
| Element no. | Description | Photo ref. | Significance | Proposal | Mitigation | Impact |
|---|---|--|---|---|--|---|
| 10.028 | Cantilever balconies | | High | Repair as necessary and retain | Avoid intrusive interventions. Restrict access if necessary to retain existing appearance. | Neutral |

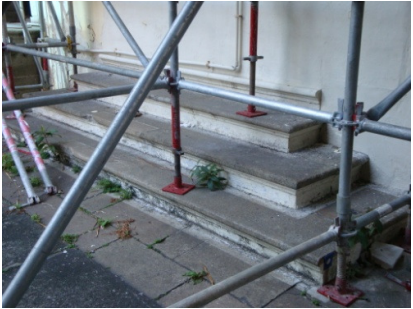
| Element no. | Description | Photo ref. | Significance | Proposal | Mitigation | Impact |
|---|---|--|---|---|---|---|
| 10.029 | Steps on east elevation | | Moderate | Repair as necessary and retain | Not applicable | Neutral |

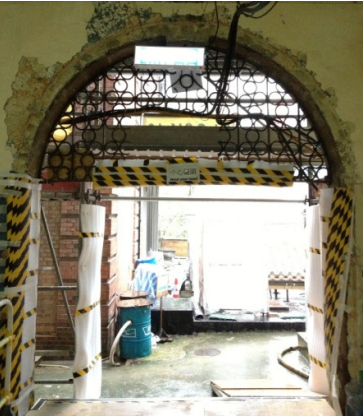
| Element no. | Description | Photo ref. | Significance | Proposal | Mitigation | Impact |
|---|---|--|---|---|---|---|
| 10.030 | Decorative metal screen<br>(See also item 10.026) | | Low | Repair and retain | Not applicable | Positive |

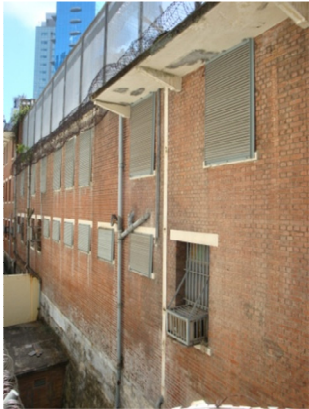
| Element no. | Description | Photo ref. | Significance | Proposal | Mitigation | Impact |
|---|--|--|---|---|---|---|
| 11.002 | External airconditioning units and other external services | | Adverse | Remove and make good brickwork | Not applicable | High |

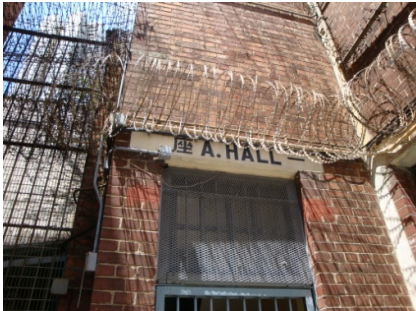
| Element no. | Description | Photo ref. | Significance | Proposal | Mitigation | Impact |
|---|--|--|---|---|---|---|
| 11.003 | Painted signs | | High | Protect in situ | Not applicable | N/A |

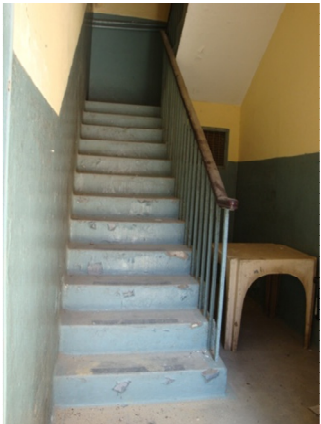
| Element no. | Description | Photo ref. | Significance | Proposal | Mitigation | Impact |
|---|---|--|---|--|---|---|
| 11.005 | Concrete stairs | | Low | Remove and rebuild as part of re-planning of interiors | None | Low |

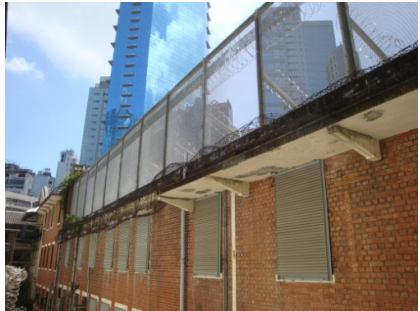
| Element no. | Description | Photo ref. | Significance | Proposal | Mitigation | Impact |
|---|---|--|---|---|--|---|
| 11.007 | Security screen at roof level | | Low | Remove | Record on measured survey drawings | Low |

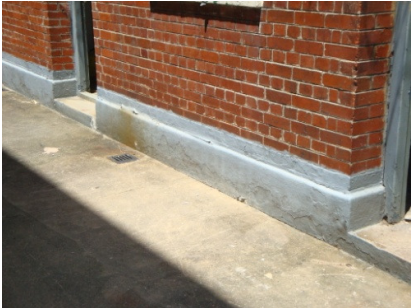
| Element no. | Description | Photo ref. | Significance | Proposal | Mitigation | Impact |
|---|---|--|---|--|---|---|
| 11.012 | Door thresholds and plinth | | Low | Retain; remove paint media from plinth and brickwork | Not applicable | Neutral |
