Central Police Station Conservation  
and Revitalisation Project:  
*Eleventh Quarterly EM&A Report*  
*(1 May 2014 to 31 July 2014)*

Issue Date: September 2014

| <b>Annex N</b> | <b><i>A Summary of Current Condition of Character Defining Elements</i></b> |

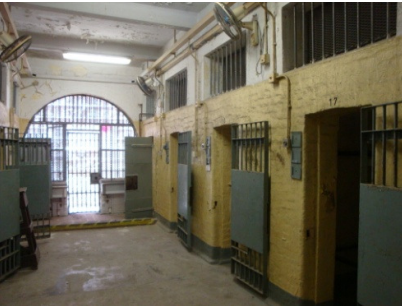
| Element no. | Description | Photo ref. | Significance | Proposal | Mitigation | Impact |
|---|---|--|---|---|---|---|
| 12.002 | Cells at GF level | | High | Remove cells in selected locations to accommodate new North-South route across site | Record existing layout on measured survey drawings. Limit number of cells affected to the minimum necessary. Retain floor structure above. Retain remainder of cells at this level for interpretation | Moderate |

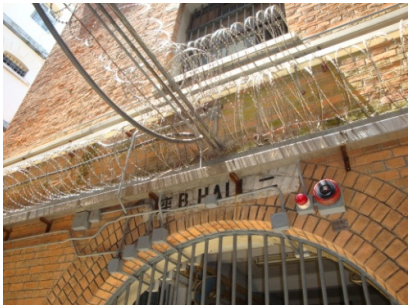
| Element no. | Description | Photo ref. | Significance | Proposal | Mitigation | Impact |
|---|--|--|---|---|---|---|
| 12.004 | Painted signs | | High | Protect in situ | Not applicable | N/A |

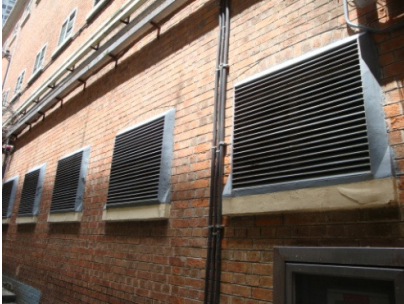
| Element no. | Description | Photo ref. | Significance | Proposal | Mitigation | Impact |
|---|---|---|---|--|--|---|
| 12.009 | External walls | | Moderate | Form openings in North and South walls in conjunction with new North-South route across site | Cut brickwork to form openings in North and South walls; do not re-bond brickwork. | Moderate |

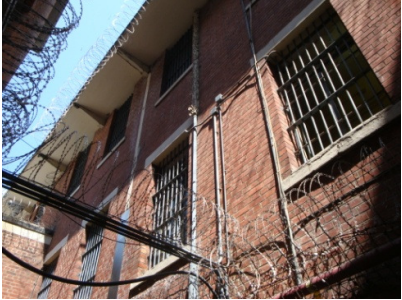
| Element no. | Description | Photo ref. | Significance | Proposal | Mitigation | Impact |
|---|---|--|---|---|---|---|
| 13.003 | Security bars at window openings | | Low | Retain | Not applicable | Neutral |

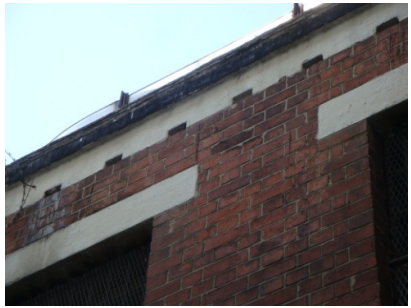
| Element no. | Description | Photo ref. | Significance | Proposal | Mitigation | Impact |
|---|---|--|---|---|---|---|
| 13.005 | Eaves detail | | Low | Retain | Not applicable | Neutral |

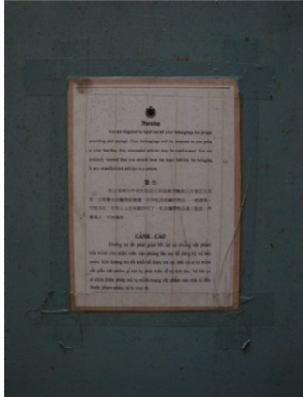
| Element no. | Description | Photo ref. | Significance | Proposal | Mitigation | Impact |
|---|---|--|---|--|---|---|
| 13.008 | Fixed signs | | Low-High | Remove and refix/display in visitors' centre/discard | Record each sign and assess significance individually and treat accordingly | N/A |

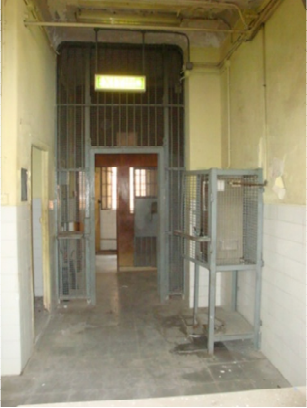
| Element no. | Description | Photo ref. | Significance | Proposal | Mitigation | Impact |
|---|---|--|---|---|---|---|
| 13.010 | Internal security screens | | Moderate | Retain where possible | Where necessary record on measured survey drawings prior to removal | Low |

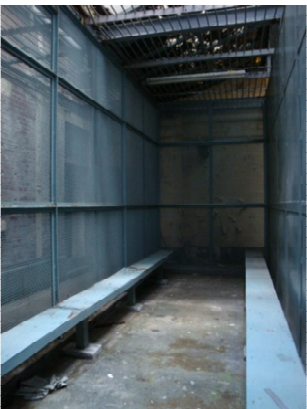
| Element no. | Description | Photo ref. | Significance | Proposal | Mitigation | Impact |
|---|--|--|---|---|---|---|
| 13.012 | Communal cells at Ground Floor | | Moderate | Remove as part of re-planning of interiors | Record on measured survey drawings | Low |

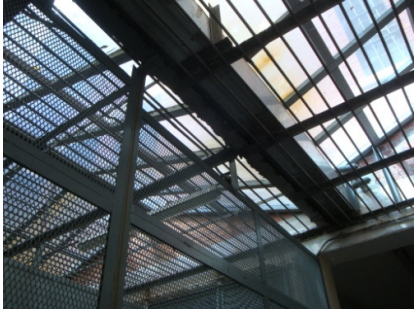
| Element no. | Description | Photo ref. | Significance | Proposal | Mitigation | Impact |
|---|---|--|---|--|---|---|
| 13.013 | Rooflight and security bars over communal cells | | Moderate | Remove as part of re-planning of interiors | Record on measured survey drawings | Low |

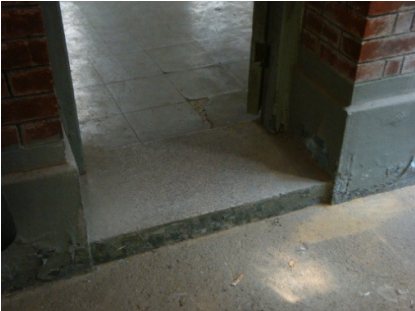
| Element no. | Description | Photo ref. | Significance | Proposal | Mitigation | Impact |
|---|---|--|---|--|---|---|
| 13.014 | Granite threshold at external door openings | | Low | Retain | Not applicable | Neutral |

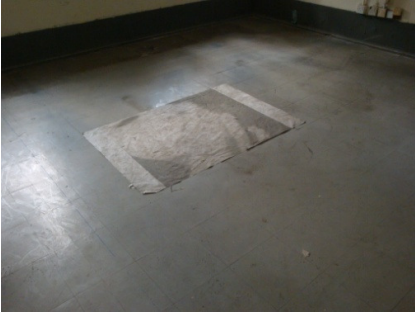
| Element no. | Description | Photo ref. | Significance | Proposal | Mitigation | Impact |
|---|---|--|---|---|---|---|
| 13.015 | Vinyl tile floor | | Adverse | Replace | Not applicable | Low |

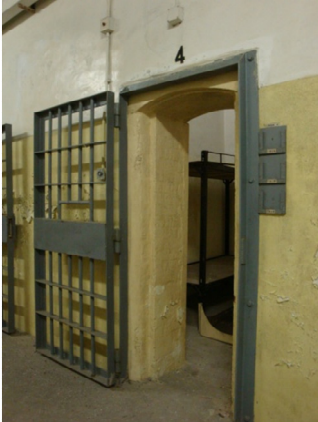
| Element no. | Description | Photo ref. | Significance | Proposal | Mitigation | Impact |
|---|---|---|---|---|---|---|
| 14.004 | Brick reveals with bull-nosed arrisses and segmental arch over (generally north side, alternating with granite surrounds – see previous item) | | High | Retain door surround and gate wherever possible | Pin back gate against wall | Low |

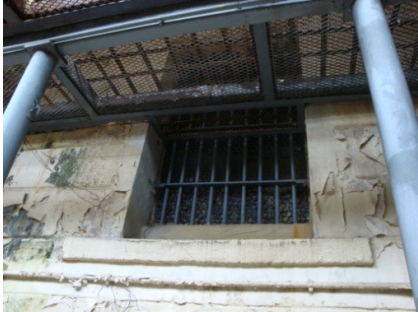
| Element no. | Description | Photo ref. | Significance | Proposal | Mitigation | Impact |
|---|---|--|---|--|--|---|
| 14.007 | Part-blocked windows at Lower Ground Floor - extent of blocking varies. | | Moderate | Open up window opening to full extent. | Record existing condition on measured survey drawings. Add further detail during demolition works. | Low |

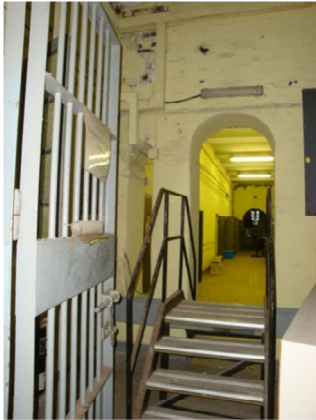
| Element no. | Description | Photo ref. | Significance | Proposal | Mitigation | Impact |
|---|--|--|---|--|---|---|
| 14.012 | Half-round headed doorway and side lights at Ground Floor west end | | Moderate | Retain insitu | Not applicable | Neutral |

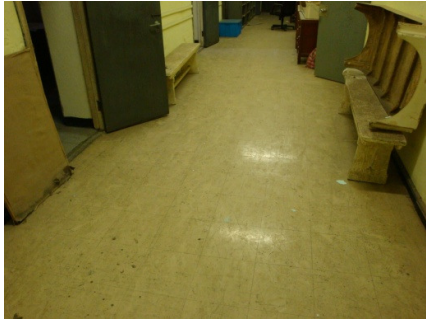
| Element no. | Description | Photo ref. | Significance | Proposal | Mitigation | Impact |
|---|--|--|---|---|---|---|
| 14.015 | Vinyl tile floor on suspended timber floor | | Adverse | Remove vinyl tiles and restore boards if possible; alternatively, replace boards with new timber to match other boarded floors elsewhere on the site. | Not applicable | Low |

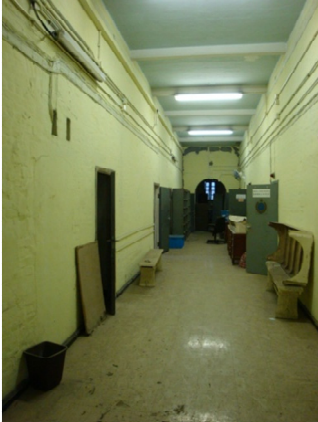
| Element no. | Description | Photo ref. | Significance | Proposal | Mitigation | Impact |
|---|---|---|---|---|---|---|
| 14.016 | Cell walls at Ground Floor | | Moderate | Retain insitu | <p>Use existing door openings wherever possible.</p> <p>Avoid further alteration to existing altered openings where feasible.</p> | Low |

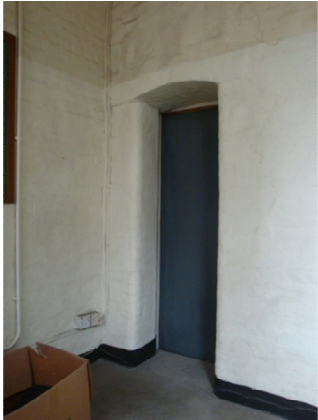
| Element no. | Description | Photo ref. | Significance | Proposal | Mitigation | Impact |
|---|--|--|---|---|--|---|
| 14.018 | Brickwork surrounds to doorways with segmental arches over | | Moderate | Increase width in selected locations to allow wheelchairs to pass | Record on measured survey drawings.<br><br>Limit interventions as far as possible. | Low |

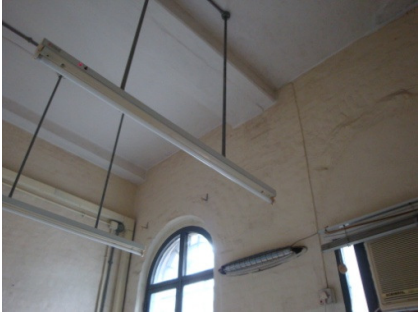
| Element no. | Description | Photo ref. | Significance | Proposal | Mitigation | Impact |
|---|---|--|---|---|--|---|
| 14.020 | Flat ceilings at Ground Floor | | Low | Form penetrations for services installations where necessary | Avoid disruption of beams. | Low |

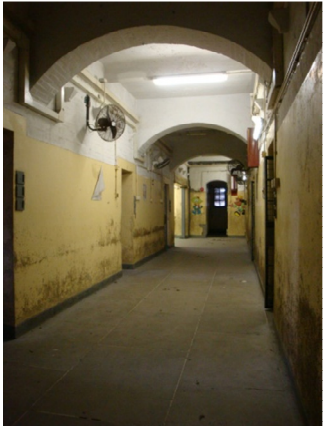
| Element no. | Description | Photo ref. | Significance | Proposal | Mitigation | Impact |
|---|---|---|---|---|---|---|
| 14.023 | Arches across central hall at First Floor | | Moderate | Retain insitu | Not applicable | Neutral |

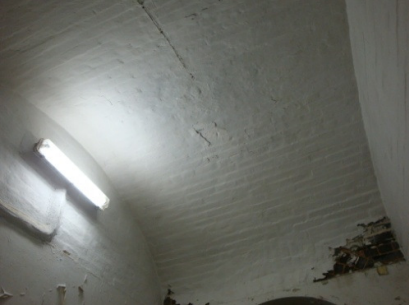
| Element no. | Description | Photo ref. | Significance | Proposal | Mitigation | Impact |
|---|---|--|---|--|---|---|
| 14.034 | Cell walls (later additions) | | Moderate | Remove where necessary to accommodate new cafe | Record on measured drawings | Low |

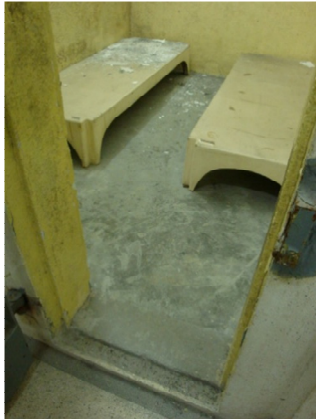
| Element no. | Description | Photo ref. | Significance | Proposal | Mitigation | Impact |
|---|---|---|---|---|---|---|
| 14.037 | Cell floors | | Low | Remove to enable piled underpinning | Record on measured survey drawings | Low |

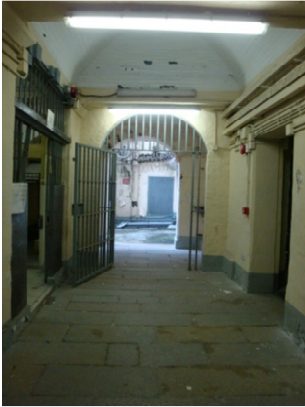
| Element no. | Description | Photo ref. | Significance | Proposal | Mitigation | Impact |
|---|--|--|---|---|---|---|
| 14.039 | Granite pavement in cross-passage between East and West Wings | | Moderate | Repair as necessary and retain insitu | Not applicable | Neutral |

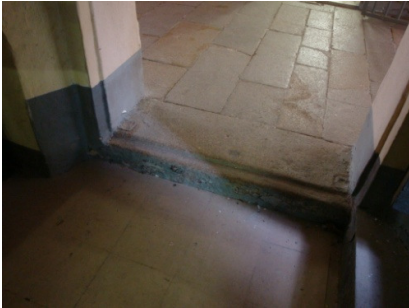
| Element no. | Description | Photo ref. | Significance | Proposal | Mitigation | Impact |
|---|--|--|---|---|---|---|
| 14.040 | Granite threshold at doorway between cross-passage and East Wing | | Moderate | Retain insitu | Not applicable | Neutral |

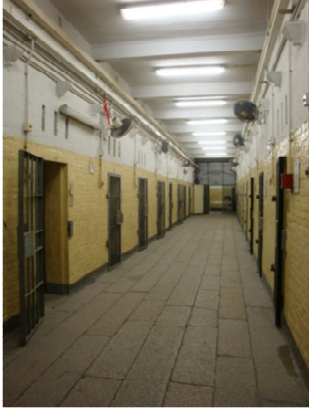
| Element no. | Description | Photo ref. | Significance | Proposal | Mitigation | Impact |
|---|--|--|---|---|---|---|
| 14.042 | Granite floor in central hall at First Floor | | Moderate | Retain insitu | Repair where necessary | Neutral |

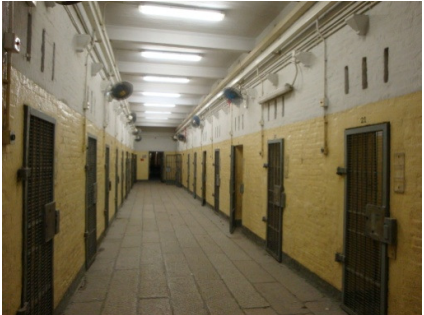
| Element no. | Description | Photo ref. | Significance | Proposal | Mitigation | Impact |
|---|--|--|---|---|---|---|
| 14.043 | Cell walls flanking central hall at First Floor | | High | Retain insitu | Not applicable | Neutral |

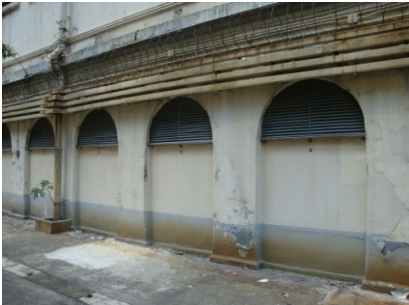
| Element no. | Description | Photo ref. | Significance | Proposal | Mitigation | Impact |
|---|--|--|---|---|---|---|
| 14.050 | Blind arcade, south elevation | | Low | Remove infill brickwork within arched openings at ground level to enable new cafe | Record on measured survey drawings.<br><br>Observe and record any evidence that brickwork infills were built at the same time as the arched openings or added later | Low |

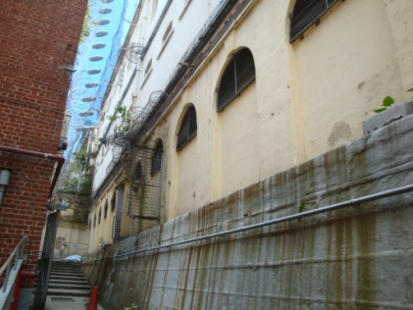
| Element no. | Description | Photo ref. | Significance | Proposal | Mitigation | Impact |
|---|---|--|---|---|---|---|
| 14.051 | Blind arcade, north elevation | | Low | Retain insitu | Not applicable | Neutral |

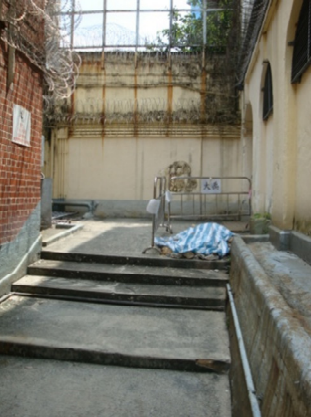
| Element no. | Description | Photo ref. | Significance | Proposal | Mitigation | Impact |
|---|---|--|---|---|---|---|
| 14.052 | Fence wall, east end of D Hall Yard | | Low | Remove to reinstate access to granite stair to Lower Ground Floor level | Record on measured drawings | Low |

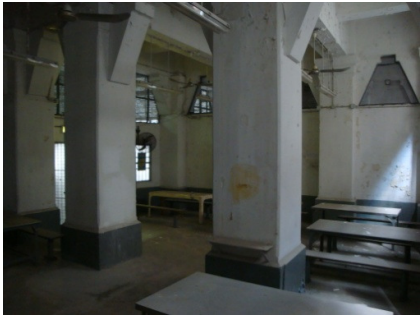
| Element no. | Description | Photo ref. | Significance | Proposal | Mitigation | Impact |
|---|---|--|---|---|---|---|
| 15.002 | Dividing walls at Lower Ground Floor | | Moderate | Remove to enable multi-purpose use | Record on measured survey drawings | Low |

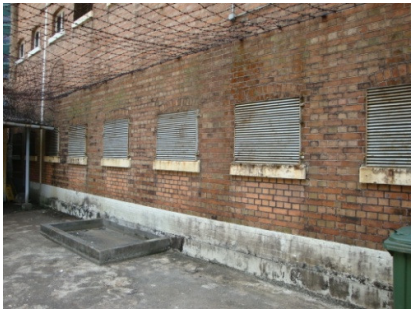
| Element no. | Description | Photo ref. | Significance | Proposal | Mitigation | Impact |
|---|---|--|---|---|---|---|
| 15.005 | Metal louvres over cell window openings | | Low | Remove | Record on measured survey drawings | Low |

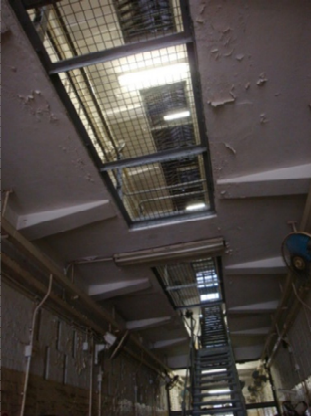
| Element no. | Description | Photo ref. | Significance | Proposal | Mitigation | Impact |
|---|---|--|---|---|---|---|
| 15.007 | Access balconies and apertures | | Moderate | Retain apertures | Provide temporary closure as required for operational reasons | Low |

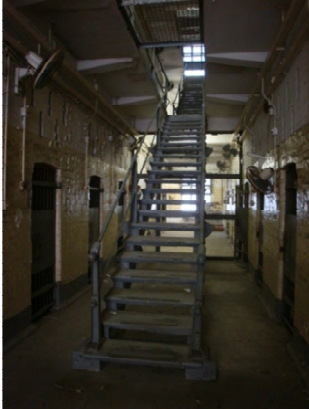
| Element no. | Description | Photo ref. | Significance | Proposal | Mitigation | Impact |
|---|---|---|---|---|---|---|
| 15.008 | Central staircase | | High | Retain | Provide secondary staircase within cell blocks to achieve code compliance | Low |

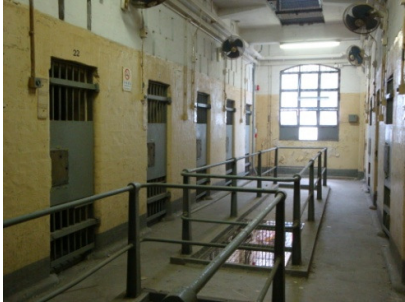
| Element no. | Description | Photo ref. | Significance | Proposal | Mitigation | Impact |
|---|---|--|---|---|---|---|
| 15.011 | Balcony balustrades | | Moderate | Retain | Install wire net across aperture to avoid need to upgrade balustrade to meet Building Code requirements | Low |

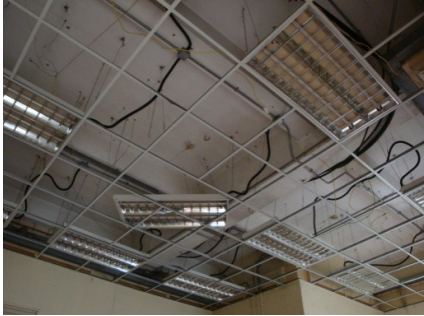
| Element no. | Description | Photo ref. | Significance | Proposal | Mitigation | Impact |
|---|---|--|---|---|---|---|
| 17.001 | Lay-in grid suspended ceiling | | Adverse | Remove | Not applicable | High |

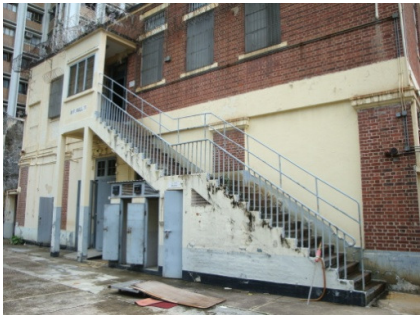
| Element no. | Description | Photo ref. | Significance | Proposal | Mitigation | Impact |
|---|---|---|---|--|--|---|
| 17.003 | Exterior decorations | | Adverse | Strip off and redecorate | Sample and analyse existing paint media; select new media to suit substrate and significance | High |

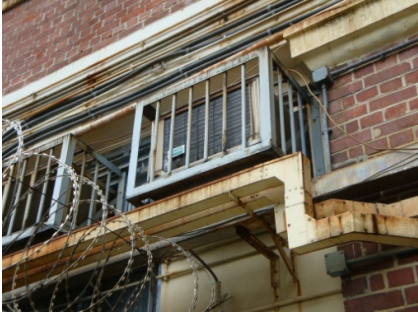
| Element no. | Description | Photo ref. | Significance | Proposal | Mitigation | Impact |
|---|--|---|---|--|---|---|
| 17.004 | External airconditioning units and other external services | | Adverse | Remove and make good brickwork | Not applicable | High |

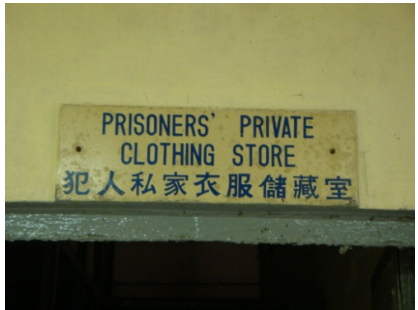
| Element no. | Description | Photo ref. | Significance | Proposal | Mitigation | Impact |
|---|--|---|---|--|---|---|
| 17.005 | Fixed signs | | Moderate | Remove and refix/display in visitors' centre/discard | Record each sign and assess significance individually and treat accordingly | Moderate |

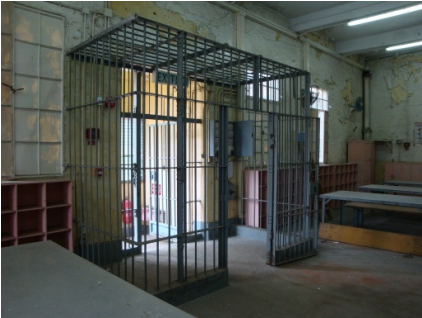
| Element no. | Description | Photo ref. | Significance | Proposal | Mitigation | Impact |
|---|---|---|---|---|---|---|
| 17.006 | Security screen at First Floor entrance | | Low | Remove | Record on measured drawings | Low |

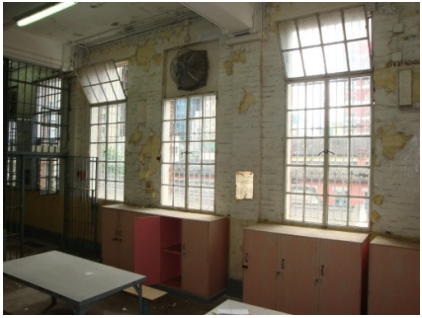
| Element no. | Description | Photo ref. | Significance | Proposal | Mitigation | Impact |
|---|---|---|---|---|---|---|
| 17.007 | Metal windows | | Moderate | Remove at First Floor to accommodate gallery space and block structural openings with blockwork | Record on measured drawings. | Moderate |

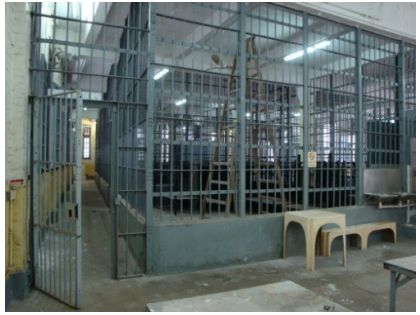
| Element no. | Description | Photo ref. | Significance | Proposal | Mitigation | Impact |
|---|---|---|---|---|---|---|
| 17.009 | Security screens | | Moderate | Remove to accommodate gallery space | Record on measured drawings | Moderate |

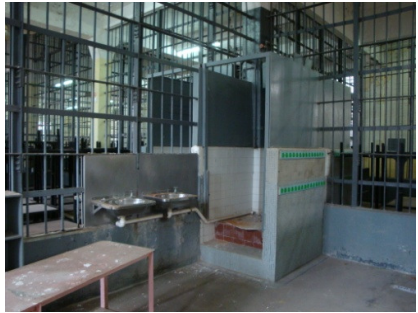
| Element no. | Description | Photo ref. | Significance | Proposal | Mitigation | Impact |
|---|---|---|---|---|---|---|
| 17.011 | Communal washing/lavatory facilities | | Moderate | Remove to accommodate gallery space | Record on measured drawings | Low |

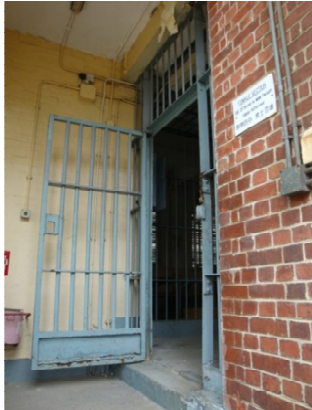
| Element no. | Description | Photo ref. | Significance | Proposal | Mitigation | Impact |
|---|---|--|---|---|---|---|
| 17.013 | Security gates at Ground openings | | Moderate | Remove to enable access to Ground Floor gallery space | Record on measured drawings | Low |

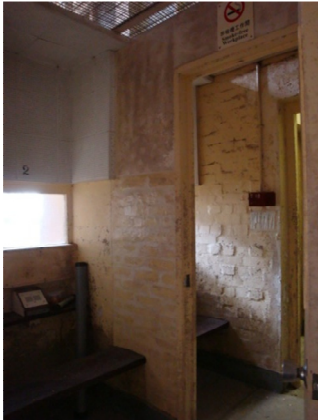
| Element no. | Description | Photo ref. | Significance | Proposal | Mitigation | Impact |
|---|---|---|---|---|--|---|
| 17.014 | Interview booths | | High | Remove to accommodate new gallery | Rebuild in new location | Moderate |

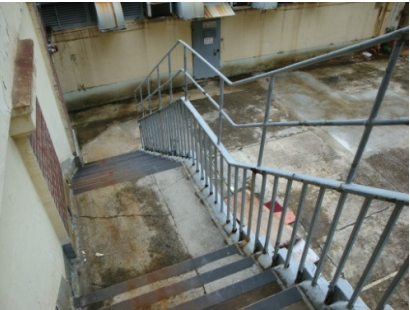
| Element no. | Description | Photo ref. | Significance | Proposal | Mitigation | Impact |
|---|---|---|---|---|--|---|
| 17.015 | External stair to First Floor | | Moderate | Upgrade balustrade to comply with Building Code | Record on measured drawings. Supplement existing balustrade elements with minimal elements if necessary. | Low |

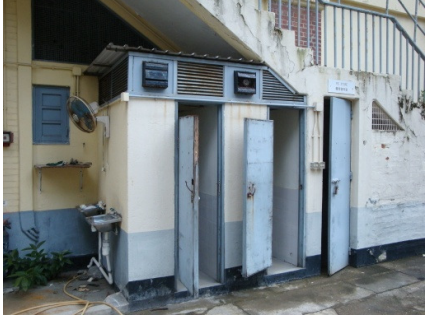
| Element no. | Description | Photo ref. | Significance | Proposal | Mitigation | Impact |
|---|--|---|---|---|---|---|
| 17.023 | External toilets at Ground Floor adjacent East elevation | | Low | Remove | Record on measured drawings | Low |

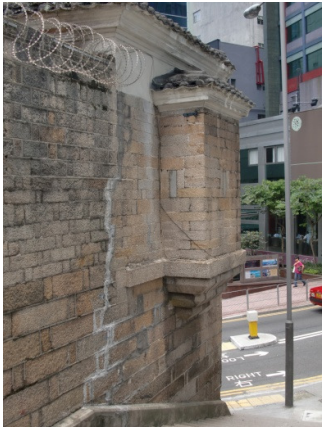
| Element no. | Description | Photo ref. | Significance | Proposal | Mitigation | Impact |
|---|---|---|---|---|---|---|
| 19.006 | Look-out turret | | High | Repair and retain insitu | Not applicable | Neutral |

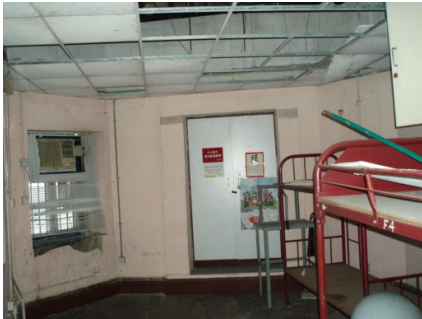
| Element no. | Description | Photo ref. | Significance | Proposal | Mitigation | Impact |
|---|---|--|---|---|---|---|
| 19.010 | Lay-in grid suspended ceiling | | Adverse | Remove | Not applicable | High |

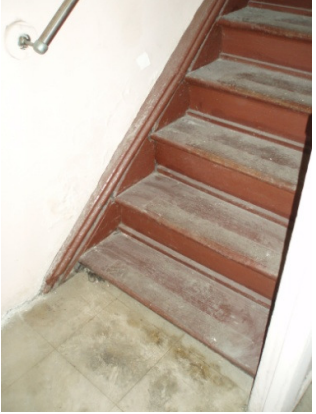
| Element no. | Description | Photo ref. | Significance | Proposal | Mitigation | Impact |
|---|---|--|---|---|---|---|
| 19.012 | Timber stair | | Moderate | Remove | Record on measured surveys drawings | Low |
