Central Police Station Conservation
and Revitalisation Project:
Thirteenth Quarterly EM&A Report
(1 November 2014 to 31 January
2015)

Annex N	<i>A Summary of Current Condition of Character Defining Elements</i>

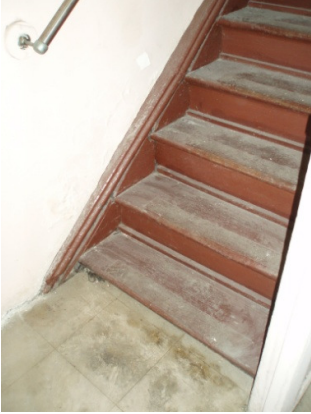
High	Repair and retain insitu	Not applicable	Neutral
19.012	Timber stair

Moderate	Remove	Record on measured surveys drawings	Low
