Central Police Station Conservation and Revitalisation Project: Fourth Quarterly EM&A Report (1 August 2012 to 31 October 2012)

Issue Date: December 2012

### Central Police Station Conservation and Revitalisation Project: Fourth Quarterly EM&A Report (1 August 2012 to 31 October 2012)

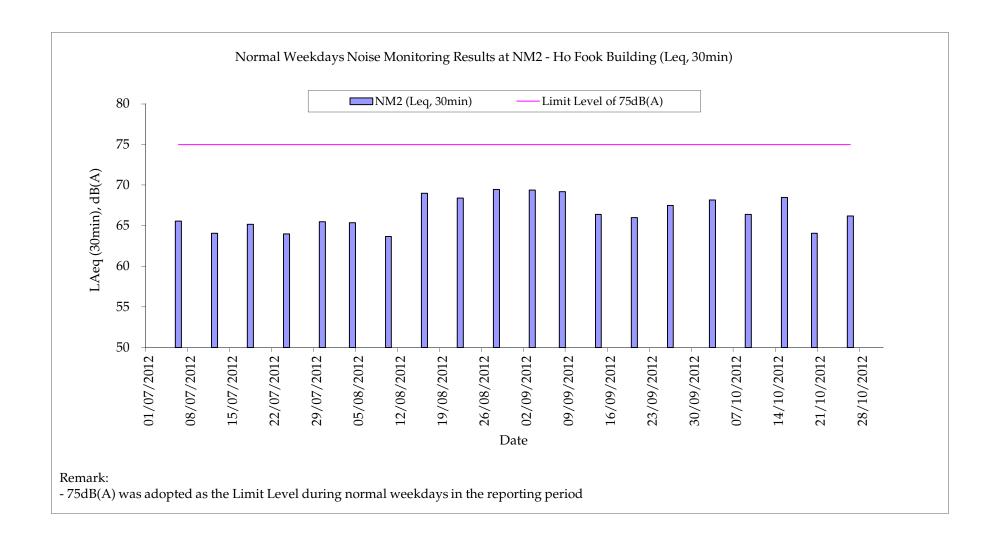
A total of 15 sets of 30-minute construction noise measurements were carried out at each monitoring station, NM2 and NM6, during normal weekdays of the reporting period. The monitoring results together with graphical presentations are presented in *Annex H*. The local impacts observed near the monitoring stations of NM2 and NM6 were summarised below:
