Central Police Station Conservation  
and Revitalisation Project:  
*Fifth Quarterly EM&A Report*  
*(1 November 2012 to 31 January*  
*2013)*

Issue Date: March 2013

Reference 0095646

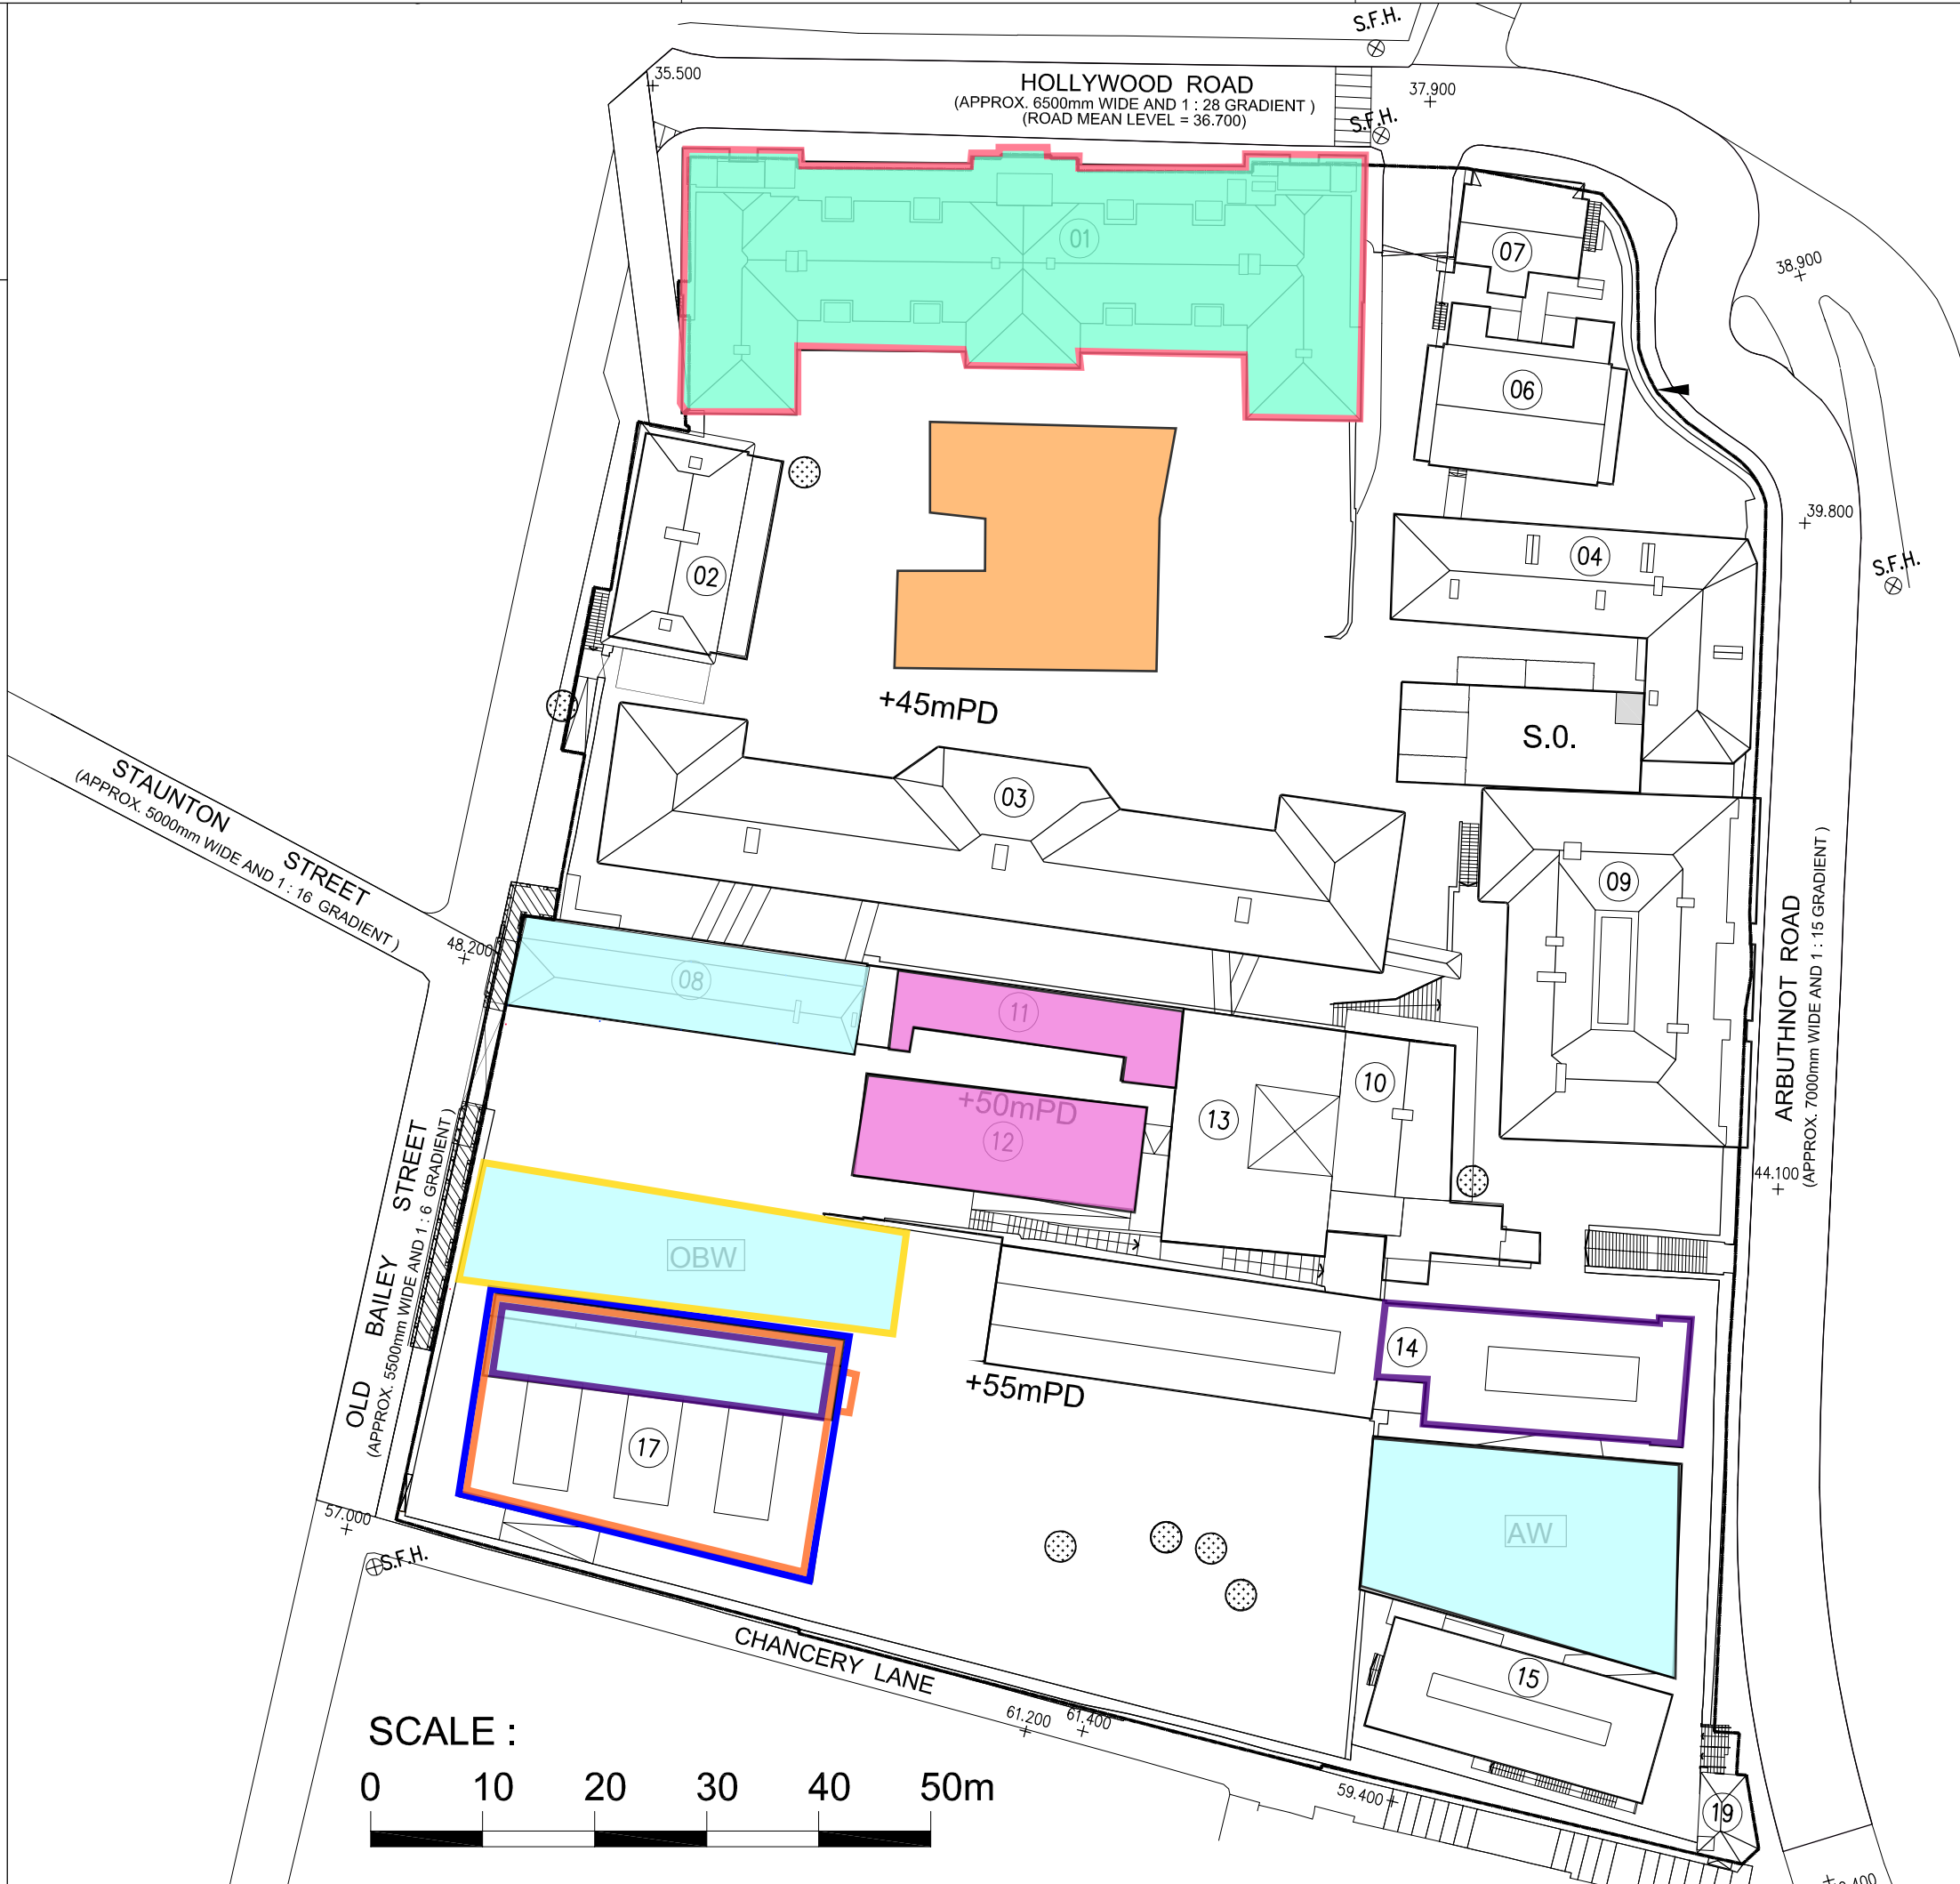
**Annex A3 Site Layout Plan marked with Works ( December - 2012)**

- 1. General Strip Out Works
- 2. Structural A&A works
- 3. Pipe Pile Wall Construction
- 4. Structural Open Up Investigation
- 5. Pipe Pile Wall and Bored Pile Wall
- 6 Ground Improvement Works
- 7. Pre-drilling Works
- 8. Demolition of NE corner Toilet and G/F Slab
- 9. Furniture Strip Out Works

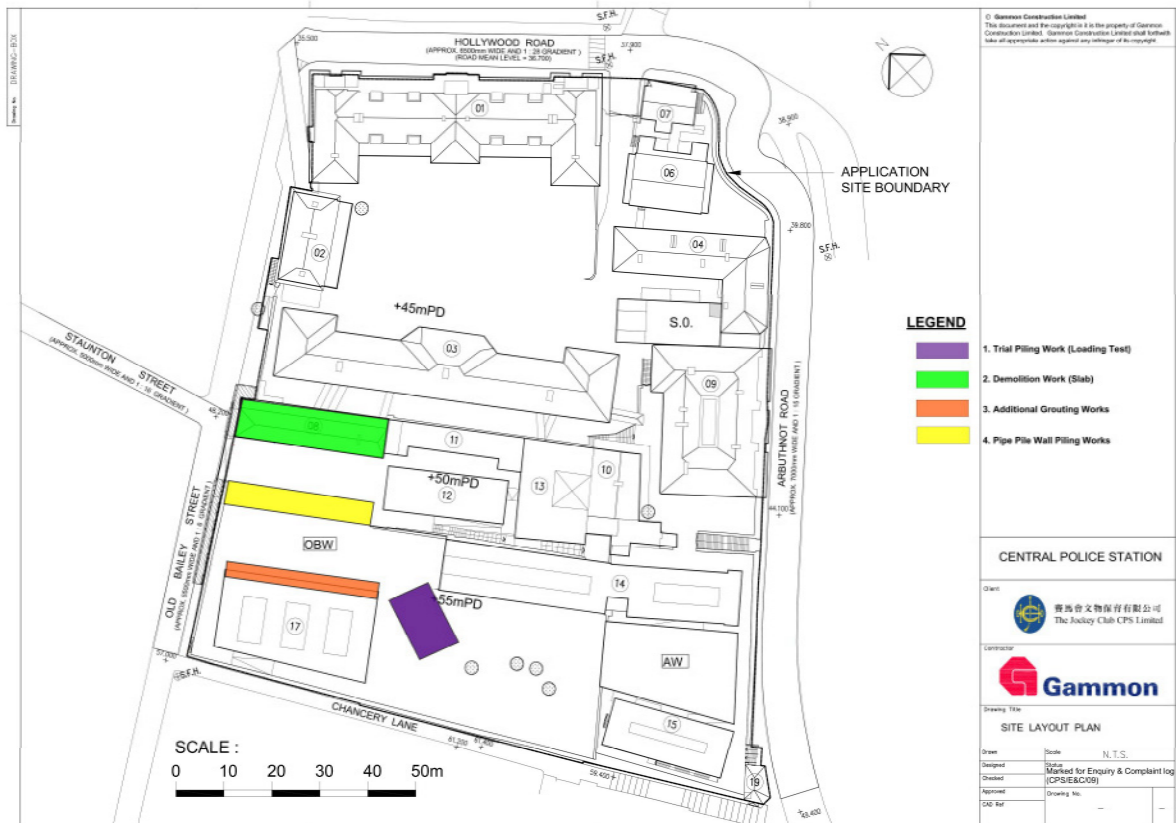
**Figure 1. Locations of works being carried out on 15 November 2012**

1. According to the information provided by the Contractor, relocation of piling machine, which was done as a preparation for the subsequent pipe piling works, was carried out near Block 8 at 7:30am on 15 November 2012. Other major construction activities undertaken on 15 November 2012 included slab demolition works at Block 8 and grouting works at Block 17, both commenced at around 9:00am.
2. The locations of the work areas are presented in Figure 1.

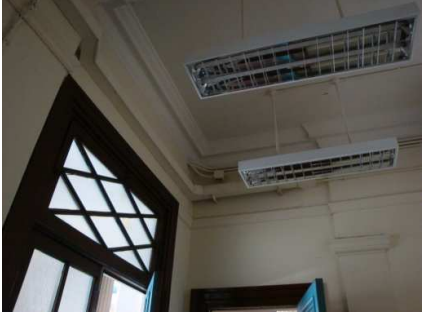
Element no.	Description	Photo ref	Significance	Proposal	Mitigation	Impact
01.005	Plaster box cornice

Moderate	Remove in exceptional cases eg. where adjacent new lift shafts	Cut back neatly to a square edge and ensure remaining section is secure.	Moderate
01.006	Panelled doors

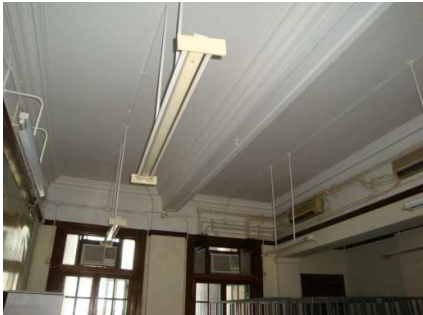
Element no.	Description	Photo ref	Significance	Proposal	Mitigation	Impact
01.009	Plaster ceilings on GF and LG1

Moderate	Install cloud ceilings to accommodate new services	Install fixed grid to minimise damage to ceiling	High
01.010	Timber door frames and architraves	 	Moderate	Conceal in exceptional cases eg. where adjacent new lift shaft	Retain architrave and door frame in situ. Avoid damage to joinery.	High

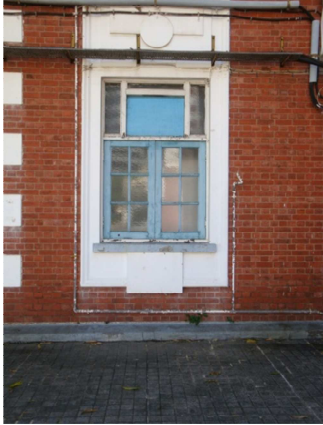
Element no.	Description	Photo ref	Significance	Proposal	Mitigation	Impact
01.016	Altered doors and windows

Adverse	Repair or renew as necessary existing frames to match original patterns	Not applicable	High
01.017	Mezzanine floor in room 01/LG1/13

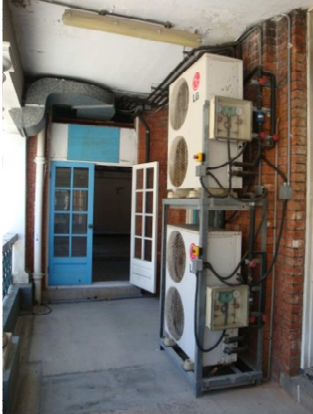
Element no.	Description	Photo ref	Significance	Proposal	Mitigation	Impact
01.020	External airconditioning units and other external services

Adverse	Remove and make good brickwork	Not applicable	High
01.021	Stair balustrades

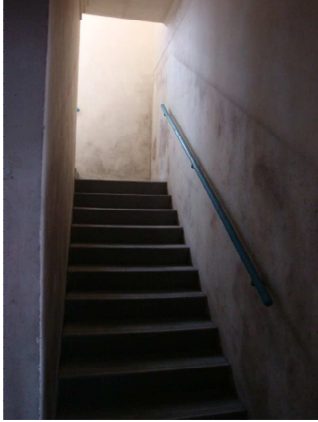
Element no.	Description	Photo ref.	Significance	Proposal	Mitigation	Impact
02.009	Concrete stairs

Adverse	Remove stairs	Not applicable	Moderate
02.010	Pitched roofs

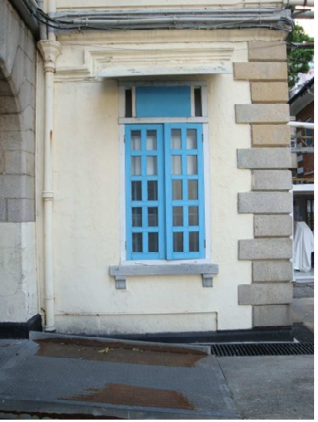
Element no.	Description	Photo ref.	Significance	Proposal	Mitigation	Impact
03.011	Altered doors and windows

Adverse	Repair or renew as necessary existing frames to match original patterns	Not applicable	High

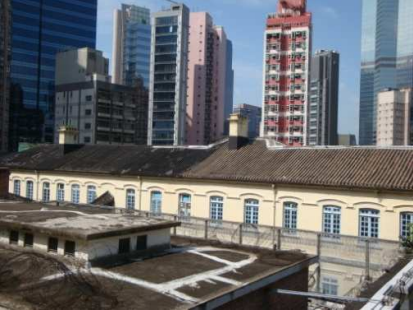
Element no.	Description	Photo ref.	Significance	Proposal	Mitigation	Impact
03.016	Pitched roofs

High	New penetrations through roofs for ventilation ducts and other services	<p>Arrange new penetrations so that they conform with the geometry of the existing roof.</p> <p>Model the size and shape of the new ducts so that the impact on the roofscape is minimised.</p> <p>Finish the new ducts in a non-reflective material that is neutral in colour and mid-tone.</p>	High
03.017	Lean-to structure adjacent North wall

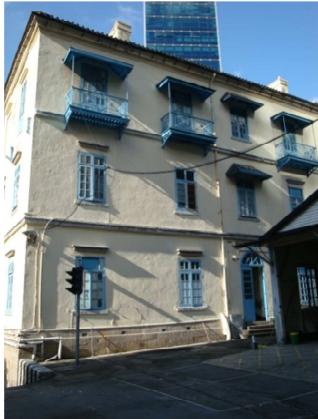
Element no.	Description	Photo ref.	Significance	Proposal	Mitigation	Impact
04.005	Exterior decorations

Adverse	Strip off and redecorate	Sample and analyse existing paint media; select new media to suit substrate and significance	High

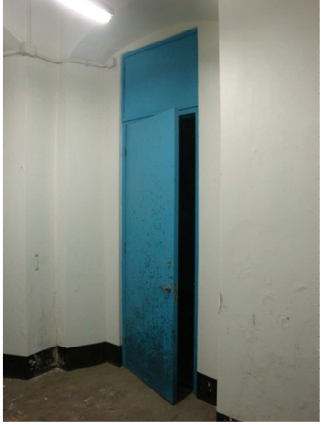
Element no.	Description	Photo ref.	Significance	Proposal	Mitigation	Impact
04.006	Block existing door openings

Moderate	Block opening as part of re-planning of interior	Retain existing door frame and architraves. Use framing and non-combustible sheet linings to block opening.	Moderate
04.007	Form new door openings

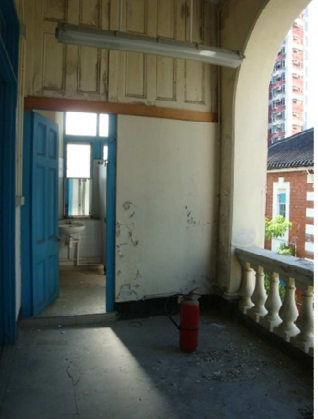
Element no.	Description	Photo ref.	Significance	Proposal	Mitigation	Impact
04.017	Toilets at ends of verandahs

Adverse	Remove and make good finishes	Not applicable	High

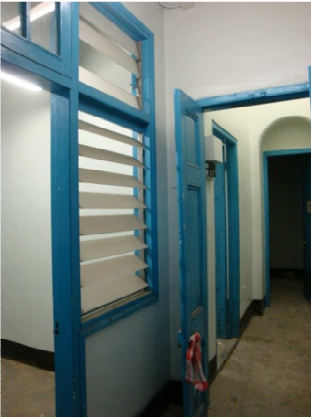
Element no.	Description	Photo ref.	Significance	Proposal	Mitigation	Impact
04.018	Partitions at GF Dormitory A

High	Remove to make way for Interpretation	Prepare measured drawings and photographs before removal.	Moderate

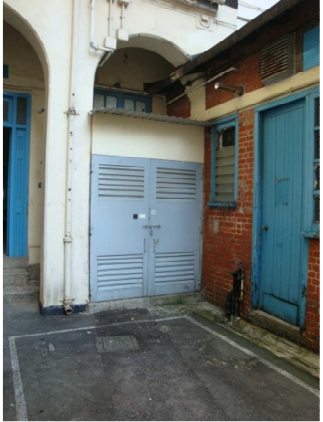
Element no.	Description	Photo ref.	Significance	Proposal	Mitigation	Impact
04.019	Switchgear in old porch 04/G/13

Adverse	Open up porch, remove electrical switchgear and make good	Not applicable	High
04.020	Flat plywood ceiling lining with plain rectangular cover battens

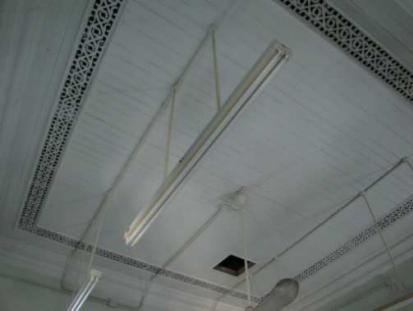
Element no.	Description	Photo ref.	Significance	Proposal	Mitigation	Impact
04.024	Clay tile floor		Low	Retain and repair as necessary	Not applicable	Neutral
04.025	Matched-boarded ceiling with perforated border

Moderate	Repair and retain insitu	Not applicable	Neutral

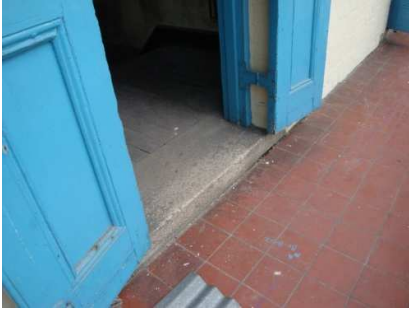
Element no.	Description	Photo ref.	Significance	Proposal	Mitigation	Impact
06.001	Granite thresholds at external doors

Low	Retain; install timber deck flush with level of step where necessary	Avoid alteration to step.	Low
06.002	Pitched roof

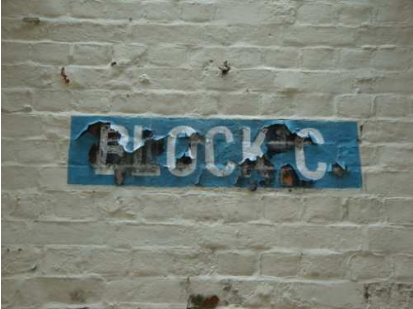
Element no.	Description	Photo ref.	Significance	Proposal	Mitigation	Impact
06.007	Painted signs

High	Protect in situ	Not applicable	N/A
06.008	Fixed signs

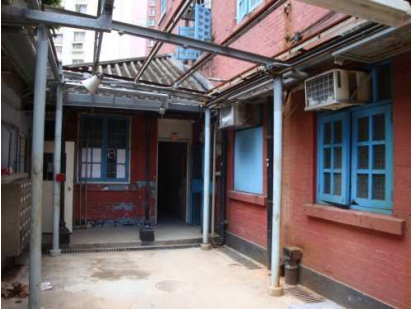
Element no.	Description	Photo ref.	Significance	Proposal	Mitigation	Impact
08.003	Exterior decorations

Adverse	Strip off and redecorate	Sample and analyse existing paint media; select new media to suit substrate and significance	High
08.004	Block existing door openings

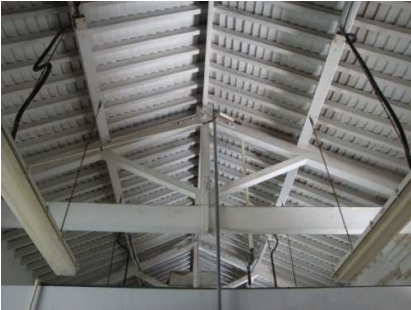
Element no.	Description	Photo ref.	Significance	Proposal	Mitigation	Impact
08.005	Timber roof structure

High	Retain	Not applicable	Neutral
08.006	External stair at west end

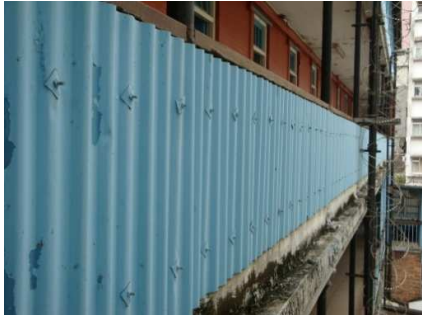
Element no.	Description	Photo ref.	Significance	Proposal	Mitigation	Impact
08.015	Corrugated steel sheet on balcony balustrades

Adverse	Remove	Not applicable	Low

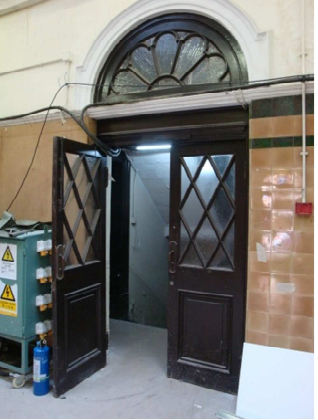
Element no.	Description	Photo ref.	Significance	Proposal	Mitigation	Impact
09.005	Panelled doors

Moderate	Replace where necessary to achieve fire resistance to comply with Code	Re-use where possible. Record design on survey drawings where element cannot be re-used.	Moderate

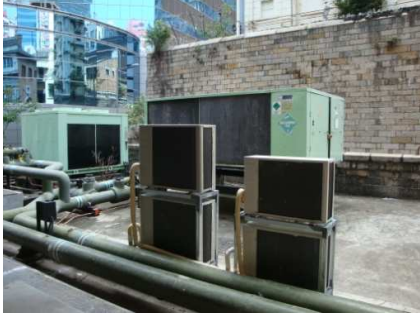
Element no.	Description	Photo ref.	Significance	Proposal	Mitigation	Impact
09.010	External airconditioning units and other external services

Adverse	Remove and make good brickwork	Not applicable	High
09.011	Pitched roofs

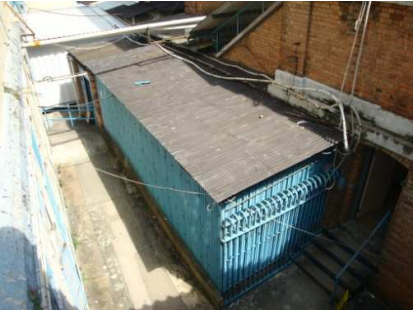
Element no.	Description	Photo ref.	Significance	Proposal	Mitigation	Impact
09.016	Single storey secure shelter at North West corner

Low	Demolish	Make good brickwork at abutments.	Low
09.017	Iron railing adjacent south side of item 09.016 above

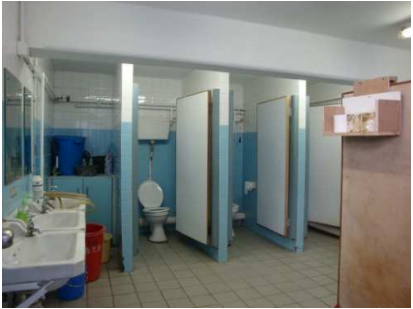
Element no.	Description	Photo ref.	Significance	Proposal	Mitigation	Impact
09.018	Public toilets in 09/LG1/17, 24

Adverse	Strip out sanitaryware, and fit-out for pottery display/service access. Form new door openings in east walls.	Retain existing door openings and metal-barred gates. Retain external granite steps and existing ground level.	Low
09.019	Cell doors

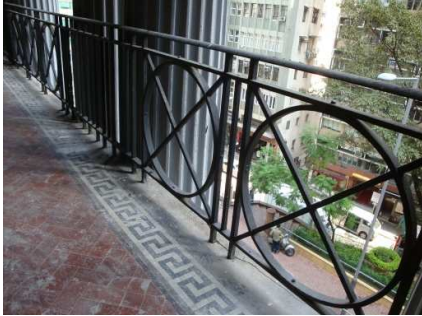
Element no.	Description	Photo ref.	Significance	Proposal	Mitigation	Impact
09.026	Iron gates at top of external stair	 	Moderate	Retain	No applicable	Neutral
09.027	Iron balustrade adjacent terrace at First Floor east side

High	Retain; install structural glass balustrade inboard of ironwork to provide compliance with Building Codes	Avoid penetration of existing tiled pavement when fixing glass balustrade.	Low

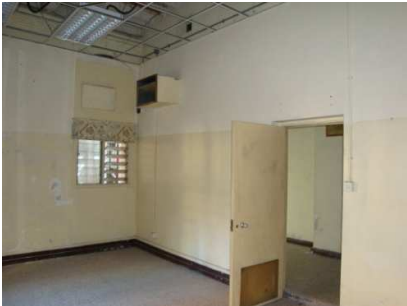
Element no.	Description	Photo ref.	Significance	Proposal	Mitigation	Impact
10.007	Form new door openings

Moderate	Form new opening as part of re-planning of interiors	New doors and frames to be of their time to avoid confusion about provenance	Moderate
10.008	Altered doors and windows

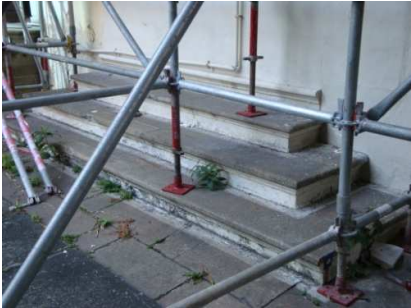
Element no.	Description	Photo ref.	Significance	Proposal	Mitigation	Impact
10.029	Steps on east elevation

Moderate	Repair as necessary and retain	Avoid alteration or obliteration.	Neutral

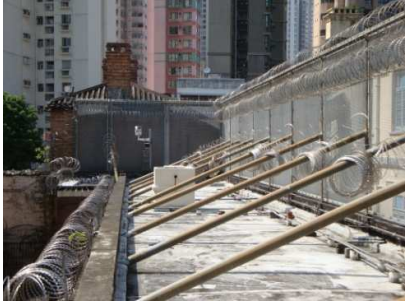
Element no.	Description	Photo ref.	Significance	Proposal	Mitigation	Impact
11.006	Flat roof

Low	Form new rooftop extension at West end to accommodate fire escape stair	Form straight joint at abutment with building 08 Ablutions Block	Low
11.007	Security screen at roof level

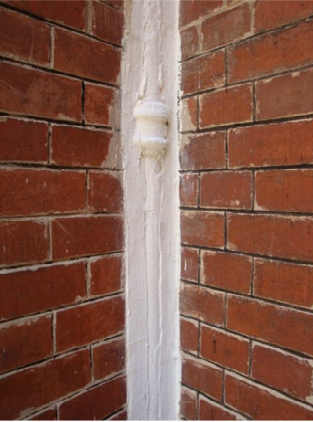
Element no.	Description	Photo ref.	Significance	Proposal	Mitigation	Impact
11.009	Rainwater goods

Low	Remove embedded cast iron pipework set into wall to reduce long term maintenance burden	Record on measured survey drawings. Make good cavity.	Low

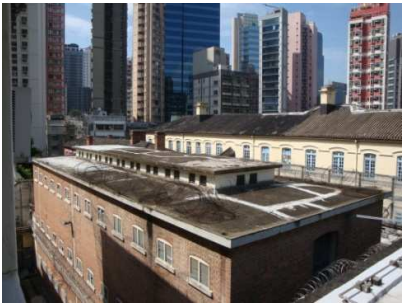
Element no.	Description	Photo ref.	Significance	Proposal	Mitigation	Impact
12.001	Flat roof

Moderate	Repair and retain	Avoid roof penetrations as far as possible	Low
12.002	Cells at GF level

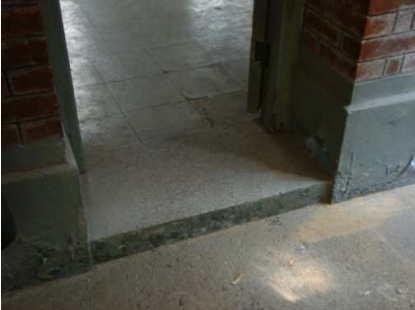
Element no.	Description	Photo ref.	Significance	Proposal	Mitigation	Impact
13.014	Granite threshold at external door openings

Low	Retain	Not applicable	Neutral
13.015	Timber boarded doors with fanlight over

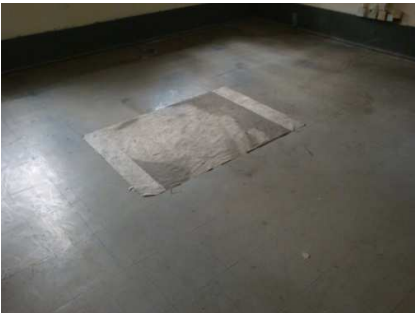
Element no.	Description	Photo ref.	Significance	Proposal	Mitigation	Impact
13.015	Vinyl tile floor

Adverse	Replace	Not applicable	Low

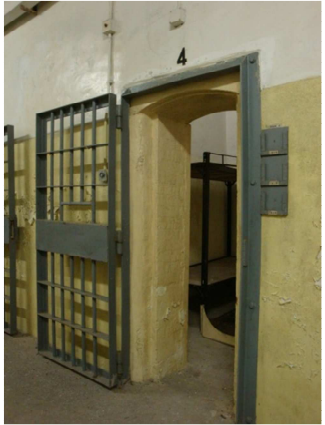
Element no.	Description	Photo ref.	Significance	Proposal	Mitigation	Impact
14.004	Brick reveals with bull-nosed arrisses and segmental arch over (generally north side, alternating with granite surrounds – see previous item)

High	Retain door surround and gate wherever possible	Pin back gate against wall	Low

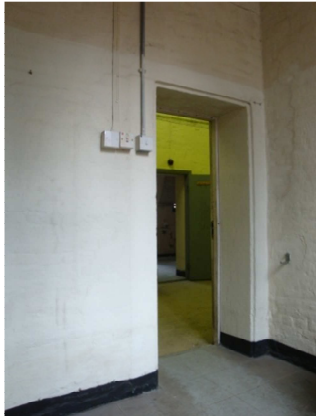
Element no.	Description	Photo ref.	Significance	Proposal	Mitigation	Impact
14.019	Granite surrounds to doorways with lintels over

Moderate	Increase width in selected locations to allow wheelchairs to pass	Record on measured survey drawings.  Limit interventions as far as possible.	Low
14.020	Flat ceilings at Ground Floor

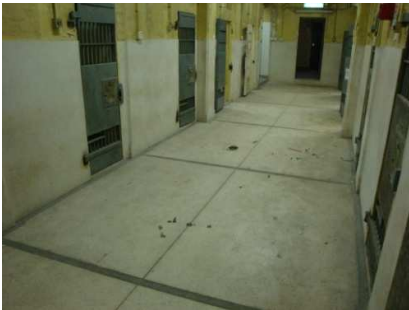
High	Retain insitu	Not applicable	Neutral
14.032	Terrazzo floor in central hall at Ground floor

Moderate	Remove to enable piled underpinning	Record on measured survey drawings	Moderate

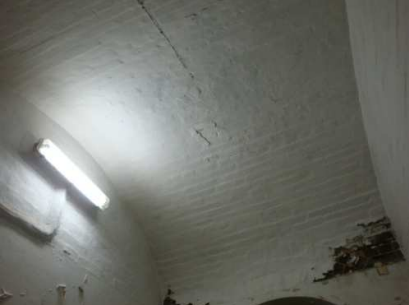
High	Retain insitu	Avoid penetrations for services	Neutral
14.034	Cell walls (later additions)

Moderate	Remove where necessary to accommodate new cafe	Record on measured drawings	Low

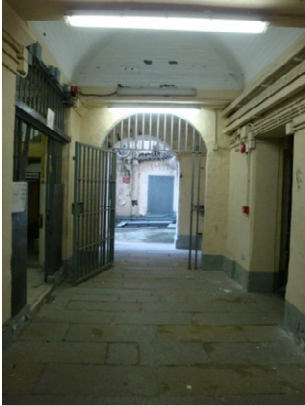
Element no.	Description	Photo ref.	Significance	Proposal	Mitigation	Impact
14.039	Granite pavement in cross-passage between East and West Wings

Moderate	Repair as necessary and retain insitu	Not applicable	Neutral
14.040	Granite threshold at doorway between cross-passage and East Wing

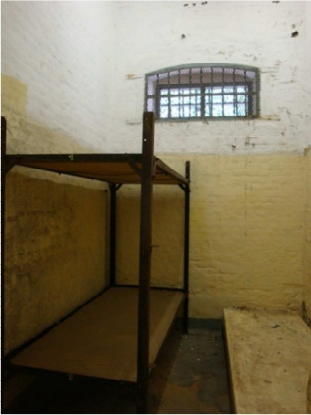
High	Retain insitu	Not applicable	Neutral
14.044	Brickwork spandrels below cell windows at Second Floor

Moderate	Remove to enable new use	Record on measured drawings.  Confine changes to one elevation, north or south.	Low

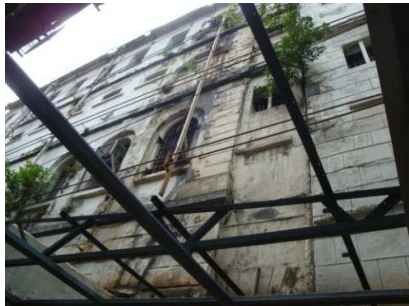
Element no.	Description	Photo ref.	Significance	Proposal	Mitigation	Impact
14.049	Metalwork and structural steel framing on exterior (typical)

Adverse	Remove	Not applicable	High
14.050	Blind arcade, south elevation

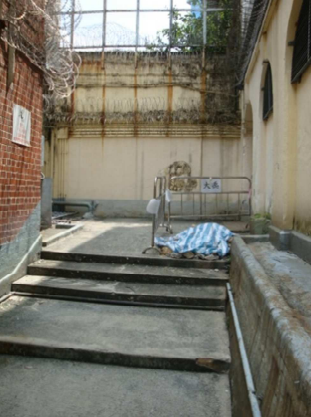
Low	Retain insitu	Not applicable	Neutral
14.052	Fence wall, east end of D Hall Yard

Low	Remove to reinstate access to granite stair to Lower Ground Floor level	Record on measured drawings	Low

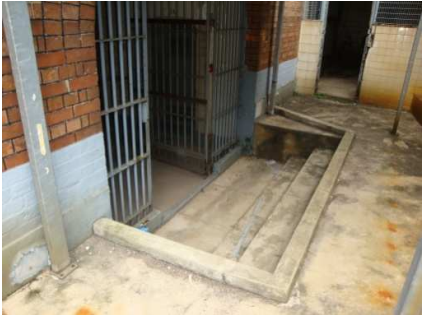
Element no.	Description	Photo ref.	Significance	Proposal	Mitigation	Impact
15.006	Raised ground level adjacent entrance

Low	Remove to enable level access	Record on measured survey drawings	Low
15.007	Access balconies and apertures

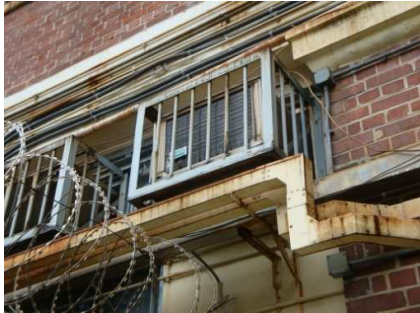
Element no.	Description	Photo ref.	Significance	Proposal	Mitigation	Impact
17.003	Exterior decorations	 	Adverse	Strip off and redecorate	Sample and analyse existing paint media; select new media to suit substrate and significance	High
17.004	External airconditioning units and other external services

Adverse	Remove and make good brickwork	Not applicable	High

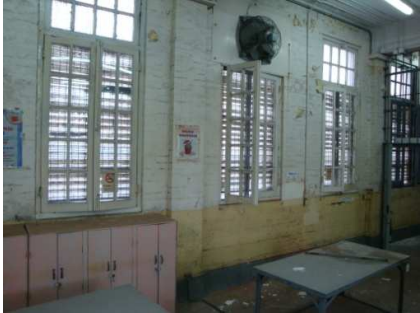
Moderate	Remove to accommodate gallery space	Record on measured drawings	Moderate
17.010	Timber windows

Moderate	Remove at First Floor to accommodate gallery space and block structural openings with blockwork	Record on measured drawings	Moderate

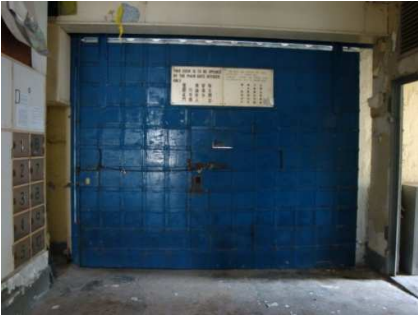
High	Retain in situ	Maintain in working order	Neutral

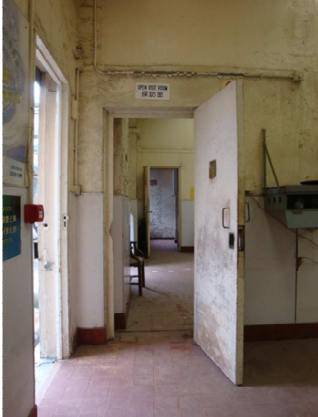
Low	Space reallocated to other uses	Record on measured drawings. Salvage entrance sign and re-use in new layout of interview booths.	Low

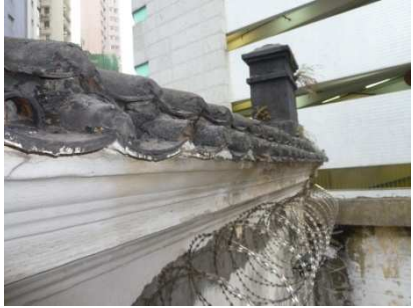
High	Repair and retain	Not applicable	Neutral

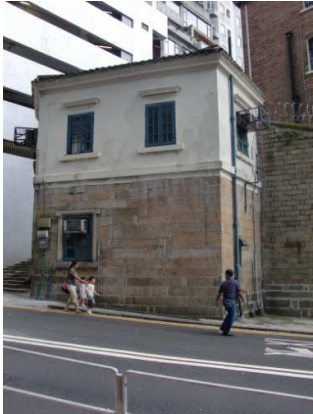
Element no.	Description	Photo ref.	Significance	Proposal	Mitigation	Impact
19.007	Windows

Moderate	Remove and make good stonework as necessary	Record existing windows on measured survey drawings	Moderate

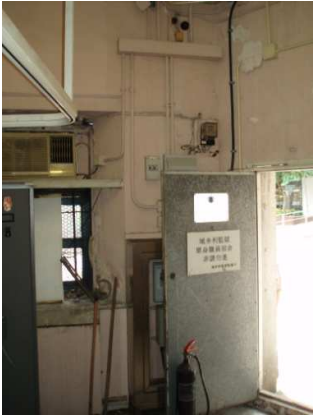
Element no.	Description	Photo ref.	Significance	Proposal	Mitigation	Impact
19.009	Electrical services

Adverse	Remove	Not applicable	Moderate
19.010	Lay-in grid suspended ceiling

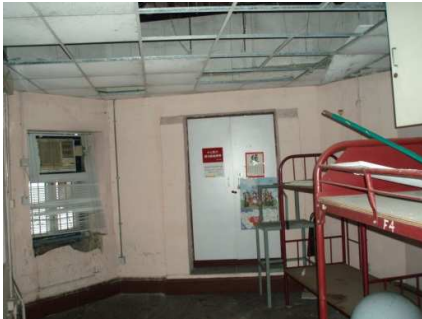
Adverse	Remove	Not applicable	High
