QUARTERLY EM&A REPORT

Central Police Station Conservation and Revitalisation Project: Seventh Quarterly EM&A Report (1 May 2013 to 31 July 2013)

Issue Date: August 2013

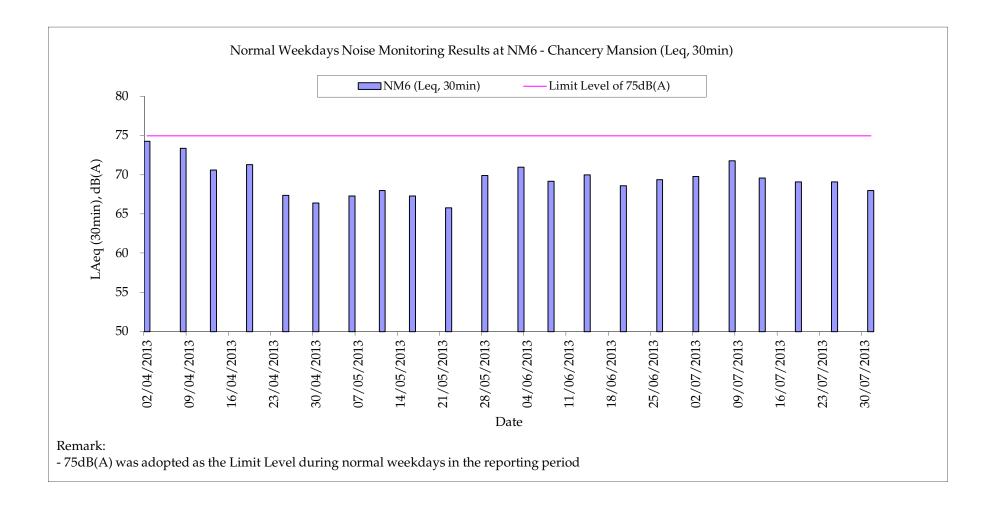
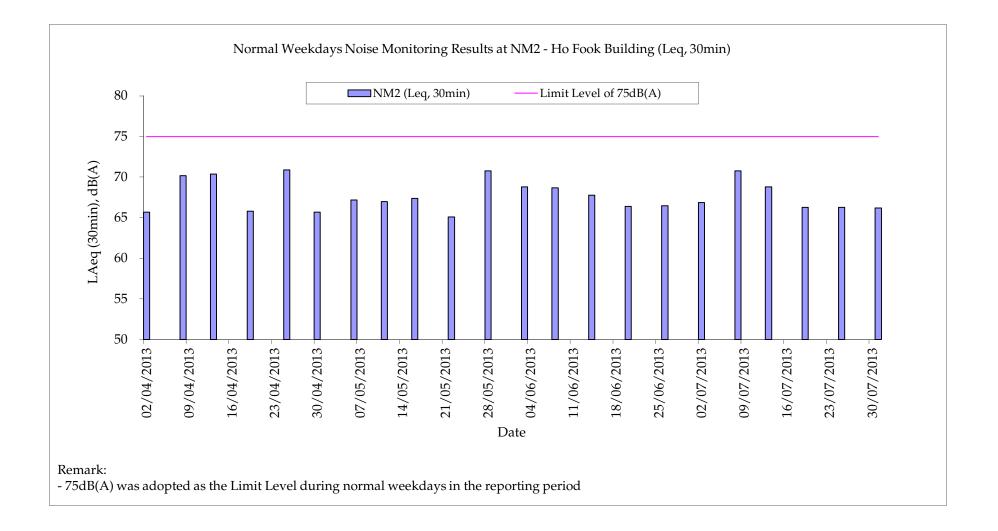
A total of 16 sets of 30-minute construction noise measurements were carried out at each monitoring station, NM2 and NM6, during normal weekdays of the reporting period. The monitoring results together with graphical presentations are presented in *Annex H*. The local impacts observed near the monitoring stations of NM2 and NM6 were summarised below:

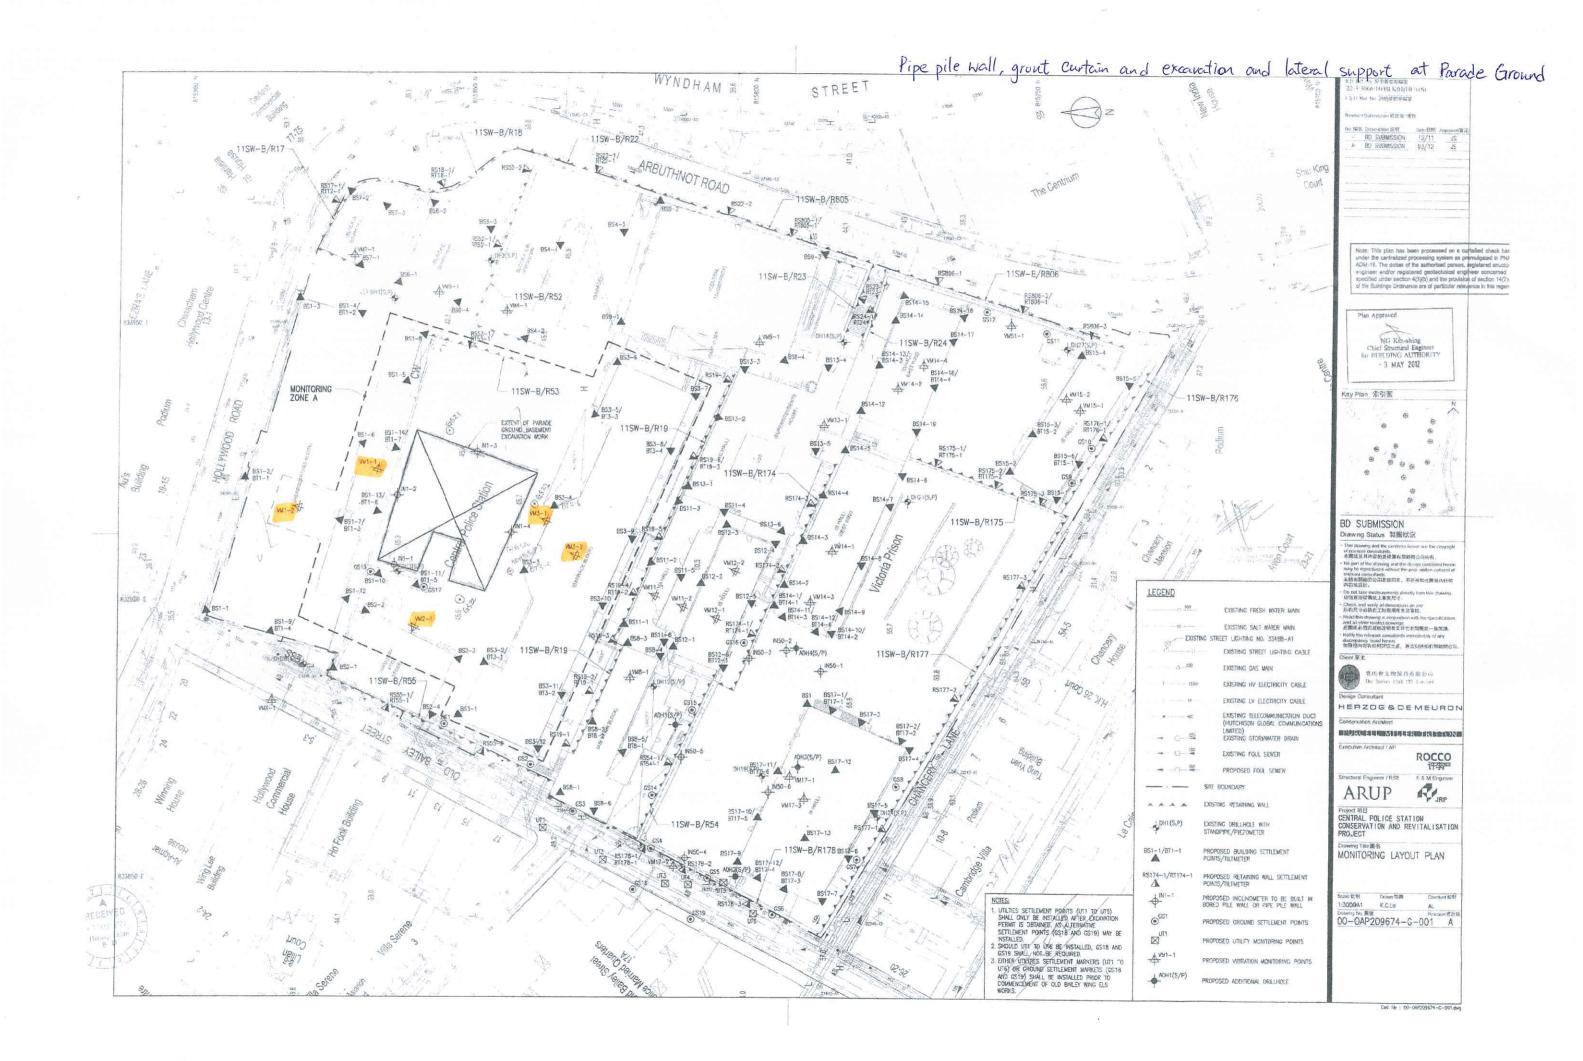
Records of Vibration Monitoring for Trial Piling and Piling Works

Trigger Levels	
	ammo				Monitoring	g Check Pts.	Alert level	Alarm level	
					Vibration	Monitoring	2mm/s	2.5mm/s	Γ
					# Vibration at	largest span of	5.0mm/s	6.0mm/s	T
					highest Str	uctural level	5.0mm/s	o.umm/s	
				Vibration	Record				
Project Title: Centr	ral Police Sta	tion Conserva	ation & Rev	italization	Project No:	WP107	19-Apr-2013	to	
(WP10	07 Parade Gr	ound Baseme	nt)						
POINT	VM1-1	#VM1-2	VM2-1	VM3-1	#VM3-2				
DATE	mm/s	mm/s	mm/s	mm/s	mm/s				
19-Jun-2012 (Initial)									
19-Apr-13	0.166	0.761	0.145	1.650	0.281				
20-Apr-13	1.430	0.160	0.164	0.178	0.157				
21-Apr-13					Sunday				_
22-Apr-13	0.241	0.255	0.093	0.128	0.114				
23-Apr-13	0.246	0.327	0.102	0.318	0.177				1
24-Apr-13	0.307	0.251	0.103	0.093	0.151				1
25-Apr-13	0.150	0.258	0.137	0.305	0.143				1
26-Apr-13	0.184	0.317	0.129	0.962	0.159				
27-Apr-13	0.183	0.232	0.093	0.414	0.132				
28-Apr-13					Sunday				_
29-Apr-13	1.310	0.420	0.160	0.211	0.172

30-Apr-13	0.264	0.112	0.172	0.565	0.156				
01-May-13					Holiday		-		_
02-May-13	0.160	0.206	0.600	1.460	0.145

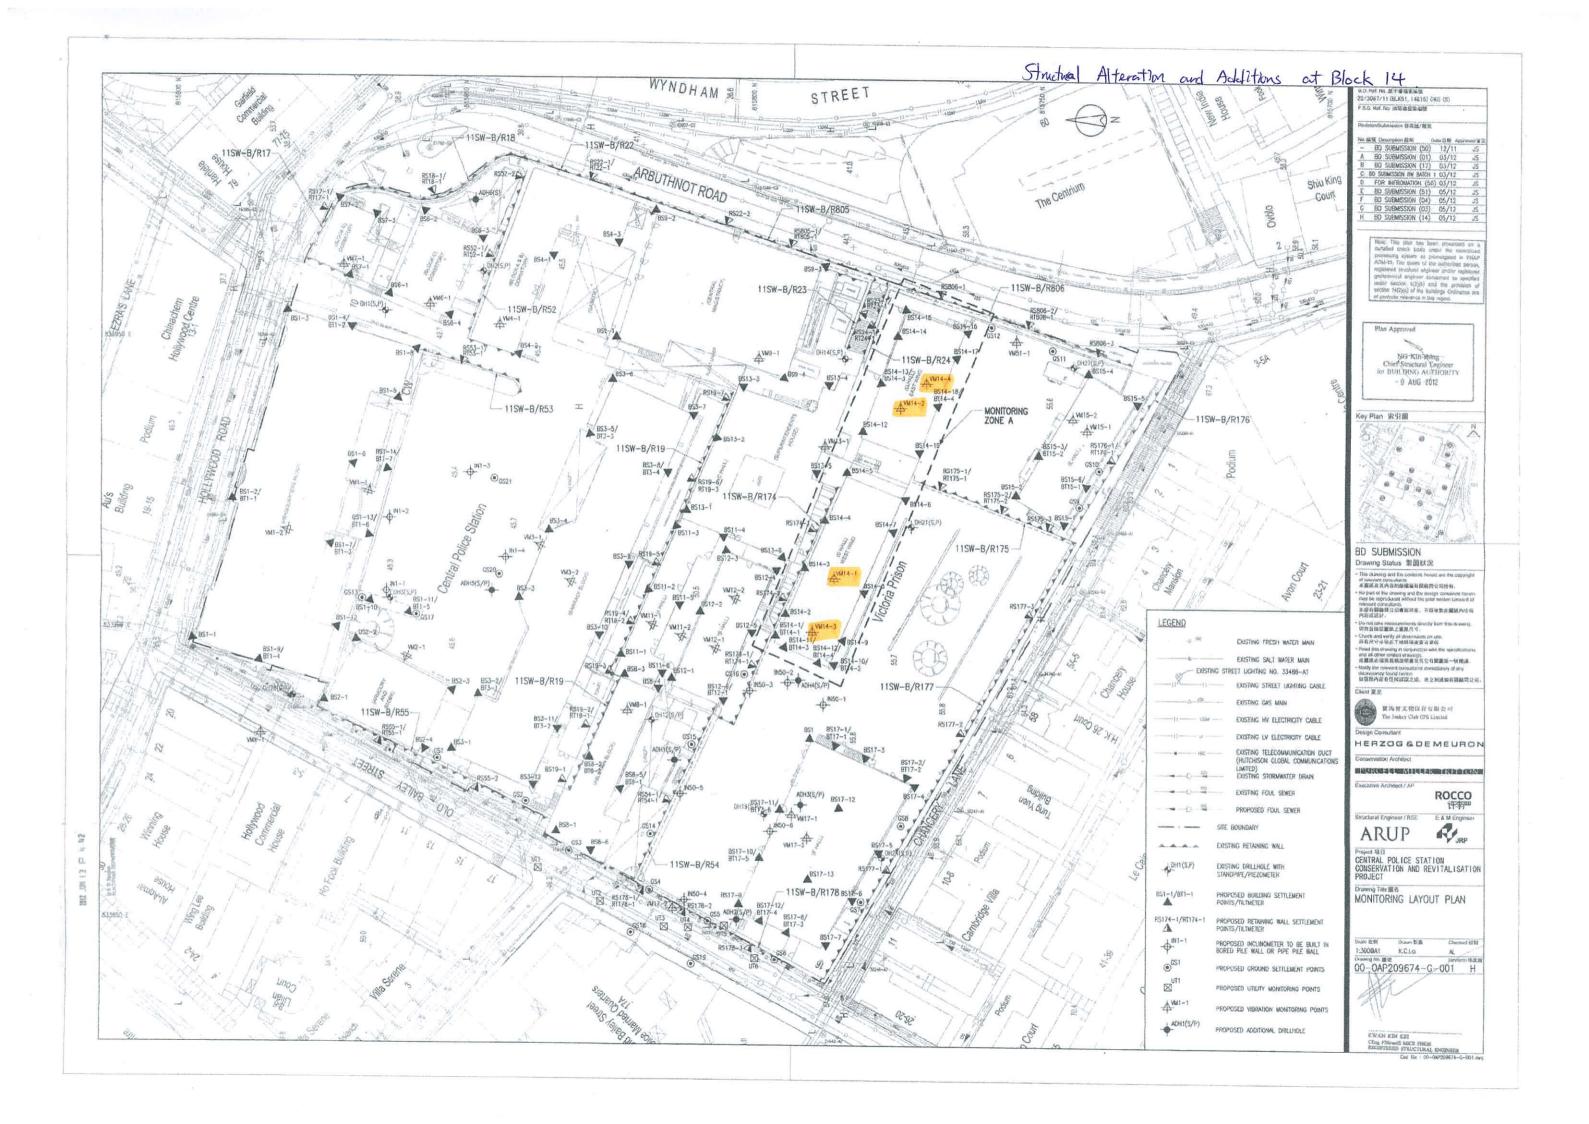
Records of Vibration Monitoring for Other Construction Works

14/14/	ŀ							(Block	、14)	
WW	相對	油筑 丁	程有限公	751		Monitoring Check	2 Dto		Trigger Levels	
AA AA	也顽	使采上	任月1137	イロ			к г із.	Alert level	Alarm level	Action level
Win Win	Wer C		- Company	TAJ		Vibrating Monito	ring	2mm/s	2.5mm/s	3mm/s
ууштуушт	way C	onstructio	n Company	Ltu.						
					Vibration	Record				
Project Title:	Central	Police Station	n Conservation	& Revitalizati	on Proje	ct No: WP201		21-Apr-2013	to	4-May-2013
POINT		VM14-1	VM14-2	VM14-3	VM14-4					
DATE	PD/(m)	mm/s	mm/s	mm/s	mm/s					
19-Nov-12 (Initial)	0.103	0.112	0.147	0.136					
21-Apr-2013						Sunday				•
22-Apr-2013		0.22	0.61	0.42	0.13					
23-Apr-2013		0.33	0.31	0.25	0.25					
24-Apr-2013		0.26	0.55	0.45	0.13					
25-Арг-2013		0.61	0.22	0.25	0.13					
26-Apr-2013		1.61	0.31	0.45	0.13					
27-Apr-2013		0.35	0.25	0.25	0.23					
28-Apr-2013						Sunday				
29-Apr-2013		0.26	0.35	0.11	0.13					
30-Арг-2013		0.32	0.62	0.61	0.25					
1-May-2013			4		Р	ublic Holiday

2-May-2013		0.15	0.23	0.25	0.15					
3-May-2013		0.52	0.52	0.28	0.13					
4-May-2013		0.13	0.26	0.38	0.13					
Remarks
