The Jockey Club CPS Limited

Central Police Station Conservation
and Revitalisation Project:
Eighth Quarterly EM&A Report
(1 August 2013 to 31 October 2013)

Issue Date: November 2013

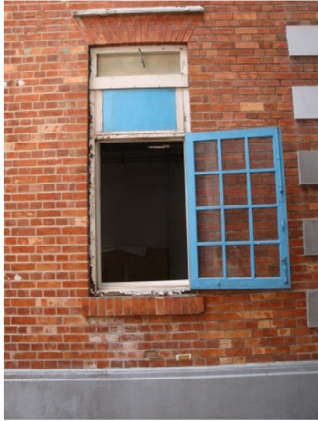
Element no.	Description	Photo ref.	Significance	Proposal	Mitigation	Impact
02.008	Altered doors and windows

Adverse	Repair or renew as necessary existing frames to match original patterns	Not applicable	High

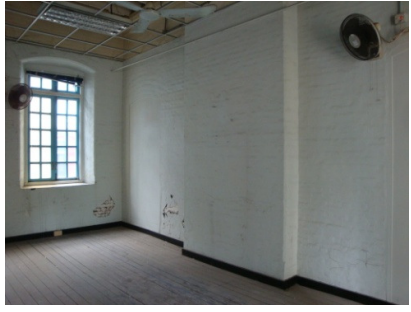
Low	Repair and retain in current location	Not applicable	Neutral
03.026	Window in south wall; original dormitory space

Moderate	Remove window and take down brickwork spandrel; subdivide space to form new fire-protected escape route.	Record existing condition on measured survey drawings. New partition wall to be reversible.	Low

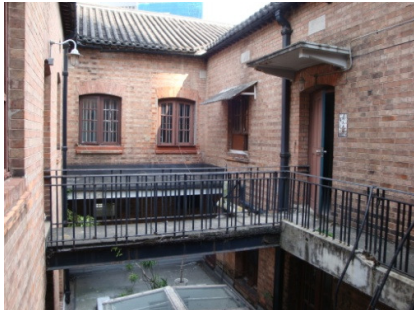
Moderate	Replace with larger sizes/closer spacing to improve performance	Use cast iron to match original pattern Make good all redundant fixing holes	High
09.013	Metal walkways across lightwell

Adverse	Remove walkways and make good brickwork at abutments	Not applicable	High

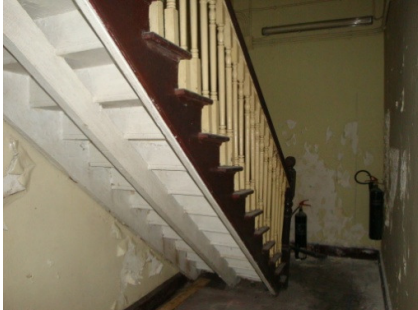
Moderate	Repair as necessary and retain	Avoid intrusive alteration. Retain open appearance/	Low
10.019	Timber stair

Moderate	Underline with fire-resisting lining	Repair as necessary and retain.	Low
