The Jockey Club CPS Limited

Central Police Station Conservation
and Revitalisation Project:
Second Annual EM&A Review Report
(1 November 2012 to 31 October
2013)

Issue Date: February 2014

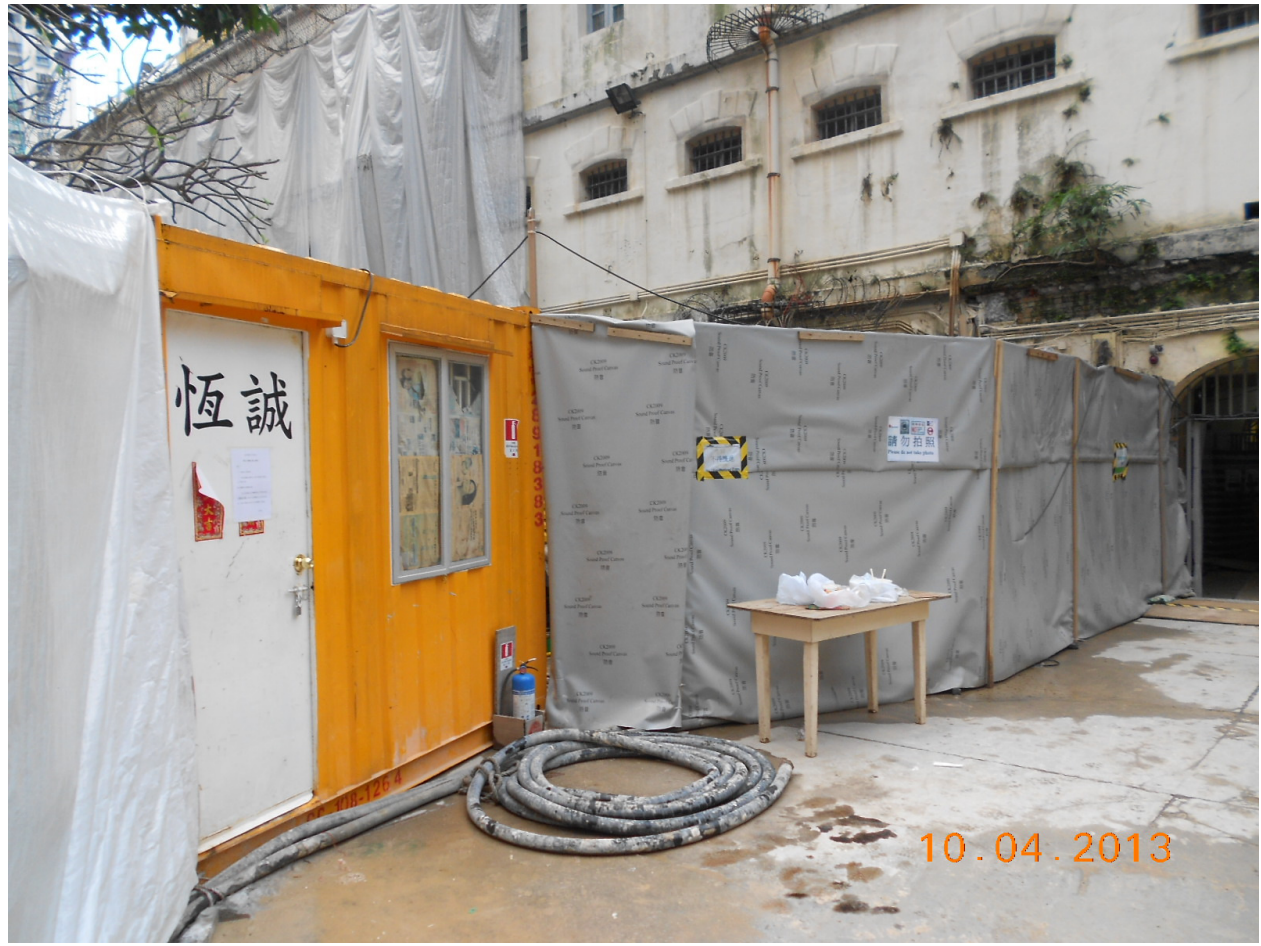
Figure 2 – Noise barrier for air compressors near Block 14

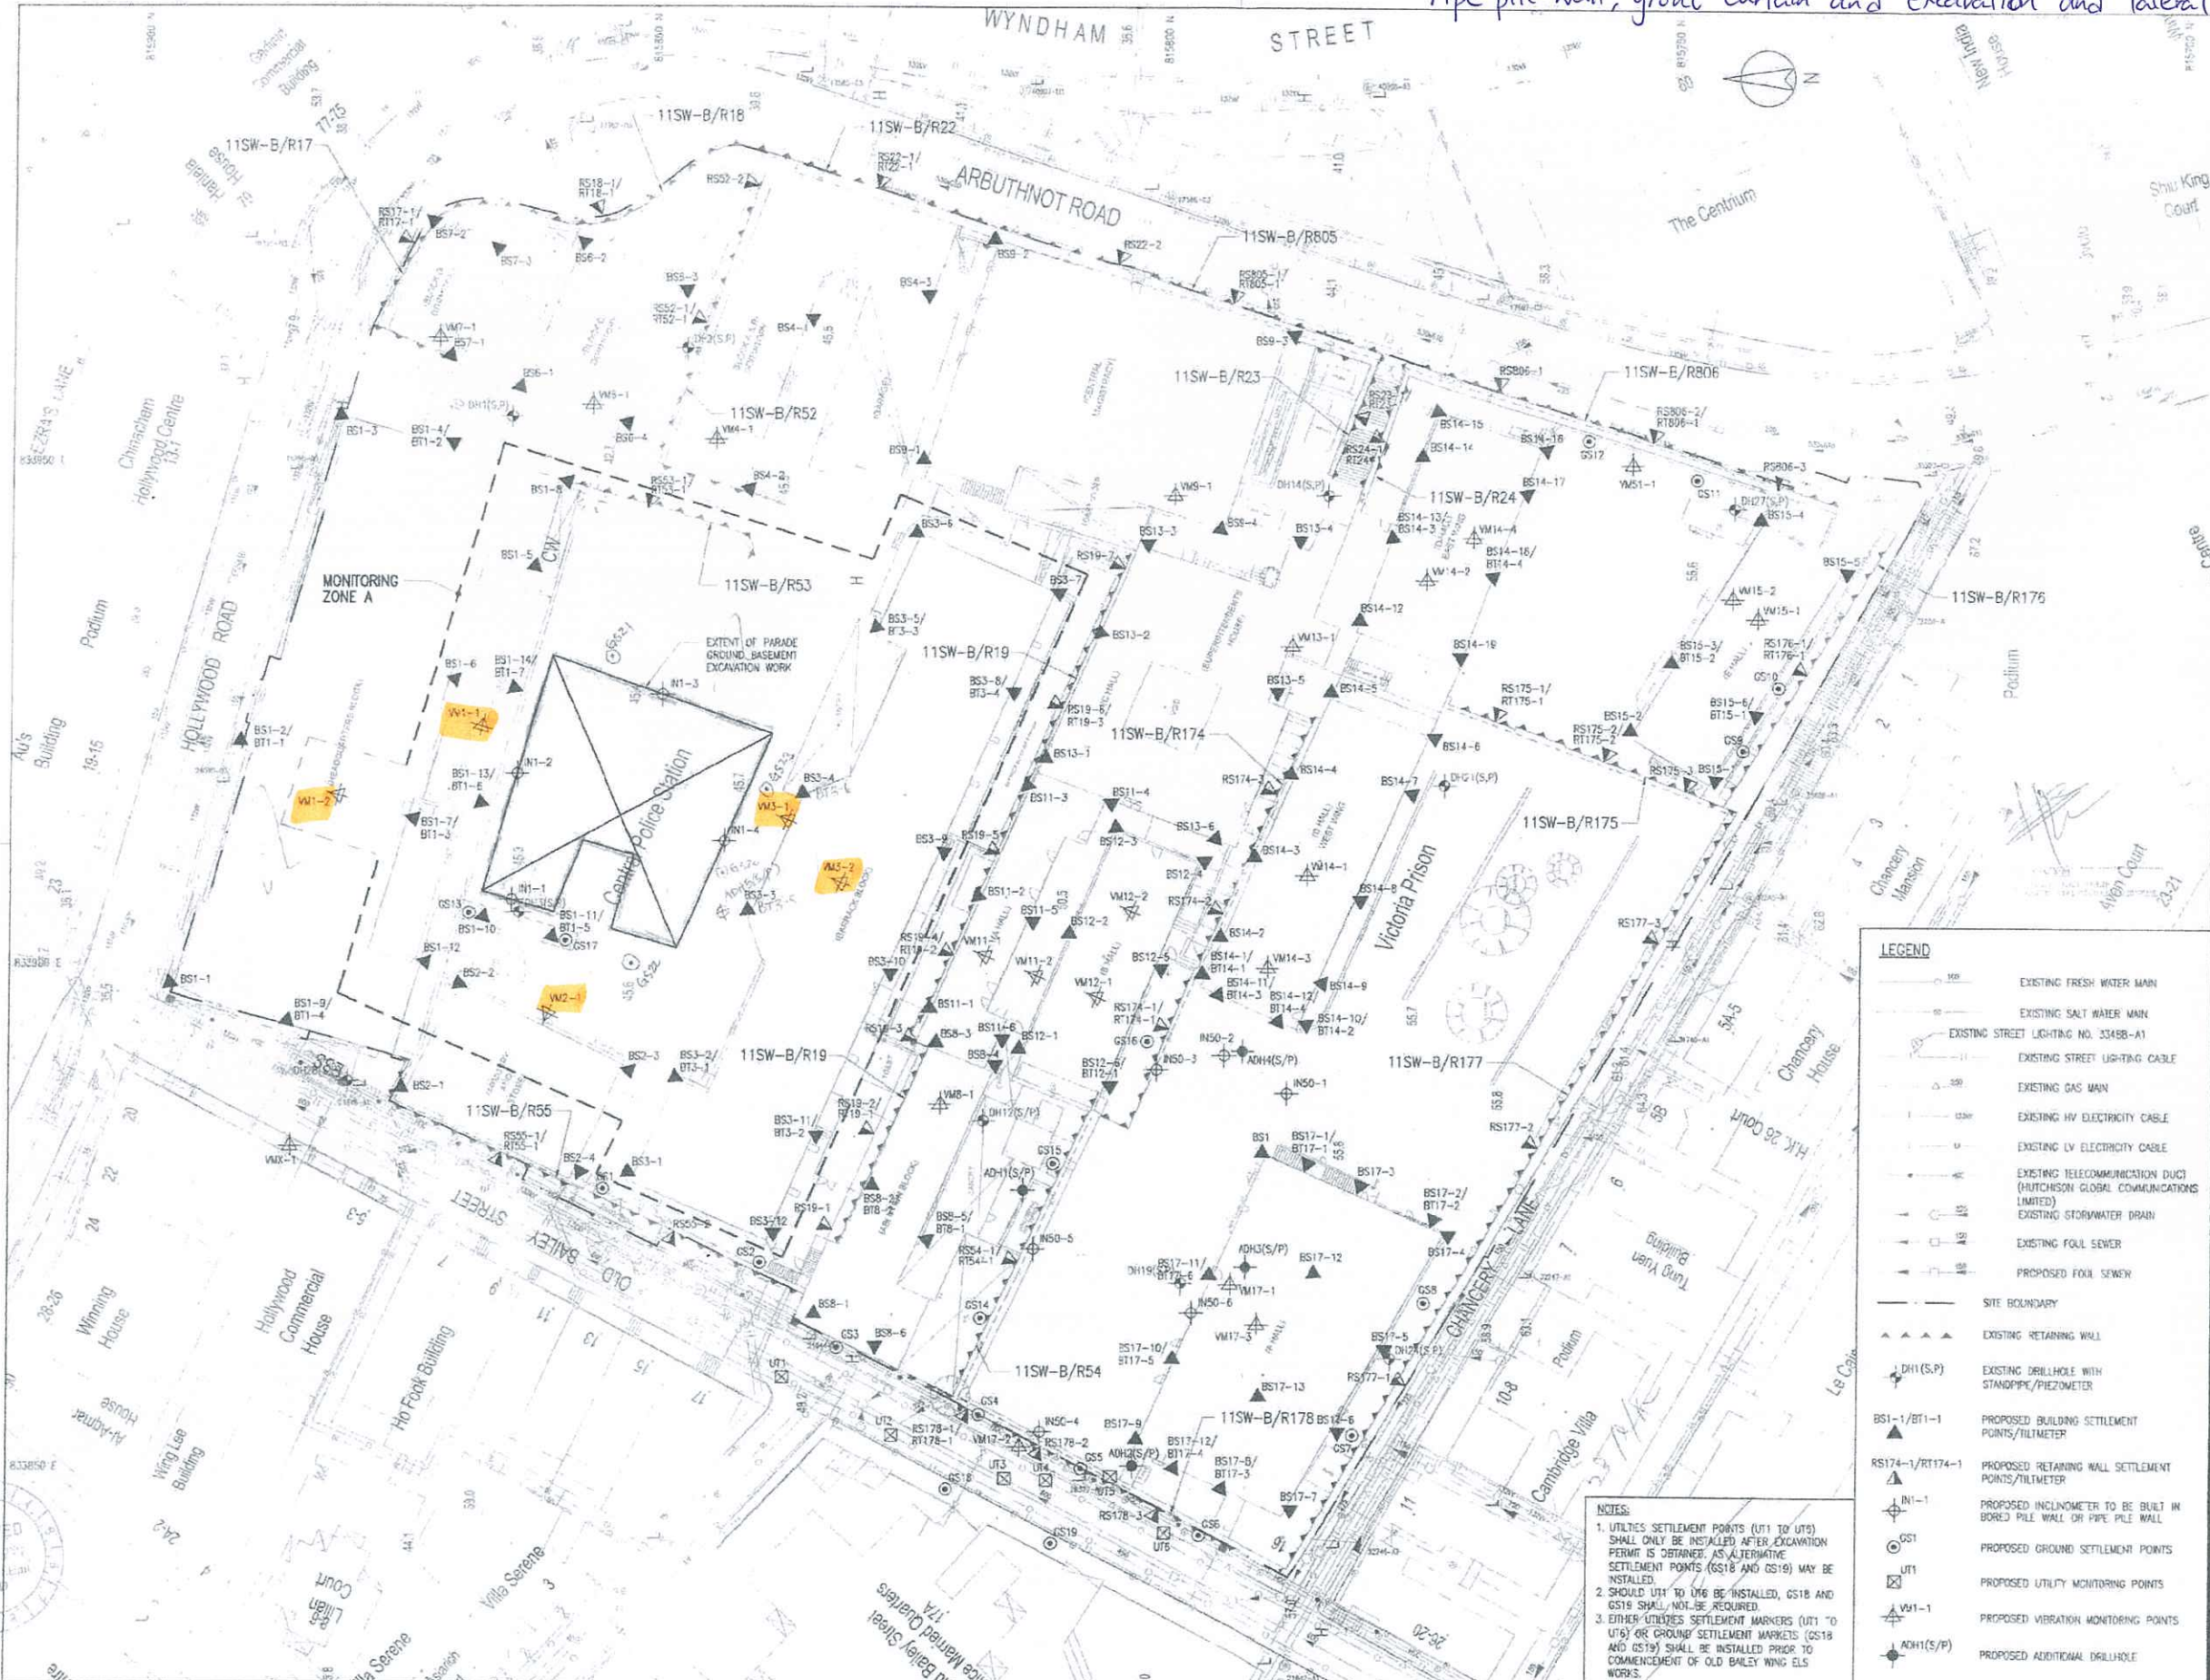
Pipe pile wall, grout curtain and excavation and lateral support at Parade Ground

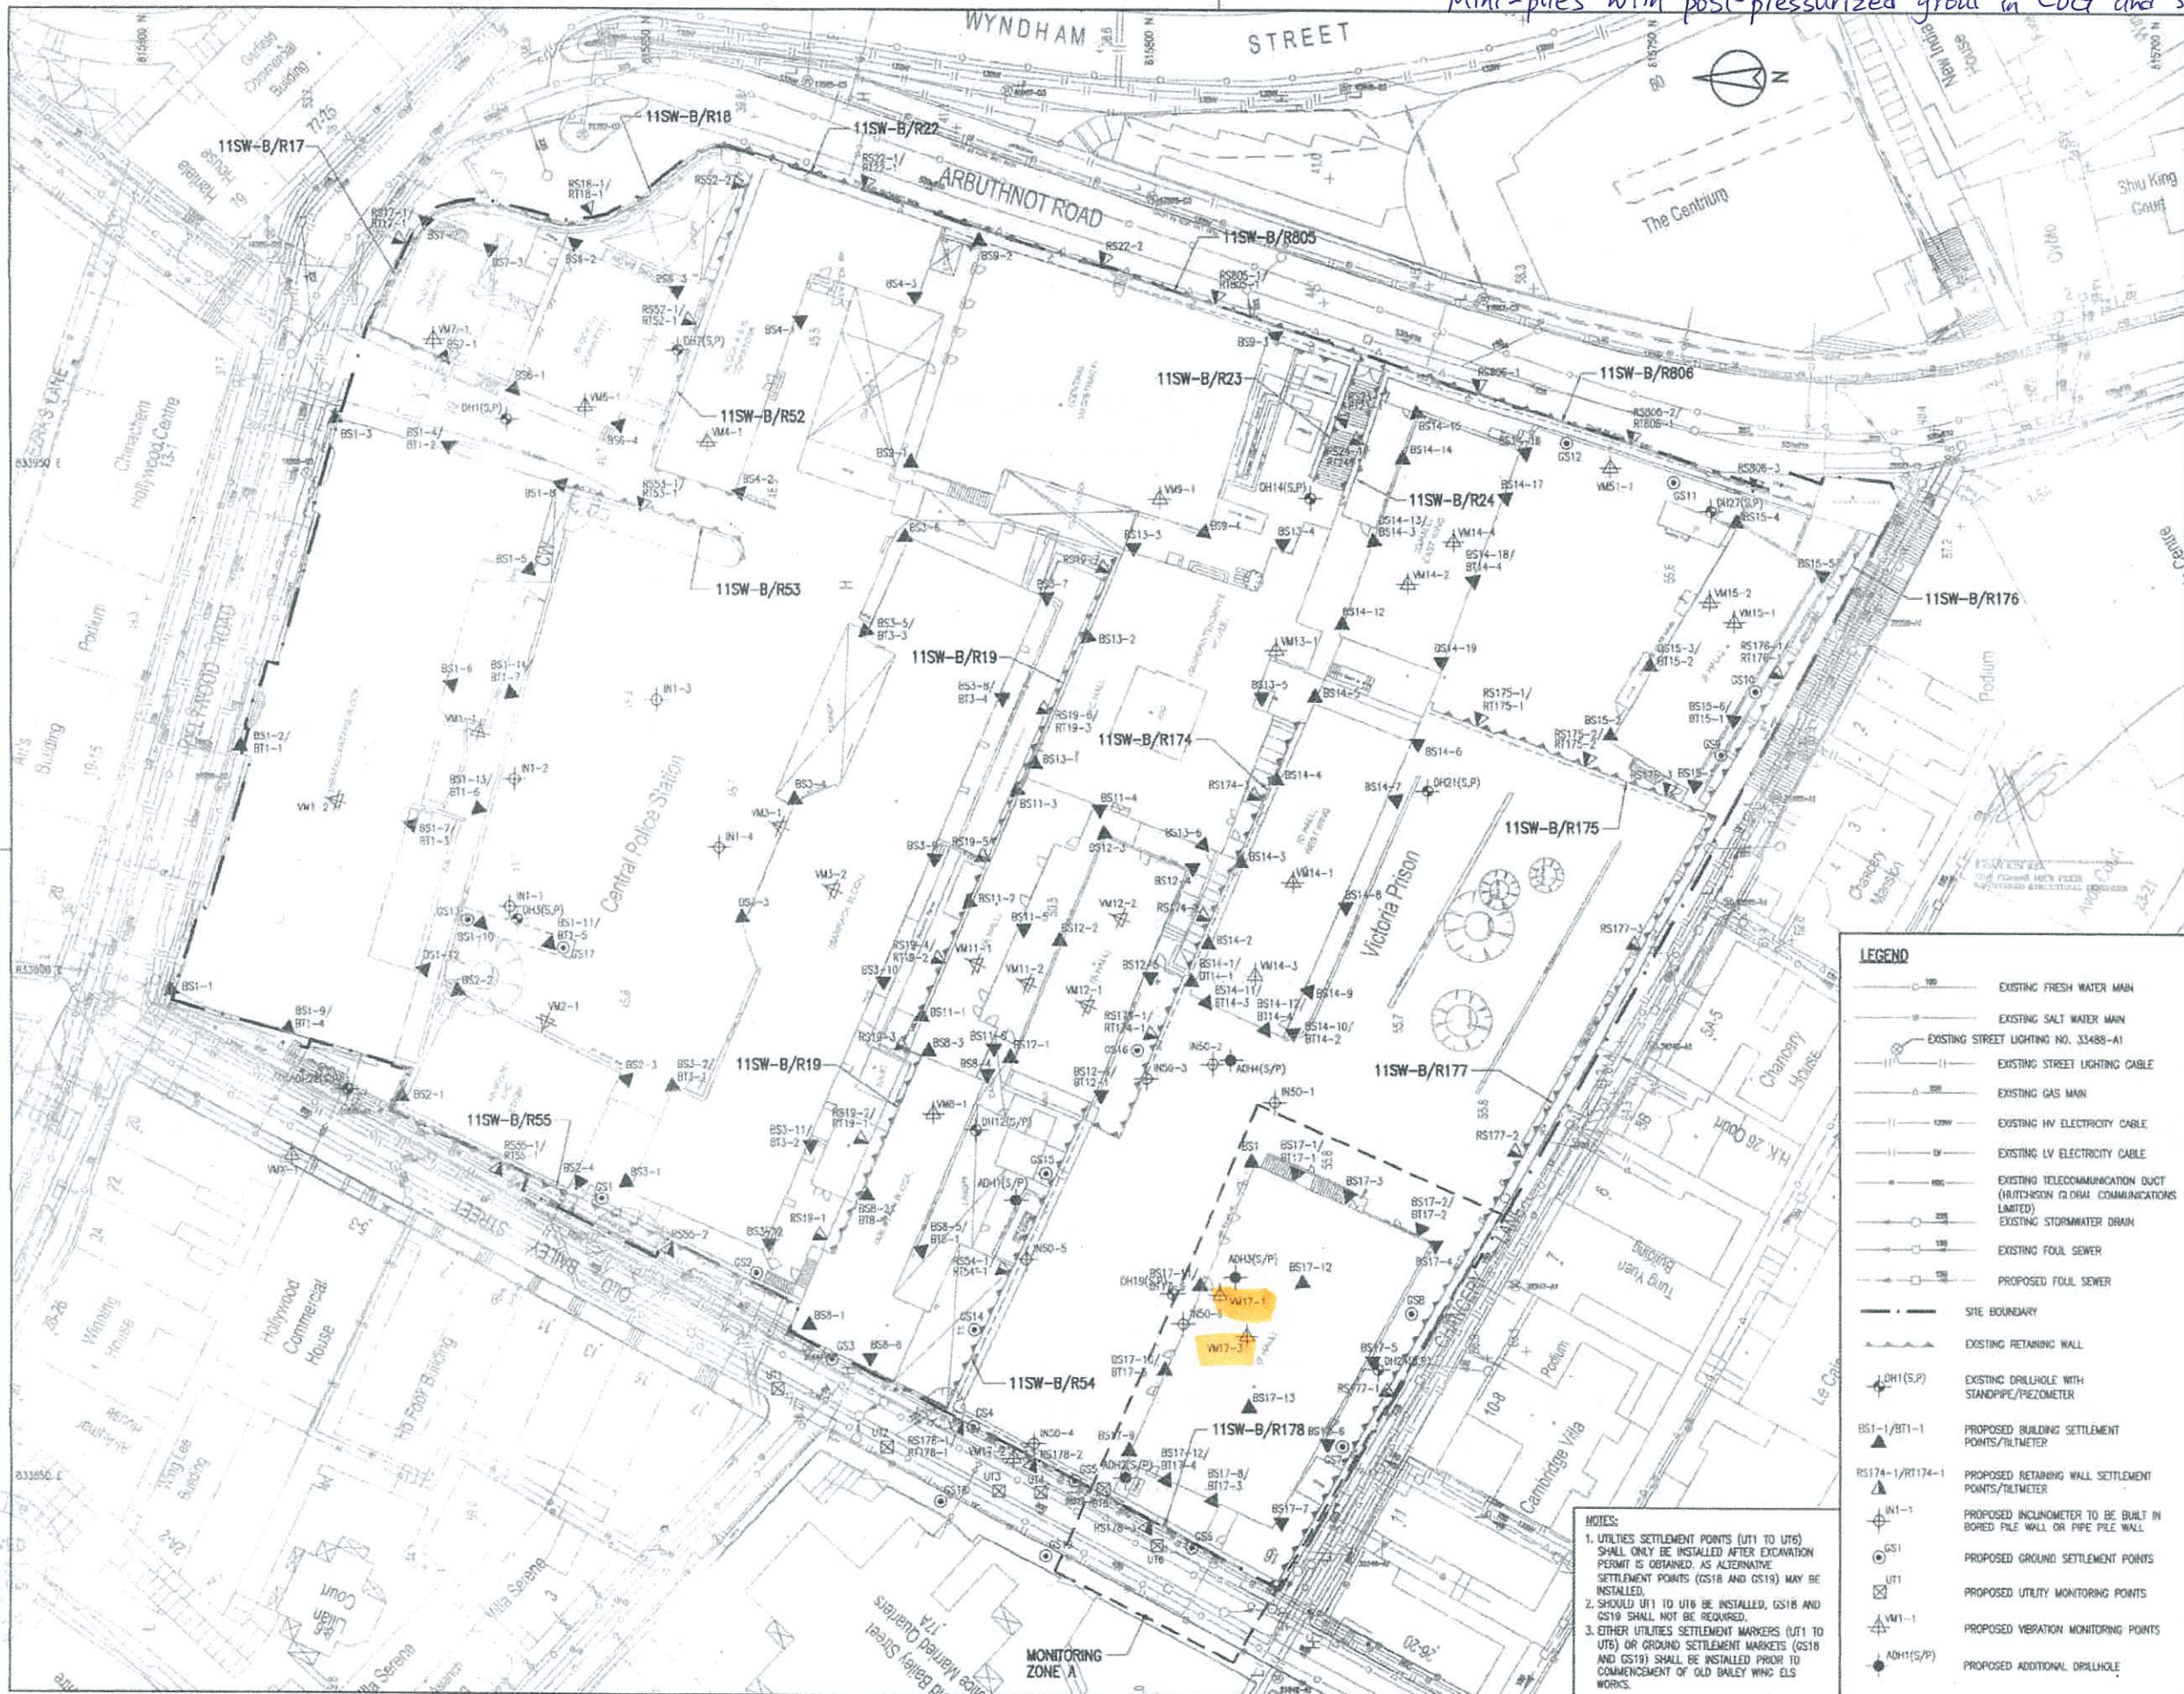
Mini-piles with post-pressurized grout in CDG and steel shear H-piles at Block 1

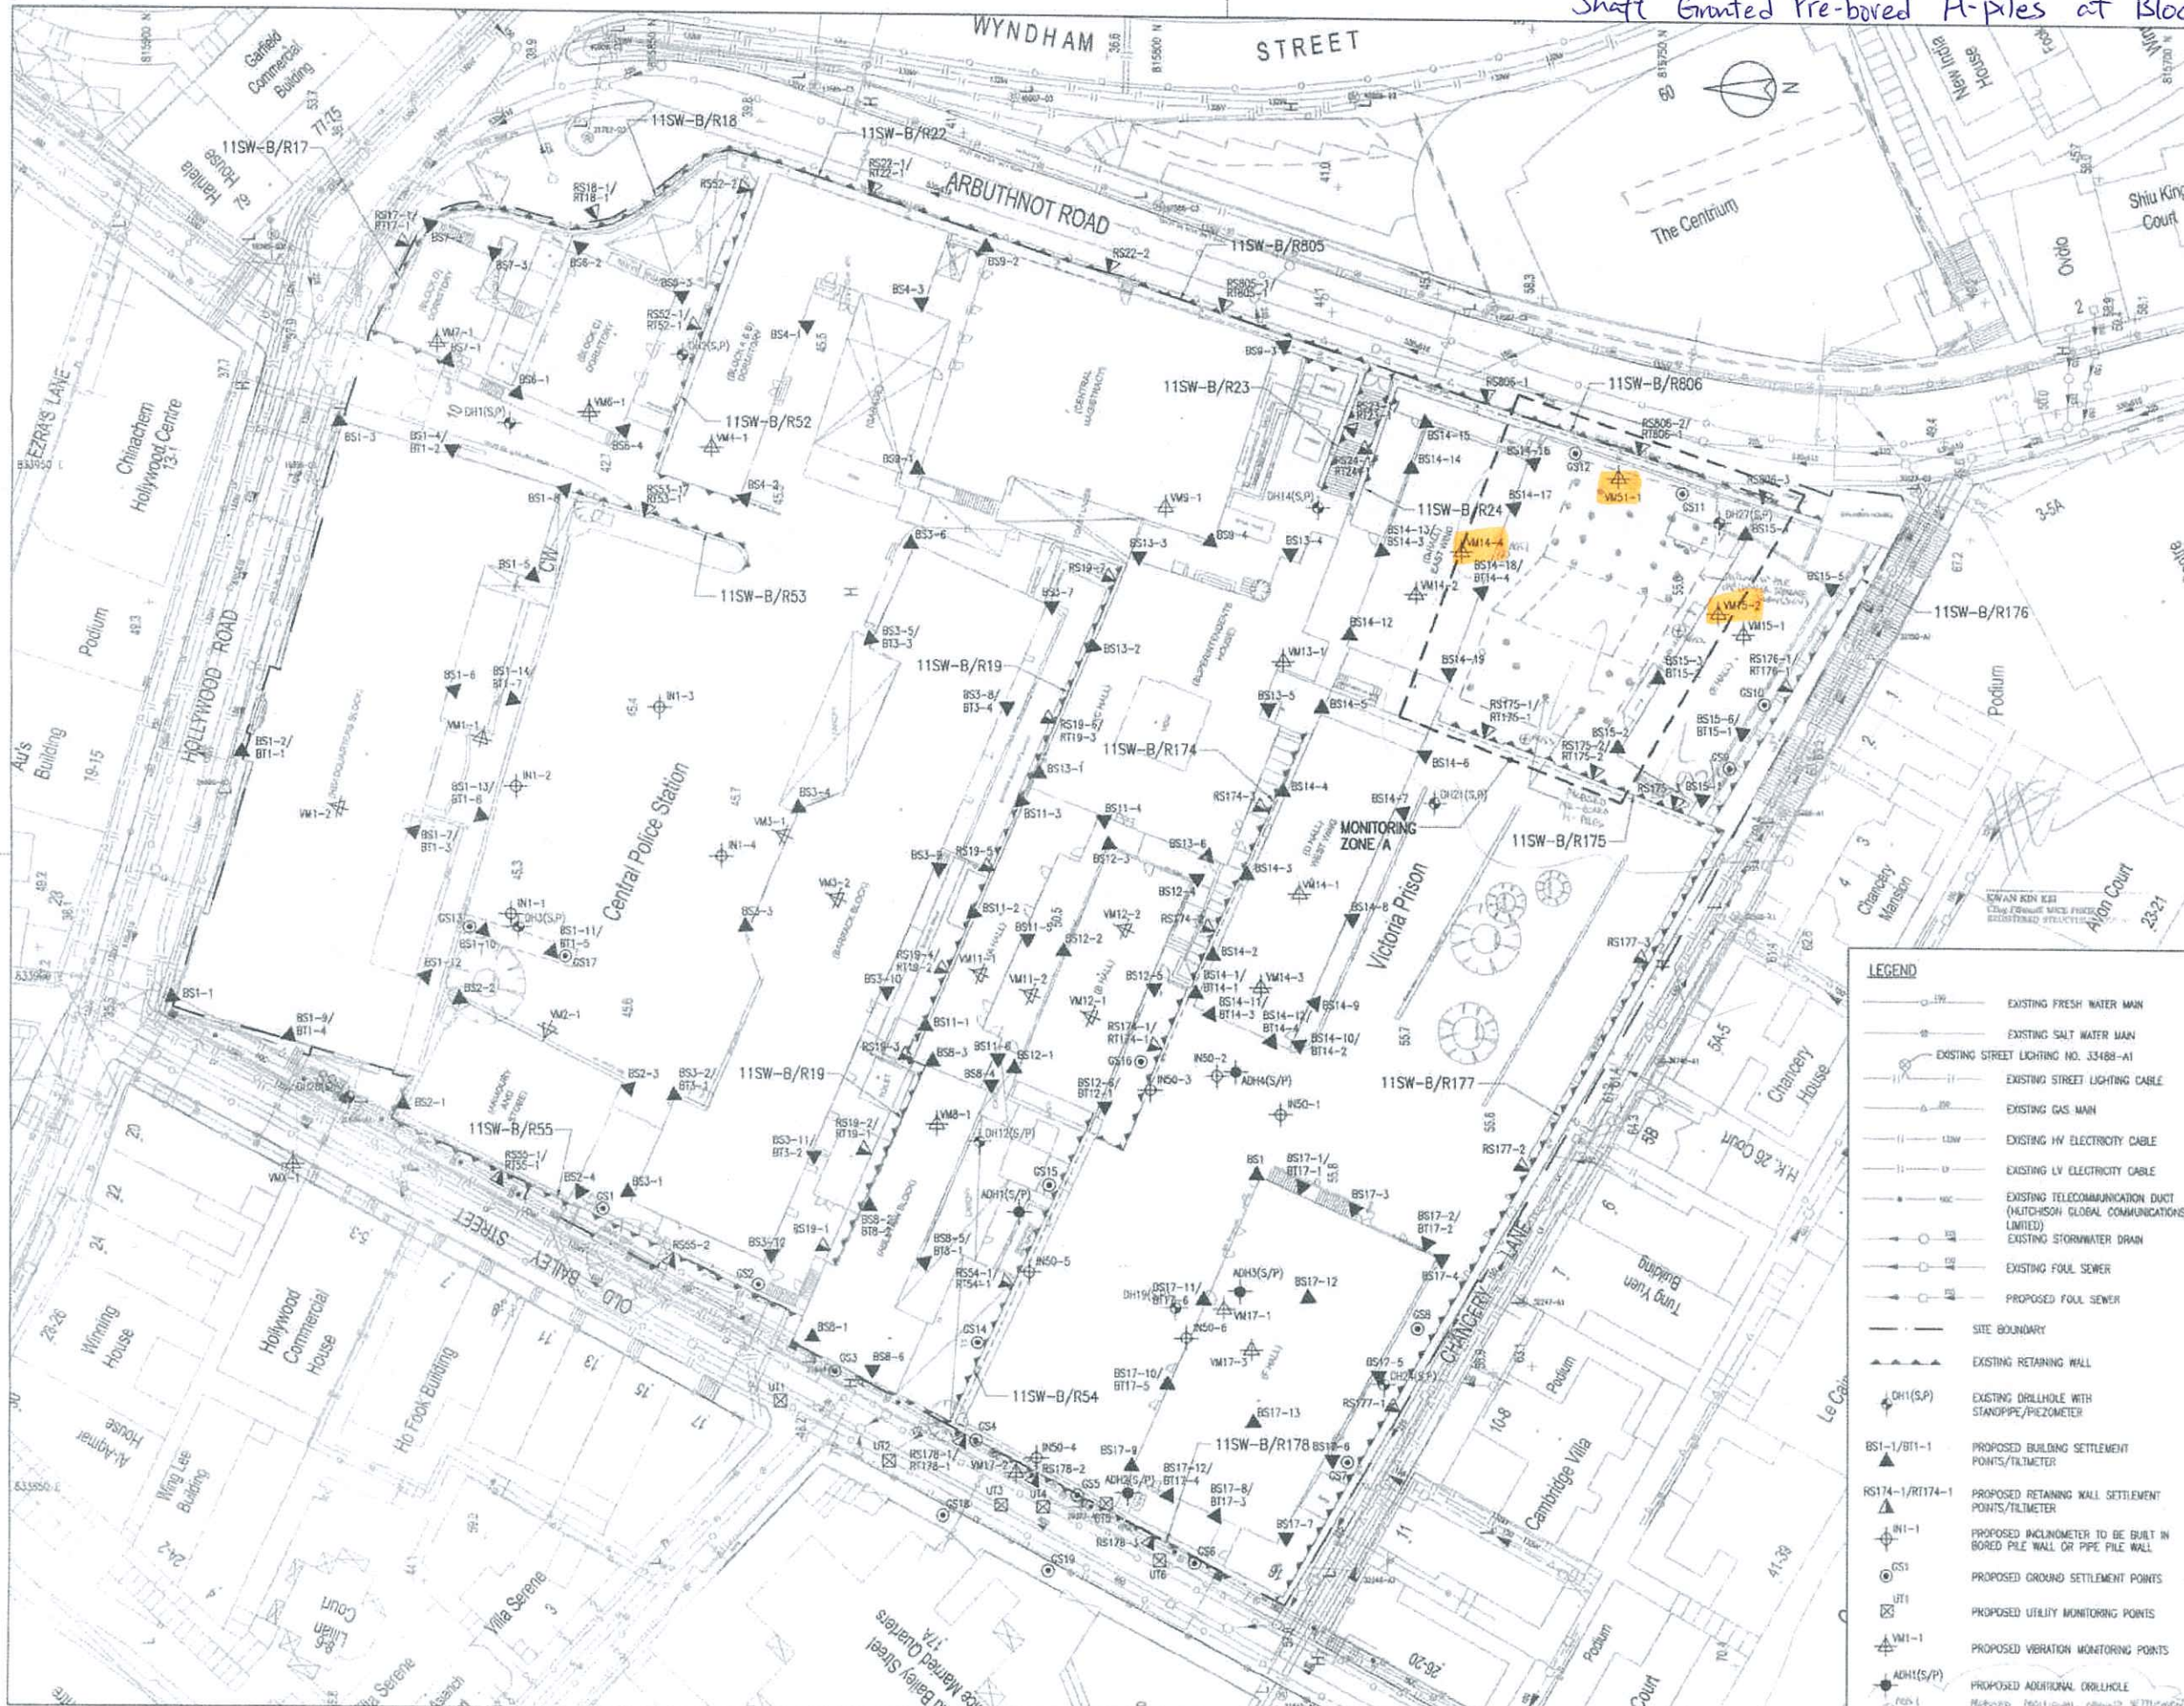
Shaft Grouted Pre-bored H-piles at Block 51 (Arbutnot Wing)

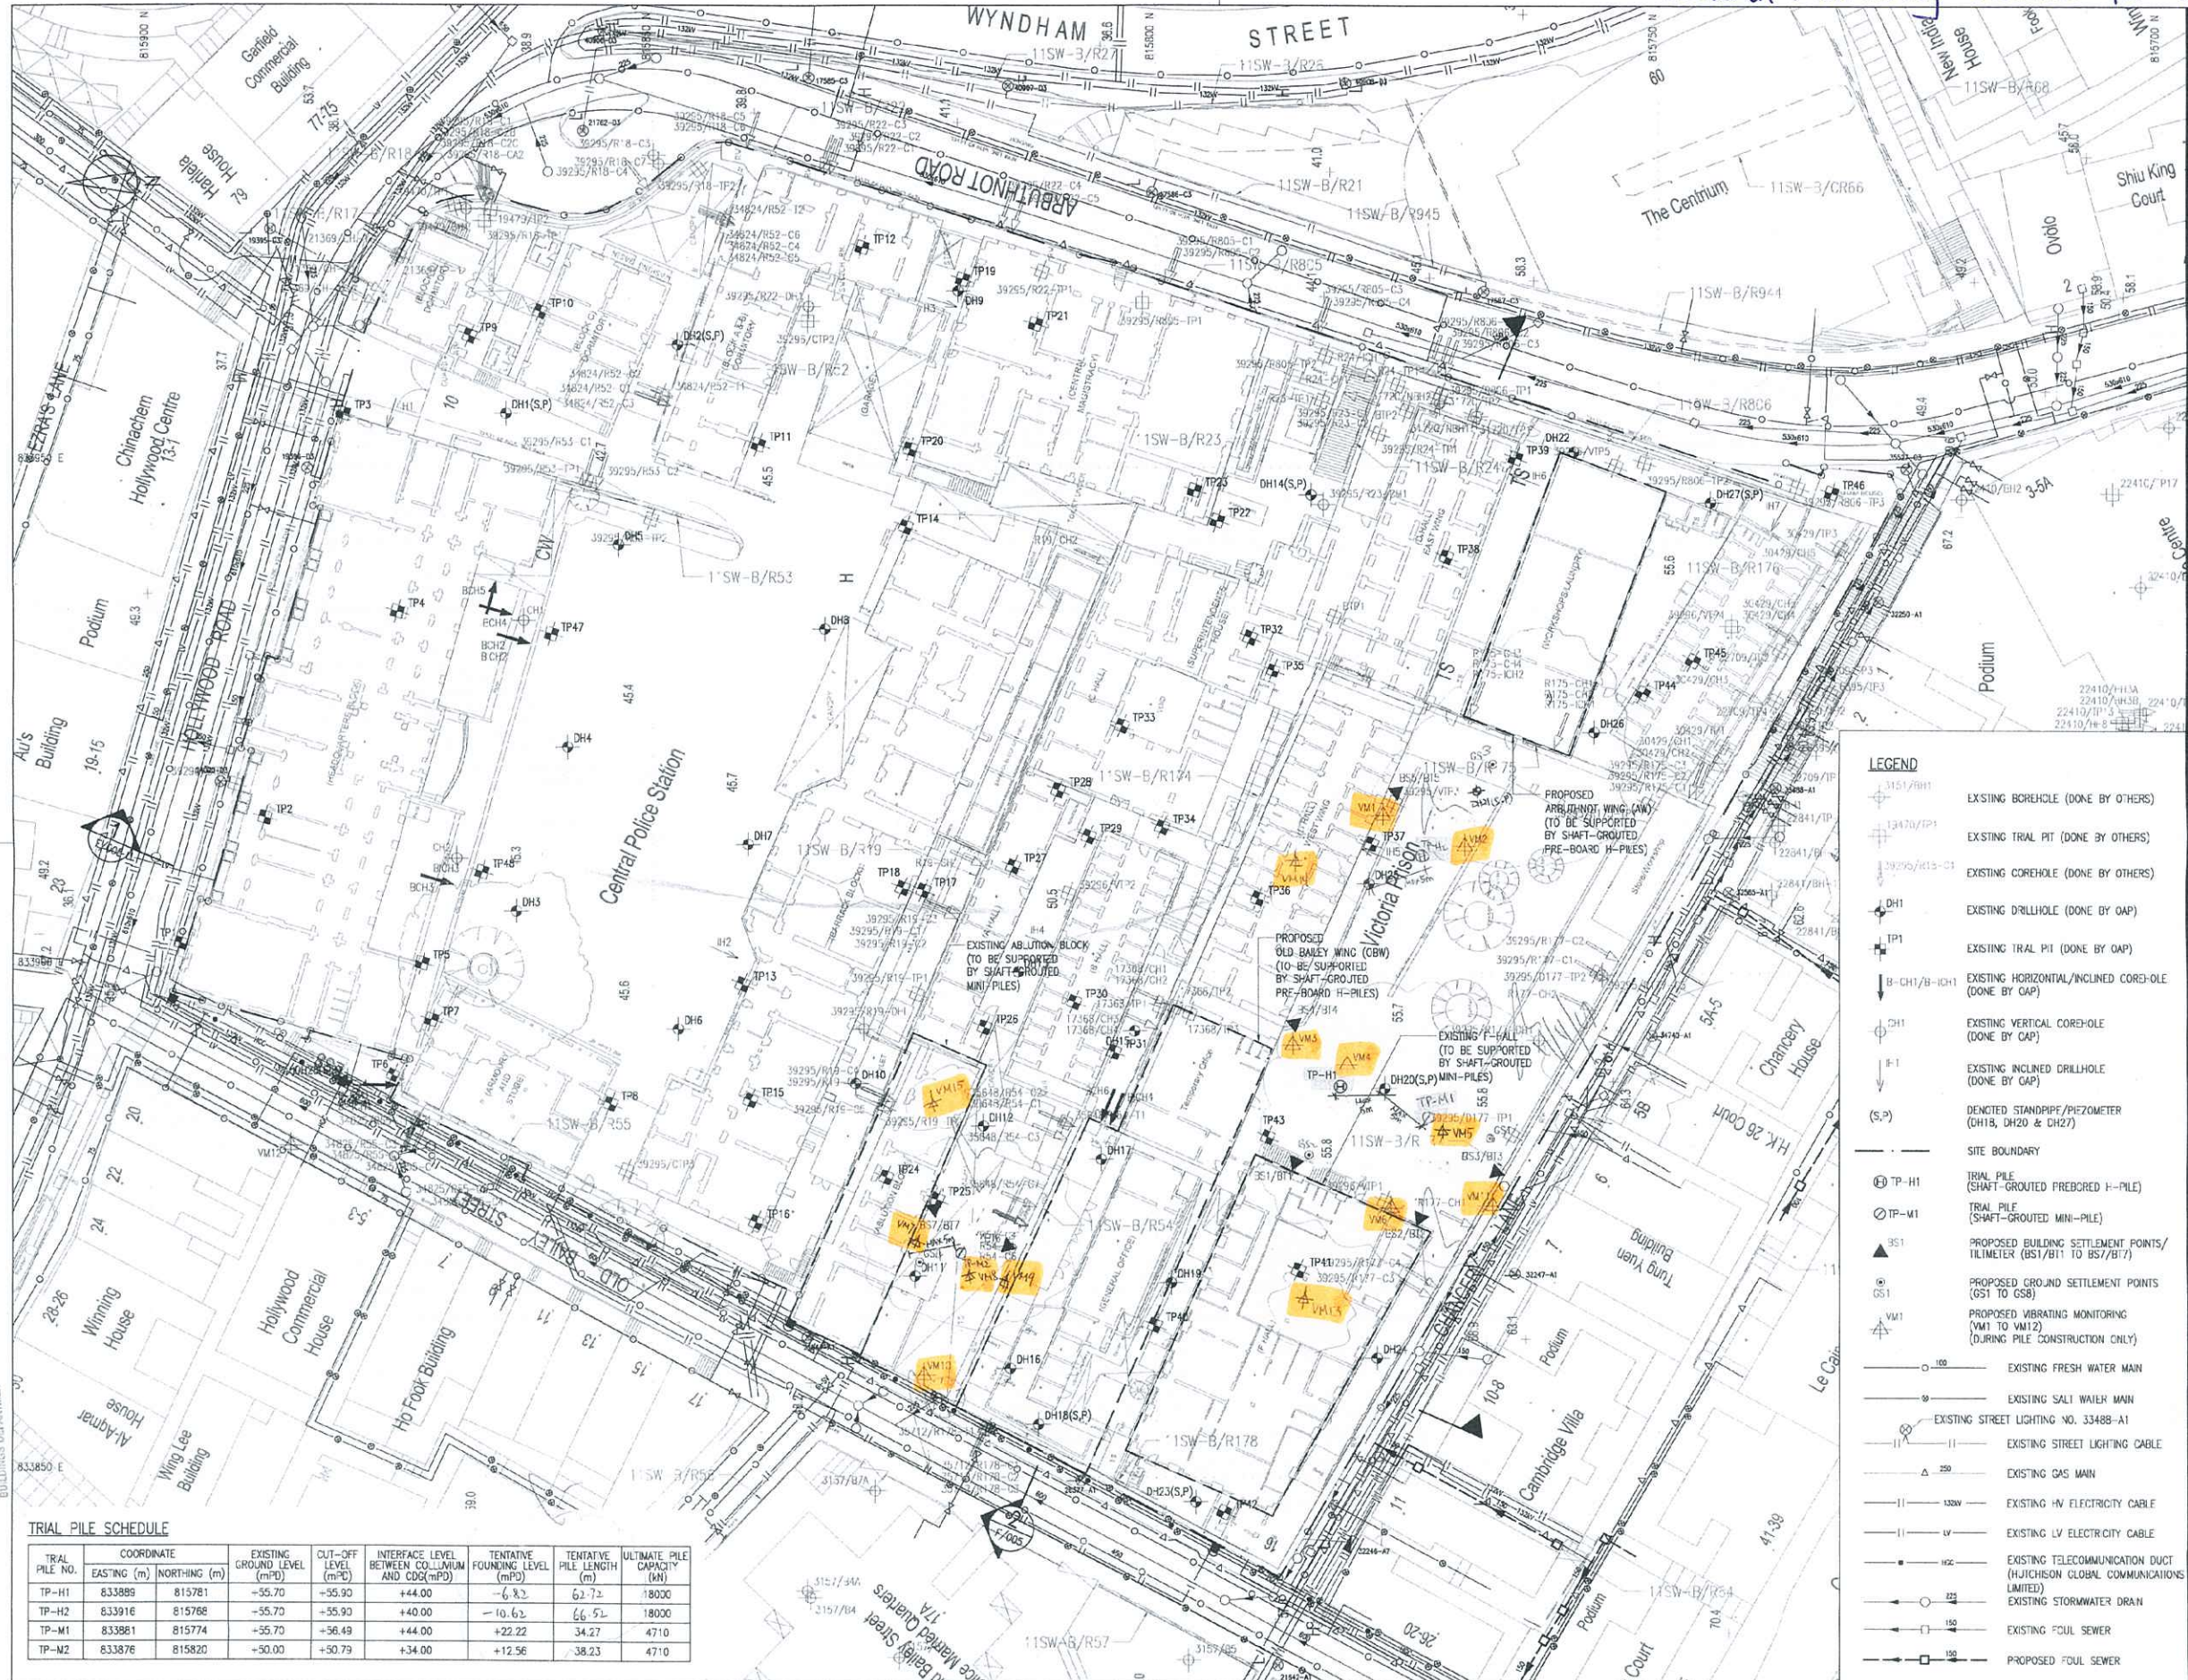
Vibration Monitoring Locations for Trial Pile near Block 17

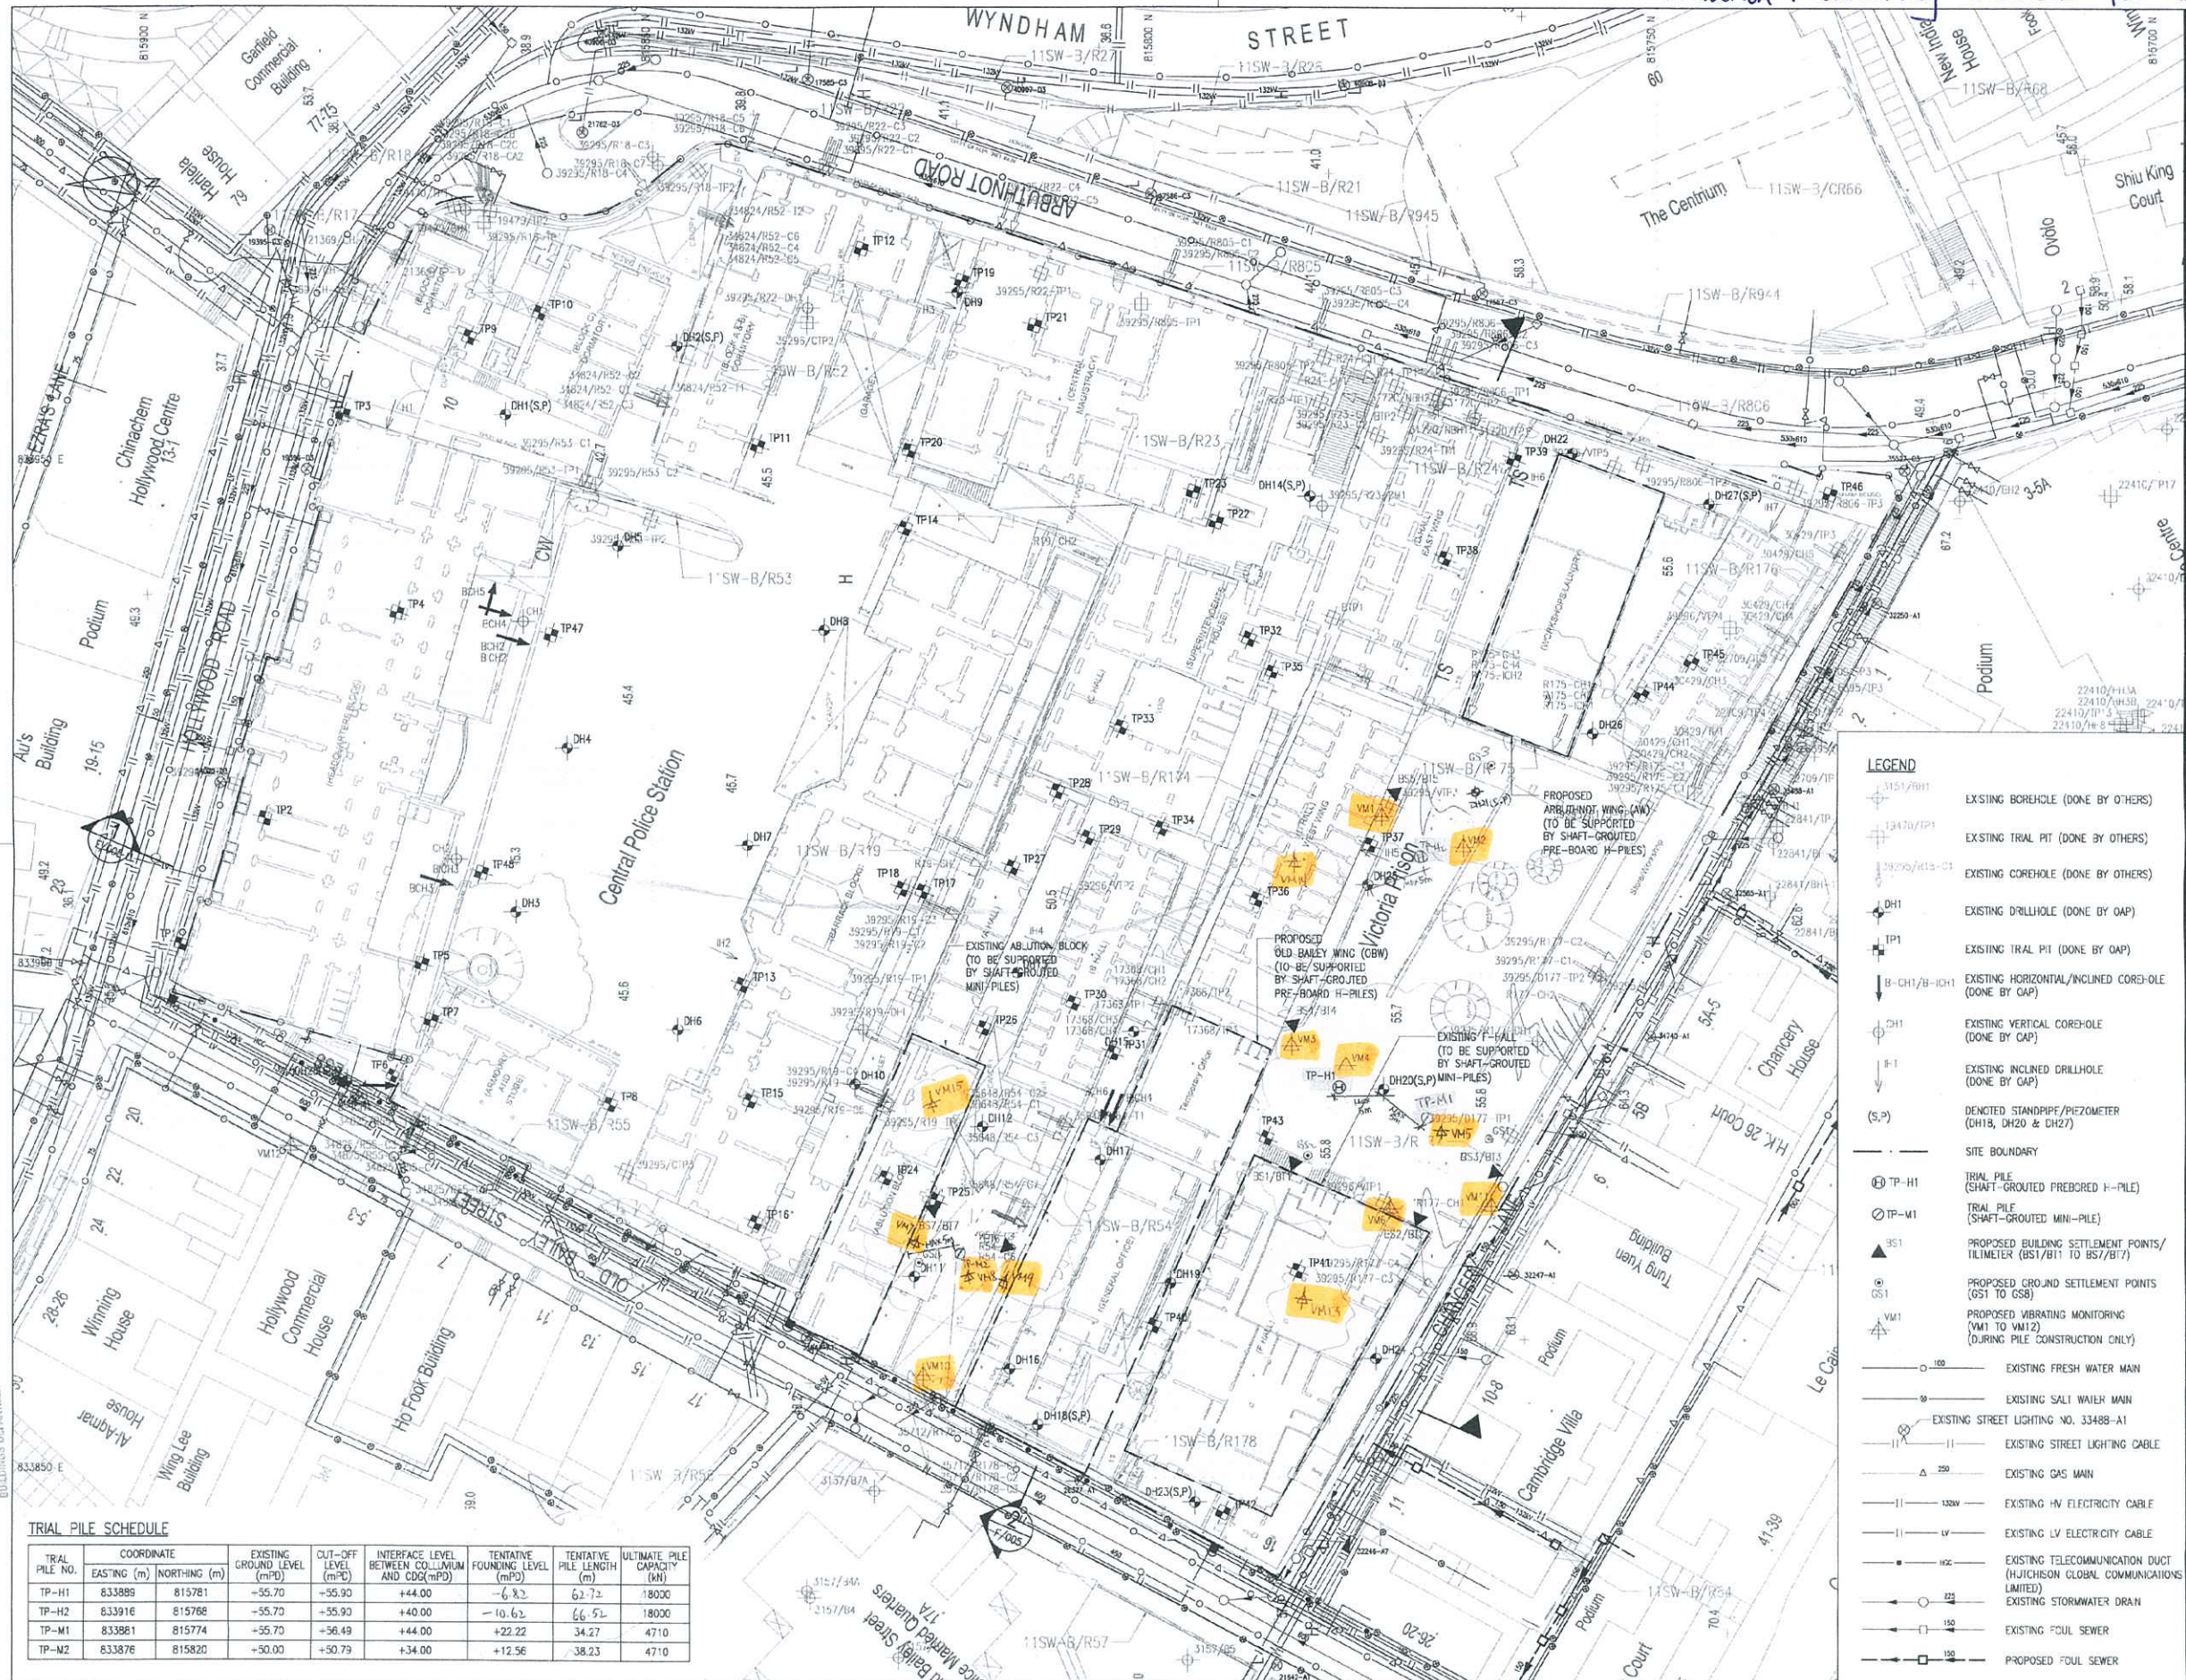
Vibration Monitoring Locations for Trial Pile near Block 17
