The Jockey Club CPS Limited

Central Police Station Conservation
and Revitalisation Project:
Second Annual EM&A Review Report
(1 November 2012 to 31 October
2013)

Issue Date: February 2014

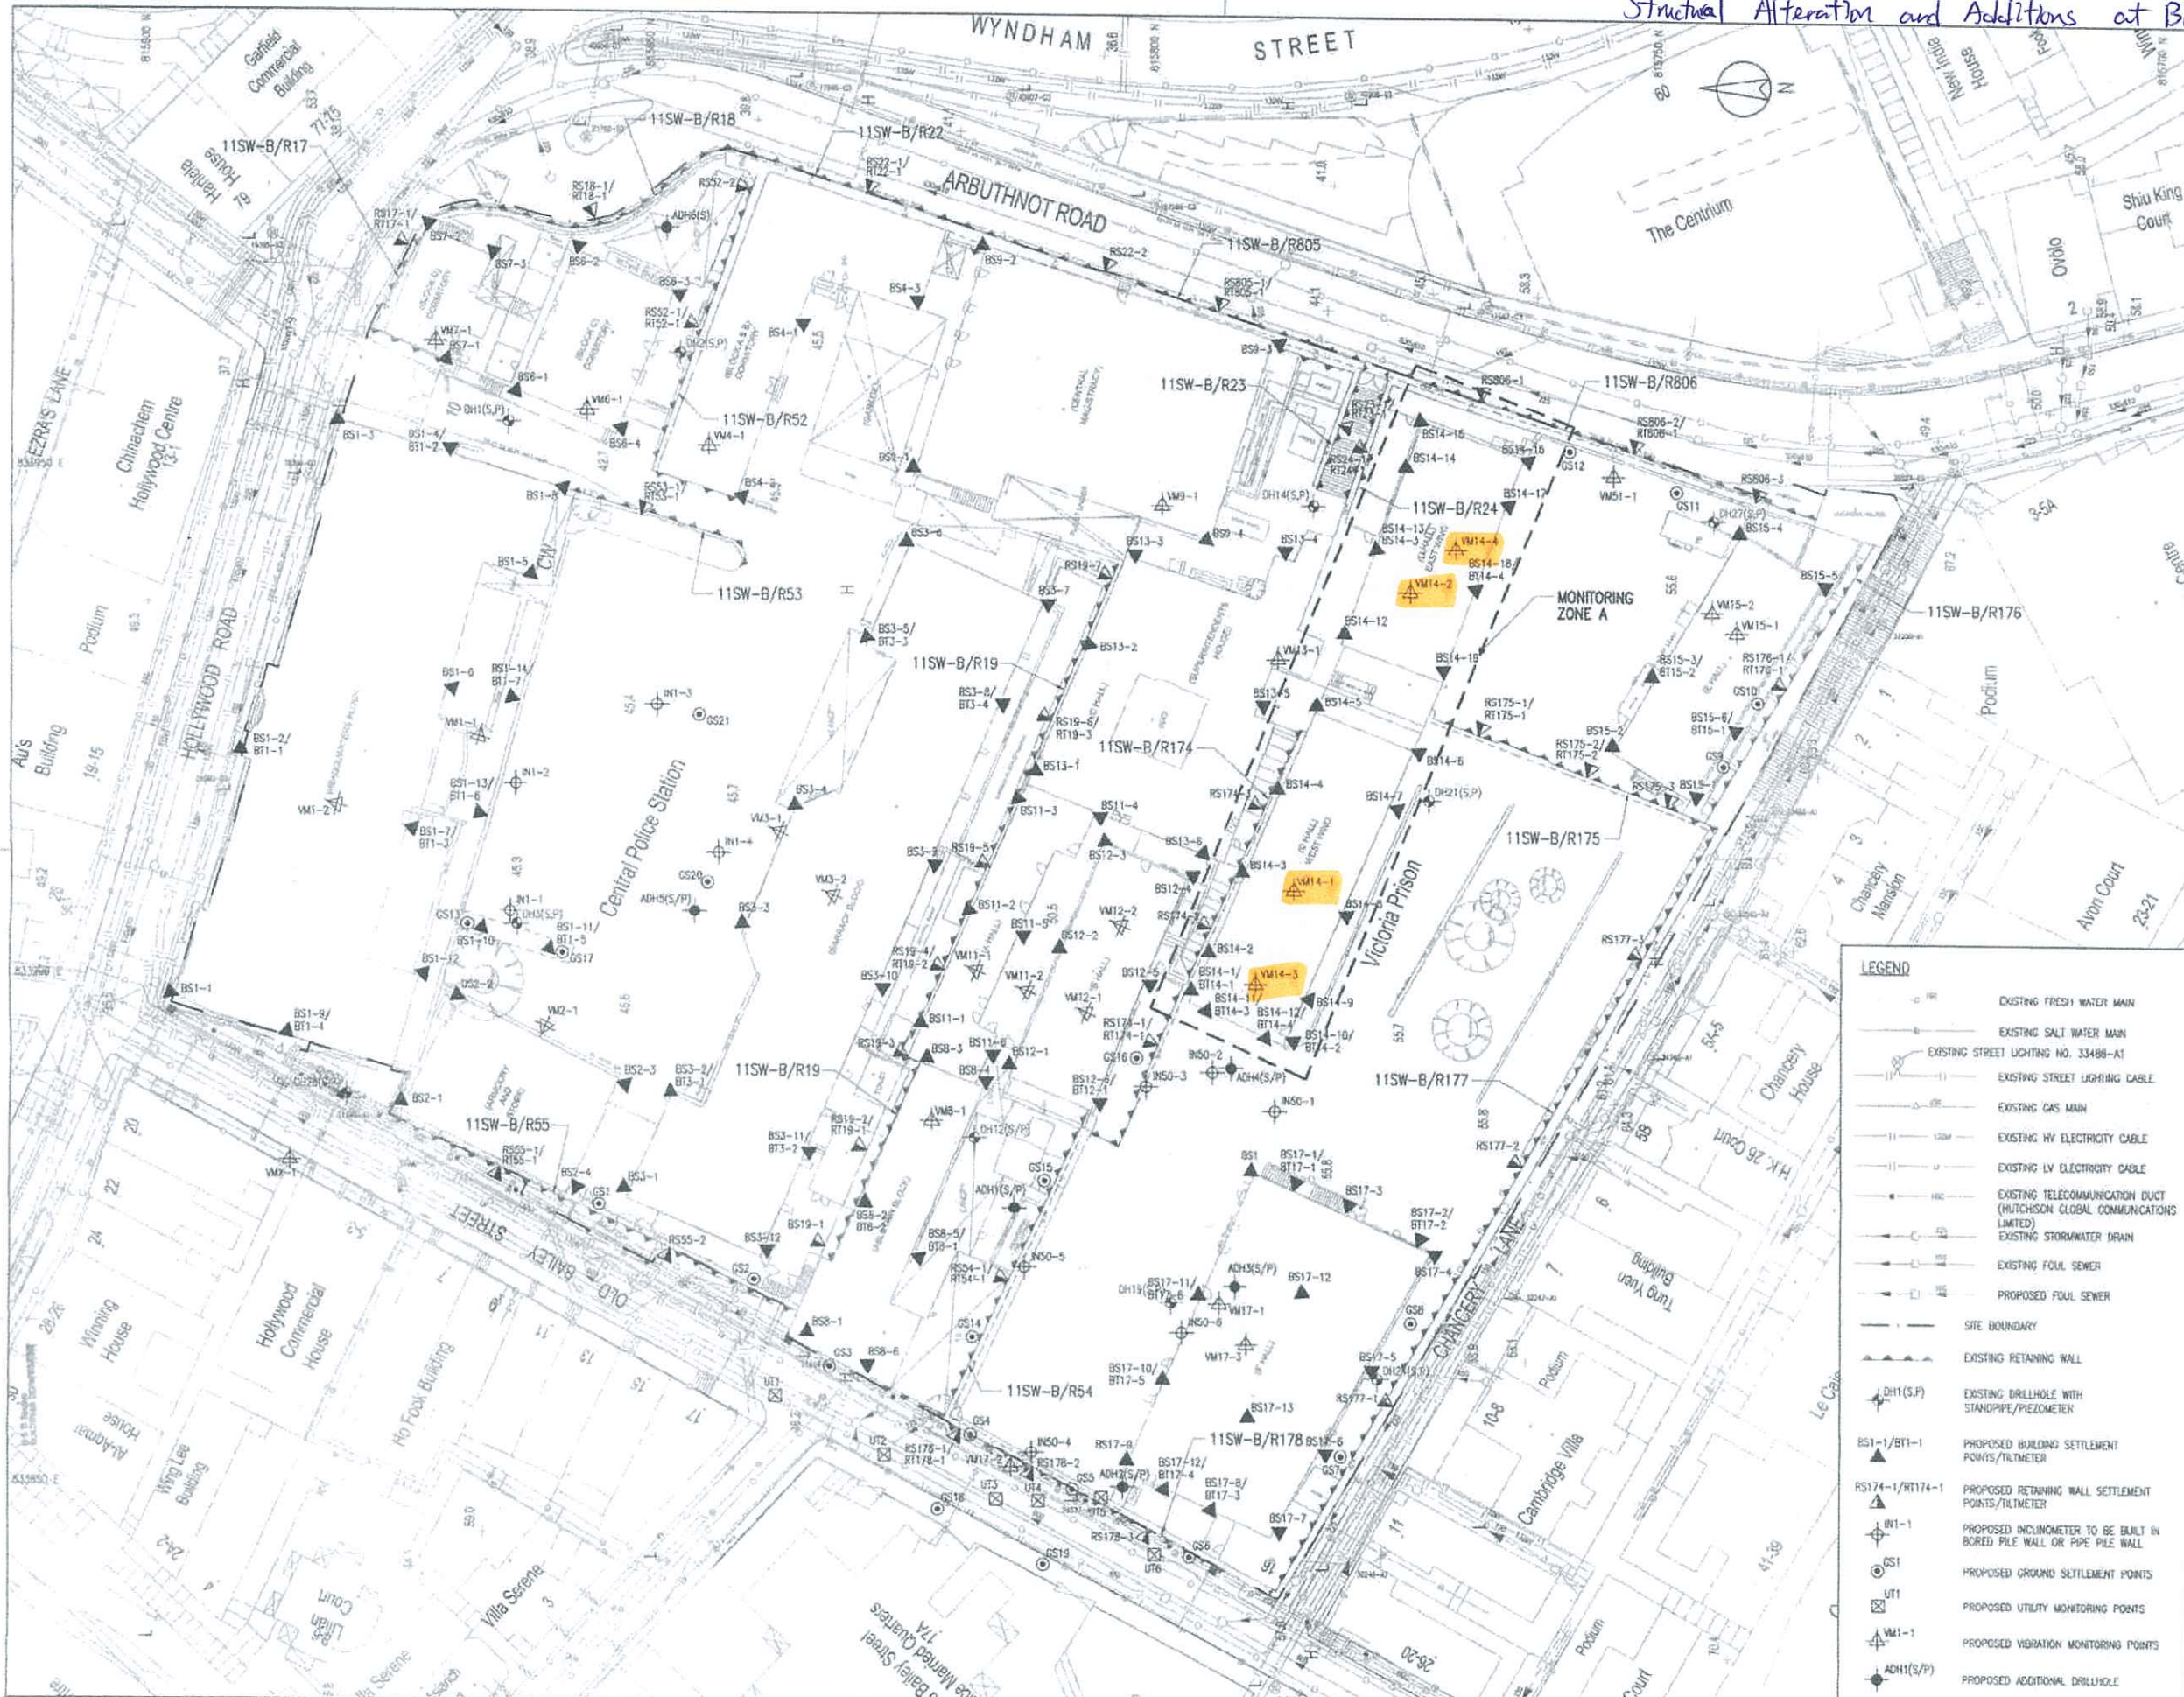
Structural Alteration and Additions at Block 14

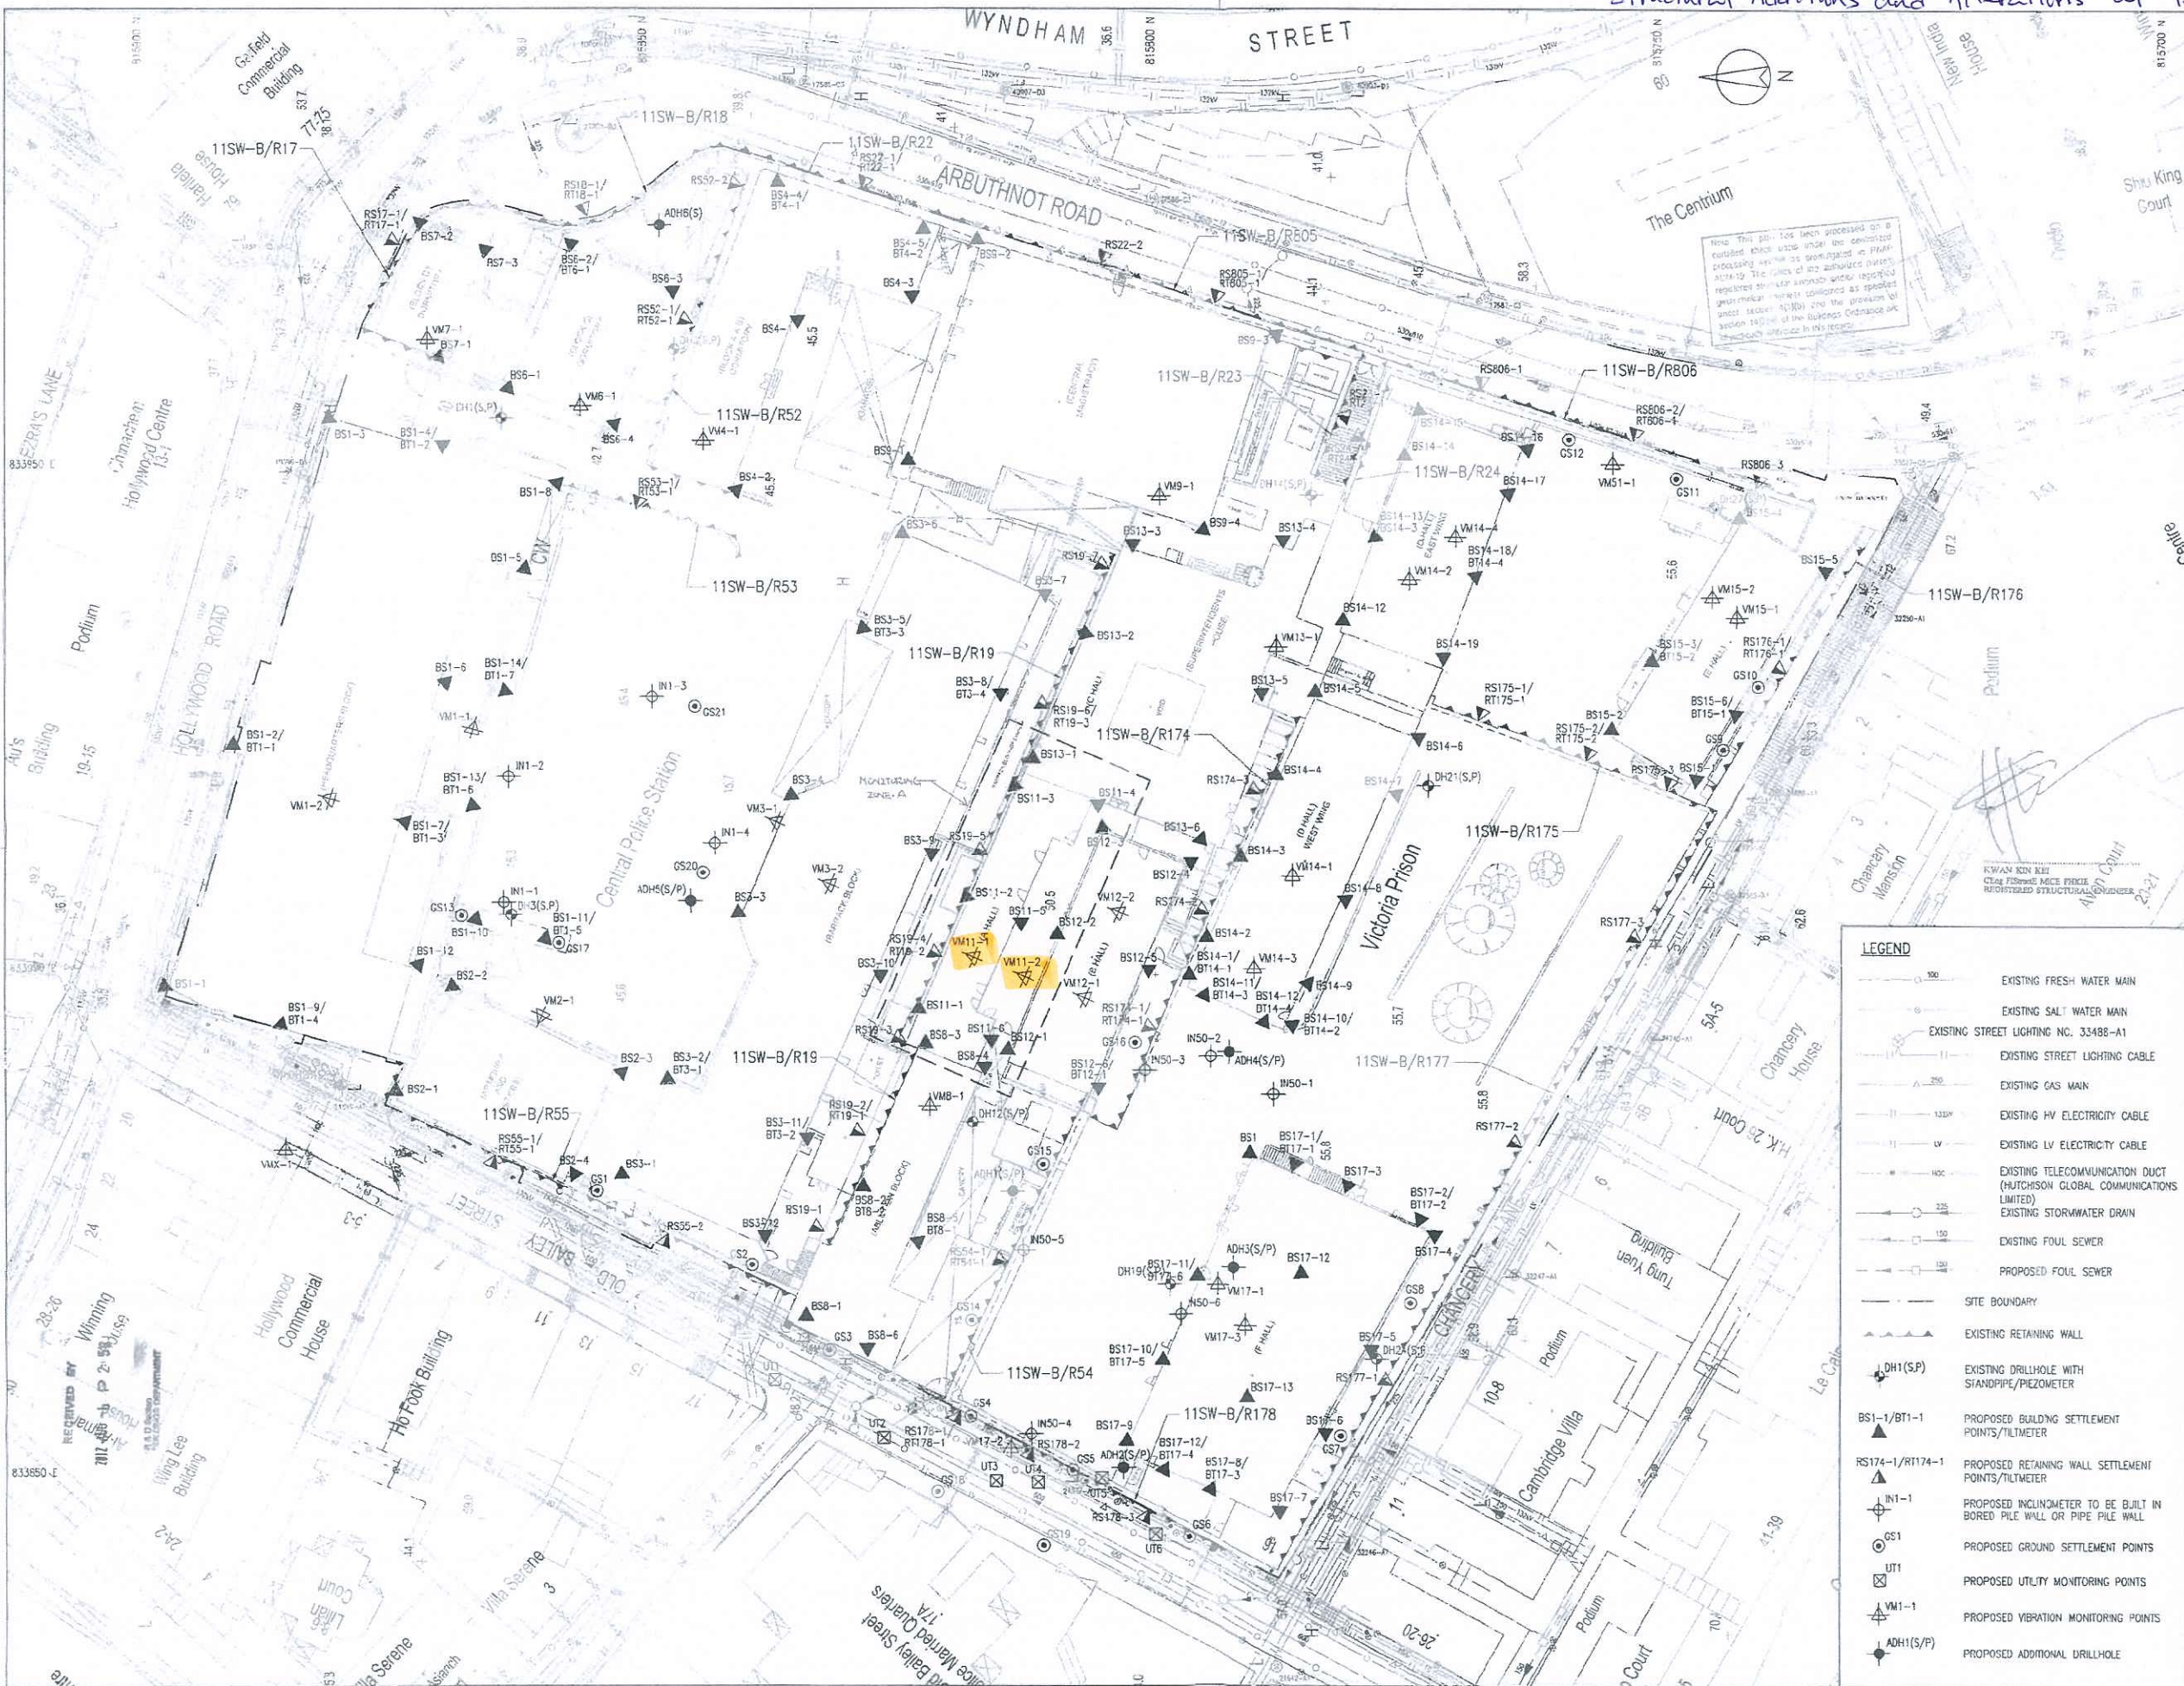
Structural Additions and Alterations at Block 11

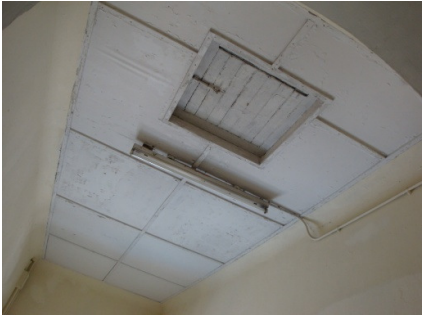
Element no.	Description	Photo ref	Significance	Proposal	Mitigation	Impact
01.001	Flat plywood ceiling lining with plain rectangular cover battens

Adverse	Replace with T&G boarding to match existing	Not applicable	High
01.002	Plaster coving at abutments of walls and ceilings

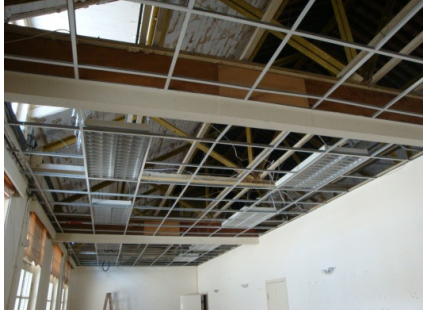
Element no.	Description	Photo ref	Significance	Proposal	Mitigation	Impact
01.003	Lay-in grid suspended ceiling

Adverse	Remove	Not applicable	High
01.004	Timber thresholds at external doors and internal doors between main corridor and individual rooms

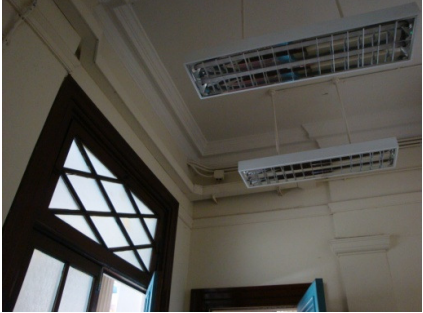
Element no.	Description	Photo ref	Significance	Proposal	Mitigation	Impact
01.005	Plaster box cornice

Moderate	Remove in exceptional cases eg. where adjacent new lift shafts	Cut back neatly to a square edge and ensure remaining section is secure.	Moderate
01.006	Panelled doors

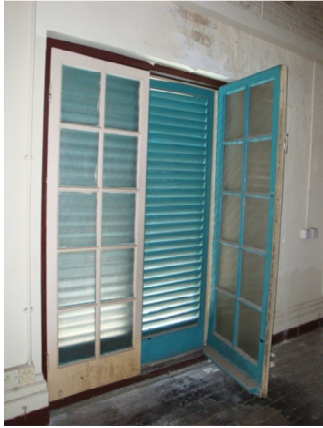
Element no.	Description	Photo ref	Significance	Proposal	Mitigation	Impact
01.007	External shutters

High	Reinstate to match existing pattern	Not applicable	High
01.008	External terraces at 1/F

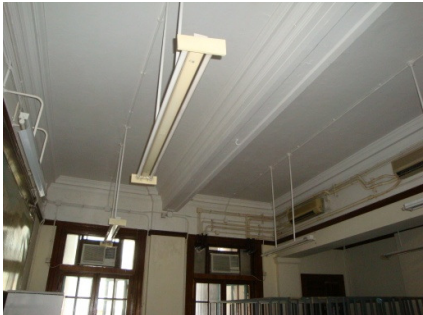
Element no.	Description	Photo ref	Significance	Proposal	Mitigation	Impact
01.009	Plaster ceilings on GF and LG1

Moderate	Install cloud ceilings to accommodate new services	Install fixed grid to minimise damage to ceiling	High
01.010	Timber door frames and architraves

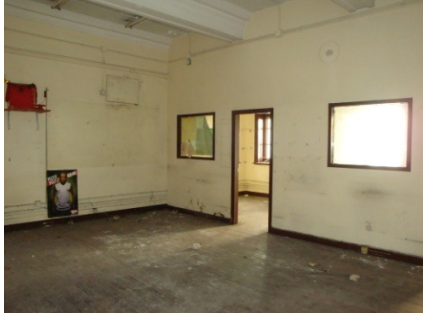
Element no.	Description	Photo ref	Significance	Proposal	Mitigation	Impact
01.011	Concrete floor

Low	Replace where new kitchens and plant rooms to be installed	Carefully remove and retain existing floorboards for re-use. Ensure controlled demolition of concrete structure and removal of debris from building to avoid damage to adjacent surfaces. Protect or carefully remove and set aside adjacent elements such as skirting boards	Low

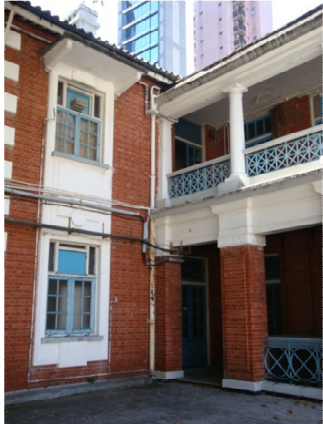
Element no.	Description	Photo ref	Significance	Proposal	Mitigation	Impact
01.012	Rainwater goods

Adverse	Replace with cast iron in pattern to match original and in correct locations	Not applicable	High

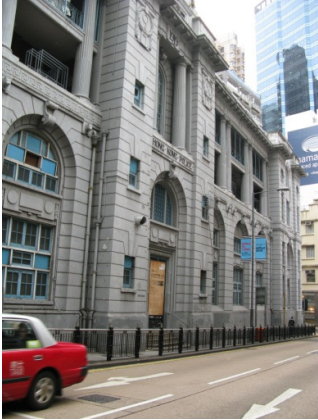
Element no.	Description	Photo ref	Significance	Proposal	Mitigation	Impact
01.013	Exterior decorations

Adverse	Strip off and redecorate	Sample and analyse existing paint media; select new media to suit substrate and significance	High

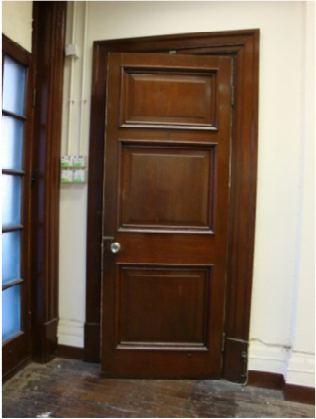
Element no.	Description	Photo ref	Significance	Proposal	Mitigation	Impact
01.014	Existing door openings

Moderate	Block opening as part of re-planning of interior	Retain existing door frame and architraves. Use framing and non-combustible sheet linings to block opening.	Moderate
01.015	Existing walls

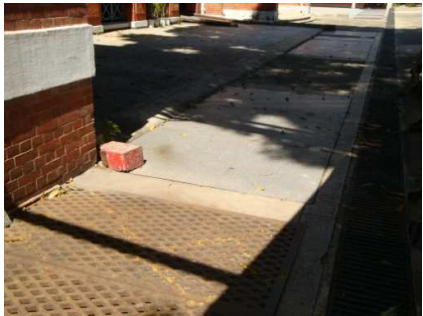
Element no.	Description	Photo ref	Significance	Proposal	Mitigation	Impact
01.018	Cast iron grilles above Service Corridor 01/LG1/35

High	Remove existing steel sheet covering [alterations to grilles awaiting confirmation from HdM]		
01.019	Perforated concrete deck above lightwell

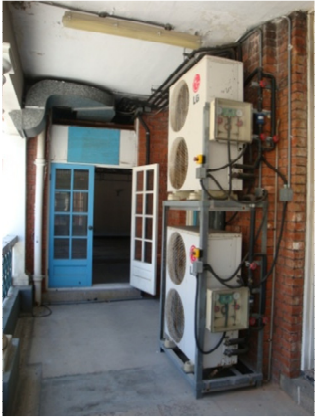
Element no.	Description	Photo ref	Significance	Proposal	Mitigation	Impact
01.020	External airconditioning units and other external services

Adverse	Remove and make good brickwork	Not applicable	High
01.021	Stair balustrades

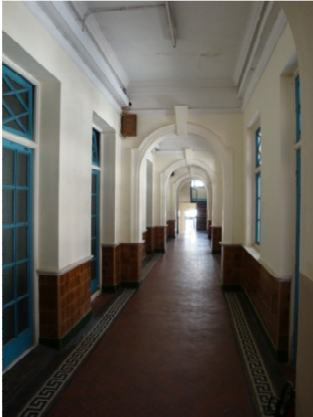
Element no.	Description	Photo ref	Significance	Proposal	Mitigation	Impact
01.022	Main corridors

High	Install new lighting, fire sprinklers, fire doors to comply with Fire Services Code	New fittings to be mounted in a manner that is of its time and reversible. Avoid physical intervention with existing plaster box cornices, architraves, dado rails	High
01.023	Painted signs

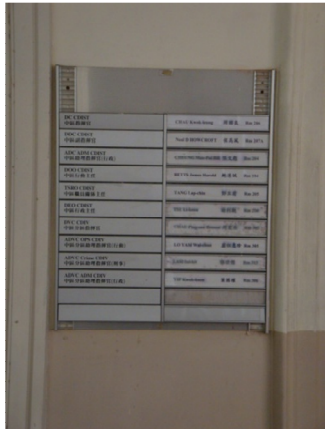
Element no.	Description	Photo ref	Significance	Proposal	Mitigation	Impact
01.024	Fixed signs

Low-High	Remove and refix/display in visitors' centre/discard	Record each sign and assess significance individually and treat accordingly	N/A

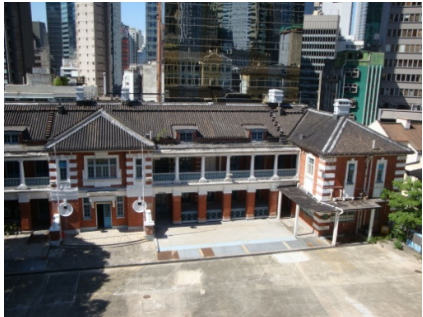
Element no.	Description	Photo ref	Significance	Proposal	Mitigation	Impact
01.025	Pitched roofs

High	New penetrations through roofs for ventilation ducts and other services	<p>Arrange new penetrations so that they conform with the geometry of the existing roof.</p> <p>Model the size and shape of the new ducts so that the impact on the roofscape is minimised.</p> <p>Finish the new ducts in a non-reflective material in a neutral mid-tone.</p>	High

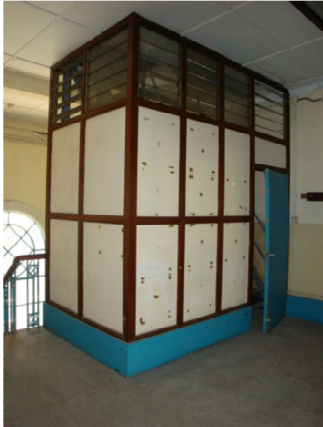
Element no.	Description	Photo ref	Significance	Proposal	Mitigation	Impact
01.026	Enclosure at First Floor landing of main stair

Adverse	Remove	Not applicable	Moderate

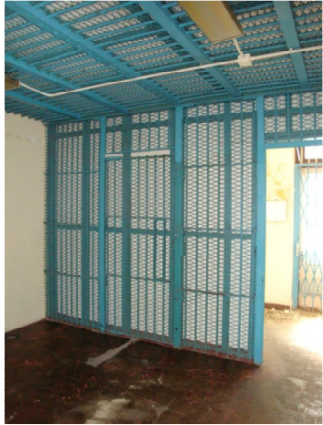
Element no.	Description	Photo ref	Significance	Proposal	Mitigation	Impact
01.027	Steel railing enclosure at FF level

Low	Remove	Record on measured drawings and photographs	Low
01.028	Tongued and grooved flat and sloped timber boarded ceilings

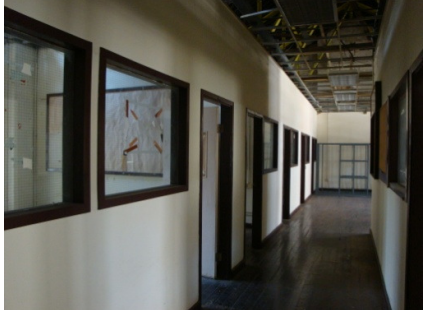
Element no.	Description	Photo ref	Significance	Proposal	Mitigation	Impact
01.029	Modern partitions

Adverse	Remove	Not applicable	High
01.030	Tiled dado

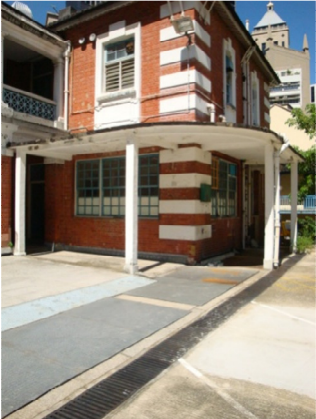
Element no.	Description	Photo ref	Significance	Proposal	Mitigation	Impact
01.031	Reinforced concrete canopy and sash windows

Moderate	Remove canopy and replace sash windows with new windows to match original	Make good brickwork where canopy removed, Reinstate rendered architraves around new window to match similar window facing on West wing	Moderate

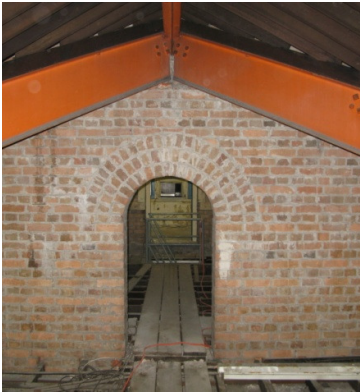
Element no.	Description	Photo ref	Significance	Proposal	Mitigation	Impact
01.032	Arched opening in brick wall above ceiling line

Low	Retain insitu and use to pass through future services. Infill only where opening is within a fire compartment	Use non-combustible material to block opening.	Low

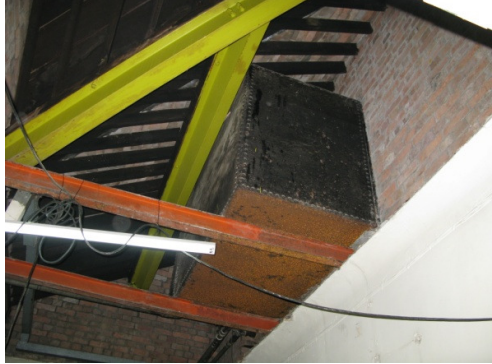
Element no.	Description	Photo ref	Significance	Proposal	Mitigation	Impact
01.033	Ceiling void service installation (Cast Iron Water Tank and pipework)

Low	Remove and make good adjacent surfaces	N/A	Low

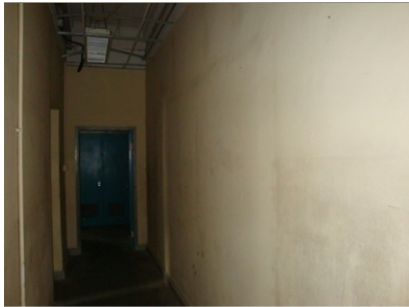
Element no.	Description	Photo ref.	Significance	Proposal	Mitigation	Impact
02.003	Modern partitions

Adverse	Remove	Not applicable	High
02.004	External airconditioning units and other external services

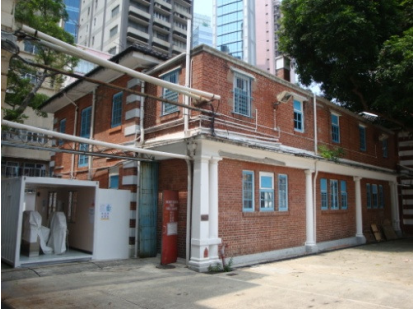
Element no.	Description	Photo ref.	Significance	Proposal	Mitigation	Impact
02.005	Brickwork walls enclosing rooms at GF and FF East side

Low	Remove and reinstate verandah	Not applicable	High
02.006	Concrete floors

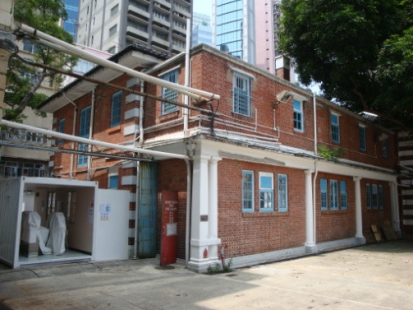
Element no.	Description	Photo ref.	Significance	Proposal	Mitigation	Impact
02.007	Rainwater goods

Adverse	Replace with cast iron in pattern to match original and in correct locations	No applicable	High

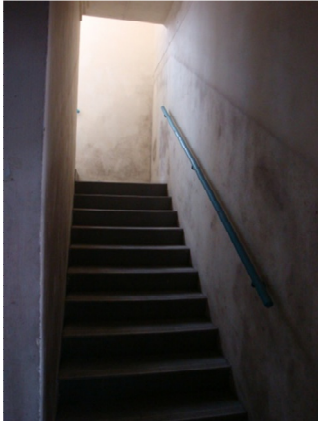
Element no.	Description	Photo ref.	Significance	Proposal	Mitigation	Impact
02.009	Concrete stairs

Adverse	Remove stairs	Not applicable	Moderate

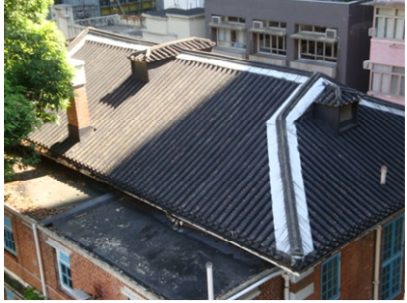
Element no.	Description	Photo ref.	Significance	Proposal	Mitigation	Impact
02.010	Pitched roofs

High	New penetrations through roofs for ventilation ducts and other services	Arrange new penetrations so that they conform with the geometry of the existing roof. Model the size and shape of the new ducts to reduce impact. Finish ducts in a non-reflective material that is neutral in colour and mid-tone.	High
02.011	Roof structure and tiled soffit

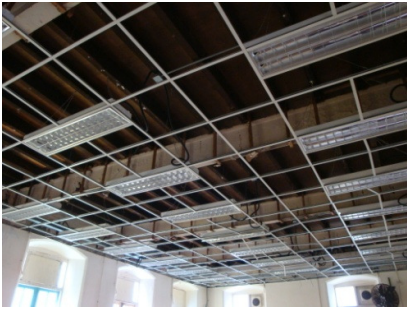
Element no.	Description	Photo ref.	Significance	Proposal	Mitigation	Impact
03.001	Lay-in grid suspended ceiling

Adverse	Remove	Not applicable	High

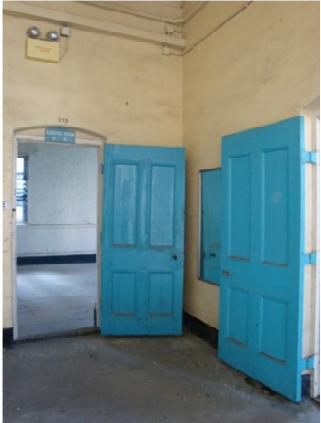
Element no.	Description	Photo ref.	Significance	Proposal	Mitigation	Impact
3.002	Panelled doors

Moderate	Replace where necessary to achieve fire resistance to comply with Code	Re-use where possible. Record design on survey drawings where item cannot be re-used.	Moderate

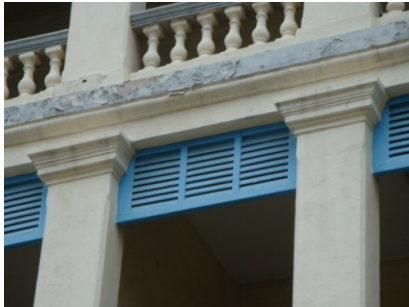
Element no.	Description	Photo ref.	Significance	Proposal	Mitigation	Impact
03.003	External shutters

High	Reinstate to match existing pattern	Not applicable	High
03.004	Timber thresholds at external doors and internal doors between main corridor and individual rooms

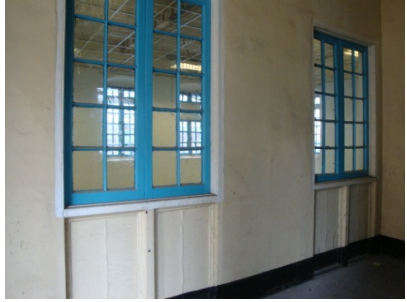
Element no.	Description	Photo ref.	Significance	Proposal	Mitigation	Impact
03.005	Timber spandrel panels below windows

Low	Conceal in exceptional cases eg. where adjacent new lift shaft	Retain frame and spandrel panel where possible. Remove only where necessary in connection with re-planning of interiors. Record on measured survey drawings.	Low
03.006	Timber floors

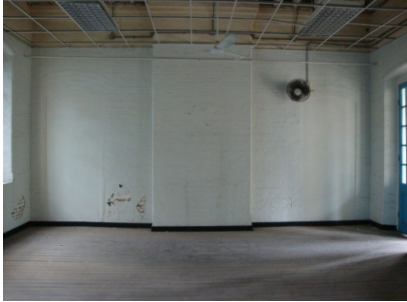
Element no.	Description	Photo ref.	Significance	Proposal	Mitigation	Impact
03.010	Form new door openings

Low	Form new opening as part of re-planning of interiors	New doors and frames to be of their time to avoid confusion about provenance. Re-open original openings where possible. Retain original reveals and arches.	Low

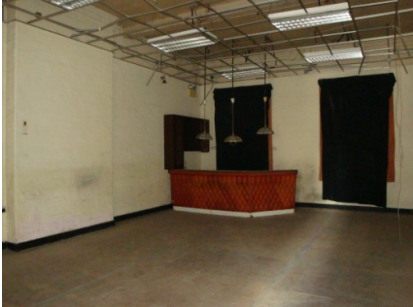
Element no.	Description	Photo ref.	Significance	Proposal	Mitigation	Impact
03.020	Assembly rooms at centre of building (all floors)

Moderate	Sub-divide two rooms on each floor to provide service core, comprising: lifts, toilets, plant rooms, stores	Form new sub-visions using lightweight partitions to achieve reversibility. Form straight joints at abutments with existing retained walls. Notch new partitions around existing brick corbels at high level as a reminder of current condition.	Moderate
03.021	Exposed soffits of timber floors

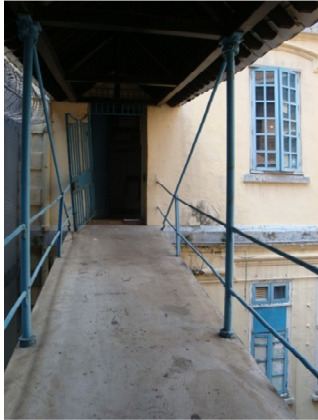
Element no.	Description	Photo ref.	Significance	Proposal	Mitigation	Impact
03.024	Bridge at east end

Moderate	Retain	Not applicable	Neutral

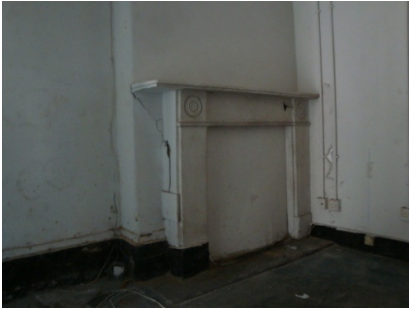
Element no.	Description	Photo ref.	Significance	Proposal	Mitigation	Impact
03.025	Chimneypiece on Ground Floor

Low	Repair and retain in current location	Not applicable	Neutral
03.026	Window in south wall; original dormitory space

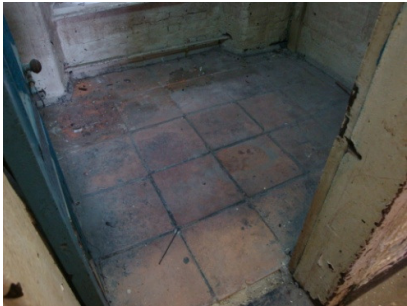
Element no.	Description	Photo ref.	Significance	Proposal	Mitigation	Impact
03.027	Clay-tiled floor in store room adjacent stairs

Low	Remove as part of re-planning of interiors	Record on measured survey drawings	Low

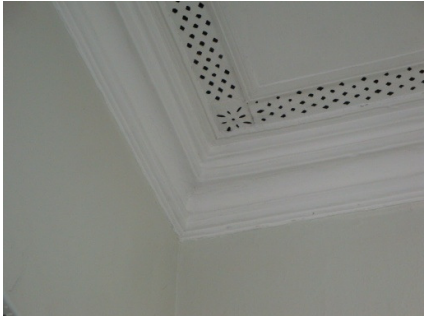
Element no.	Description	Photo ref.	Significance	Proposal	Mitigation	Impact
04.003	Plaster box cornice

Moderate	Remove in exceptional cases where eg. where adjacent new lift shafts	Cut back neatly to a square edge and ensure remaining section is secure.	Moderate

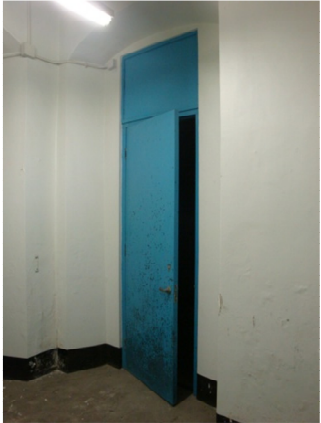
Element no.	Description	Photo ref.	Significance	Proposal	Mitigation	Impact
04.006	Block existing door openings

Moderate	Block opening as part of re-planning of interior	Retain existing door frame and architraves. Use framing and non-combustible sheet linings to block opening.	Moderate

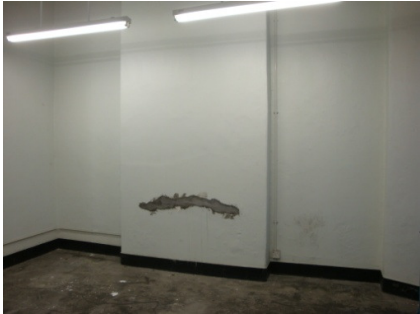
Element no.	Description	Photo ref.	Significance	Proposal	Mitigation	Impact
04.007	Form new door openings

Moderate	Form new opening as part of re-planning of interiors	New doors and frames to be of their time to avoid confusion about provenance	Moderate

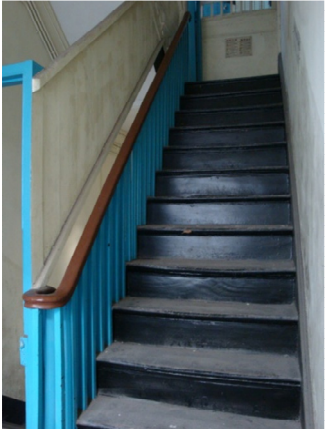
Element no.	Description	Photo ref.	Significance	Proposal	Mitigation	Impact
04.012	Stair from First to Second Floor

High	Replace stair to improve safety	New stair to be built of steel to comply with Code and to distinguish it as being "of its time".	Moderate

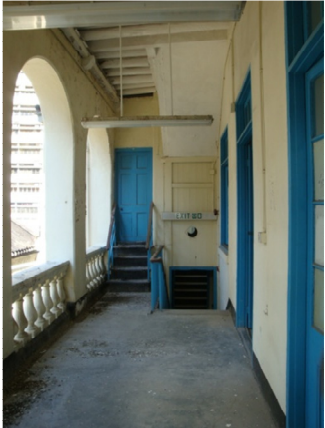
Element no.	Description	Photo ref.	Significance	Proposal	Mitigation	Impact
04.013	External verandahs

High	Install new lighting, fire sprinklers, fire doors to comply with Fire Services Code, extract ducting to external walls	New fittings to be mounted in a manner that is of its time and reversible. Avoid physical intervention with existing plaster box cornices in rooms, architraves, dado rails. Position outlet grilles in external walls on centre-line of arcade arches and above structural arch	High

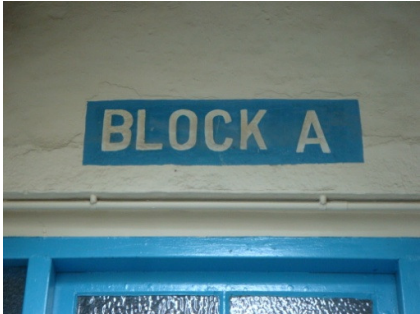
Element no.	Description	Photo ref.	Significance	Proposal	Mitigation	Impact
04.014	Painted signs

High	Protect in situ	Not applicable	N/A
04.015	Fixed signs

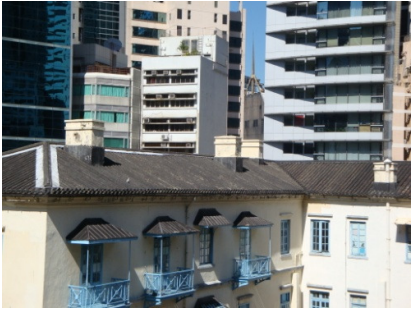
Element no.	Description	Photo ref.	Significance	Proposal	Mitigation	Impact
04.016	Pitched roofs

High	New penetrations through roofs for ventilation ducts and other services	<p>Arrange new penetrations so that they conform with the geometry of the existing roof.</p> <p>Model the size and shape of the new ducts so that the impact on the roofscape is minimised.</p> <p>Finish the new ducts in a non-reflective material that is neutral in colour.</p>	High

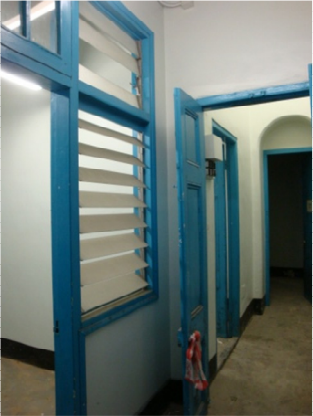
Element no.	Description	Photo ref.	Significance	Proposal	Mitigation	Impact
04.018	Partitions at GF Dormitory A

High	Remove to make way for Interpretation	Prepare measured drawings and photographs before removal.	Moderate

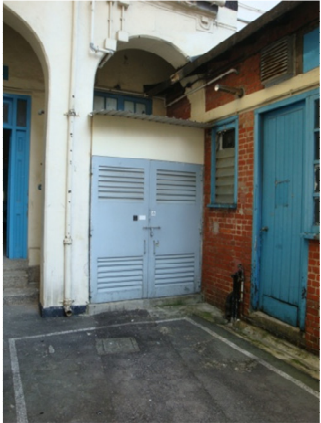
Element no.	Description	Photo ref.	Significance	Proposal	Mitigation	Impact
04.019	Switchgear in old porch 04/G/13

Adverse	Open up porch, remove electrical switchgear and make good	Not applicable	High

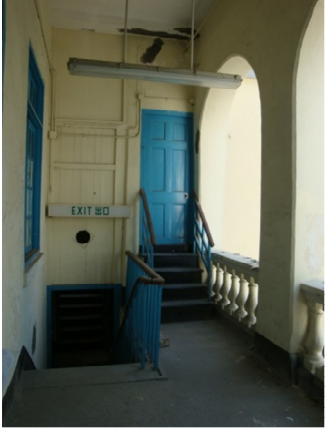
Element no.	Description	Photo ref.	Significance	Proposal	Mitigation	Impact
04.021	Steps up to doorway on FF verandah

Moderate	Remove steps and doorway to form new fore escape route	Record steps and doorway on measured drawings	Moderate

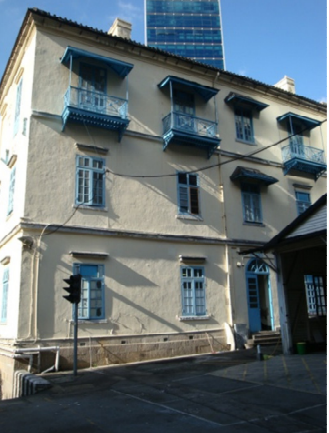
Element no.	Description	Photo ref.	Significance	Proposal	Mitigation	Impact
04.023	Cantilever balconies

High	<p>Retain and repair as necessary.</p> <p>Reinstate balcony on west elevation.</p>	<p>Avoid highly visible intervention to enhance structural integrity and/or compliance with building codes.</p> <p>Restrict access if necessary to achieve this objective.</p>	Low

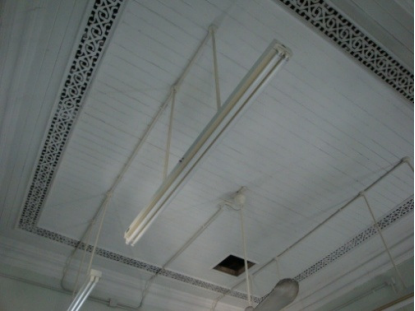
Element no.	Description	Photo ref.	Significance	Proposal	Mitigation	Impact
04.024	Clay tile floor		Low	Retain and repair as necessary	Not applicable	Neutral
04.025	Matched-boarded ceiling with perforated border

Moderate	Repair and retain insitu	Not applicable	Neutral

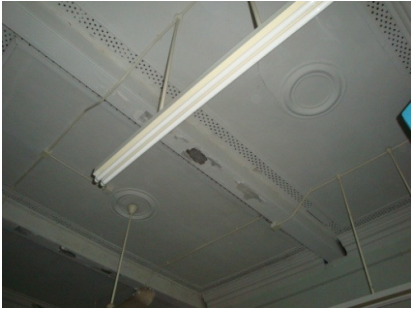
Element no.	Description	Photo ref.	Significance	Proposal	Mitigation	Impact
04.026	Ceiling rose

Low	Repair and retain insitu	Not applicable	Neutral

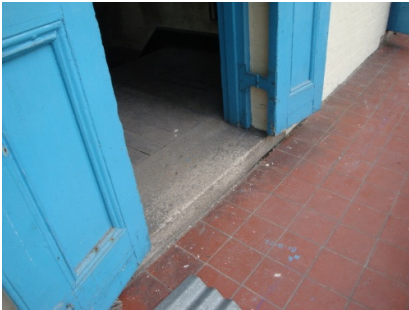
Element no.	Description	Photo ref.	Significance	Proposal	Mitigation	Impact
06.001	Granite thresholds at external doors

Low	Retain; install timber deck flush with level of step where necessary	Avoid alteration to step.	Low
06.002	Pitched roof

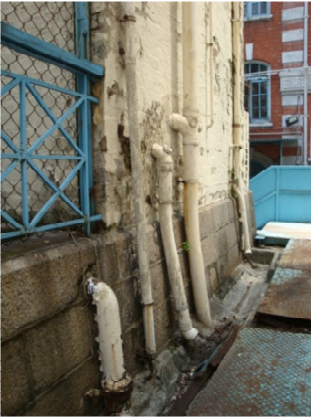
Element no.	Description	Photo ref.	Significance	Proposal	Mitigation	Impact
06.003	Rainwater goods

Adverse	Replace with cast iron in pattern to match original and in correct locations	Not applicable	High
06.004	Exterior decorations

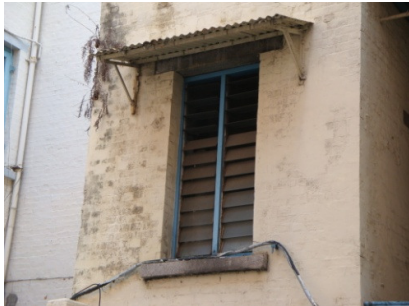
Element no.	Description	Photo ref.	Significance	Proposal	Mitigation	Impact
06.005	Altered doors and windows

Adverse	Adverse	Repair or renew as necessary existing frames to match original patterns	Not applicable
06.006	External airconditioning units and other external services

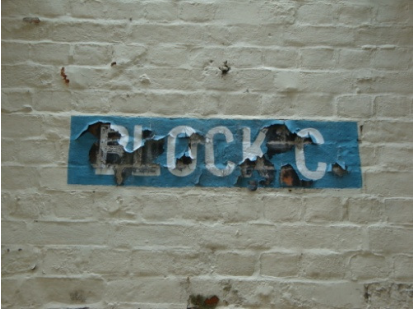
Element no.	Description	Photo ref.	Significance	Proposal	Mitigation	Impact
06.007	Painted signs

High	Protect in situ	Not applicable	N/A
06.008	Fixed signs

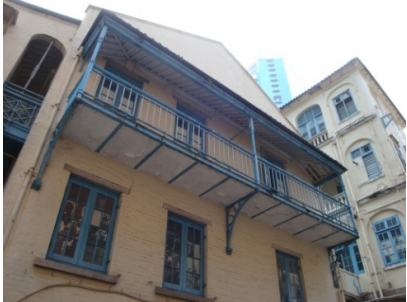
Element no.	Description	Photo ref.	Significance	Proposal	Mitigation	Impact
06.009	Cantilever balconies

High	Retain and repair as necessary.	Avoid highly visible intervention to enhance structural integrity and/or compliance with building codes. Restrict access if necessary to achieve this objective.	Low
06.010	Iron balustrades

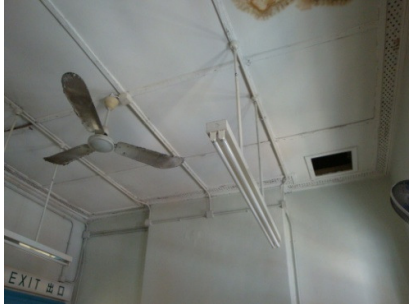
Element no.	Description	Photo ref.	Significance	Proposal	Mitigation	Impact
06.011	Perforated margin at perimeter of ceiling

Low	Repair and retain.	Where fire-proofing of floor is required, use a product that can be installed within the floor void, leaving the ceiling lining intact.	Low
06.012	Block existing door openings

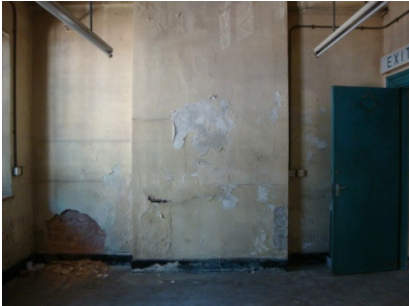
Element no.	Description	Photo ref.	Significance	Proposal	Mitigation	Impact
06.013	Form new door openings

Moderate	Form new opening as part of re-planning of interiors	New doors and frames to be of their time to avoid confusion about provenance	Moderate
06.014	Stair balustrades

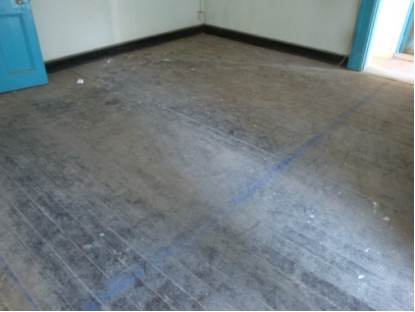
Element no.	Description	Photo ref.	Significance	Proposal	Mitigation	Impact
06.015	Timber floors

High	Retain all boarded floors and skirtings	Reinstate floor boards and skirtings after fire proofing works	Low
06.016	Vinyl tile floor

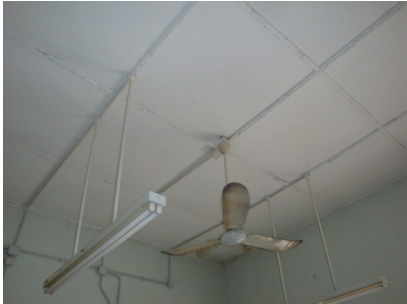
Element no.	Description	Photo ref.	Significance	Proposal	Mitigation	Impact
06.017	Batten and panel ceiling lining

Low	Replace with lath and plaster ceiling	Not applicable	Low
06.018	Exposed roof covering

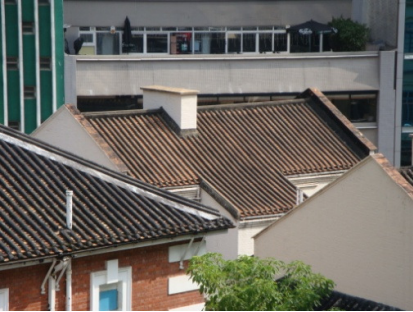
Element no.	Description	Photo ref.	Significance	Proposal	Mitigation	Impact
07.001	Pitched roofs

High	New penetrations through roofs for ventilation ducts and other services	<p>Arrange new penetrations so that they conform with the geometry of the existing roof.</p> <p>Model the size and shape of the new ducts so that the impact on the roofscape is minimised.</p> <p>Finish the new ducts in a non-reflective material that is neutral in colour and mid-tone.</p>	High
07.002	Rainwater goods

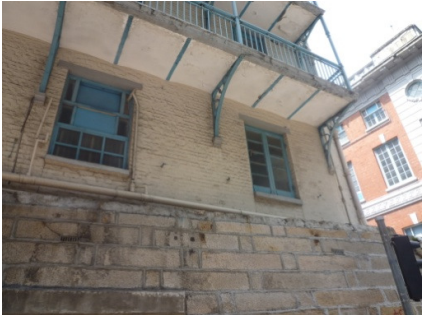
Element no.	Description	Photo ref.	Significance	Proposal	Mitigation	Impact
07.003	Exterior decorations

Adverse	Strip off and redecorate	Sample and analyse existing paint media; select new media to suit substrate and significance	High
07.004	Altered doors and windows

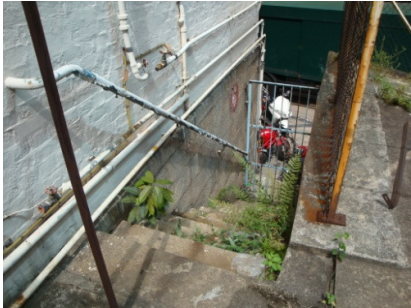
Element no.	Description	Photo ref.	Significance	Proposal	Mitigation	Impact
07.005	External airconditioning units and other external services

Adverse	Remove and make good brickwork	Not applicable	High
07.006	Clothes drying racks

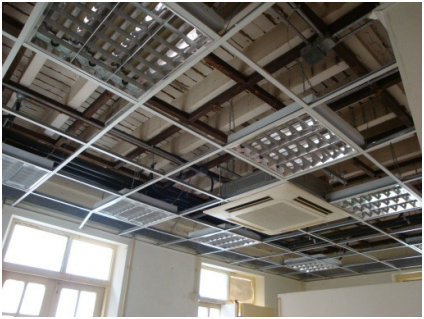
Element no.	Description	Photo ref.	Significance	Proposal	Mitigation	Impact
07.008	Lay-in grid suspended ceiling

Adverse	Remove	Not applicable	High
07.009	Corbelled brickwork at perimeter of room

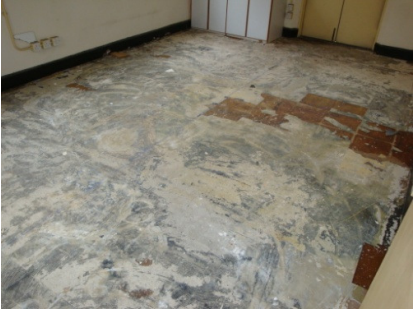
Element no.	Description	Photo ref.	Significance	Proposal	Mitigation	Impact
07.010	Plywood floor

Adverse	Replace with hardwood floor boards	Not applicable	High
07.011	Timber thresholds at external doors and internal doors between main corridor and individual rooms

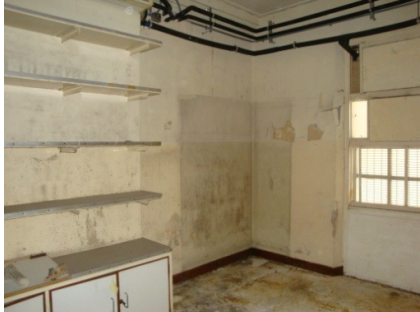
Element no.	Description	Photo ref.	Significance	Proposal	Mitigation	Impact
07.012	Form new door openings

Moderate	Form new opening as part of re-planning of interiors	New doors and frames to be of their time to avoid confusion about provenance	Moderate
07.013	Stair balustrades

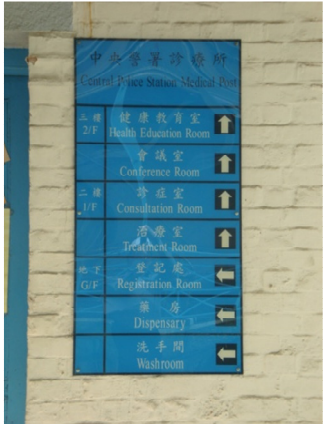
Element no.	Description	Photo ref.	Significance	Proposal	Mitigation	Impact
07.014	Fixed signs

Low-High	Remove and refix/display in visitors' centre/discard	Record each sign and assess significance individually and treat accordingly	N/A

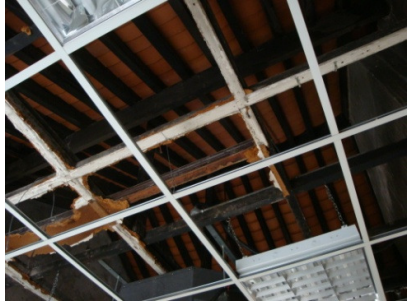
Element no.	Description	Photo ref.	Significance	Proposal	Mitigation	Impact
07.015	Exposed roof tiling

Moderate	Retain as existing	Consider insulating between upper and lower layers of roof tiles to provide thermal insulation and vapour barrier	Low
07.016	Concrete floor

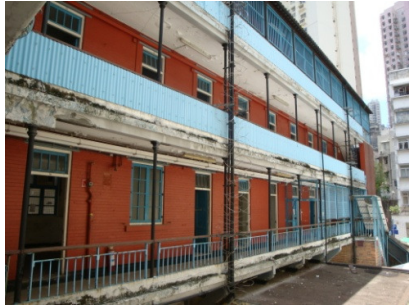
Element no.	Description	Photo ref.	Significance	Proposal	Mitigation	Impact
08.001	Panelled doors

Low	Replace where necessary to achieve compliance with Building Code	Re-use where possible. Record design on survey drawings where element cannot be re-used.	Moderate
08.002	Rainwater goods

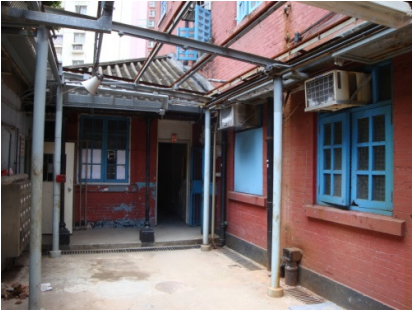
Element no.	Description	Photo ref.	Significance	Proposal	Mitigation	Impact
08.003	Exterior decorations

Adverse	Strip off and redecorate	Sample and analyse existing paint media; select new media to suit substrate and significance	High
08.004	Block existing door openings

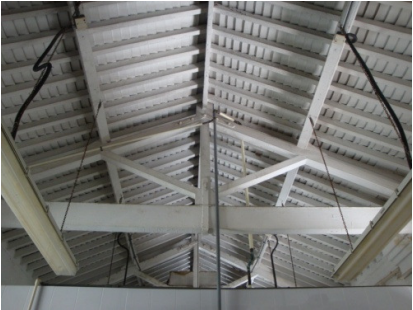
Element no.	Description	Photo ref.	Significance	Proposal	Mitigation	Impact
08.005	Timber roof structure

High	Retain	Not applicable	Neutral
08.006	External stair at west end

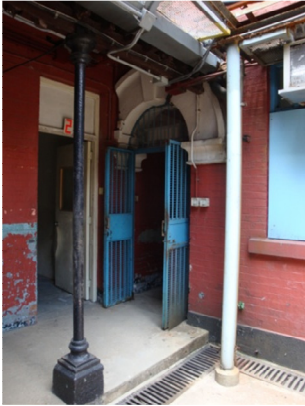
Element no.	Description	Photo ref.	Significance	Proposal	Mitigation	Impact
08.007	External airconditioning units and other external services

Adverse	Remove and make good brickwork	Not applicable	High
08.008	Painted signs

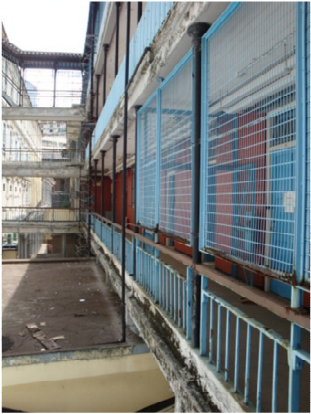
Element no.	Description	Photo ref.	Significance	Proposal	Mitigation	Impact
08.009	Wire mesh screens

Adverse	Remove	Not applicable	Low
08.010	Internal walls and concrete floors

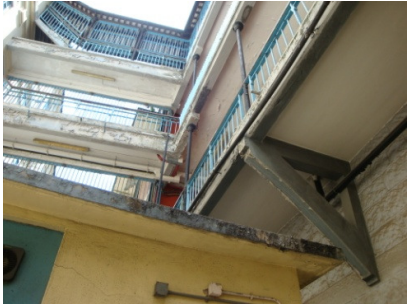
Element no.	Description	Photo ref.	Significance	Proposal	Mitigation	Impact
					clashes.	
08.011	Cantilever balconies on north side

Moderate	Repair and retain insitu	Not applicable

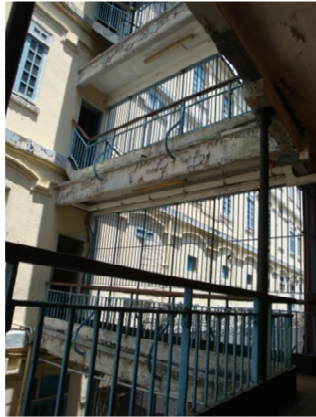
Element no.	Description	Photo ref.	Significance	Proposal	Mitigation	Impact
08.012	Bridge access to Barrack Block

Moderate	Retain	<p>Repair as necessary.</p> <p>Alter balustrade to achieve reasonable level of operational safety.</p> <p>Restrict access to repairs and maintenance and means of escape.</p>	Low
08.013	Balcony balustrades

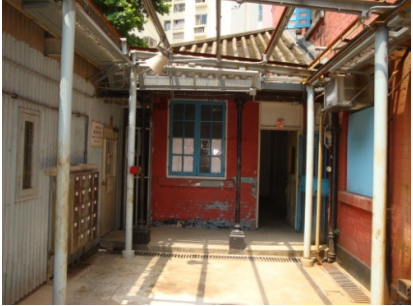
Element no.	Description	Photo ref.	Significance	Proposal	Mitigation	Impact
08.014	Single-storey outbuilding with pitched roof over

Low	Demolish to make way for new loading bay.	<p>Record on measured survey drawings.</p> <p>Infill existing internal opening leaving reveals exposed.</p> <p>Tooth-in new brickwork at abutments after existing walls removed.</p> <p>Salvage cast iron columns for possible re-use.</p>	Low
08.015	Corrugated steel sheet on balcony balustrades

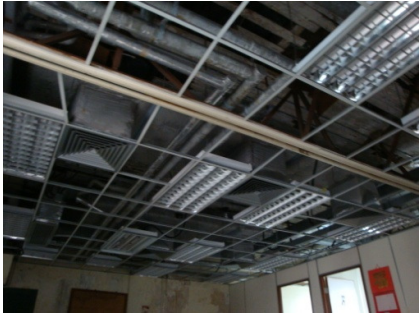
Element no.	Description	Photo ref.	Significance	Proposal	Mitigation	Impact
09.001	Lay-in grid suspended ceiling

Adverse	Remove	Not applicable	High
09.002	Modern partitions
