The Jockey Club CPS Limited

Central Police Station Conservation
and Revitalisation Project:
Second Annual EM&A Review Report
(1 November 2012 to 31 October
2013)

Issue Date: February 2014

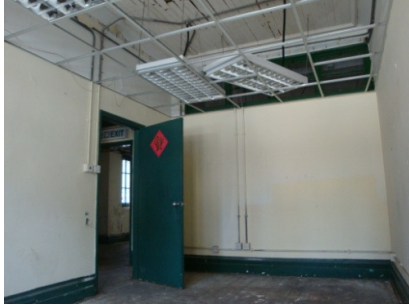
Element no.	Description	Photo ref.	Significance	Proposal	Mitigation	Impact
09.003	Internal walls

Moderate	Remove selected internal walls where strictly necessary as part of re-planning of interiors	Walls or early or original date to be retained in part eg. By leaving a "nib" where the wall is bonded to another wall. At the point where the wall is cut away, form the cut-line on the line of a vertical joint in alternate courses. Bricks in the remaining courses to be left "as cut", and not re-bonded, as evidence of the current condition.	Moderate
09.004	Plaster box cornice

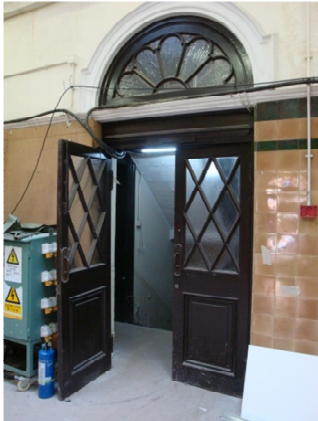
Element no.	Description	Photo ref.	Significance	Proposal	Mitigation	Impact
09.005	Panelled doors

Moderate	Replace where necessary to achieve fire resistance to comply with Code	Re-use where possible. Record design on survey drawings where element cannot be re-used.	Moderate

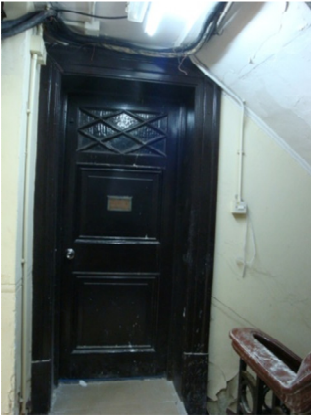
Element no.	Description	Photo ref.	Significance	Proposal	Mitigation	Impact
09.006	Block existing door openings

Moderate	Block opening as part of re-planning of interior	Retain existing door frame and architraves. Use framing and non-combustible sheet linings to block opening.	Moderate
09.007	Form new door openings		Moderate	Form new opening as part of re-planning of interiors	New doors and frames to be of their time to avoid confusion about provenance	Moderate

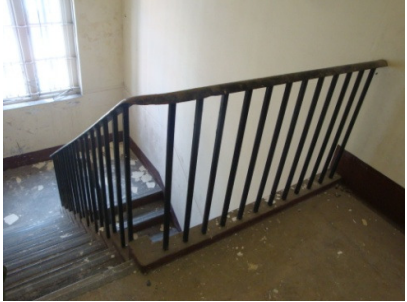
Element no.	Description	Photo ref.	Significance	Proposal	Mitigation	Impact
09.008	Stair balustrades

High	Balustrades to be supplemented with additional handrails and supports to mitigate non-compliance with code	New fittings to be of their time and made reversible. Physical intervention to existing stairs and balustrades to be kept to the minimum.	Moderate
09.009	Fixed signs

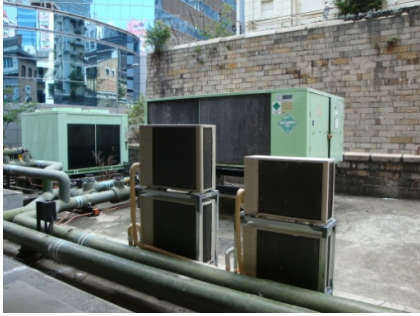
Element no.	Description	Photo ref.	Significance	Proposal	Mitigation	Impact
09.010	External airconditioning units and other external services

Adverse	Remove and make good brickwork	Not applicable	High
09.011	Pitched roofs

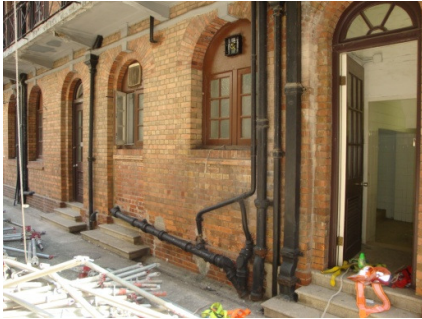
Element no.	Description	Photo ref.	Significance	Proposal	Mitigation	Impact
09.012	Rainwater goods

Moderate	Replace with larger sizes/closer spacing to improve performance	Use cast iron to match original pattern Make good all redundant fixing holes	High
09.013	Metal walkways across lightwell

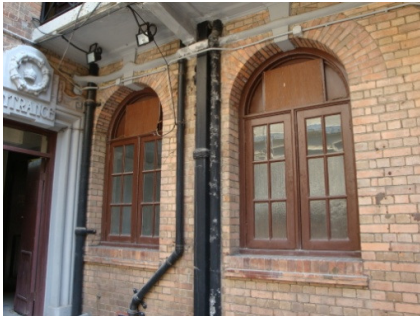
Element no.	Description	Photo ref.	Significance	Proposal	Mitigation	Impact
09.014	Altered doors and windows

Adverse	Repair or renew as necessary existing frames to match original patterns	Not applicable	High
09.015	Sloping canopy over external stair on west side

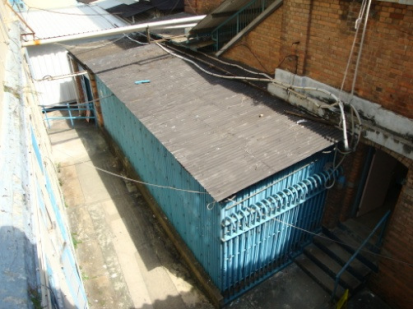
Element no.	Description	Photo ref.	Significance	Proposal	Mitigation	Impact
09.016	Single storey secure shelter at North West corner

Low	Demolish	Make good brickwork at abutments.	Low
09.017	Iron railing adjacent south side of item 09.016 above

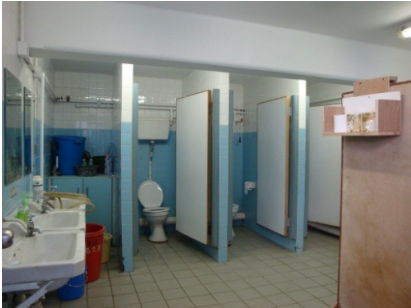
Element no.	Description	Photo ref.	Significance	Proposal	Mitigation	Impact
09.018	Public toilets in 09/LG1/17, 24

Adverse	Strip out sanitaryware, and fit-out for pottery display/service access. Form new door openings in east walls.	Retain existing door openings and metal-barred gates. Retain external granite steps and existing ground level.	Low
09.019	Cell doors

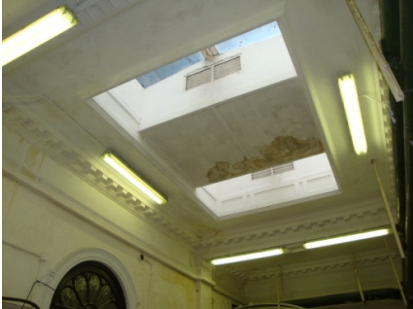
Element no.	Description	Photo ref.	Significance	Proposal	Mitigation	Impact
09.024	Lanterns above entrance hall

Adverse	Remove existing lanterns and install single lantern	Not applicable	Moderate
09.025	Boarded ceilings on Second Floor

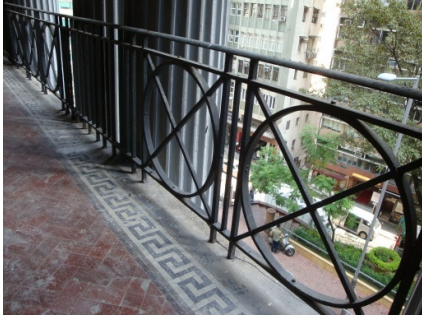
Element no.	Description	Photo ref.	Significance	Proposal	Mitigation	Impact
09.026	Iron gates at top of external stair	 	Moderate	Retain	No applicable	Neutral
09.027	Iron balustrade adjacent terrace at First Floor east side

High	Retain; install structural glass balustrade inboard of ironwork to provide compliance with Building Codes	Avoid penetration of existing tiled pavement when fixing glass balustrade.	Low

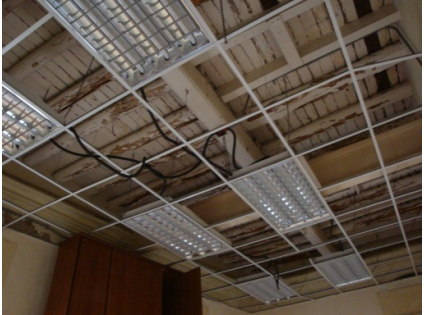
Element no.	Description	Photo ref.	Significance	Proposal	Mitigation	Impact
10.001	Lay-in grid suspended ceiling

Adverse	Remove	Not applicable	High
10.002	Plaster box cornice

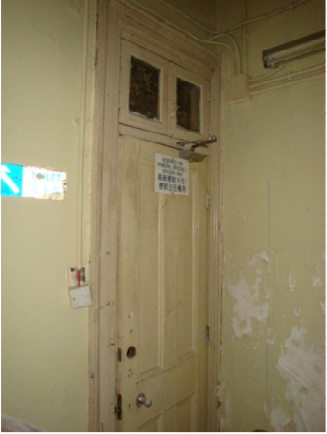
Element no.	Description	Photo ref.	Significance	Proposal	Mitigation	Impact
10.003	Panelled doors and linings

Moderate	Replace where necessary to achieve fire resistance to comply with Code	Re-use where possible. Record design on survey drawings where element cannot be re-used.	Moderate

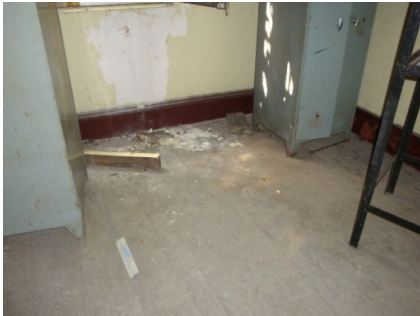
Element no.	Description	Photo ref.	Significance	Proposal	Mitigation	Impact
10.004	Timber boarded floor with moulded skirtings

High	Repair as necessary and retain	Lift carefully and refix upon completion of fire-proofing and services installation	Low
10.005	Exterior decorations

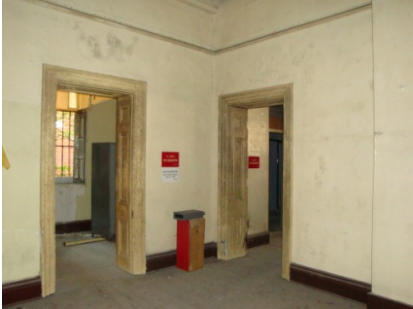
Element no.	Description	Photo ref.	Significance	Proposal	Mitigation	Impact
10.006	Block existing door openings

Moderate	Block opening as part of re-planning of interior	Retain existing door frame and architraves. Use framing and non-combustible sheet linings to block opening.	Moderate
10.007	Form new door openings

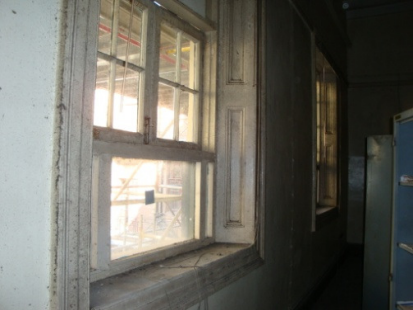
Element no.	Description	Photo ref.	Significance	Proposal	Mitigation	Impact
10.008	Altered doors and windows

Adverse	Repair or renew as necessary existing frames to match original patterns	Not applicable	High
10.009	External airconditioning units and other external services

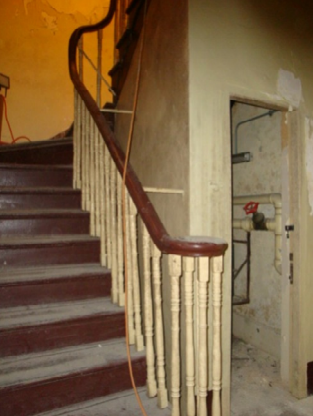
Element no.	Description	Photo ref.	Significance	Proposal	Mitigation	Impact
10.010	Stair balustrades

High	Balustrades to be supplemented with additional handrails and supports to mitigate non-compliance with code	New fittings to be of their time and made reversible. Physical intervention to existing stairs and balustrades to be kept to the minimum.	Moderate

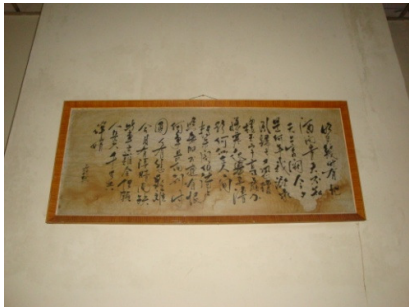
Element no.	Description	Photo ref.	Significance	Proposal	Mitigation	Impact
10.011	Fixed signs

Low-High	Remove and refix/display in visitors' centre/discard	Record each sign and assess significance individually and treat accordingly	N/A
10.012	Pitched roofs

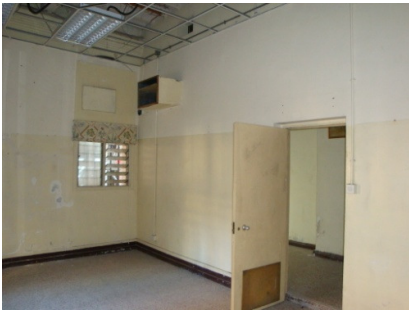
Element no.	Description	Photo ref.	Significance	Proposal	Mitigation	Impact
10.013	Internal walls

Moderate	Remove selected internal walls where strictly necessary as part of re-planning of interiors	Walls or early or original date to be retained in part eg. By leaving a “nib” where the wall is bonded to another wall. At the point where the wall is cut away, form the cut-line on the line of a vertical joint in alternate courses. Bricks in the remaining courses to be left “as cut”, and not re-bonded, as evidence of the current condition.	Moderate

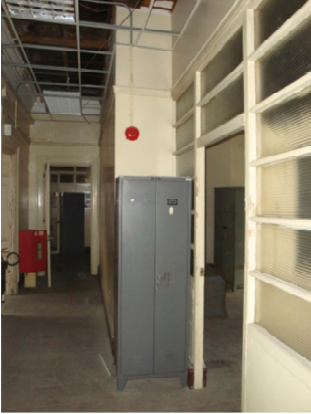
Element no.	Description	Photo ref.	Significance	Proposal	Mitigation	Impact
10.014	Partitions on SF

Moderate	Remove partitions	Record partitions on measured drawings	Moderate
10.015	Blocked windows on south elevation of south-east wing

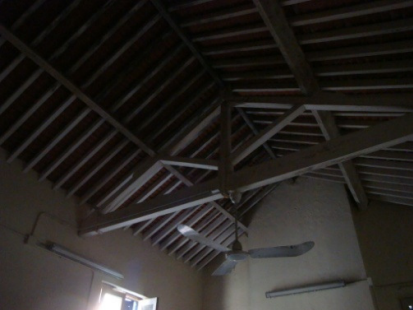
Element no.	Description	Photo ref.	Significance	Proposal	Mitigation	Impact
10.018	Timber roof structure above south-east wing

Moderate	Repair as necessary and retain	Avoid intrusive alteration. Retain open appearance/	Low
10.019	Timber stair

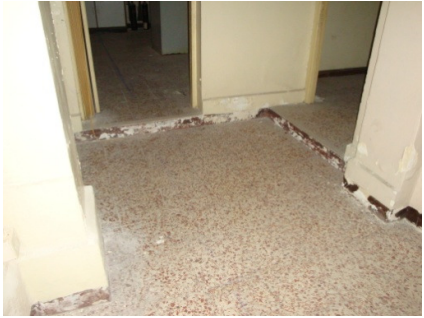
Element no.	Description	Photo ref.	Significance	Proposal	Mitigation	Impact
10.020	Clay/terrazzo tile floor on Ground Floor and steps

Adverse	Adjust levels to enable level access and replace floor finish	Not applicable	Low
10.024	Granite wall on North elevation

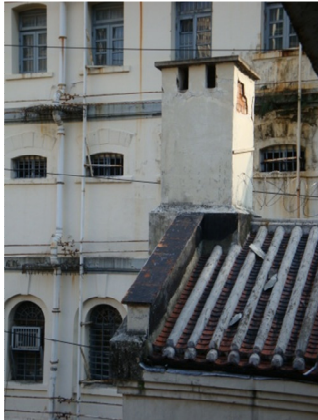
Element no.	Description	Photo ref.	Significance	Proposal	Mitigation	Impact
10.027	Chimney on east elevation

Low	Retain	Not applicable	Neutral
10.028	Cantilever balconies

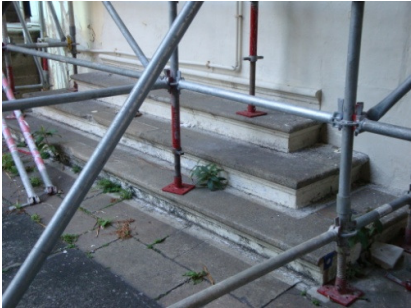
Element no.	Description	Photo ref.	Significance	Proposal	Mitigation	Impact
10.029	Steps on east elevation

Moderate	Repair as necessary and retain	Not applicable	Neutral
10.030	Decorative metal screen (See also item 10.026)

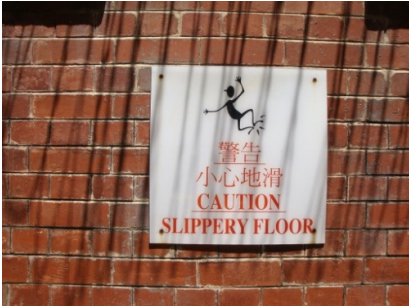
Element no.	Description	Photo ref.	Significance	Proposal	Mitigation	Impact
11.004	Fixed signs

Low-High	Remove and refix/display in visitors' centre/discard	Record each sign and assess significance individually and treat accordingly	N/A
11.005	Concrete stairs

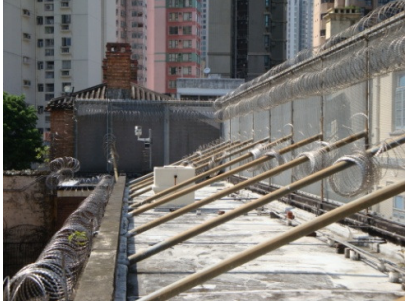
Element no.	Description	Photo ref.	Significance	Proposal	Mitigation	Impact
11.006	Flat roof

Low	Form new rooftop extension at West end to accommodate fire escape stair	Form straight joint at abutment with building 08 Ablutions Block	Low
11.007	Security screen at roof level

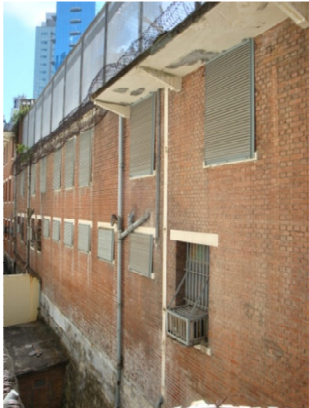
Element no.	Description	Photo ref.	Significance	Proposal	Mitigation	Impact
11.008	Rainwater goods

Adverse	Replace with cast iron in pattern to match original and in correct locations	Not applicable	High

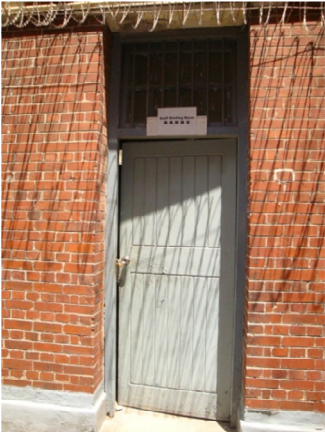
Element no.	Description	Photo ref.	Significance	Proposal	Mitigation	Impact
11.010	Timber doors

Low	Repair and retain	Not applicable	Neutral

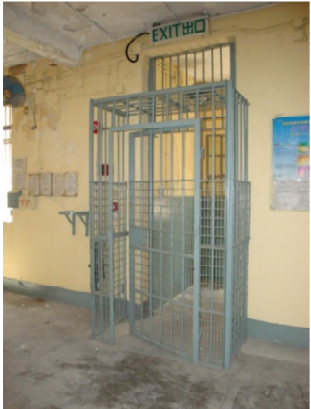
Element no.	Description	Photo ref.	Significance	Proposal	Mitigation	Impact
11.011	Security screen and door at First Floor

Low	Remove	Record on measured survey drawings	Low
11.012	Door thresholds and plinth

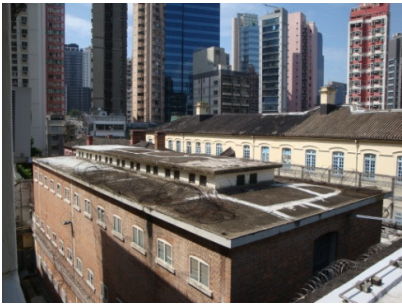
Element no.	Description	Photo ref.	Significance	Proposal	Mitigation	Impact
12.001	Flat roof

Moderate	Repair and retain	Avoid roof penetrations as far as possible	Low
12.002	Cells at GF level

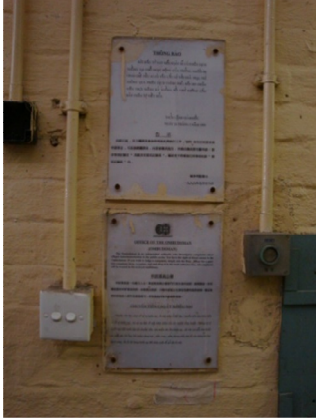
Element no.	Description	Photo ref.	Significance	Proposal	Mitigation	Impact
12.005	Fixed signs

Low-High	Remove and refix/display in visitors' centre/discard	Record each sign and assess significance individually and treat accordingly	N/A
12.006	Rainwater goods

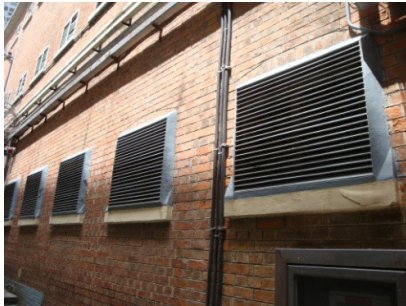
Element no.	Description	Photo ref.	Significance	Proposal	Mitigation	Impact
12.009	External walls

Moderate	Form openings in North and South walls in conjunction with new North-South route across site	Cut brickwork to form openings in North and South walls; do not re-bond brickwork.	Moderate

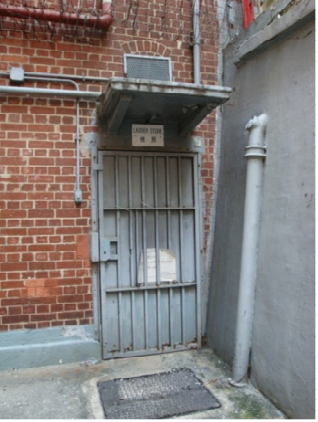
Element no.	Description	Photo ref.	Significance	Proposal	Mitigation	Impact
13.002	Door to Ladder Store

Low	Retain	Not applicable	Neutral
13.003	Security bars at window openings

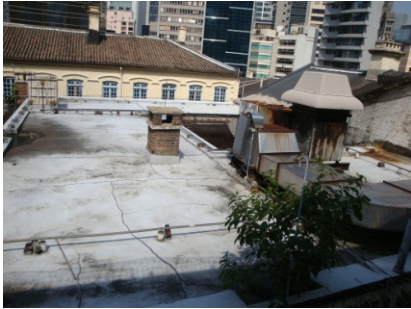
Element no.	Description	Photo ref.	Significance	Proposal	Mitigation	Impact
13.004	Flat roof

Low	Retain	Avoid roof penetrations as far as possible.	Low
13.005	Eaves detail

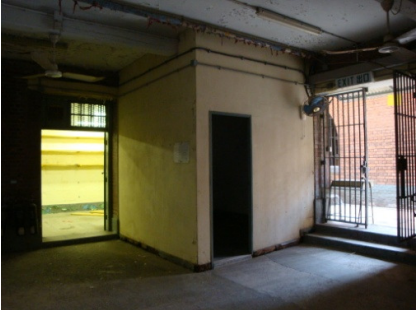
Element no.	Description	Photo ref.	Significance	Proposal	Mitigation	Impact
13.007	Internal partition walls

Low	Remove as part of re-planning of interiors	Record on measured survey drawings	Low
13.008	Fixed signs

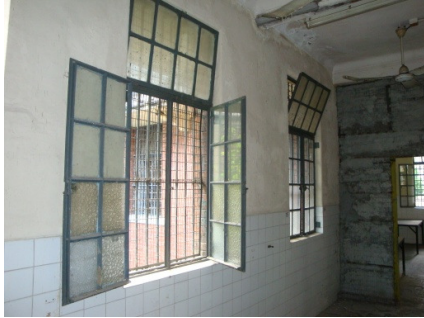
Element no.	Description	Photo ref.	Significance	Proposal	Mitigation	Impact
13.009	Metal window frames

Moderate	Repair and retain	Not applicable	Neutral
13.010	Internal security screens

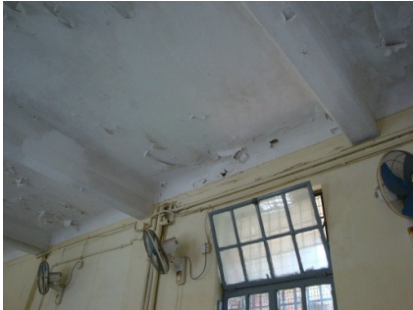
Element no.	Description	Photo ref.	Significance	Proposal	Mitigation	Impact
13.011	Coving at abutments between RC beams and walls

Low	Avoid penetrations for services installations as far as possible.	Cut away neatly for services penetrations and make good at abutments.	Low
13.012	Communal cells at Ground Floor

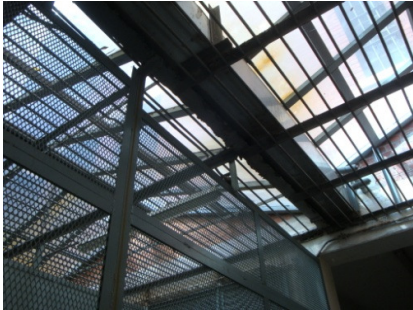
Element no.	Description	Photo ref.	Significance	Proposal	Mitigation	Impact
13.013	Rooflight and security bars over communal cells

Moderate	Remove as part of re-planning of interiors	Record on measured survey drawings	Low
13.014	Granite threshold at external door openings

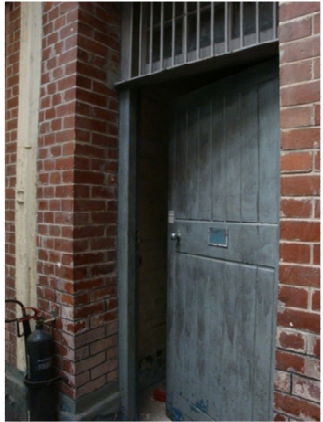
Element no.	Description	Photo ref.	Significance	Proposal	Mitigation	Impact
13.015	Timber boarded doors with fanlight over

Low	Repair as necessary and retain	Not applicable	Neutral
13.015	Vinyl tile floor

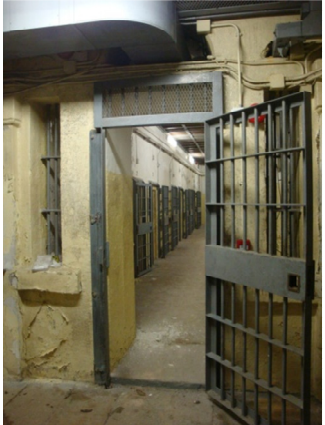
Element no.	Description	Photo ref.	Significance	Proposal	Mitigation	Impact
14.001	West entrance at Lower Ground Floor

Moderate	Retain as public entrance at this level.	<p>Retain security gate and granite threshold.</p> <p>Adjust adjacent ground level as necessary to achieve barrier-free access.</p> <p>Pin gate back against adjacent wall in the open position if necessary.</p>	Low

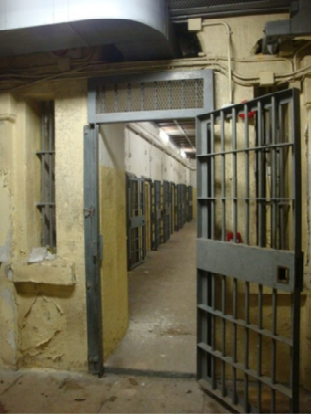
Element no.	Description	Photo ref.	Significance	Proposal	Mitigation	Impact
14.002	Half-round headed doorway and side lights

Moderate	Retain	Remove air duct and make good masonry above arch.	Low

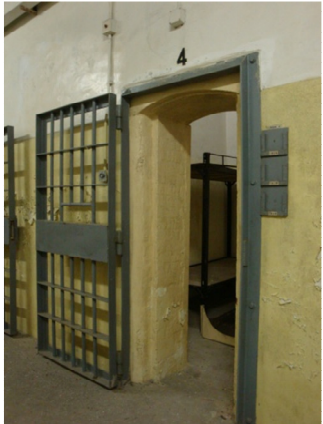
Element no.	Description	Photo ref.	Significance	Proposal	Mitigation	Impact
14.004	Brick reveals with bull-nosed arrisses and segmental arch over (generally north side, alternating with granite surrounds – see previous item)

High	Retain door surround and gate wherever possible	Pin back gate against wall	Low

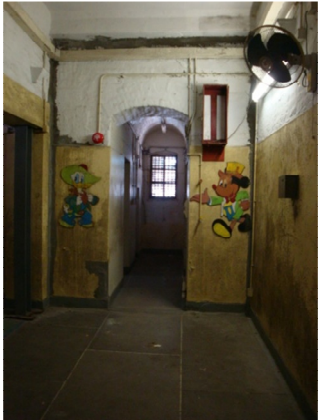
Element no.	Description	Photo ref.	Significance	Proposal	Mitigation	Impact
14.005	Arched opening at East end First Floor

Low	Retain as existing	Not applicable	Low
14.006	Concrete floor generally at Lower Ground Floor

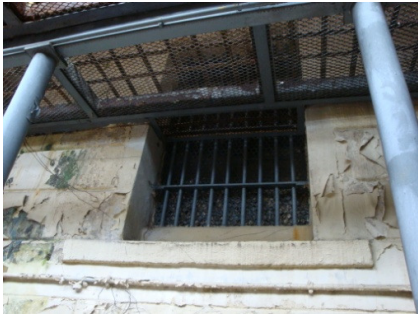
Element no.	Description	Photo ref.	Significance	Proposal	Mitigation	Impact
14.007	Part-blocked windows at Lower Ground Floor - extent of blocking varies.

Moderate	Open up window opening to full extent.	Record existing condition on measured survey drawings. Add further detail during demolition works.	Low
14.008	External granite stair from Lower Ground to Ground Floor level

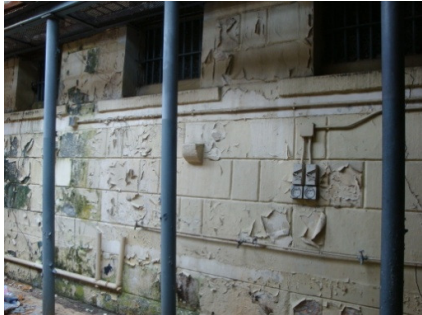
Element no.	Description	Photo ref.	Significance	Proposal	Mitigation	Impact
14.009	Ashlar pattern on external walls

Moderate	Form new openings for entrance/exit to building	<p>Set out new openings to cause minimum disruption to ashlar pattern.</p> <p>Record existing pattern on measured survey drawings.</p>	Low

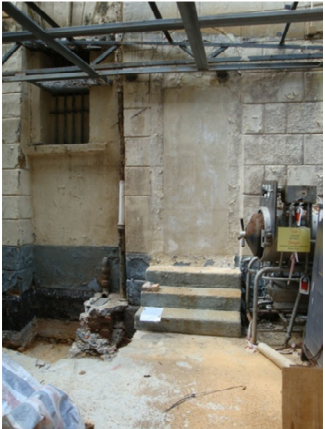
Element no.	Description	Photo ref.	Significance	Proposal	Mitigation	Impact
14.010	Blocked doorway at south-east corner

Low	Preserve blocked opening intact.	Not applicable	Neutral

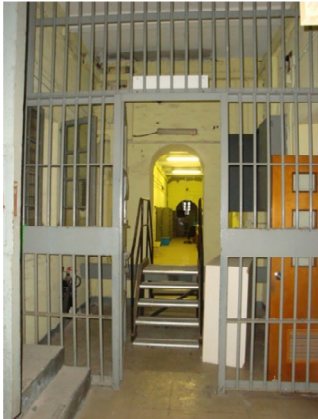
Element no.	Description	Photo ref.	Significance	Proposal	Mitigation	Impact
14.011	Metal security gate and screen

Low	Retain insitu	Pin gate in open position if necessary	Neutral

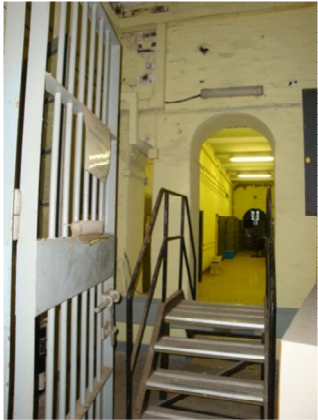
Element no.	Description	Photo ref.	Significance	Proposal	Mitigation	Impact
14.012	Half-round headed doorway and side lights at Ground Floor west end

Moderate	Retain insitu	Not applicable	Neutral
14.013	Structural steelwork bracing and temporary access stair

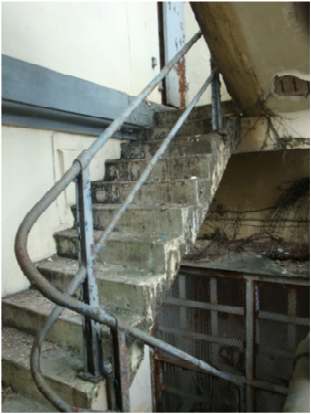
Element no.	Description	Photo ref.	Significance	Proposal	Mitigation	Impact
14.014	RC staircase at north-east corner

Low	Remove	Record on measured drawings	Low
14.015	Vinyl tile floor on suspended timber floor

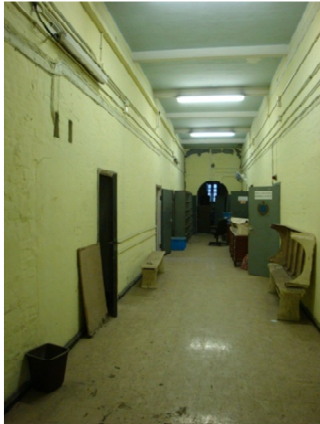
Element no.	Description	Photo ref.	Significance	Proposal	Mitigation	Impact
14.016	Cell walls at Ground Floor

Moderate	Retain insitu	<p>Use existing door openings wherever possible.</p> <p>Avoid further alteration to existing altered openings where feasible.</p>	Low

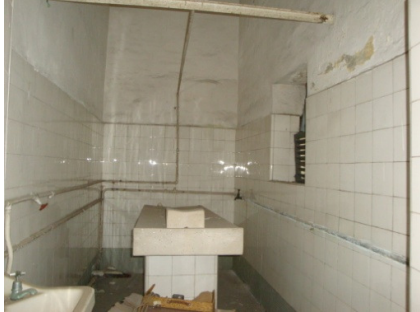
Element no.	Description	Photo ref.	Significance	Proposal	Mitigation	Impact
14.017	Mortuary

High	Preserve insitu	Avoid any service penetrations from adjacent spaces	Neutral
14.018	Brickwork surrounds to doorways with segmental arches over

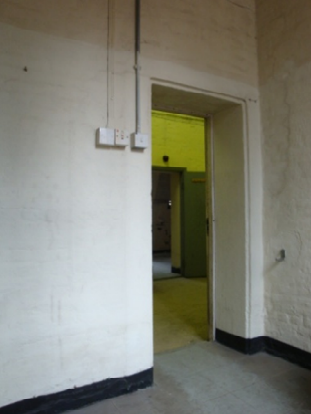
Element no.	Description	Photo ref.	Significance	Proposal	Mitigation	Impact
14.019	Granite surrounds to doorways with lintels over

Moderate	Increase width in selected locations to allow wheelchairs to pass	Record on measured survey drawings. Limit interventions as far as possible.	Low
14.020	Flat ceilings at Ground Floor

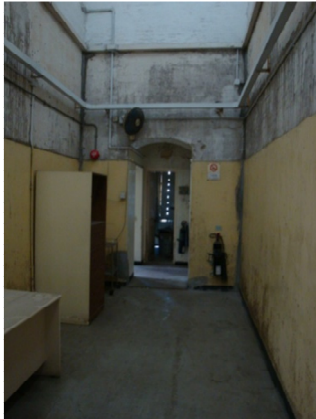
Element no.	Description	Photo ref.	Significance	Proposal	Mitigation	Impact
14.021	Arched opening at east end

Low	Retain insitu	Not applicable	Neutral

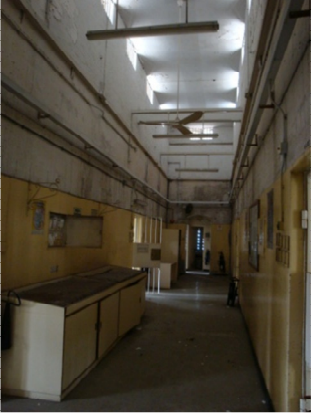
Element no.	Description	Photo ref.	Significance	Proposal	Mitigation	Impact
14.022	Top-lit central hall

High	Retain insitu	Not applicable	Neutral

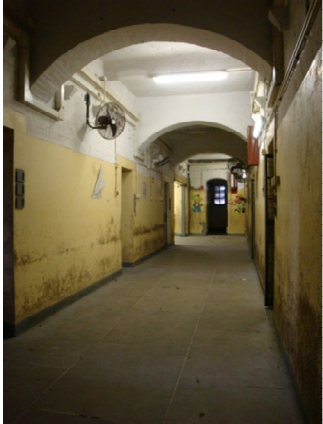
Element no.	Description	Photo ref.	Significance	Proposal	Mitigation	Impact
14.023	Arches across central hall at First Floor

Moderate	Retain insitu	Not applicable	Neutral

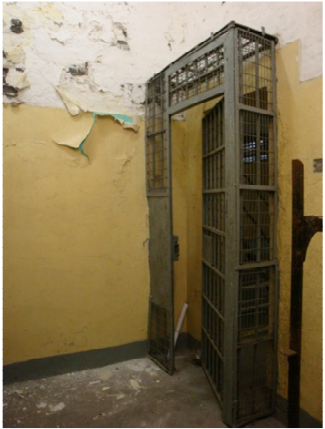
Element no.	Description	Photo ref.	Significance	Proposal	Mitigation	Impact
14.024	Inset security gate and screen in First Floor cells

Low	Remove to suit new use	Remove where necessary. Record on measured drawings.	Low

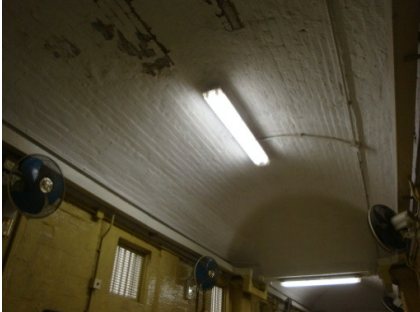
Element no.	Description	Photo ref.	Significance	Proposal	Mitigation	Impact
14.031	Brick vault over central hall at Ground Floor

High	Retain insitu	Not applicable	Neutral
14.032	Terrazzo floor in central hall at Ground floor

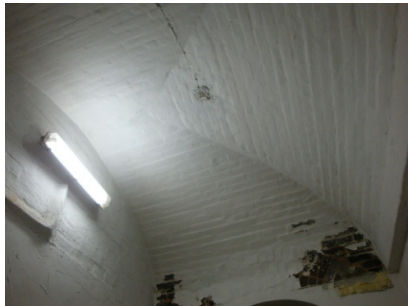
Element no.	Description	Photo ref.	Significance	Proposal	Mitigation	Impact
14.033	Brick vaults above cells

High	Retain insitu	Avoid penetrations for services	Neutral
14.034	Cell walls (later additions)

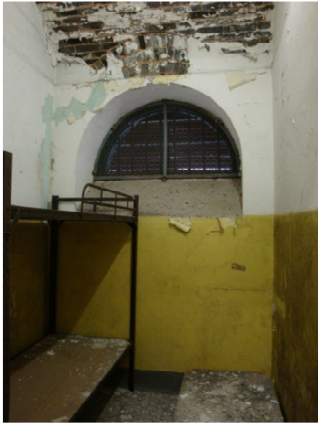
Element no.	Description	Photo ref.	Significance	Proposal	Mitigation	Impact
14.035	Brickwork spandrels below cell windows on south side at Ground Floor

Moderate	Remove to accommodate new cafe	Record on measured survey drawings	Low

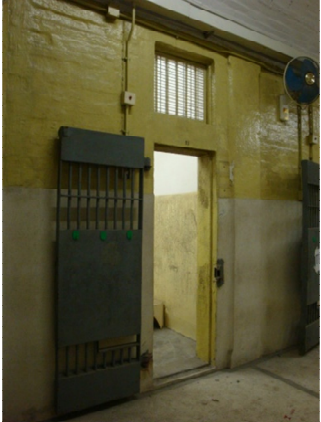
Element no.	Description	Photo ref.	Significance	Proposal	Mitigation	Impact
14.036	Cell walls flanking central hall

High	Remove to accommodate new cafe	Record on measured survey drawings. Retain selected cells for interpretation purposes.	Moderate

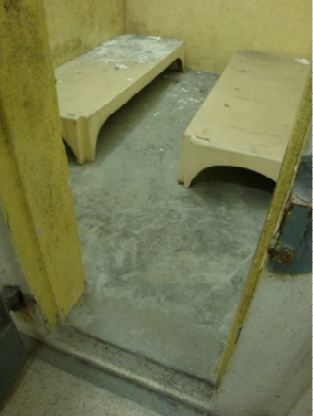
Element no.	Description	Photo ref.	Significance	Proposal	Mitigation	Impact
14.037	Cell floors

Low	Remove to enable piled underpinning	Record on measured survey drawings	Low

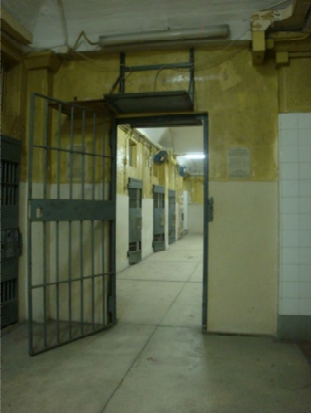
Element no.	Description	Photo ref.	Significance	Proposal	Mitigation	Impact
14.038	Partition wall across central hall at Ground Floor

Low	Remove to accommodate new cafe	Record on measured survey drawings	Low

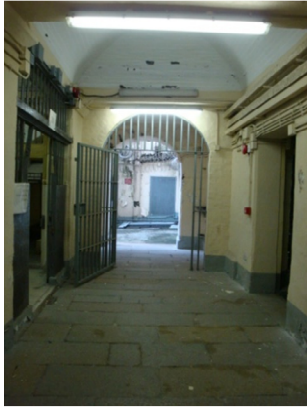
Element no.	Description	Photo ref.	Significance	Proposal	Mitigation	Impact
14.039	Granite pavement in cross-passage between East and West Wings

Moderate	Repair as necessary and retain insitu	Not applicable	Neutral
14.040	Granite threshold at doorway between cross-passage and East Wing

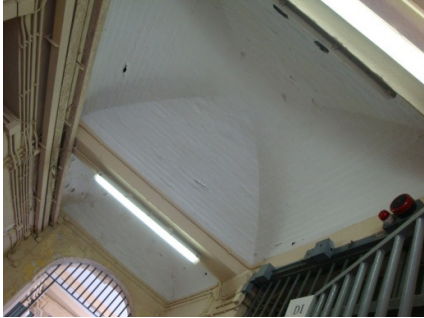
Element no.	Description	Photo ref.	Significance	Proposal	Mitigation	Impact
14.041	Brick vault over cross-passage

High	Retain insitu	Avoid any services penetrations	Neutral
14.042	Granite floor in central hall at First Floor

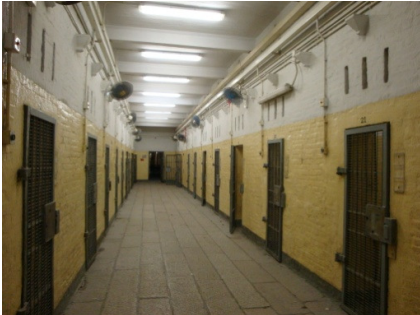
Element no.	Description	Photo ref.	Significance	Proposal	Mitigation	Impact
14.043	Cell walls flanking central hall at First Floor

High	Retain insitu	Not applicable	Neutral
14.044	Brickwork spandrels below cell windows at Second Floor

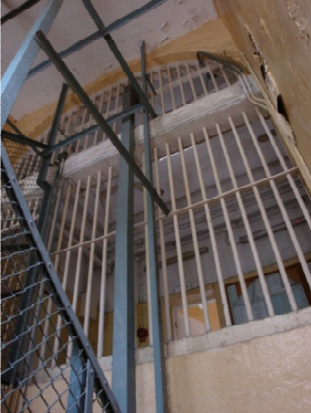
Element no.	Description	Photo ref.	Significance	Proposal	Mitigation	Impact
14.045	Metal security screen adjacent main stair

Moderate	Retain insitu	Not applicable	Neutral

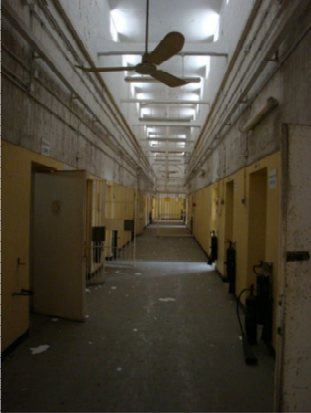
Element no.	Description	Photo ref.	Significance	Proposal	Mitigation	Impact
14.046	Double-height central hall at Second Floor

High	Retain insitu	Not applicable	Neutral

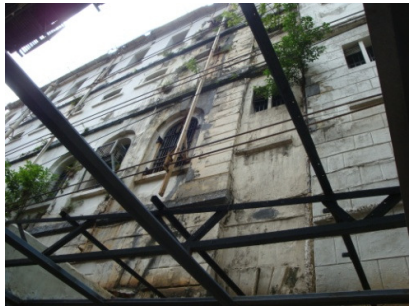
Element no.	Description	Photo ref.	Significance	Proposal	Mitigation	Impact
14.049	Metalwork and structural steel framing on exterior (typical)

Adverse	Remove	Not applicable	High
14.050	Blind arcade, south elevation

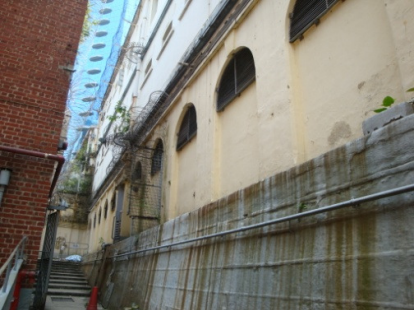
Element no.	Description	Photo ref.	Significance	Proposal	Mitigation	Impact
14.051	Blind arcade, north elevation

Low	Retain insitu	Not applicable	Neutral
14.052	Fence wall, east end of D Hall Yard

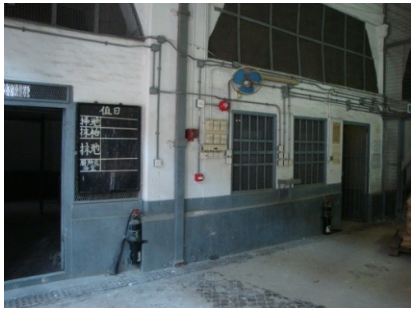
Element no.	Description	Photo ref.	Significance	Proposal	Mitigation	Impact
15.001	Dividing walls at Lower Ground Floor

Moderate	Remove to enable multi-purpose use	Record on measured survey drawings	Low
15.002	Dividing walls at Lower Ground Floor

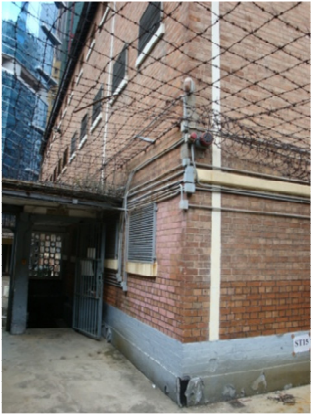
Element no.	Description	Photo ref.	Significance	Proposal	Mitigation	Impact
15.004	Services installations

Adverse	Remove	Not applicable	Moderate
15.005	Metal louvres over cell window openings

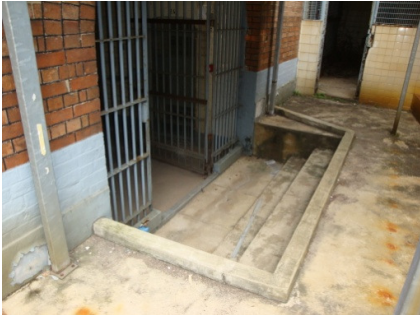
Element no.	Description	Photo ref.	Significance	Proposal	Mitigation	Impact
15.006	Raised ground level adjacent entrance

Low	Remove to enable level access	Record on measured survey drawings	Low
15.007	Access balconies and apertures

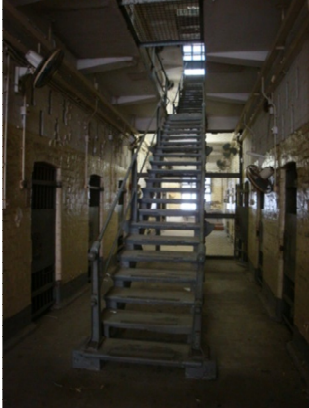
Element no.	Description	Photo ref.	Significance	Proposal	Mitigation	Impact
15.008	Central staircase

High	Retain	Provide secondary staircase within cell blocks to achieve code compliance	Low

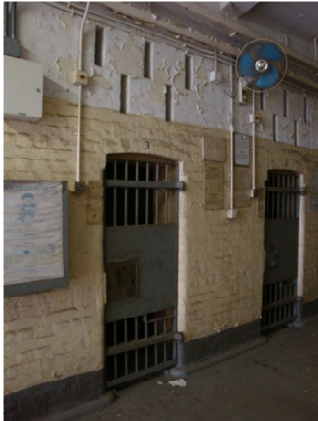
Element no.	Description	Photo ref.	Significance	Proposal	Mitigation	Impact
15.009	Cell walls flanking central hall

High	Retain	Pin back cell doors against walls.	Neutral

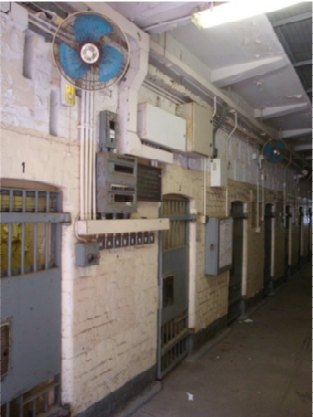
Element no.	Description	Photo ref.	Significance	Proposal	Mitigation	Impact
15.010	Services installations

Adverse	Remove	Not applicable	Moderate
15.011	Balcony balustrades

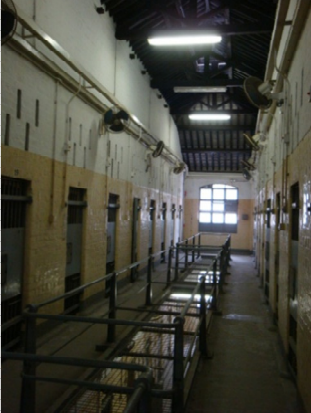
Element no.	Description	Photo ref.	Significance	Proposal	Mitigation	Impact
15.012	Second Floor central hall

High	Retain	Not applicable	Neutral

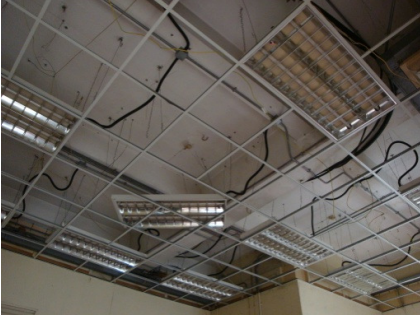
Element no.	Description	Photo ref.	Significance	Proposal	Mitigation	Impact
17.001	Lay-in grid suspended ceiling

Adverse	Remove	Not applicable	High

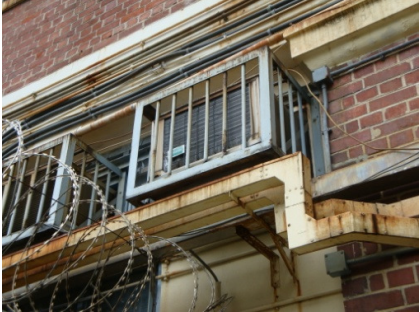
Element no.	Description	Photo ref.	Significance	Proposal	Mitigation	Impact
17.004	External airconditioning units and other external services

Adverse	Remove and make good brickwork	Not applicable	High
17.005	Fixed signs

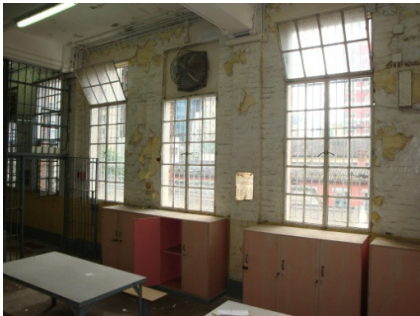
Element no.	Description	Photo ref.	Significance	Proposal	Mitigation	Impact
17.006	Security screen at First Floor entrance	 	Low	Remove	Record on measured drawings	Low
17.007	Metal windows

Moderate	Remove at First Floor to accommodate gallery space and block structural openings with blockwork	Record on measured drawings.	Moderate

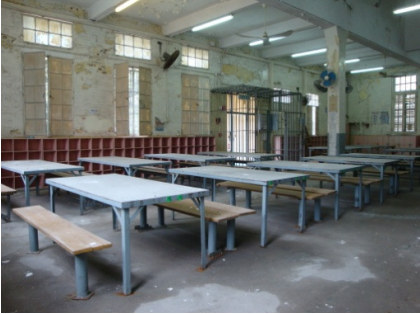
Element no.	Description	Photo ref.	Significance	Proposal	Mitigation	Impact
17.008	Fixed furniture

Moderate	Remove to accommodate gallery space	None	Low
17.009	Security screens

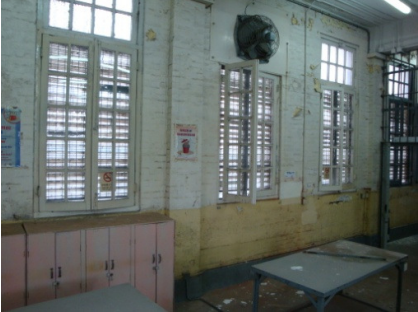
Element no.	Description	Photo ref.	Significance	Proposal	Mitigation	Impact
17.010	Timber windows

Moderate	Remove at First Floor to accommodate gallery space and block structural openings with blockwork	Record on measured drawings	Moderate
17.011	Communal washing/lavatory facilities

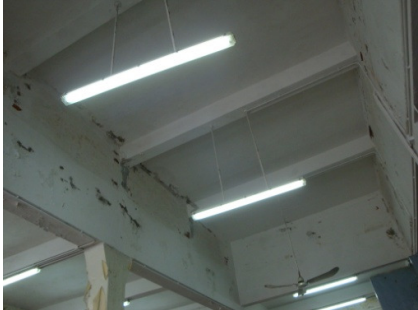
Element no.	Description	Photo ref.	Significance	Proposal	Mitigation	Impact
17.012	Blocked up lantern light

Low	Unblock lantern and fit glazing	Record on measured drawings	Low
17.013	Security gates at Ground openings

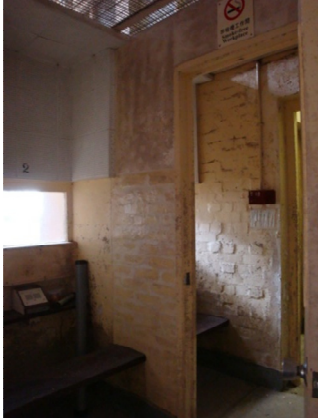
Element no.	Description	Photo ref.	Significance	Proposal	Mitigation	Impact
17.014	Interview booths

High	Remove to accommodate new gallery	Rebuild in new location	Moderate
17.015	External stair to First Floor

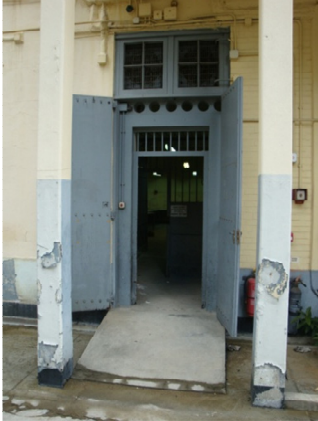
Element no.	Description	Photo ref.	Significance	Proposal	Mitigation	Impact
17.016	Ground Floor main entrance

Low	Retain as existing.	Keep fixed shut if not required for operational use.	Low

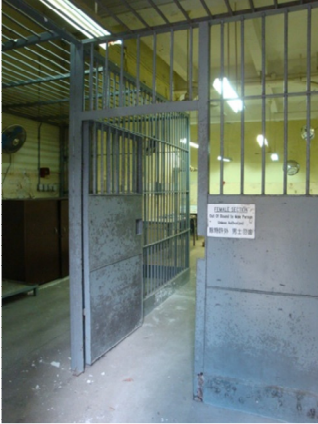
Element no.	Description	Photo ref.	Significance	Proposal	Mitigation	Impact
17.017	Security screen at Ground Floor main entrance

Low	Remove to accommodate gallery space	Record on measured drawings	Low

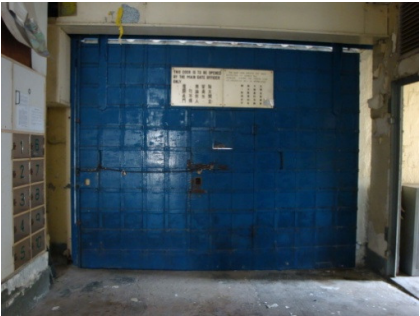
Element no.	Description	Photo ref.	Significance	Proposal	Mitigation	Impact
17.018	Blue Entrance Gate (facing Old Bailey Street)

High	Retain in situ	Maintain in working order	Neutral
17.019	Blue Entrance Gate (inner) and enclosed yard

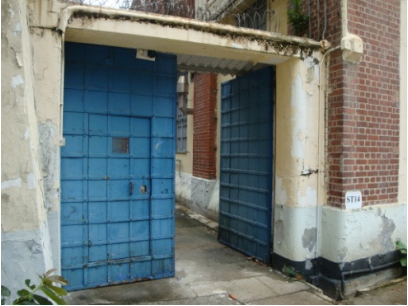
Element no.	Description	Photo ref.	Significance	Proposal	Mitigation	Impact
17.020	Blue Entrance Gate (inner) facing Prison Yard

Moderate	Retain gate and enclosing frame	Repair and maintain in working order	Low

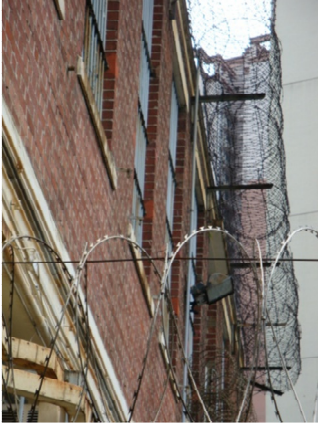
Element no.	Description	Photo ref.	Significance	Proposal	Mitigation	Impact
17.021	Barbed wire

Moderate	Remove	Record on measured drawings. Make good fixing points where attached to brickwork.	Low

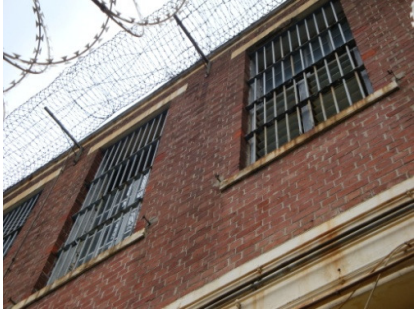
Element no.	Description	Photo ref.	Significance	Proposal	Mitigation	Impact
17.022	Metal security bars at windows

Moderate	Remove as part of blocking up window openings to accommodate gallery space at First Floor	Record on measured drawings	Low
17.023	External toilets at Ground Floor adjacent East elevation

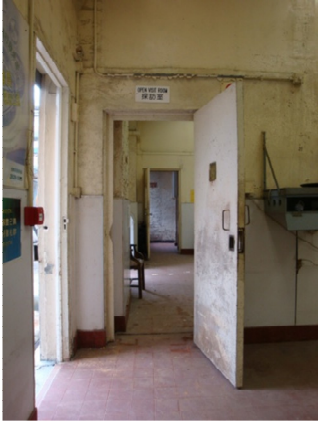
Element no.	Description	Photo ref.	Significance	Proposal	Mitigation	Impact
17.024	Open Visit Room

Low	Space reallocated to other uses	Record on measured drawings. Salvage entrance sign and re-use in new layout of interview booths.	Low

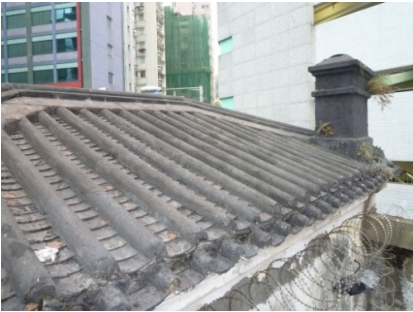
Element no.	Description	Photo ref.	Significance	Proposal	Mitigation	Impact
19.001	Pitched roofs

High	New penetrations through roofs for ventilation ducts and other services	Arrange new penetrations so that they conform with the geometry of the existing roof. Model the size and shape of the new ducts so that the impact on the roofscape is minimised. Finish the new ducts in a non-reflective material that is neutral in colour and mid-tone.	High
19.002	Chimney

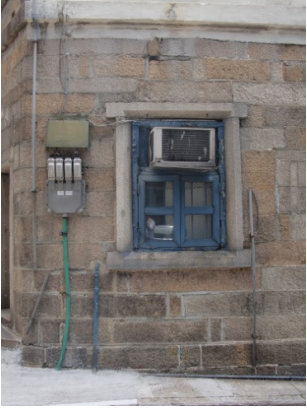
Element no.	Description	Photo ref.	Significance	Proposal	Mitigation	Impact
19.003	Rainwater goods and other external services

Adverse	Remove and make good wall surface. Replace defective and non-matching rainwater goods with cast iron fittings to match original.	Not applicable	Moderate

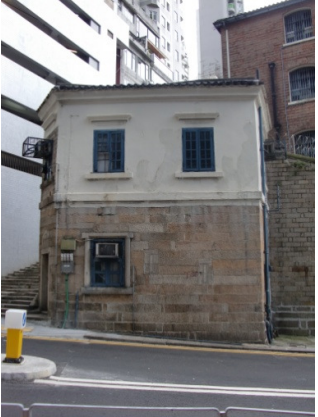
Element no.	Description	Photo ref.	Significance	Proposal	Mitigation	Impact
19.004	External stone wall facing

High	Carry out close inspection of painted areas to determine extent of original granite facing and remove paint media where applicable.	Not applicable	Moderate

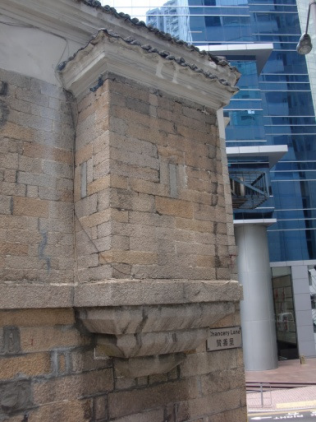
Element no.	Description	Photo ref.	Significance	Proposal	Mitigation	Impact
19.005	Gun loops

High	Remove concrete infilling and make good stonework where necessary.	Not applicable	Moderate

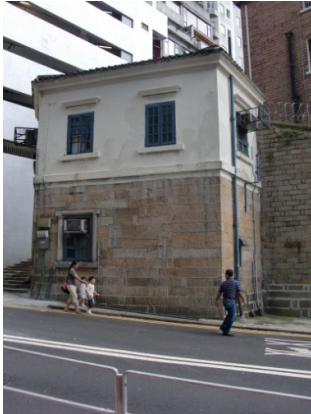
Element no.	Description	Photo ref.	Significance	Proposal	Mitigation	Impact
19.007	Windows

Moderate	Remove and make good stonework as necessary	Record existing windows on measured survey drawings	Moderate

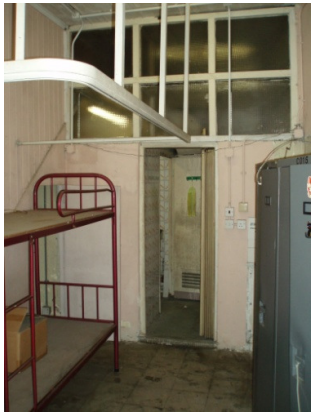
Element no.	Description	Photo ref.	Significance	Proposal	Mitigation	Impact
19.008	Modern partitions

Adverse	Remove	Not applicable	Moderate

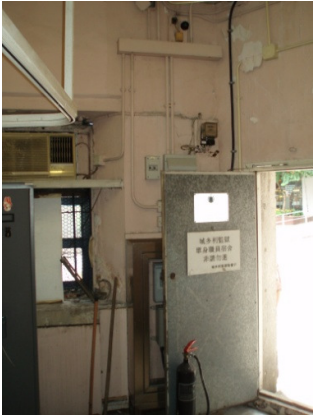
Element no.	Description	Photo ref.	Significance	Proposal	Mitigation	Impact
19.009	Electrical services

Adverse	Remove	Not applicable	Moderate
19.010	Lay-in grid suspended ceiling

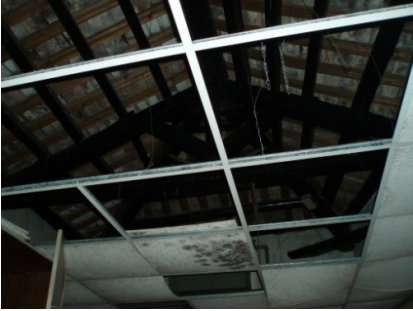
Element no.	Description	Photo ref.	Significance	Proposal	Mitigation	Impact
19.011	Exposed timber roof structure

High	Repair and retain insitu	Not applicable	Neutral
19.012	Timber stair
