The Jockey Club CPS Limited

Central Police Station Conservation
and Revitalisation Project:
First Annual EM&A Review Report
(1 November 2011 to 31 October
2012)

Environmental Resources Management

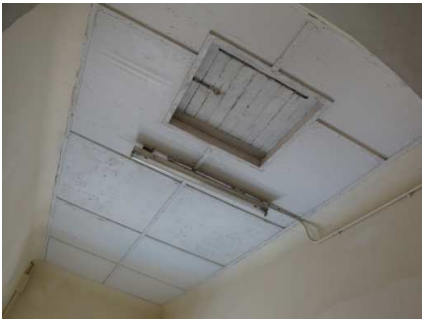
Element no.	Description	Photo ref	Significance	Proposal	Mitigation	Impact
01.001	Flat plywood ceiling lining with plain rectangular cover battens

Adverse	Replace with T&G boarding to match existing	Not applicable	High
01.002	Plaster coving at abutments of walls and ceilings

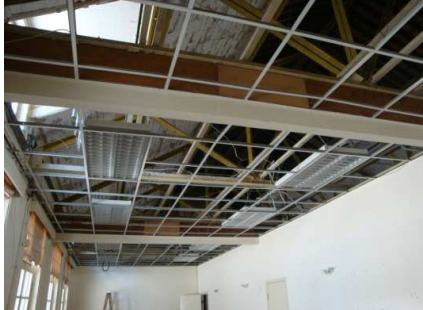
Element no.	Description	Photo ref	Significance	Proposal	Mitigation	Impact
01.003	Lay-in grid suspended ceiling

Adverse	Remove	Not applicable	High
01.004	Timber thresholds at external doors and internal doors between main corridor and individual rooms

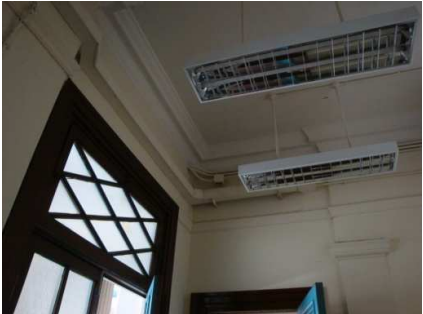
Element no.	Description	Photo ref	Significance	Proposal	Mitigation	Impact
01.005	Plaster box cornice

Moderate	Remove in exceptional cases eg. where adjacent new lift shafts	Cut back neatly to a square edge and ensure remaining section is secure.	Moderate
01.006	Panelled doors

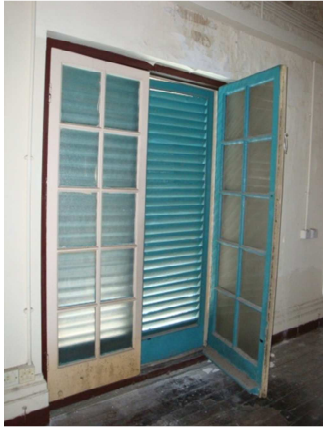
Element no.	Description	Photo ref	Significance	Proposal	Mitigation	Impact
01.007	External shutters

High	Reinstate to match existing pattern	Not applicable	High
01.008	External terraces at 1/F

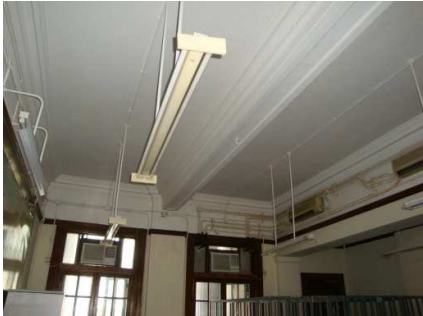
Element no.	Description	Photo ref	Significance	Proposal	Mitigation	Impact
01.009	Plaster ceilings on GF and LG1

Moderate	Install cloud ceilings to accommodate new services	Install fixed grid to minimise damage to ceiling	High
01.010	Timber door frames and architraves

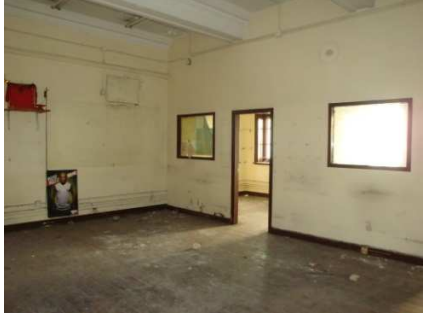
Element no.	Description	Photo ref	Significance	Proposal	Mitigation	Impact
01.011	Concrete floor

Low	Replace where new kitchens and plant rooms to be installed	Carefully remove and retain existing floorboards for re-use. Ensure controlled demolition of concrete structure and removal of debris from building to avoid damage to adjacent surfaces. Protect or carefully remove and set aside adjacent elements such as skirting boards	Low

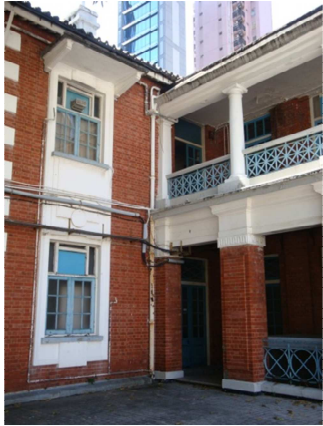
Element no.	Description	Photo ref	Significance	Proposal	Mitigation	Impact
01.012	Rainwater goods

Adverse	Replace with cast iron in pattern to match original and in correct locations	Not applicable	High

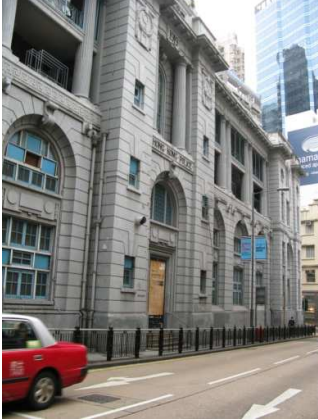
Element no.	Description	Photo ref	Significance	Proposal	Mitigation	Impact
01.013	Exterior decorations

Adverse	Strip off and redecorate	Sample and analyse existing paint media; select new media to suit substrate and significance	High

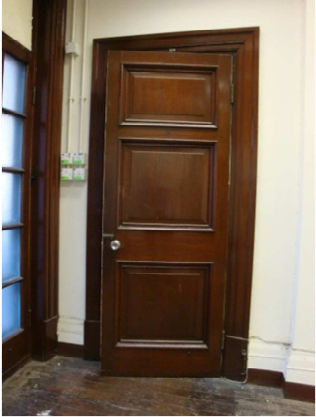
Element no.	Description	Photo ref	Significance	Proposal	Mitigation	Impact
01.014	Existing door openings

Moderate	Block opening as part of re-planning of interior	Retain existing door frame and architraves. Use framing and non-combustible sheet linings to block opening.	Moderate
01.015	Existing walls

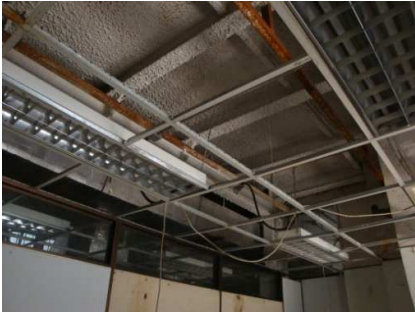
Adverse	Repair or renew as necessary existing frames to match original patterns	Not applicable	High
01.017	Mezzanine floor in room 01/LG1/13

Adverse	Remove floor and supporting columns to re-create original double-height space	Not applicable	High

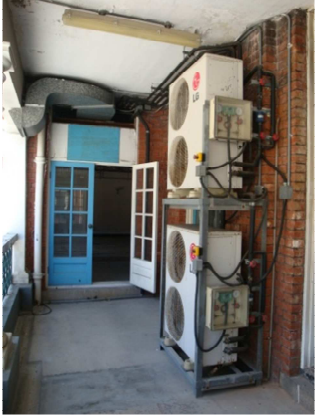
Element no.	Description	Photo ref	Significance	Proposal	Mitigation	Impact
01.020	External airconditioning units and other external services

Adverse	Remove and make good brickwork	Not applicable	High
01.021	Stair balustrades

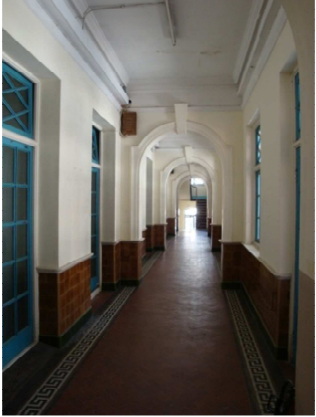
Element no.	Description	Photo ref	Significance	Proposal	Mitigation	Impact
01.022	Main corridors

High	Install new lighting, fire sprinklers, fire doors to comply with Fire Services Code	New fittings to be mounted in a manner that is of its time and reversible. Avoid physical intervention with existing plaster box cornices, architraves, dado rails	High
01.023	Painted signs

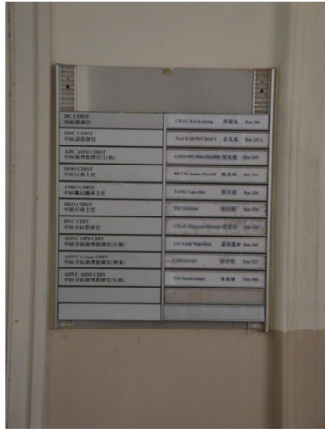
Element no.	Description	Photo ref	Significance	Proposal	Mitigation	Impact
01.024	Fixed signs

Low-High	Remove and refix/display in visitors' centre/discard	Record each sign and assess significance individually and treat accordingly	N/A
01.025	Pitched roofs

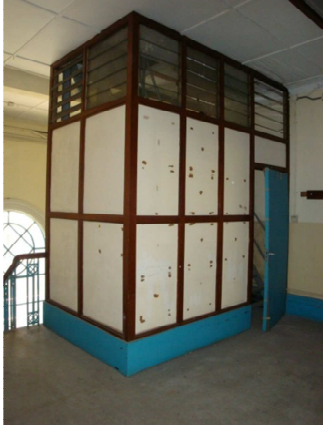
Element no.	Description	Photo ref	Significance	Proposal	Mitigation	Impact
					material in a neutral mid-tone.	
01.026	Enclosure at First Floor landing of main stair

Adverse	Remove	Not applicable	Moderate

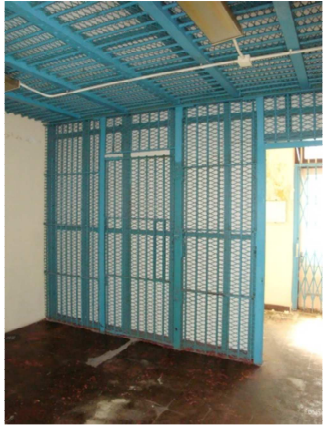
Element no.	Description	Photo ref	Significance	Proposal	Mitigation	Impact
01.027	Steel railing enclosure at FF level

Low	Remove	Record on measured drawings and photographs	Low
01.028	Tongued and grooved flat and sloped timber boarded ceilings

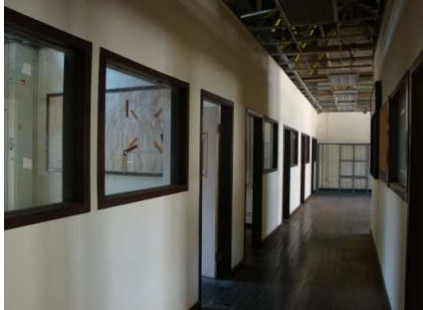
Element no.	Description	Photo ref	Significance	Proposal	Mitigation	Impact
01.029	Modern partitions

Adverse	Remove	Not applicable	High
01.030	Tiled dado

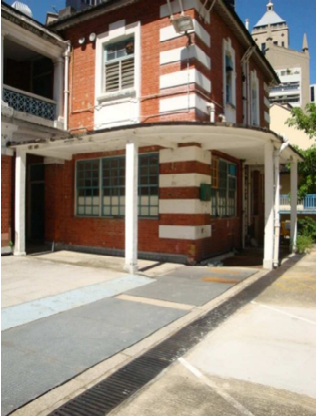
Element no.	Description	Photo ref	Significance	Proposal	Mitigation	Impact
01.031	Reinforced concrete canopy and sash windows

Moderate	Remove canopy and replace sash windows with new windows to match original	Make good brickwork where canopy removed, Reinstate rendered architraves around new window to match similar window facing on West wing	Moderate
01.032	Arched opening in brick wall above ceiling line

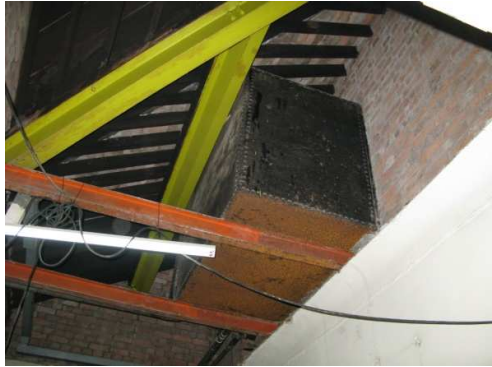
Element no.	Description	Photo ref	Significance	Proposal	Mitigation	Impact
01.033	Ceiling void service installation (Cast Iron Water Tank and pipework)

Low	Remove and make good adjacent surfaces	N/A	Low

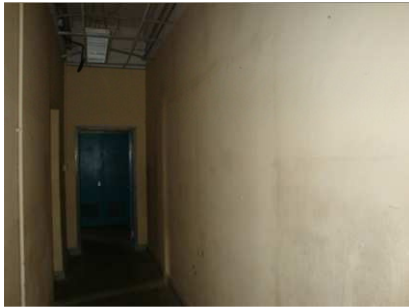
Element no.	Description	Photo ref.	Significance	Proposal	Mitigation	Impact
02.003	Modern partitions

Adverse	Remove	Not applicable	High
02.004	External airconditioning units and other external services

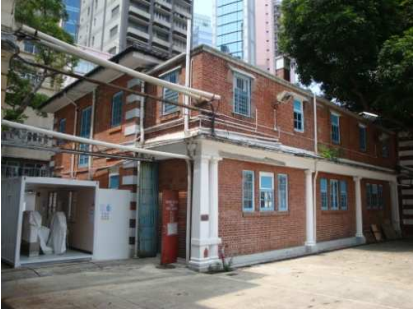
Element no.	Description	Photo ref.	Significance	Proposal	Mitigation	Impact
02.005	Brickwork walls enclosing rooms at GF and FF East side

Low	Remove and reinstate verandah	Not applicable	High
02.006	Concrete floors

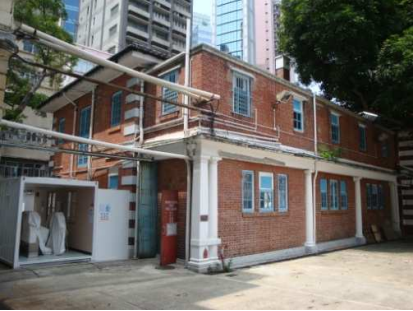
Element no.	Description	Photo ref.	Significance	Proposal	Mitigation	Impact
02.007	Rainwater goods

Adverse	Replace with cast iron in pattern to match original and in correct locations	No applicable	High
02.008	Altered doors and windows

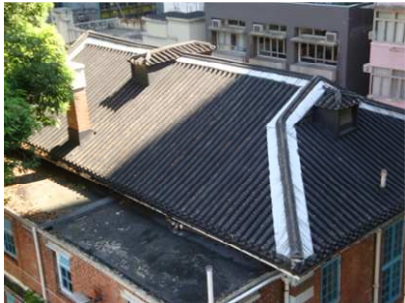
Adverse	Remove stairs	Not applicable	Moderate
02.010	Pitched roofs

High	New penetrations through roofs for ventilation ducts and other services	Arrange new penetrations so that they conform with the geometry of the existing roof. Model the size and shape of the new ducts to reduce impact. Finish ducts in a non-reflective material that is neutral in colour and mid-tone.	High

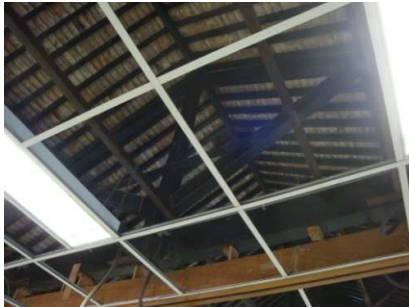
Element no.	Description	Photo ref.	Significance	Proposal	Mitigation	Impact
02.011	Roof structure and tiled soffit

High	Repair and retain.	N/A	Neutral

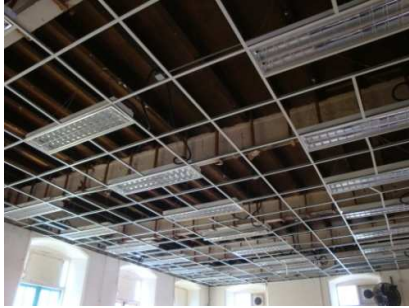
Element no.	Description	Photo ref.	Significance	Proposal	Mitigation	Impact
03.001	Lay-in grid suspended ceiling

Adverse	Remove	Not applicable	High

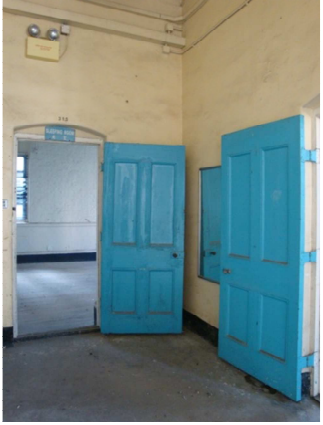
Element no.	Description	Photo ref.	Significance	Proposal	Mitigation	Impact
3.002	Panelled doors

Moderate	Replace where necessary to achieve fire resistance to comply with Code	Re-use where possible. Record design on survey drawings where item cannot be re-used.	Moderate
03.003	External shutters

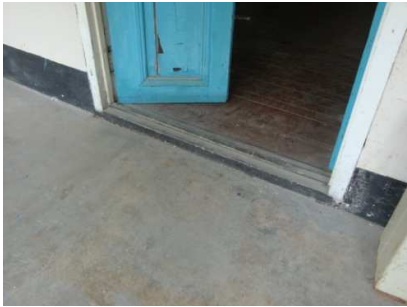
Element no.	Description	Photo ref.	Significance	Proposal	Mitigation	Impact
03.004	Timber thresholds at external doors and internal doors between main corridor and individual rooms

Low	Remove to enable level access	Splice extensions to door jambs, extend width of bottom rail of doors to match existing	Low
03.005	Timber spandrel panels below windows

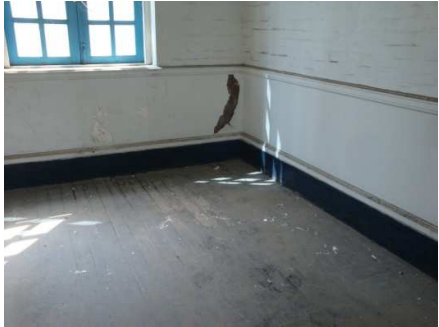
Element no.	Description	Photo ref.	Significance	Proposal	Mitigation	Impact
03.006	Timber floors

High	Replace where new kitchens and plant rooms to be installed	Limit extent of removal as much as possible. Carefully remove and retain existing floorboards for re-use. Ensure controlled dismantling of timber structure and set aside for possible re-use. Protect or carefully remove and set aside adjacent elements such as skirting boards	Medium

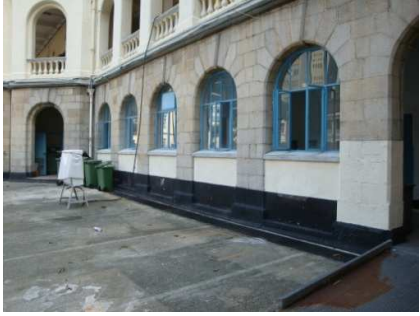
Adverse	Replace with cast iron in pattern to match original and in correct locations	No applicable	High
03.008	Exterior decorations

Adverse	Strip off and redecorate	Sample and analyse existing paint media; select new media to suit substrate and significance	High

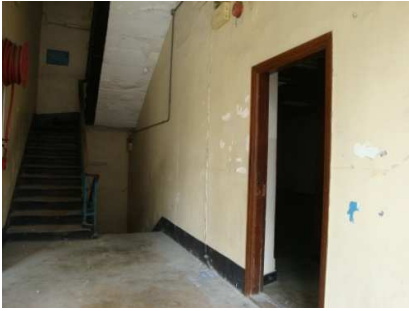
Element no.	Description	Photo ref.	Significance	Proposal	Mitigation	Impact
03.009	Block existing door openings

Low	Block opening as part of re-planning of interior	Retain existing door frame and architraves. Use framing and non-combustible sheet linings to block opening.	Low
03.010	Form new door openings

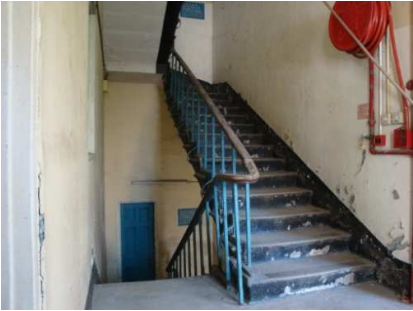
Adverse	Remove and make good brickwork	Not applicable	High
03.013	Stair balustrades

High	Balustrades to be supplemented with additional handrails and supports to mitigate non-compliance with code	New fittings to be of their time and made reversible. Physical intervention to existing stairs and balustrades to be kept to the minimum.	Moderate

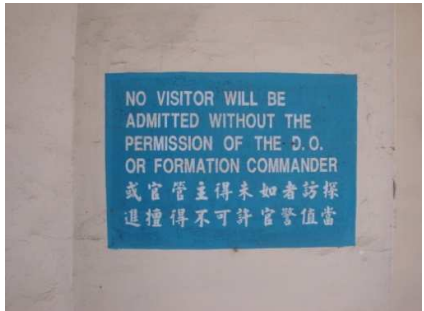
Element no.	Description	Photo ref.	Significance	Proposal	Mitigation	Impact
03.014	Painted signs

High	Protect in situ	Not applicable	N/A
03.015	Fixed signs

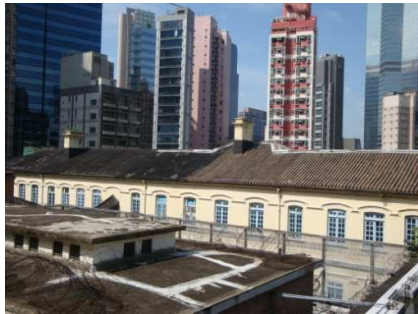
Element no.	Description	Photo ref.	Significance	Proposal	Mitigation	Impact
03.016	Pitched roofs

High	New penetrations through roofs for ventilation ducts and other services	<p>Arrange new penetrations so that they conform with the geometry of the existing roof.</p> <p>Model the size and shape of the new ducts so that the impact on the roovescape is minimised.</p> <p>Finish the new ducts in a non-reflective material that is neutral in colour and mid-tone.</p>	High
03.017	Lean-to structure adjacent North wall

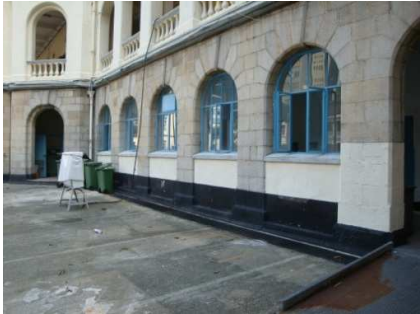
Element no.	Description	Photo ref.	Significance	Proposal	Mitigation	Impact
03.018	Metal-frames windows at GF North elevation

Adverse	Remove window frames, masonry spandrel panels below and reinstate verandah	Not applicable	High
03.019	Internal walls at Ground Floor level

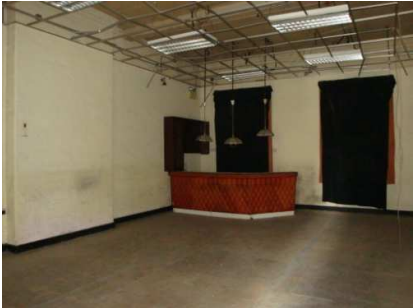
Element no.	Description	Photo ref.	Significance	Proposal	Mitigation	Impact
03.020	Assembly rooms at centre of building (all floors)

Moderate	Sub-divide two rooms on each floor to provide service core, comprising: lifts, toilets, plant rooms, stores	Form new sub-visions using lightweight partitions to achieve reversibility. Form straight joints at abutments with existing retained walls. Notch new partitions around existing brick corbels at high level as a reminder of current condition.	Moderate
03.021	Exposed soffits of timber floors

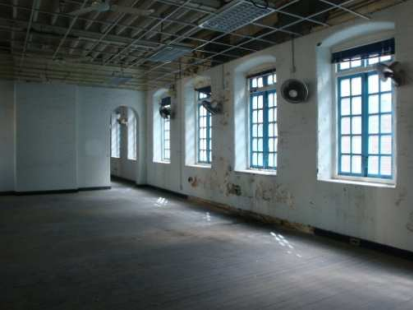
Element no.	Description	Photo ref.	Significance	Proposal	Mitigation	Impact
03.022	Existing window frames/openings

High	Open up selected openings to form new fire escape doors	Retain any salvageable material for possible re-use elsewhere. Retain existing window jambs intact. Cut away masonry to form door openings along same line as window jamb; do not re-bind cut brickwork. Record existing condition on measured survey drawings.	Low
03.023	Single storey outbuildings on south side

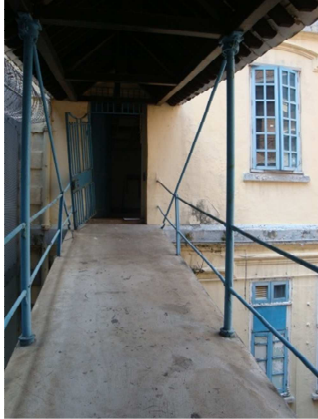
Element no.	Description	Photo ref.	Significance	Proposal	Mitigation	Impact
03.024	Bridge at east end

Moderate	Retain	Not applicable	Neutral
03.025	Chimneypiece on Ground Floor

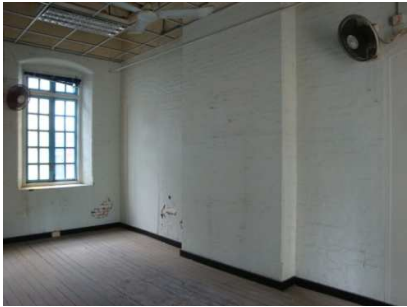
Element no.	Description	Photo ref.	Significance	Proposal	Mitigation	Impact
03.026	Window in south wall; original dormitory space

Moderate	Remove window and take down brickwork spandrel; subdivide space to form new fire-protected escape route.	Record existing condition on measured survey drawings. New partition wall to be reversible.	Low
03.027	Clay-tiled floor in store room adjacent stairs

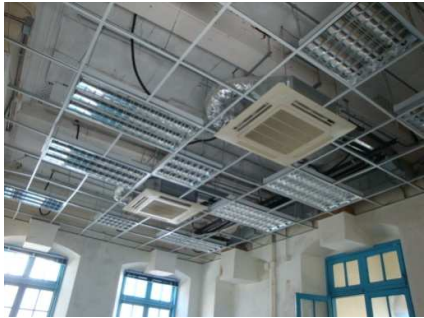
Element no.	Description	Photo ref.	Significance	Proposal	Mitigation	Impact
04.001	Lay-in grid suspended ceiling

Adverse	Remove	Not applicable	High
04.002	Timber thresholds at external doors and internal doors between main corridor and individual rooms

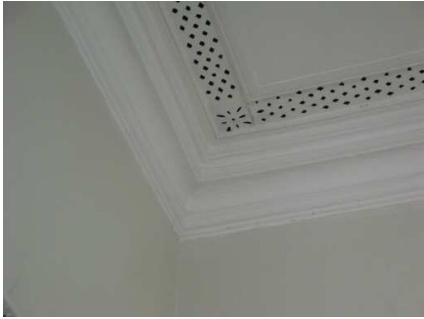
Element no.	Description	Photo ref.	Significance	Proposal	Mitigation	Impact
04.003	Plaster box cornice

Moderate	Remove in exceptional cases where eg. where adjacent new lift shafts	Cut back neatly to a square edge and ensure remaining section is secure.	Moderate
04.004	Rainwater goods

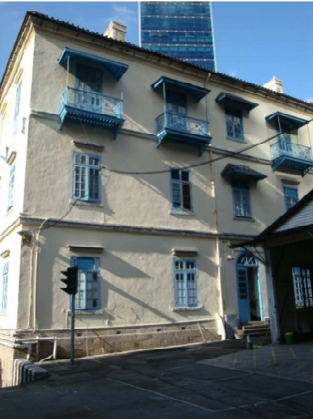
Element no.	Description	Photo ref.	Significance	Proposal	Mitigation	Impact
04.005	Exterior decorations

Adverse	Strip off and redecorate	Sample and analyse existing paint media; select new media to suit substrate and significance	High

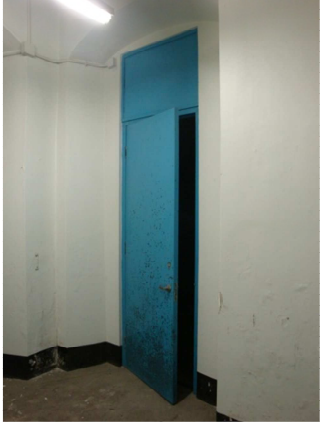
Element no.	Description	Photo ref.	Significance	Proposal	Mitigation	Impact
04.006	Block existing door openings

Moderate	Block opening as part of re-planning of interior	Retain existing door frame and architraves. Use framing and non-combustible sheet linings to block opening.	Moderate
04.007	Form new door openings

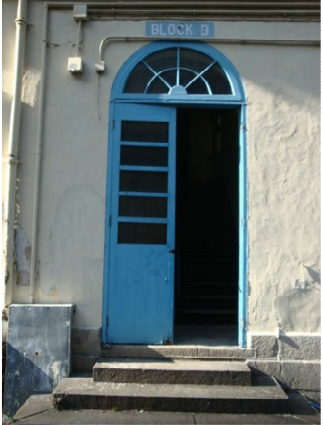
Element no.	Description	Photo ref.	Significance	Proposal	Mitigation	Impact
04.008	Altered doors and windows

Adverse	Repair or renew as necessary existing frames to match original patterns	Not applicable	High

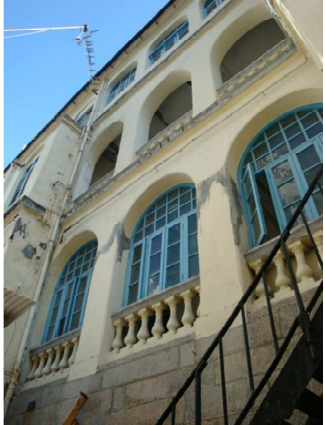
Element no.	Description	Photo ref.	Significance	Proposal	Mitigation	Impact
04.009	Window frames in arcades of North and East elevations

Adverse	Remove window frames and make good masonry reveals and reinstate verandah	Not applicable	High

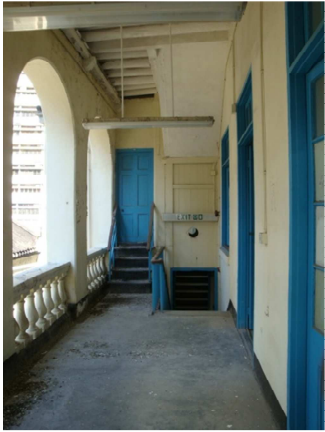
Element no.	Description	Photo ref.	Significance	Proposal	Mitigation	Impact
04.013	External verandahs

High	Install new lighting, fire sprinklers, fire doors to comply with Fire Services Code, extract ducting to external walls	New fittings to be mounted in a manner that is of its time and reversible. Avoid physical intervention with existing plaster box cornices in rooms, architraves, dado rails. Position outlet grilles in external walls on centre-line of arcade arches and above structural arch	High
04.014	Painted signs

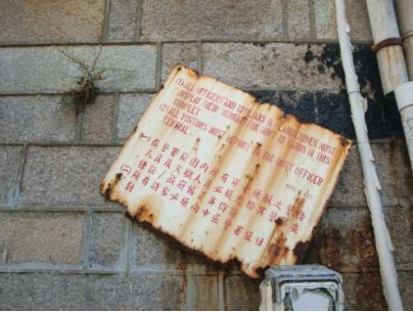
Element no.	Description	Photo ref.	Significance	Proposal	Mitigation	Impact
04.015	Fixed signs

Low-High	Remove and refix/display in visitors' centre/discard	Record each sign and assess significance individually and treat accordingly	N/A
04.016	Pitched roofs

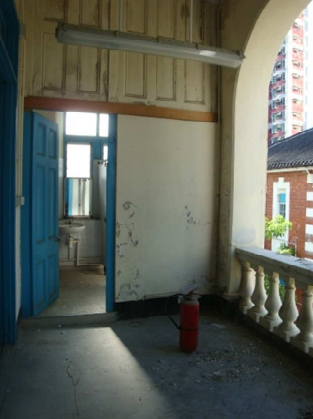
Element no.	Description	Photo ref.	Significance	Proposal	Mitigation	Impact
04.017	Toilets at ends of verandahs

Adverse	Remove and make good finishes	Not applicable	High

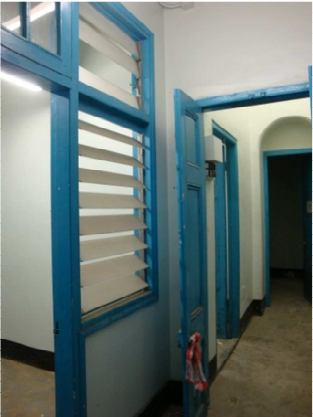
Element no.	Description	Photo ref.	Significance	Proposal	Mitigation	Impact
04.018	Partitions at GF Dormitory A

High	Remove to make way for Interpretation	Prepare measured drawings and photographs before removal.	Moderate

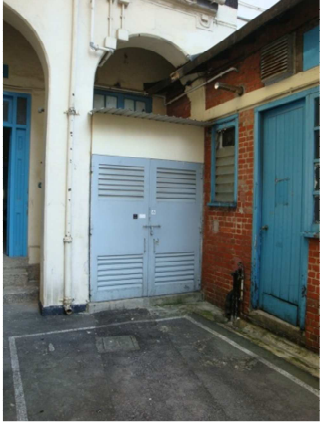
Element no.	Description	Photo ref.	Significance	Proposal	Mitigation	Impact
04.019	Switchgear in old porch 04/G/13

Adverse	Open up porch, remove electrical switchgear and make good	Not applicable	High
04.020	Flat plywood ceiling lining with plain rectangular cover battens

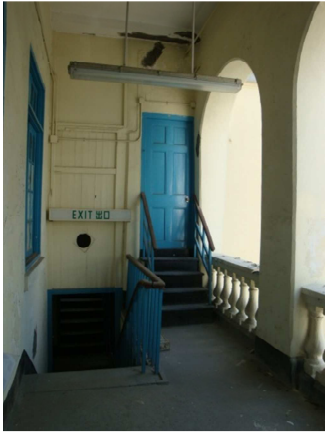
Element no.	Description	Photo ref.	Significance	Proposal	Mitigation	Impact
04.021	Steps up to doorway on FF verandah

Moderate	Remove steps and doorway to form new fore escape route	Record steps and doorway on measured drawings	Moderate
04.022	Timber boarded floors with moulded skirtings

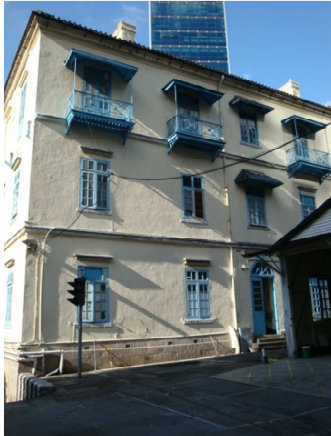
Element no.	Description	Photo ref.	Significance	Proposal	Mitigation	Impact
04.023	Cantilever balconies

High	<p>Retain and repair as necessary.</p> <p>Reinstate balcony on west elevation.</p>	<p>Avoid highly visible intervention to enhance structural integrity and/or compliance with building codes.</p> <p>Restrict access if necessary to achieve this objective.</p>	Low

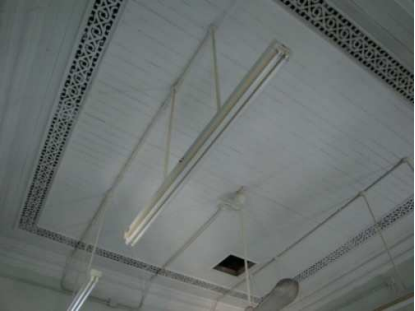
Element no.	Description	Photo ref.	Significance	Proposal	Mitigation	Impact
04.024	Clay tile floor		Low	Retain and repair as necessary	Not applicable	Neutral
04.025	Matched-boarded ceiling with perforated border

Moderate	Repair and retain insitu	Not applicable	Neutral

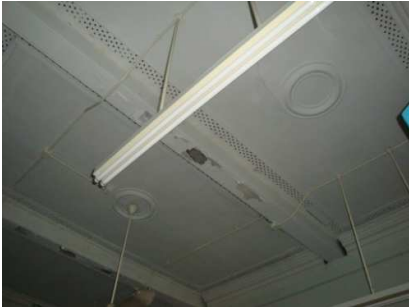
Element no.	Description	Photo ref.	Significance	Proposal	Mitigation	Impact
04.026	Ceiling rose

Low	Repair and retain insitu	Not applicable	Neutral

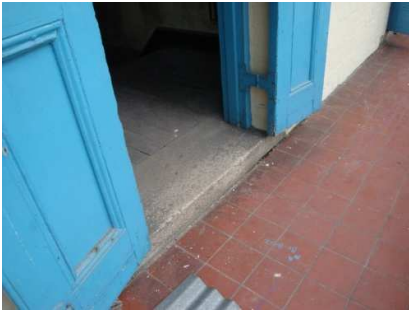
Element no.	Description	Photo ref.	Significance	Proposal	Mitigation	Impact
06.001	Granite thresholds at external doors

Low	Retain; install timber deck flush with level of step where necessary	Avoid alteration to step.	Low
06.002	Pitched roof

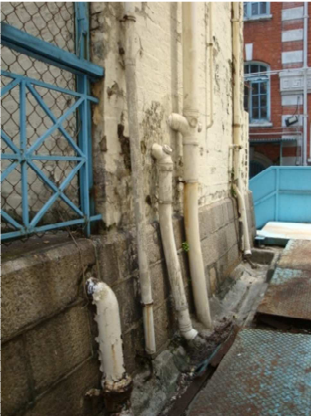
Element no.	Description	Photo ref.	Significance	Proposal	Mitigation	Impact
06.003	Rainwater goods

Adverse	Replace with cast iron in pattern to match original and in correct locations	Not applicable	High
06.004	Exterior decorations

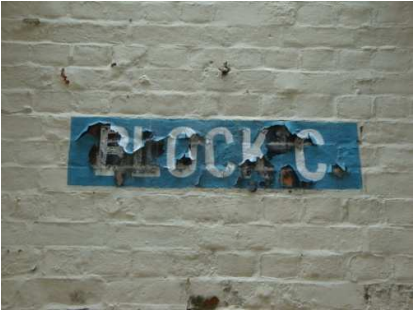
Element no.	Description	Photo ref.	Significance	Proposal	Mitigation	Impact
06.007	Painted signs

High	Protect in situ	Not applicable	N/A
06.008	Fixed signs

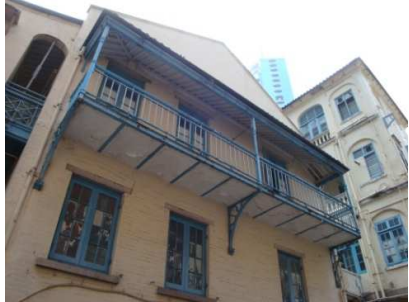
Element no.	Description	Photo ref.	Significance	Proposal	Mitigation	Impact
06.009	Cantilever balconies

High	Retain and repair as necessary.	Avoid highly visible intervention to enhance structural integrity and/or compliance with building codes. Restrict access if necessary to achieve this objective.	Low
06.010	Iron balustrades

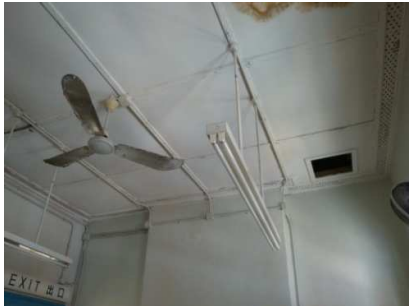
Element no.	Description	Photo ref.	Significance	Proposal	Mitigation	Impact
06.011	Perforated margin at perimeter of ceiling

Low	Repair and retain.	Where fire-proofing of floor is required, use a product that can be installed within the floor void, leaving the ceiling lining intact.	Low
06.012	Block existing door openings

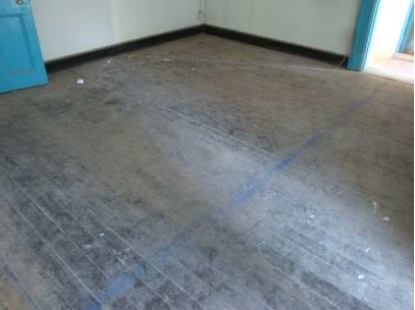
Element no.	Description	Photo ref.	Significance	Proposal	Mitigation	Impact
06.015	Timber floors

High	Retain all boarded floors and skirtings	Reinstate floor boards and skirtings after fire proofing works	Low
06.016	Vinyl tile floor

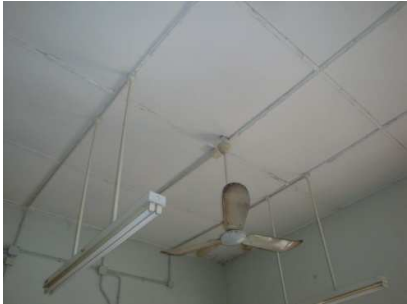
Element no.	Description	Photo ref.	Significance	Proposal	Mitigation	Impact
06.017	Batten and panel ceiling lining

Low	Replace with lath and plaster ceiling	Not applicable	Low
06.018	Exposed roof covering	 	Moderate	Retain as existing	Consider insulating between upper and lower layers of roof tiles to provide thermal insulation and vapour barrier	Low

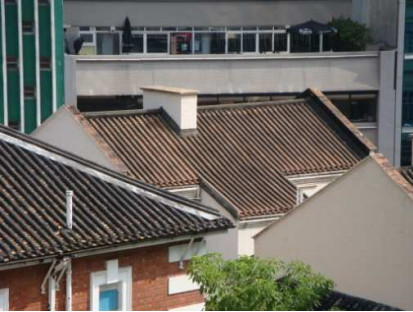
Element no.	Description	Photo ref.	Significance	Proposal	Mitigation	Impact
07.001	Pitched roofs

High	New penetrations through roofs for ventilation ducts and other services	<p>Arrange new penetrations so that they conform with the geometry of the existing roof.</p> <p>Model the size and shape of the new ducts so that the impact on the roofscape is minimised.</p> <p>Finish the new ducts in a non-reflective material that is neutral in colour and mid-tone.</p>	High
07.002	Rainwater goods

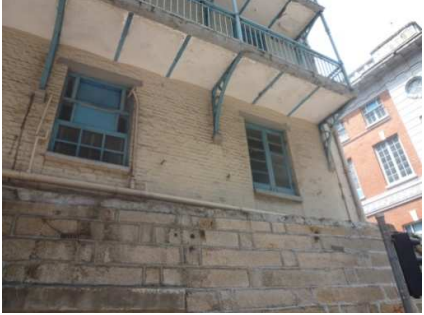
Element no.	Description	Photo ref.	Significance	Proposal	Mitigation	Impact
07.003	Exterior decorations

Adverse	Strip off and redecorate	Sample and analyse existing paint media; select new media to suit substrate and significance	High
07.004	Altered doors and windows

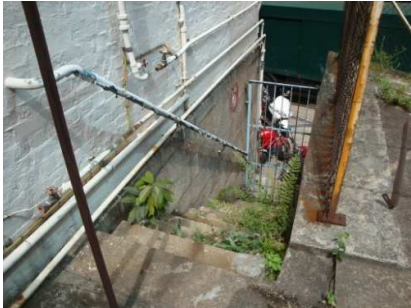
Element no.	Description	Photo ref.	Significance	Proposal	Mitigation	Impact
07.005	External airconditioning units and other external services

Adverse	Remove and make good brickwork	Not applicable	High
07.006	Clothes drying racks

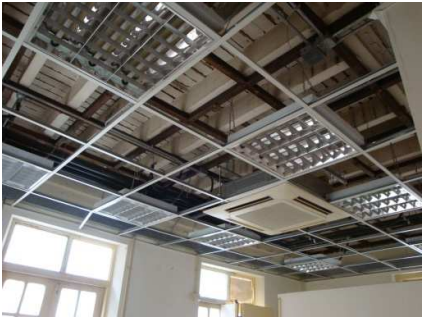
Element no.	Description	Photo ref.	Significance	Proposal	Mitigation	Impact
07.008	Lay-in grid suspended ceiling

Adverse	Remove	Not applicable	High
07.009	Corbelled brickwork at perimeter of room

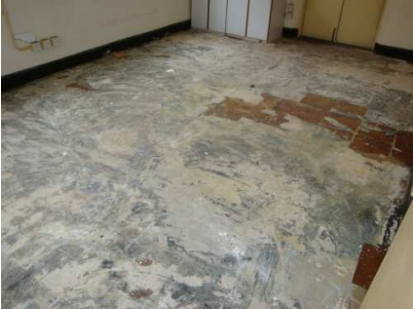
Element no.	Description	Photo ref.	Significance	Proposal	Mitigation	Impact
07.010	Plywood floor

Adverse	Replace with hardwood floor boards	Not applicable	High
07.011	Timber thresholds at external doors and internal doors between main corridor and individual rooms

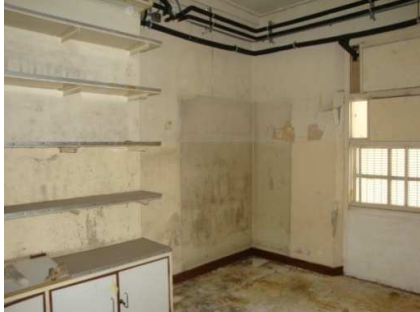
Element no.	Description	Photo ref.	Significance	Proposal	Mitigation	Impact
07.012	Form new door openings

Moderate	Form new opening as part of re-planning of interiors	New doors and frames to be of their time to avoid confusion about provenance	Moderate
07.013	Stair balustrades

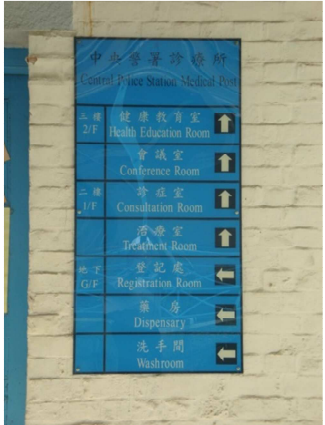
Element no.	Description	Photo ref.	Significance	Proposal	Mitigation	Impact
07.014	Fixed signs

Low-High	Remove and refix/display in visitors' centre/discard	Record each sign and assess significance individually and treat accordingly	N/A
07.015	Exposed roof tiling

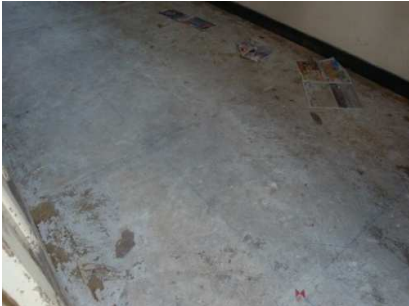
Element no.	Description	Photo ref.	Significance	Proposal	Mitigation	Impact
07.016	Concrete floor

Adverse	Overlay with hardwood floor boards	Not applicable	Moderate

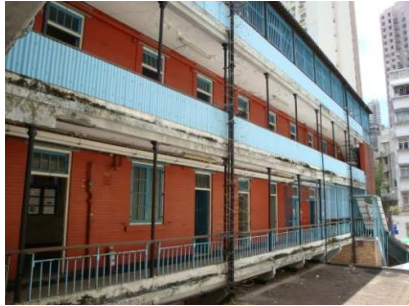
Element no.	Description	Photo ref.	Significance	Proposal	Mitigation	Impact
08.001	Panelled doors

Low	Replace where necessary to achieve compliance with Building Code	Re-use where possible. Record design on survey drawings where element cannot be re-used.	Moderate
08.002	Rainwater goods

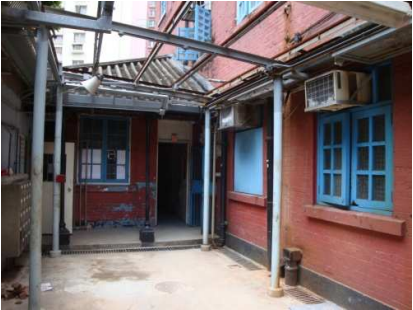
Element no.	Description	Photo ref.	Significance	Proposal	Mitigation	Impact
08.003	Exterior decorations

Adverse	Strip off and redecorate	Sample and analyse existing paint media; select new media to suit substrate and significance	High
08.004	Block existing door openings

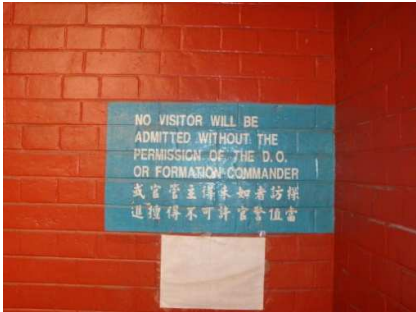
Adverse	Remove and make good brickwork	Not applicable	High
08.008	Painted signs

High	Protect in situ	Not applicable	N/A

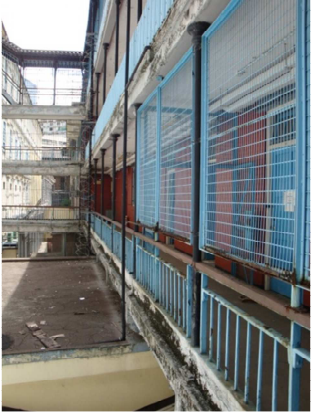
Element no.	Description	Photo ref.	Significance	Proposal	Mitigation	Impact
08.009	Wire mesh screens

Adverse	Remove	Not applicable	Low
08.010	Internal walls and concrete floors

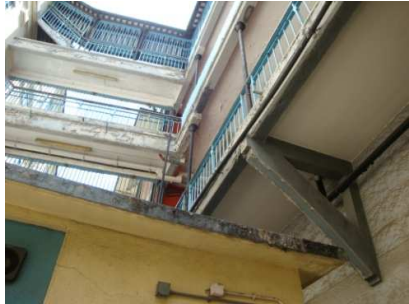
Element no.	Description	Photo ref.	Significance	Proposal	Mitigation	Impact
08.011	Cantilever balconies on north side

Moderate	Repair and retain insitu	Not applicable	
08.012	Bridge access to Barrack Block

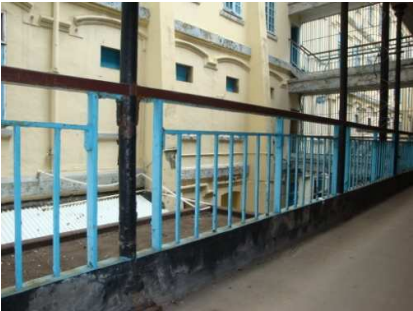
Element no.	Description	Photo ref.	Significance	Proposal	Mitigation	Impact
08.013	Balcony balustrades

Low	<p>Repair as necessary and retain.</p> <p>Remove selected sections to enable installation of new bridge connections to Barrack Block.</p>	<p>Avoid removal of associated iron columns.</p> <p>Form interventions at selected positions so as to maintain the rhythm of the balustrades and ensure proper support at ends.</p>	Low
08.014	Single-storey outbuilding with pitched roof over

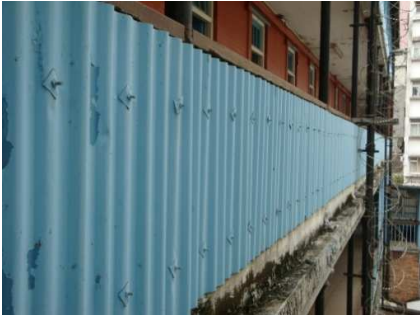
Element no.	Description	Photo ref.	Significance	Proposal	Mitigation	Impact
08.015	Corrugated steel sheet on balcony balustrades

Adverse	Remove	Not applicable	Low

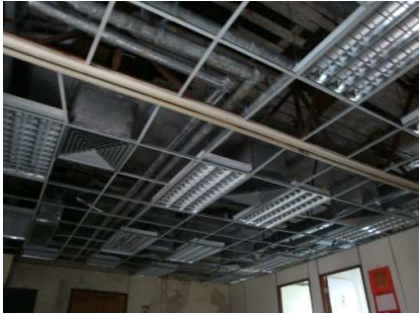
Element no.	Description	Photo ref.	Significance	Proposal	Mitigation	Impact
09.001	Lay-in grid suspended ceiling

Adverse	Remove	Not applicable	High
09.002	Modern partitions

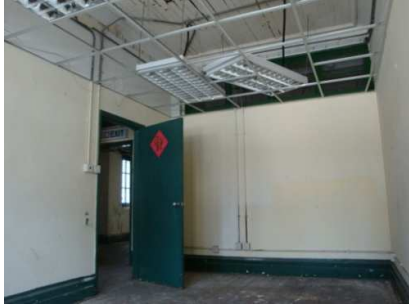
Element no.	Description	Photo ref.	Significance	Proposal	Mitigation	Impact
09.003	Internal walls

Moderate	Remove selected internal walls where strictly necessary as part of re-planning of interiors	Walls or early or original date to be retained in part eg. By leaving a “nib” where the wall is bonded to another wall. At the point where the wall is cut away, form the cut-line on the line of a vertical joint in alternate courses. Bricks in the remaining courses to be left “as cut”, and not re-bonded, as evidence of the current condition.	Moderate
09.004	Plaster box cornice

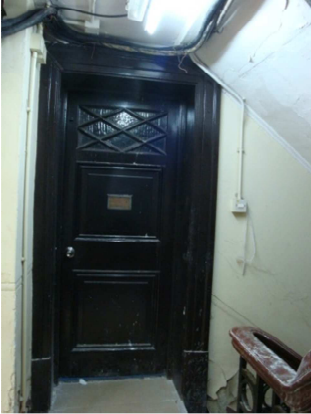
Element no.	Description	Photo ref.	Significance	Proposal	Mitigation	Impact
09.006	Block existing door openings

Moderate	Block opening as part of re-planning of interior	Retain existing door frame and architraves. Use framing and non-combustible sheet linings to block opening.	Moderate
09.007	Form new door openings		Moderate	Form new opening as part of re-planning of interiors	New doors and frames to be of their time to avoid confusion about provenance	Moderate

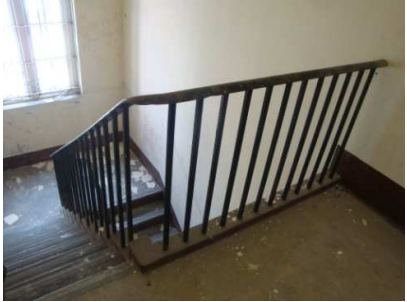
Element no.	Description	Photo ref.	Significance	Proposal	Mitigation	Impact
09.008	Stair balustrades

High	Balustrades to be supplemented with additional handrails and supports to mitigate non-compliance with code	New fittings to be of their time and made reversible. Physical intervention to existing stairs and balustrades to be kept to the minimum.	Moderate
09.009	Fixed signs

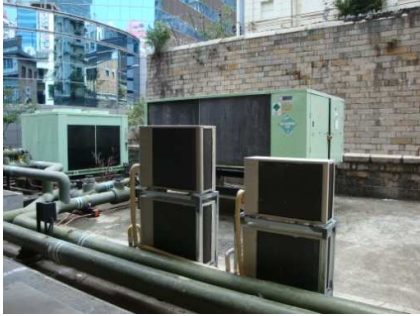
Element no.	Description	Photo ref.	Significance	Proposal	Mitigation	Impact
09.010	External airconditioning units and other external services

Adverse	Remove and make good brickwork	Not applicable	High
09.011	Pitched roofs

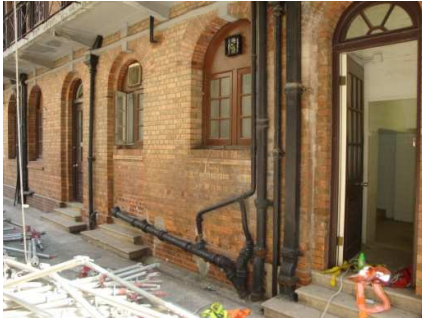
Element no.	Description	Photo ref.	Significance	Proposal	Mitigation	Impact
09.012	Rainwater goods

Moderate	Replace with larger sizes/closer spacing to improve performance	Use cast iron to match original pattern Make good all redundant fixing holes	High
09.013	Metal walkways across lightwell

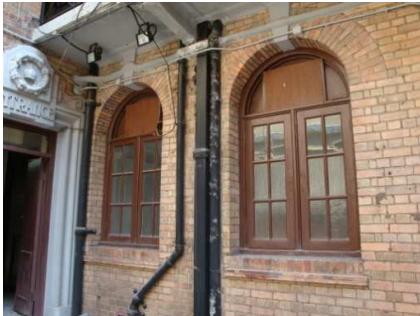
Element no.	Description	Photo ref.	Significance	Proposal	Mitigation	Impact
09.014	Altered doors and windows

Adverse	Repair or renew as necessary existing frames to match original patterns	Not applicable	High
09.015	Sloping canopy over external stair on west side

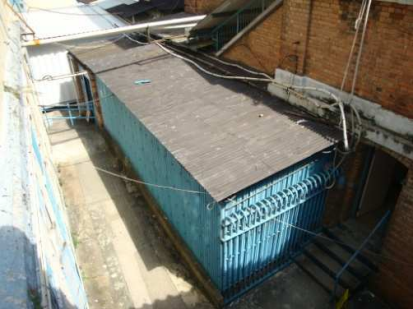
Element no.	Description	Photo ref.	Significance	Proposal	Mitigation	Impact
09.016	Single storey secure shelter at North West corner

Low	Demolish	Make good brickwork at abutments.	Low
09.017	Iron railing adjacent south side of item 09.016 above

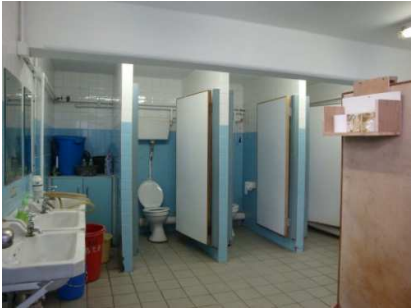
Element no.	Description	Photo ref.	Significance	Proposal	Mitigation	Impact
09.018	Public toilets in 09/LG1/17, 24

Adverse	Strip out sanitaryware, and fit-out for pottery display/service access. Form new door openings in east walls.	Retain existing door openings and metal-barred gates. Retain external granite steps and existing ground level.	Low
09.019	Cell doors

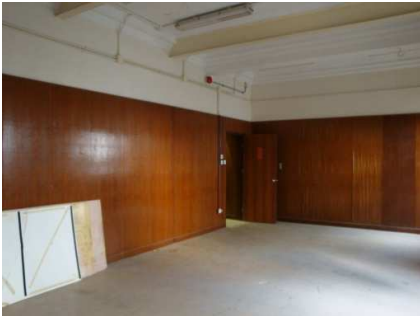
Element no.	Description	Photo ref.	Significance	Proposal	Mitigation	Impact
09.020	Meeting room at G/02-05

Moderate	Remove timber panelling from walls and sub divide to form new toilets and lift shaft	Record existing wall linings, and any earlier lining behind, on measured survey drawings.	Moderate
09.021	Lobbies within entrance hall G/12	 	Adverse	Remove	Not applicable	N/A

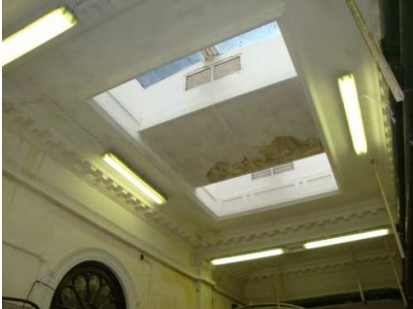
Element no.	Description	Photo ref.	Significance	Proposal	Mitigation	Impact
09.024	Lanterns above entrance hall

Adverse	Remove existing lanterns and install single lantern	Not applicable	Moderate
09.025	Boarded ceilings on Second Floor

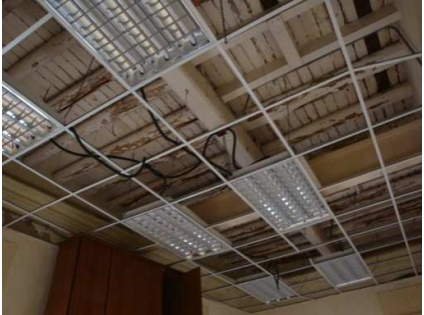
Element no.	Description	Photo ref.	Significance	Proposal	Mitigation	Impact
10.001	Lay-in grid suspended ceiling

Adverse	Remove	Not applicable	High
10.002	Plaster box cornice

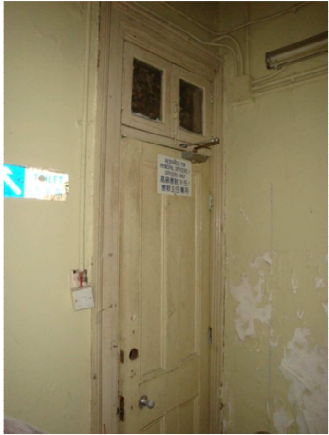
Element no.	Description	Photo ref.	Significance	Proposal	Mitigation	Impact
10.003	Panelled doors and linings

Moderate	Replace where necessary to achieve fire resistance to comply with Code	Re-use where possible. Record design on survey drawings where element cannot be re-used.	Moderate
10.004	Timber boarded floor with moulded skirtings

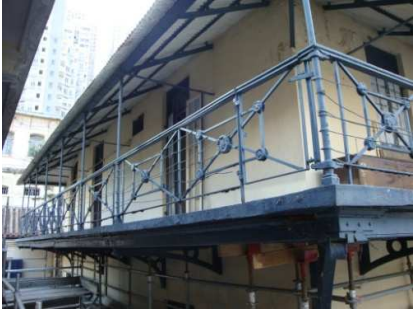
Element no.	Description	Photo ref.	Significance	Proposal	Mitigation	Impact
10.005	Exterior decorations

Adverse	Strip off and redecorate	Sample and analyse existing paint media; select new media to suit substrate and significance	High
10.006	Block existing door openings

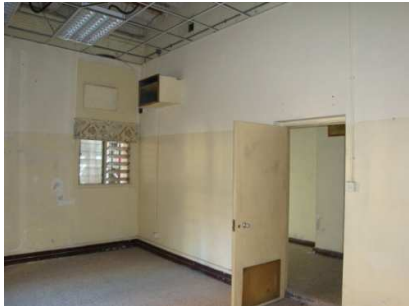
Element no.	Description	Photo ref.	Significance	Proposal	Mitigation	Impact
10.007	Form new door openings

Moderate	Form new opening as part of re-planning of interiors	New doors and frames to be of their time to avoid confusion about provenance	Moderate
10.008	Altered doors and windows

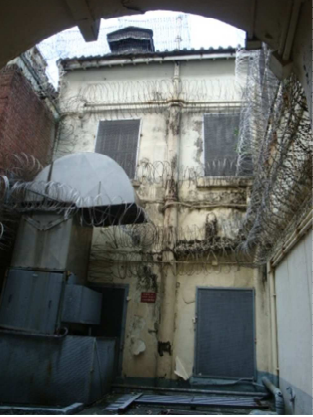
Element no.	Description	Photo ref.	Significance	Proposal	Mitigation	Impact
10.009	External airconditioning units and other external services

Adverse	Remove and make good brickwork	Not applicable	High

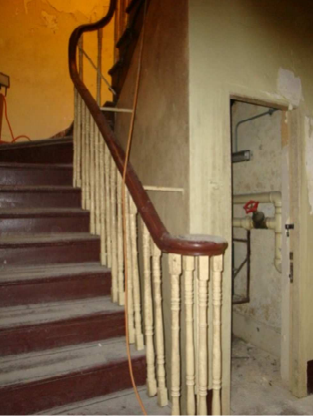
Element no.	Description	Photo ref.	Significance	Proposal	Mitigation	Impact
10.010	Stair balustrades

High	Balustrades to be supplemented with additional handrails and supports to mitigate non-compliance with code	New fittings to be of their time and made reversible. Physical intervention to existing stairs and balustrades to be kept to the minimum.	Moderate
10.011	Fixed signs

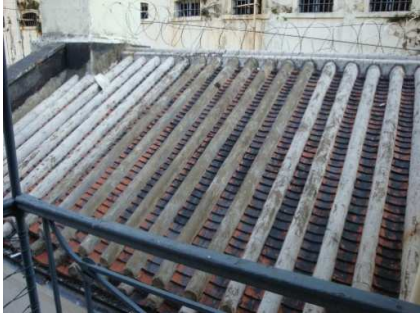
Element no.	Description	Photo ref.	Significance	Proposal	Mitigation	Impact
10.012	Pitched roofs

High	New penetrations through roofs for ventilation ducts and other services	<p>Arrange new penetrations so that they conform with the geometry of the existing roof.</p> <p>Model the size and shape of the new ducts so that the impact on the roofscape is minimised.</p> <p>Finish the new ducts in a non-reflective material that is neutral in colour and mid-tone.</p>	High

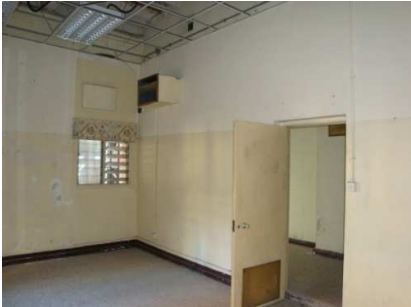
10.013	Internal walls

Moderate	Remove selected internal walls where strictly necessary as part of re-planning of interiors	<p>Walls or early or original date to be retained in part eg. By leaving a “nib” where the wall is bonded to another wall.</p> <p>At the point where the wall is cut away, form the cut-line on the line of a vertical joint in alternate courses. Bricks in the remaining courses to be left “as cut”, and not re-bonded, as evidence of</p>	Moderate

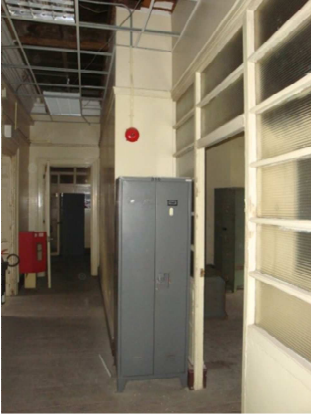
Element no.	Description	Photo ref.	Significance	Proposal	Mitigation	Impact
10.014	Partitions on SF

Moderate	Remove partitions	Record partitions on measured drawings	Moderate
10.015	Blocked windows on south elevation of south-east wing

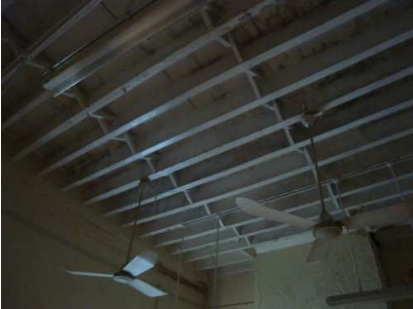
Element no.	Description	Photo ref.	Significance	Proposal	Mitigation	Impact
10.016	Open-joisted ceiling on Ground Floor of south-east wing

Moderate	Underline floor to provide fire protection.	Avoid intrusive alteration. Use fire-proofing products and methods that enable existing structure and boarding to be retained.	Low
10.017	Moulded timber picture rail

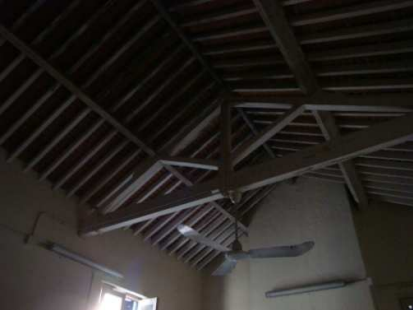
Element no.	Description	Photo ref.	Significance	Proposal	Mitigation	Impact
10.018	Timber roof structure above south-east wing

Moderate	Repair as necessary and retain	Avoid intrusive alteration. Retain open appearance/	Low
10.019	Timber stair

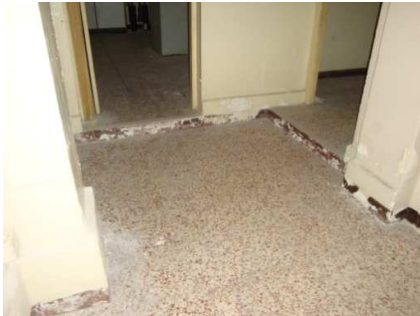
Element no.	Description	Photo ref.	Significance	Proposal	Mitigation	Impact
10.020	Clay/terrazzo tile floor on Ground Floor and steps

Adverse	Adjust levels to enable level access and replace floor finish	Not applicable	Low
10.024	Granite wall on North elevation

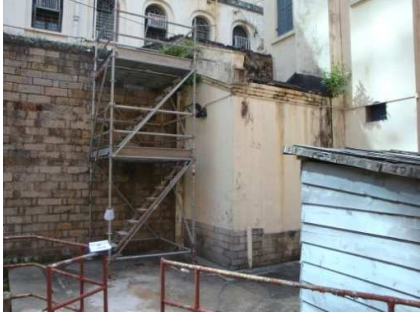
Element no.	Description	Photo ref.	Significance	Proposal	Mitigation	Impact
10.025	Single storey outbuilding at South East corner

Moderate	Demolish outbuilding and make good at abutments	Record outbuilding on measured drawings	Low
10.026	Blocked archway on East elevation

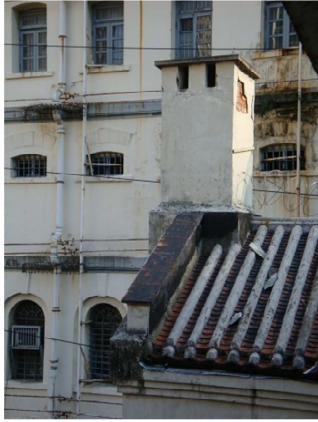
Element no.	Description	Photo ref.	Significance	Proposal	Mitigation	Impact
10.027	Chimney on east elevation

Low	Retain	Not applicable	Neutral
10.028	Cantilever balconies

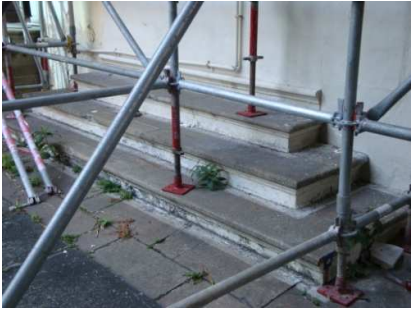
Element no.	Description	Photo ref.	Significance	Proposal	Mitigation	Impact
10.029	Steps on east elevation

Moderate	Repair as necessary and retain	Avoid alteration or obliteration.	Neutral

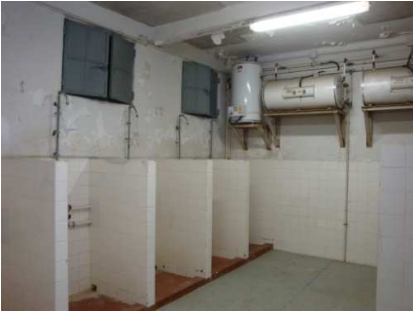
Element no.	Description	Photo ref.	Significance	Proposal	Mitigation	Impact
11.001	Form new door openings

Low	Form new opening as part of re-planning of interiors	New doors and frames to be of their time to avoid confusion about provenance	Low

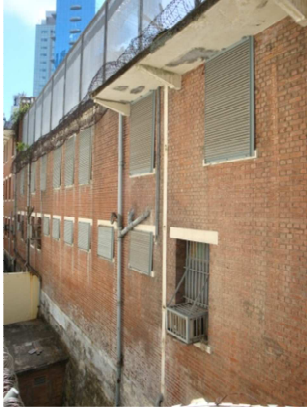
Element no.	Description	Photo ref.	Significance	Proposal	Mitigation	Impact
11.002	External airconditioning units and other external services

Adverse	Remove and make good brickwork	Not applicable	High
11.003	Painted signs

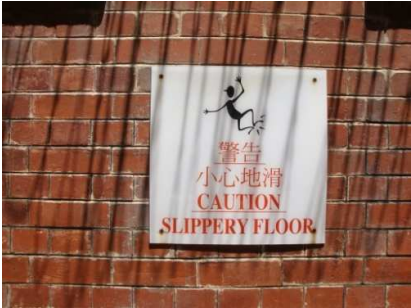
Element no.	Description	Photo ref.	Significance	Proposal	Mitigation	Impact
11.004	Fixed signs

Low-High	Remove and refix/display in visitors' centre/discard	Record each sign and assess significance individually and treat accordingly	N/A
11.005	Concrete stairs

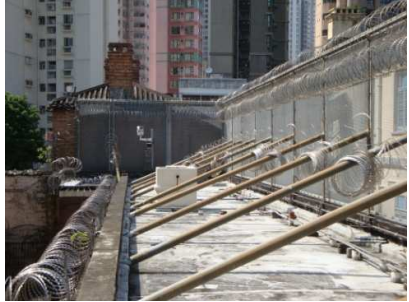
Element no.	Description	Photo ref.	Significance	Proposal	Mitigation	Impact
11.006	Flat roof

Low	Form new rooftop extension at West end to accommodate fire escape stair	Form straight joint at abutment with building 08 Ablutions Block	Low
11.007	Security screen at roof level

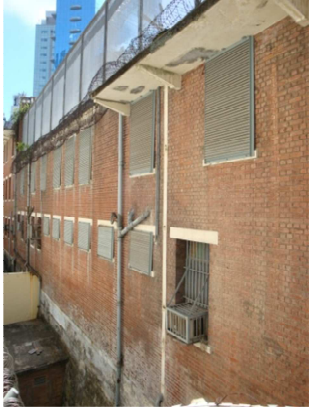
Element no.	Description	Photo ref.	Significance	Proposal	Mitigation	Impact
11.008	Rainwater goods

Adverse	Replace with cast iron in pattern to match original and in correct locations	Not applicable	High

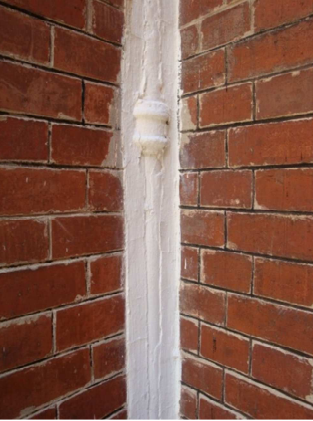
Element no.	Description	Photo ref.	Significance	Proposal	Mitigation	Impact
11.009	Rainwater goods

Low	Remove embedded cast iron pipework set into wall to reduce long term maintenance burden	Record on measured survey drawings. Make good cavity.	Low

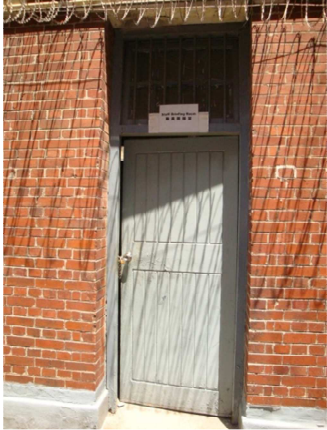
Element no.	Description	Photo ref.	Significance	Proposal	Mitigation	Impact
11.010	Timber doors

Low	Repair and retain	Not applicable	Neutral
