The Jockey Club CPS Limited

Central Police Station Conservation
and Revitalisation Project:
First Annual EM&A Review Report
(1 November 2011 to 31 October
2012)

Environmental Resources Management

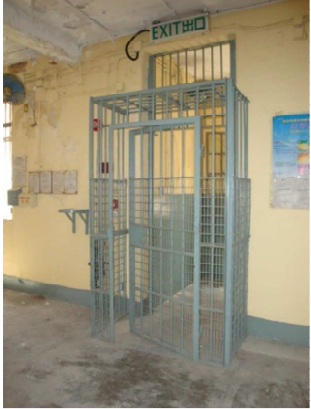
Element no.	Description	Photo ref.	Significance	Proposal	Mitigation	Impact
11.011	Security screen and door at First Floor

Low	Remove	Record on measured survey drawings	Low
11.012	Door thresholds and plinth

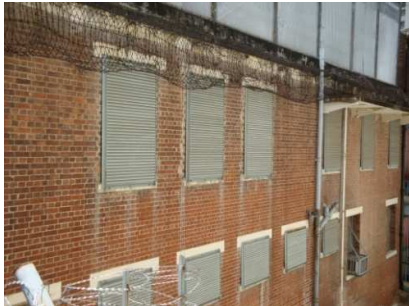
Element no.	Description	Photo ref.	Significance	Proposal	Mitigation	Impact
11.013	Metal louvres on window openings

Adverse	Remove	Not applicable	Low

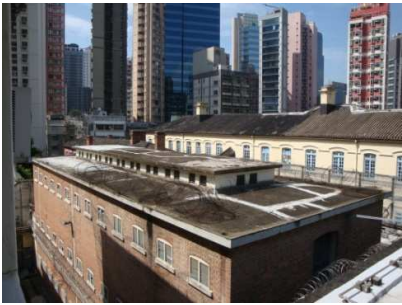
Element no.	Description	Photo ref.	Significance	Proposal	Mitigation	Impact
12.001	Flat roof

Moderate	Repair and retain	Avoid roof penetrations as far as possible	Low
12.002	Cells at GF level

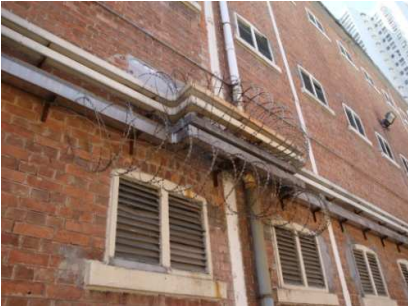
Element no.	Description	Photo ref.	Significance	Proposal	Mitigation	Impact
12.003	External airconditioning units and other external services

Adverse	Remove and make good brickwork	Not applicable	High
12.004	Painted signs

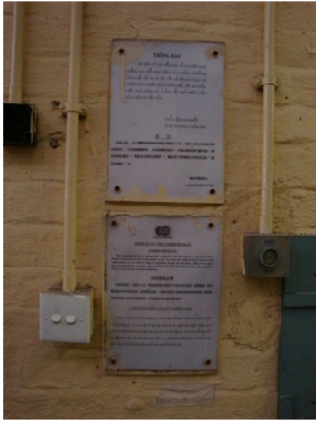
Element no.	Description	Photo ref.	Significance	Proposal	Mitigation	Impact
12.005	Fixed signs

Low-High	Remove and refix/display in visitors' centre/discard	Record each sign and assess significance individually and treat accordingly	N/A
12.006	Rainwater goods

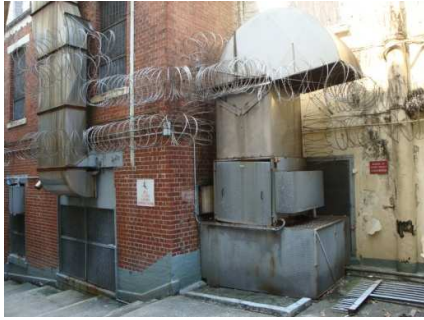
Element no.	Description	Photo ref.	Significance	Proposal	Mitigation	Impact
13.001	External airconditioning units and other external services

Adverse	Remove	Not applicable	Moderate

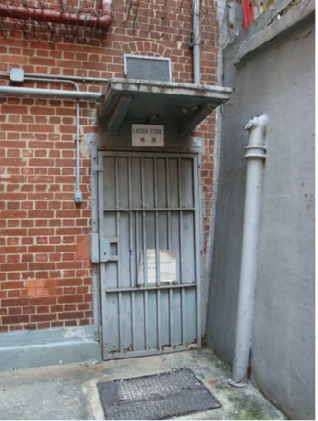
Element no.	Description	Photo ref.	Significance	Proposal	Mitigation	Impact
13.002	Door to Ladder Store

Low	Retain	Not applicable	Neutral
13.003	Security bars at window openings

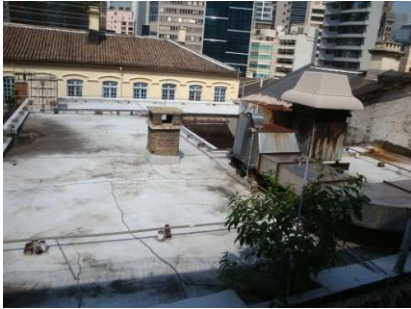
Element no.	Description	Photo ref.	Significance	Proposal	Mitigation	Impact
13.004	Flat roof

Low	Retain	Avoid roof penetrations as far as possible.	Low
13.005	Eaves detail

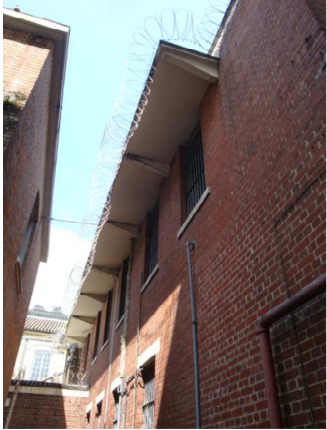
Element no.	Description	Photo ref.	Significance	Proposal	Mitigation	Impact
13.006	Cantilever reinforced concrete canopy

Low	Retain	Not applicable	Neutral
13.007	Internal partition walls

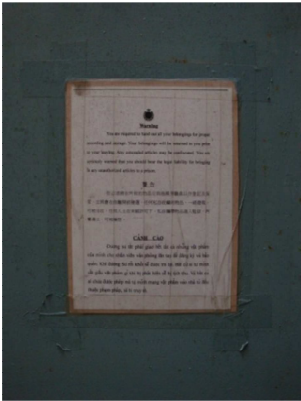
Element no.	Description	Photo ref.	Significance	Proposal	Mitigation	Impact
13.008	Fixed signs

Low-High	Remove and refix/display in visitors' centre/discard	Record each sign and assess significance individually and treat accordingly	N/A
13.009	Metal window frames

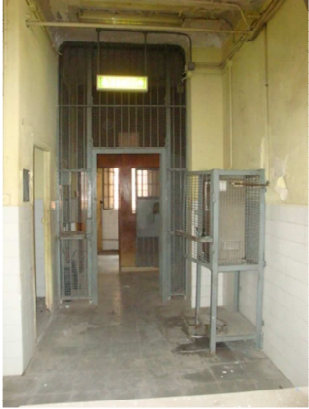
Element no.	Description	Photo ref.	Significance	Proposal	Mitigation	Impact
13.010	Internal security screens

Moderate	Retain where possible	Where necessary record on measured survey drawings prior to removal	Low
13.011	Coving at abutments between RC beams and walls

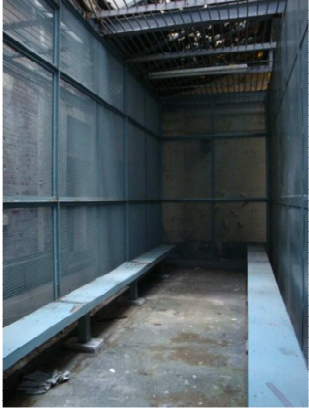
Element no.	Description	Photo ref.	Significance	Proposal	Mitigation	Impact
13.012	Communal cells at Ground Floor

Moderate	Remove as part of re-planning of interiors	Record on measured survey drawings	Low
13.013	Rooflight and security bars over communal cells

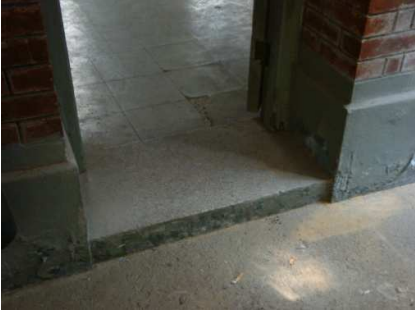
Element no.	Description	Photo ref.	Significance	Proposal	Mitigation	Impact
13.014	Granite threshold at external door openings

Low	Retain	Not applicable	Neutral
13.015	Timber boarded doors with fanlight over

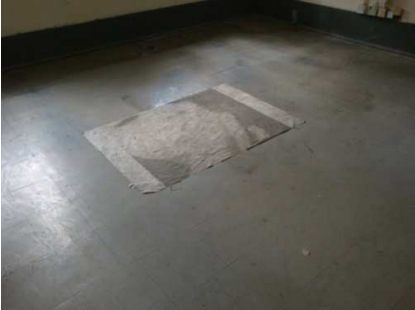
Element no.	Description	Photo ref.	Significance	Proposal	Mitigation	Impact
13.015	Vinyl tile floor

Adverse	Replace	Not applicable	Low

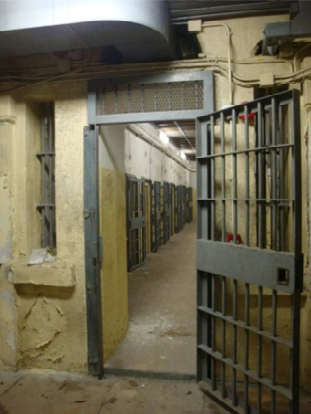
Element no.	Description	Photo ref.	Significance	Proposal	Mitigation	Impact
14.002	Half-round headed doorway and side lights

Moderate	Retain	Remove air duct and make good masonry above arch.	Low

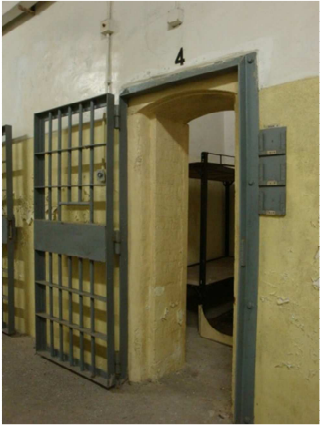
Element no.	Description	Photo ref.	Significance	Proposal	Mitigation	Impact
14.004	Brick reveals with bull-nosed arrisses and segmental arch over (generally north side, alternating with granite surrounds – see previous item)

High	Retain door surround and gate wherever possible	Pin back gate against wall	Low

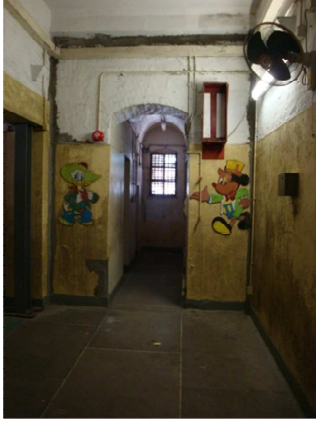
Element no.	Description	Photo ref.	Significance	Proposal	Mitigation	Impact
14.005	Arched opening at East end First Floor

Low	Retain as existing	Not applicable	Low
14.006	Concrete floor generally at Lower Ground Floor

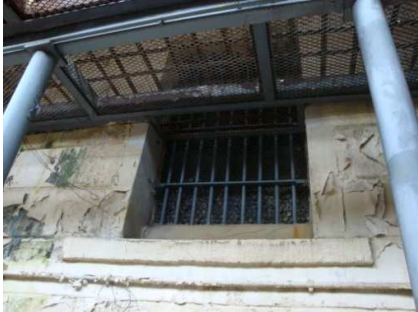
Element no.	Description	Photo ref.	Significance	Proposal	Mitigation	Impact
14.007	Part-blocked windows at Lower Ground Floor - extent of blocking varies.

Moderate	Open up window opening to full extent.	Record existing condition on measured survey drawings. Add further detail during demolition works.	Low
14.008	External granite stair from Lower Ground to Ground Floor level

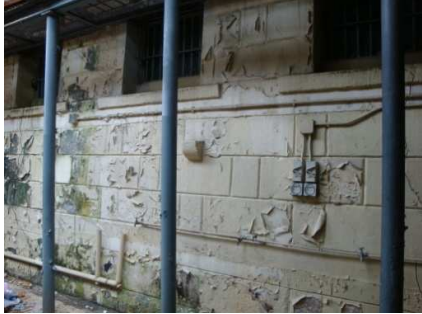
Element no.	Description	Photo ref.	Significance	Proposal	Mitigation	Impact
14.009	Ashlar pattern on external walls

Moderate	Form new openings for entrance/exit to building	<p>Set out new openings to cause minimum disruption to ashlar pattern.</p> <p>Record existing pattern on measured survey drawings.</p>	Low
14.010	Blocked doorway at south-east corner

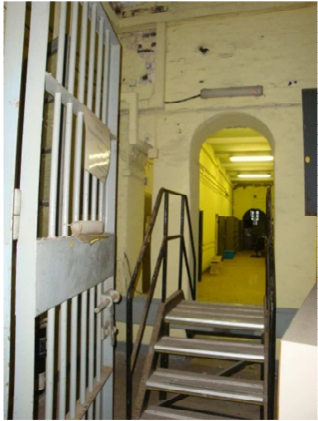
Element no.	Description	Photo ref.	Significance	Proposal	Mitigation	Impact
14.012	Half-round headed doorway and side lights at Ground Floor west end

Moderate	Retain insitu	Not applicable	Neutral
14.013	Structural steelwork bracing and temporary access stair

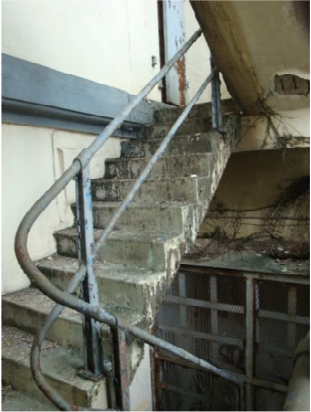
Element no.	Description	Photo ref.	Significance	Proposal	Mitigation	Impact
14.014	RC staircase at north-east corner

Low	Remove	Record on measured drawings	Low
14.015	Vinyl tile floor on suspended timber floor

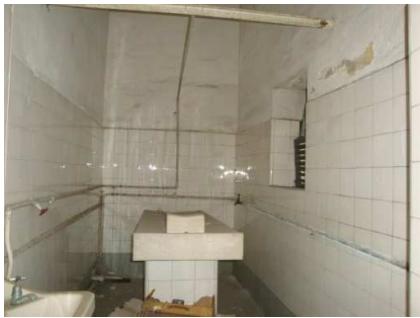
Moderate	Retain insitu	Use existing door openings wherever possible. Avoid further alteration to existing altered openings where feasible.	Low
14.017	Mortuary

High	Preserve insitu	Avoid any service penetrations from adjacent spaces	Neutral

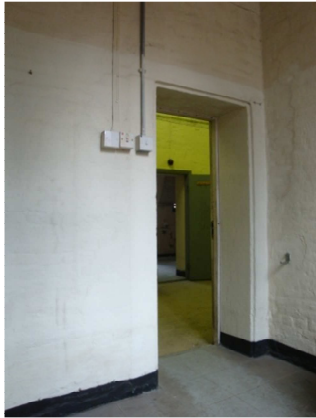
Element no.	Description	Photo ref.	Significance	Proposal	Mitigation	Impact
14.019	Granite surrounds to doorways with lintels over

Moderate	Increase width in selected locations to allow wheelchairs to pass	Record on measured survey drawings. Limit interventions as far as possible.	Low
14.020	Flat ceilings at Ground Floor

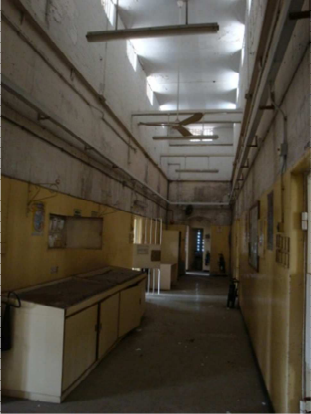
Element no.	Description	Photo ref.	Significance	Proposal	Mitigation	Impact
14.022	Top-lit central hall

High	Retain insitu	Not applicable	Neutral

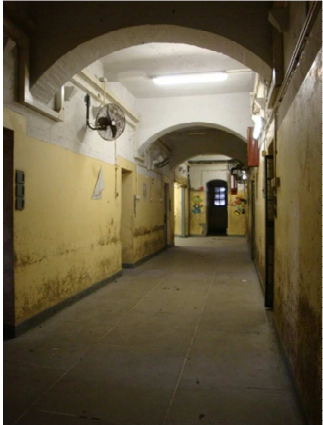
Element no.	Description	Photo ref.	Significance	Proposal	Mitigation	Impact
14.023	Arches across central hall at First Floor

Moderate	Retain insitu	Not applicable	Neutral

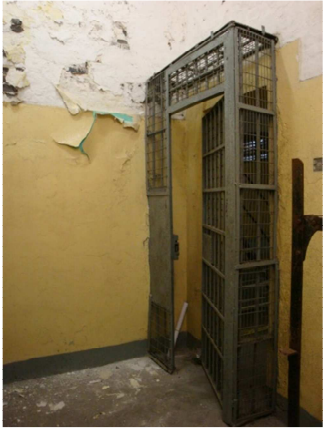
Element no.	Description	Photo ref.	Significance	Proposal	Mitigation	Impact
14.024	Inset security gate and screen in First Floor cells

Low	Remove to suit new use	Remove where necessary. Record on measured drawings.	Low

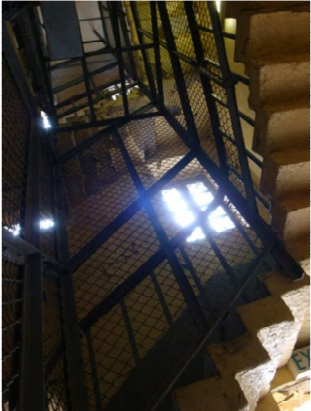
Element no.	Description	Photo ref.	Significance	Proposal	Mitigation	Impact
14.030	Main stair

High	Remove wire mesh and framing	Record on measured drawings	Low

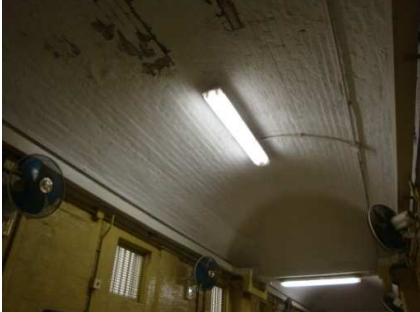
Element no.	Description	Photo ref.	Significance	Proposal	Mitigation	Impact
14.031	Brick vault over central hall at Ground Floor

High	Retain insitu	Not applicable	Neutral
14.032	Terrazzo floor in central hall at Ground floor

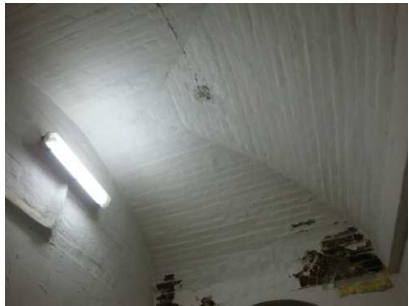
Element no.	Description	Photo ref.	Significance	Proposal	Mitigation	Impact
14.033	Brick vaults above cells

High	Retain insitu	Avoid penetrations for services	Neutral
14.034	Cell walls (later additions)

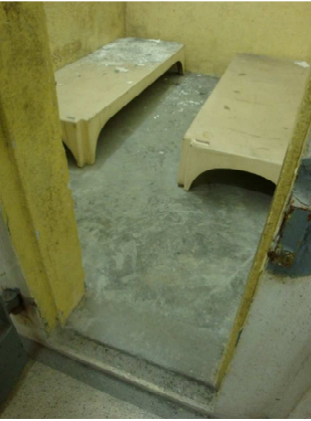
Element no.	Description	Photo ref.	Significance	Proposal	Mitigation	Impact
14.037	Cell floors

Low	Remove to enable piled underpinning	Record on measured survey drawings	Low

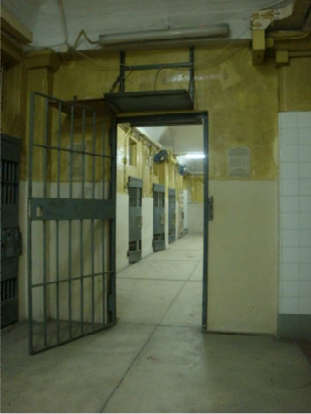
Element no.	Description	Photo ref.	Significance	Proposal	Mitigation	Impact
14.038	Partition wall across central hall at Ground Floor

Low	Remove to accommodate new cafe	Record on measured survey drawings	Low

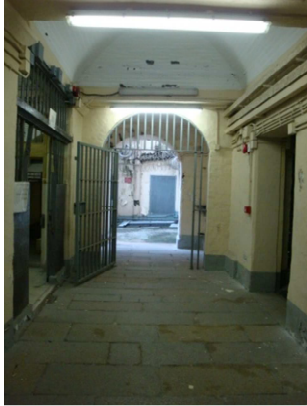
Element no.	Description	Photo ref.	Significance	Proposal	Mitigation	Impact
14.039	Granite pavement in cross-passage between East and West Wings

Moderate	Repair as necessary and retain insitu	Not applicable	Neutral
14.040	Granite threshold at doorway between cross-passage and East Wing

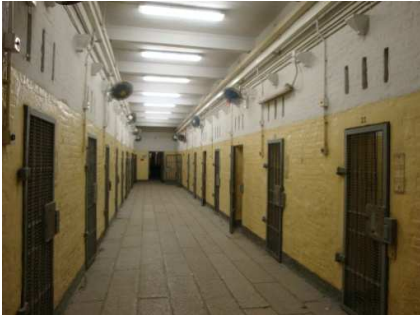
Element no.	Description	Photo ref.	Significance	Proposal	Mitigation	Impact
14.043	Cell walls flanking central hall at First Floor

High	Retain insitu	Not applicable	Neutral
14.044	Brickwork spandrels below cell windows at Second Floor

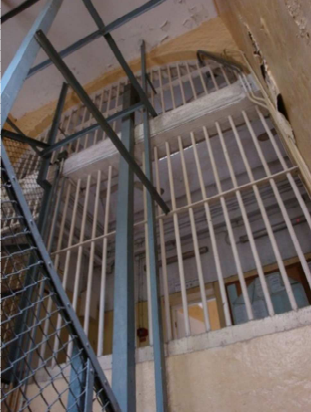
Element no.	Description	Photo ref.	Significance	Proposal	Mitigation	Impact
14.045	Metal security screen adjacent main stair

Moderate	Retain insitu	Not applicable	Neutral

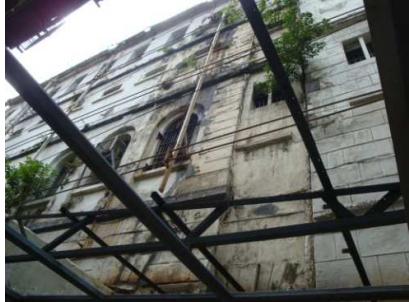
Element no.	Description	Photo ref.	Significance	Proposal	Mitigation	Impact
14.049	Metalwork and structural steel framing on exterior (typical)

Adverse	Remove	Not applicable	High
14.050	Blind arcade, south elevation

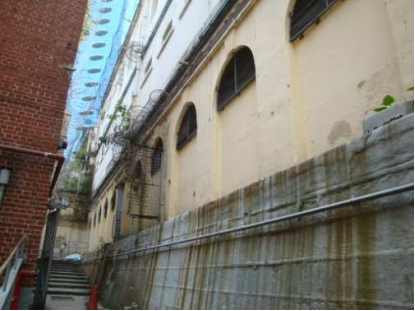
Element no.	Description	Photo ref.	Significance	Proposal	Mitigation	Impact
14.051	Blind arcade, north elevation

Low	Retain insitu	Not applicable	Neutral
14.052	Fence wall, east end of D Hall Yard

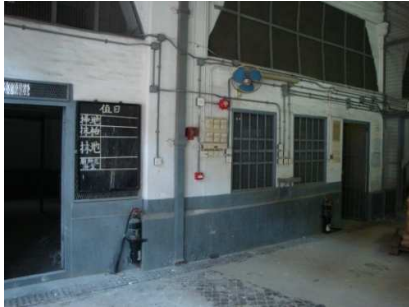
Element no.	Description	Photo ref.	Significance	Proposal	Mitigation	Impact
15.001	Dividing walls at Lower Ground Floor

Moderate	Remove to enable multi-purpose use	Record on measured survey drawings	Low
15.002	Dividing walls at Lower Ground Floor

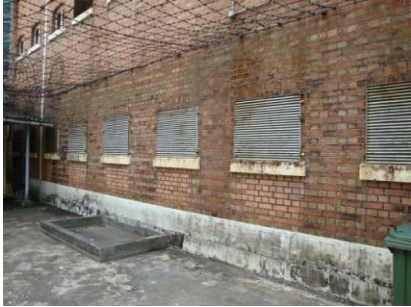
Adverse	Remove	Not applicable	Moderate
15.005	Metal louvres over cell window openings

Low	Remove	Record on measured survey drawings	Low

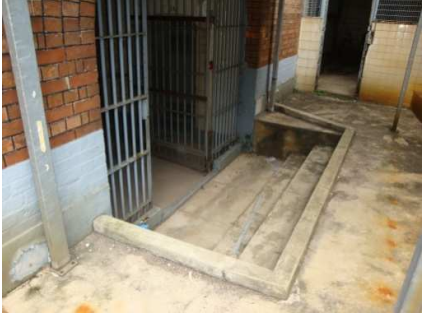
Element no.	Description	Photo ref.	Significance	Proposal	Mitigation	Impact
15.006	Raised ground level adjacent entrance

Low	Remove to enable level access	Record on measured survey drawings	Low
15.007	Access balconies and apertures

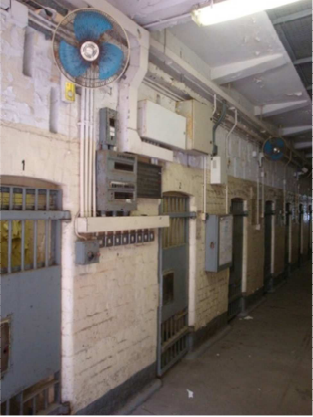
Element no.	Description	Photo ref.	Significance	Proposal	Mitigation	Impact
15.010	Services installations

Adverse	Remove	Not applicable	Moderate
15.011	Balcony balustrades

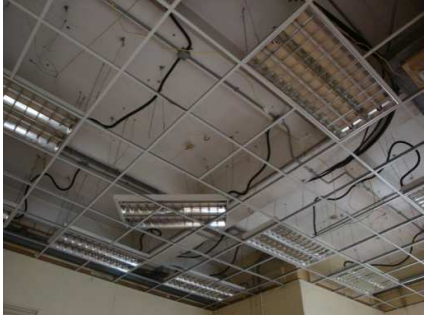
Element no.	Description	Photo ref.	Significance	Proposal	Mitigation	Impact
17.001	Lay-in grid suspended ceiling

Adverse	Remove	Not applicable	High
17.002	Rainwater goods

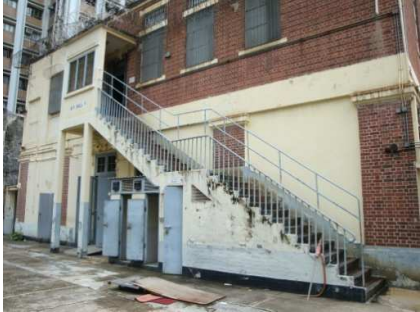
Element no.	Description	Photo ref.	Significance	Proposal	Mitigation	Impact
17.003	Exterior decorations

Adverse	Strip off and redecorate	Sample and analyse existing paint media; select new media to suit substrate and significance	High
17.004	External airconditioning units and other external services

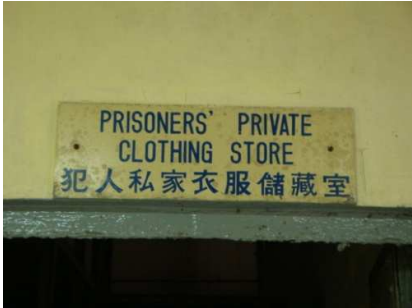
Element no.	Description	Photo ref.	Significance	Proposal	Mitigation	Impact
17.005	Fixed signs

Moderate	Remove and refix/display in visitors' centre/discard	Record each sign and assess significance individually and treat accordingly	Moderate
17.006	Security screen at First Floor entrance

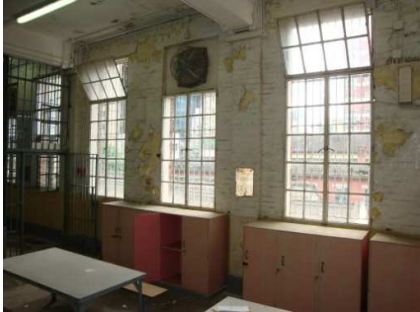
Element no.	Description	Photo ref.	Significance	Proposal	Mitigation	Impact
17.007	Metal windows

Moderate	Remove at First Floor to accommodate gallery space and block structural openings with blockwork	Record on measured drawings.	Moderate
17.008	Fixed furniture

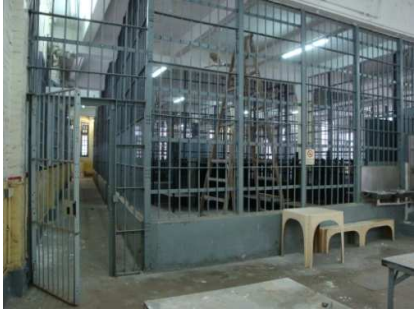
Element no.	Description	Photo ref.	Significance	Proposal	Mitigation	Impact
17.009	Security screens

Moderate	Remove to accommodate gallery space	Record on measured drawings	Moderate
17.010	Timber windows

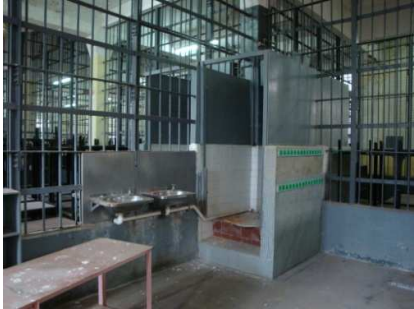
Element no.	Description	Photo ref.	Significance	Proposal	Mitigation	Impact
17.011	Communal washing/lavatory facilities

Moderate	Remove to accommodate gallery space	Record on measured drawings	Low
17.012	Blocked up lantern light

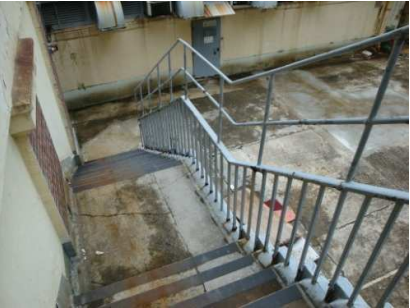
High	Remove to accommodate new gallery	Rebuild in new location	Moderate
17.015	External stair to First Floor

Moderate	Upgrade balustrade to comply with Building Code	Record on measured drawings. Supplement existing balustrade elements with minimal elements if necessary.	Low

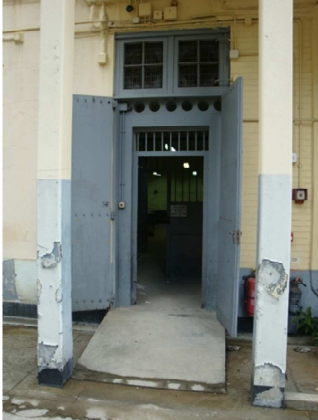
Element no.	Description	Photo ref.	Significance	Proposal	Mitigation	Impact
17.016	Ground Floor main entrance

Low	Retain as existing.	Keep fixed shut if not required for operational use.	Low

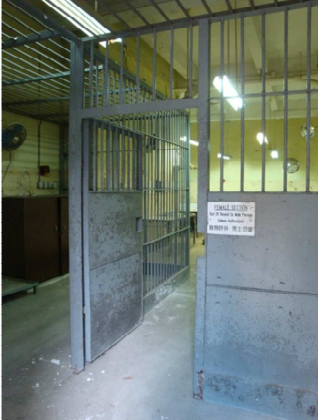
Element no.	Description	Photo ref.	Significance	Proposal	Mitigation	Impact
17.017	Security screen at Ground Floor main entrance

Low	Remove to accommodate gallery space	Record on measured drawings	Low
17.018	Blue Entrance Gate (facing Old Bailey Street)

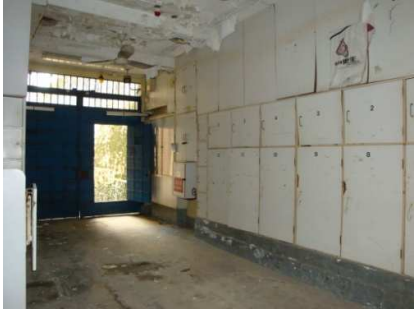
Element no.	Description	Photo ref.	Significance	Proposal	Mitigation	Impact
17.019	Blue Entrance Gate (inner) and enclosed yard

Moderate	Retain gate and enclosing walls and roof in situ; remove cupboards.	Repair and maintain gate in working order	Low
17.020	Blue Entrance Gate (inner) facing Prison Yard

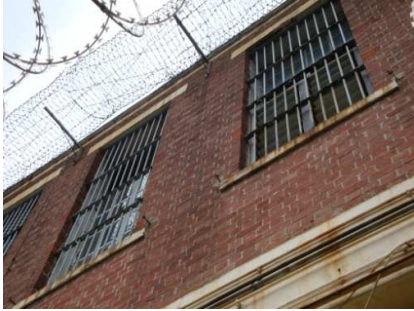
Moderate	Remove	Record on measured drawings. Make good fixing points where attached to brickwork.	Low
17.022	Metal security bars at windows

Moderate	Remove as part of blocking up window openings to accommodate gallery space at First Floor	Record on measured drawings	Low

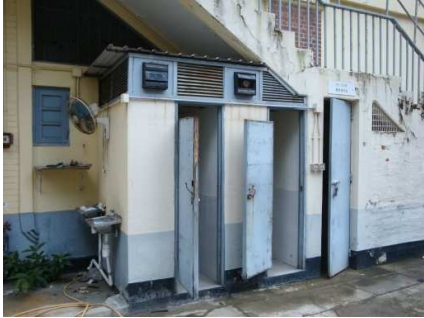
Element no.	Description	Photo ref.	Significance	Proposal	Mitigation	Impact
17.023	External toilets at Ground Floor adjacent East elevation

Low	Remove	Record on measured drawings	Low
17.024	Open Visit Room

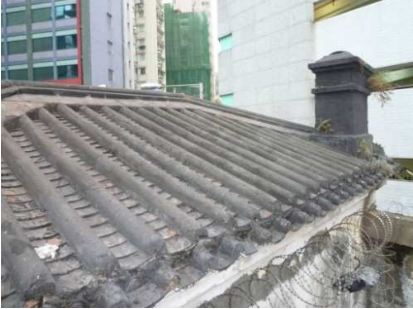
Element no.	Description	Photo ref.	Significance	Proposal	Mitigation	Impact
19.001	Pitched roofs

High	New penetrations through roofs for ventilation ducts and other services	Arrange new penetrations so that they conform with the geometry of the existing roof. Model the size and shape of the new ducts so that the impact on the roofscape is minimised. Finish the new ducts in a non-reflective material that is neutral in colour and mid-tone.	High
19.002	Chimney

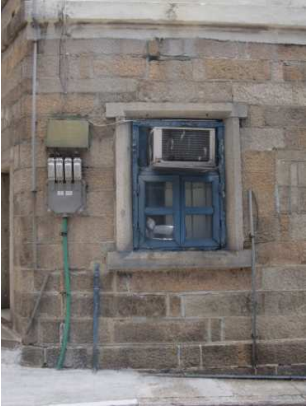
Element no.	Description	Photo ref.	Significance	Proposal	Mitigation	Impact
19.003	Rainwater goods and other external services

Adverse	Remove and make good wall surface. Replace defective and non-matching rainwater goods with cast iron fittings to match original.	Not applicable	Moderate

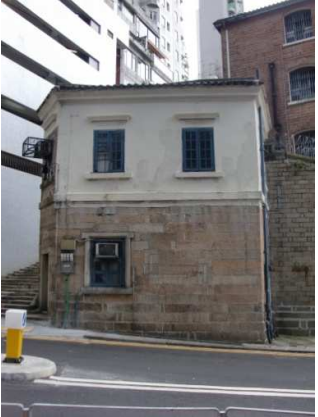
Element no.	Description	Photo ref.	Significance	Proposal	Mitigation	Impact
19.004	External stone wall facing

High	Carry out close inspection of painted areas to determine extent of original granite facing and remove paint media where applicable.	Not applicable	Moderate

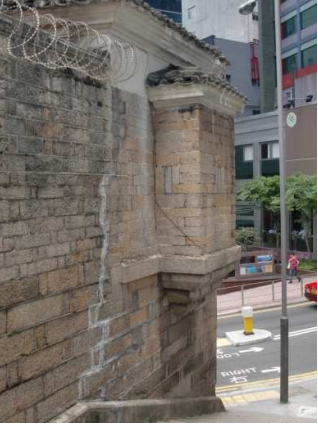
Element no.	Description	Photo ref.	Significance	Proposal	Mitigation	Impact
19.006	Look-out turret

High	Repair and retain insitu	Not applicable	Neutral

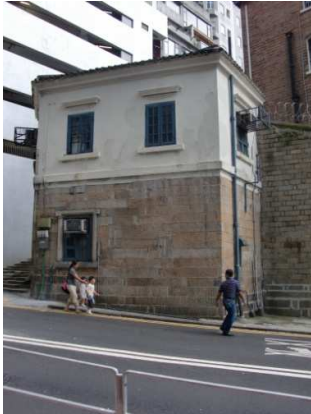
Element no.	Description	Photo ref.	Significance	Proposal	Mitigation	Impact
19.007	Windows

Moderate	Remove and make good stonework as necessary	Record existing windows on measured survey drawings	Moderate

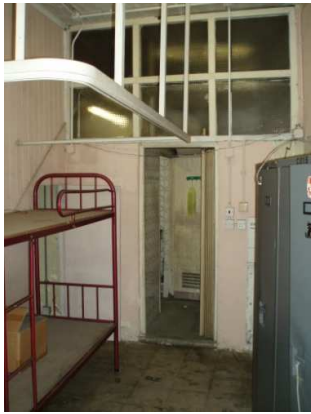
Element no.	Description	Photo ref.	Significance	Proposal	Mitigation	Impact
19.008	Modern partitions

Adverse	Remove	Not applicable	Moderate

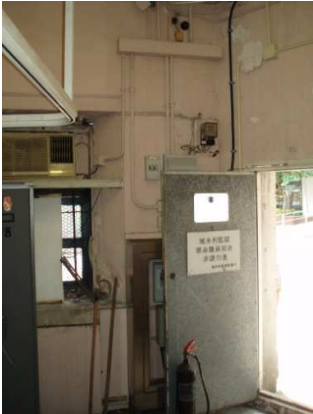
Element no.	Description	Photo ref.	Significance	Proposal	Mitigation	Impact
19.009	Electrical services

Adverse	Remove	Not applicable	Moderate
19.010	Lay-in grid suspended ceiling

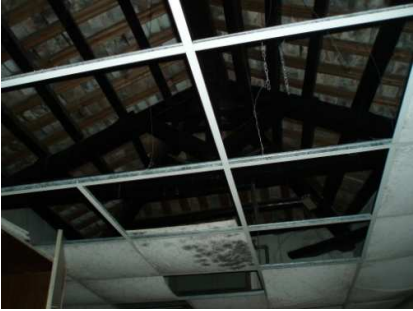
Element no.	Description	Photo ref.	Significance	Proposal	Mitigation	Impact
19.011	Exposed timber roof structure

High	Repair and retain insitu	Not applicable	Neutral
19.012	Timber stair
