The Jockey Club CPS Limited

Central Police Station Conservation  
and Revitalisation Project:  
*Third Annual EM&A Review Report*  
*(1 November 2013 to 31 October*  
*2014)*

Issue Date: March 2015

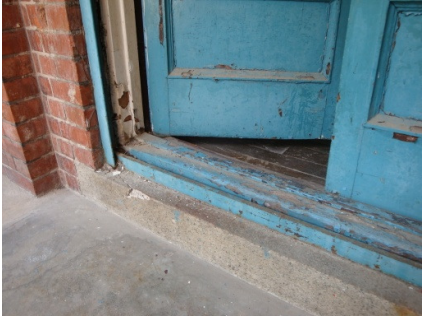
Adverse	Remove	Not applicable	High
01.004	Timber thresholds at external doors and internal doors between main corridor and individual rooms

Low	Remove to enable level access	Splice extensions to door jambs, extend width of bottom rail of doors to match existing	Low

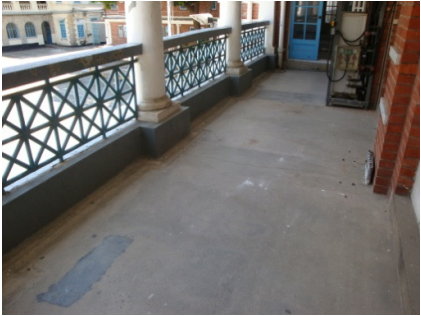
High	Reinstate to match existing pattern	Not applicable	High
01.008	External terraces at 1/F

High	Overlay existing concrete paving with timber deck to provide level access	New deck to be reversible	Low

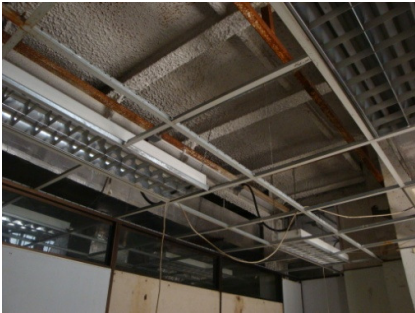
Adverse	Remove floor and supporting columns to re-create original double-height space	Not applicable	High

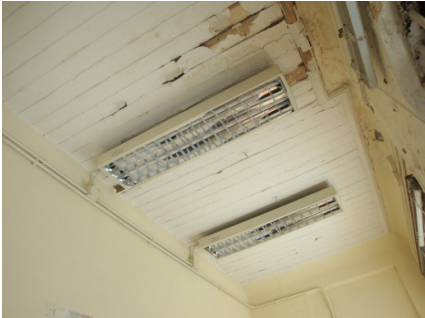
Low	Remove	Record on measured drawings and photographs	Low
01.028	Tongued and grooved flat and sloped timber boarded ceilings

Moderate	Repair where necessary and reinstate where missing	Not applicable	Moderate

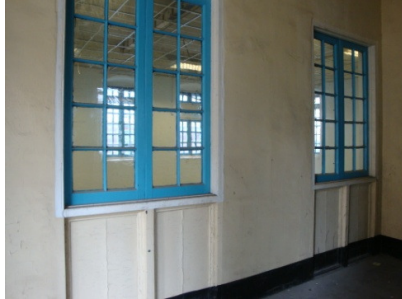
Element no.	Description	Photo ref.	Significance	Proposal	Mitigation	Impact
03.005	Timber spandrel panels below windows

Low	Conceal in exceptional cases eg. where adjacent new lift shaft	Retain frame and spandrel panel where possible. Remove only where necessary in connection with re-planning of interiors. Record on measured survey drawings.	Low
03.006	Timber floors

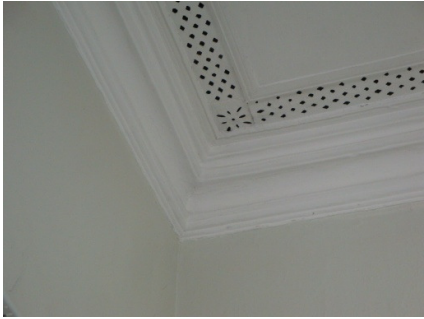
Element no.	Description	Photo ref.	Significance	Proposal	Mitigation	Impact
04.003	Plaster box cornice

Moderate	Remove in exceptional cases where eg. where adjacent new lift shafts	Cut back neatly to a square edge and ensure remaining section is secure.	Moderate

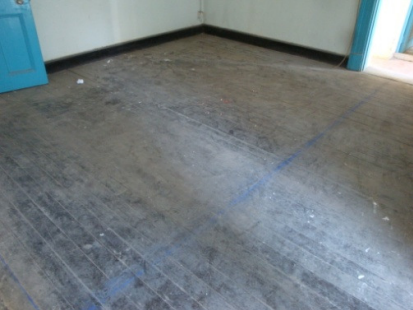
Element no.	Description	Photo ref.	Significance	Proposal	Mitigation	Impact
06.015	Timber floors

High	Retain all boarded floors and skirtings	Reinstate floor boards and skirtings after fire proofing works	Low
06.016	Vinyl tile floor

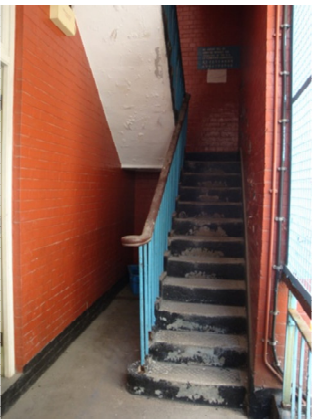
Moderate	Retain	Repair as necessary.  Alter balustrade to achieve reasonable level of operational safety.  Restrict access to repairs and maintenance and means of escape.	Low

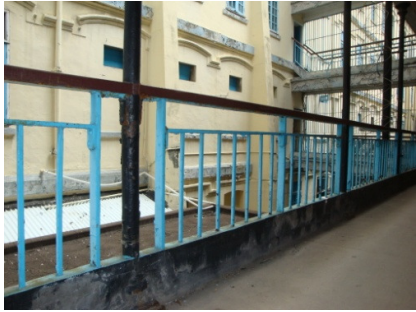
Low	<p>Repair as necessary and retain.</p> <p>Remove selected sections to enable installation of new bridge connections to Barrack Block.</p>	<p>Avoid removal of associated iron columns.</p> <p>Form interventions at selected positions so as to maintain the rhythm of the balustrades and ensure proper support at ends.</p>	Low

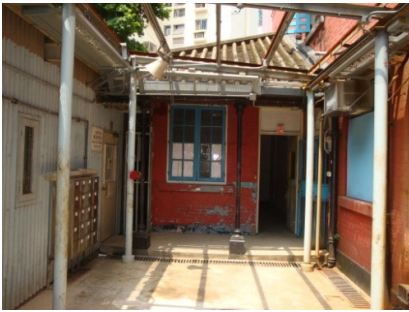
Element no.	Description	Photo ref.	Significance	Proposal	Mitigation	Impact
08.014	Single-storey outbuilding with pitched roof over

Low	Demolish to make way for new loading bay.	<p>Record on measured survey drawings.</p> <p>Infill existing internal opening leaving reveals exposed.</p> <p>Tooth-in new brickwork at abutments after existing walls removed.</p> <p>Salvage cast iron columns for possible re-use.</p>	Low
08.015	Corrugated steel sheet on balcony balustrades

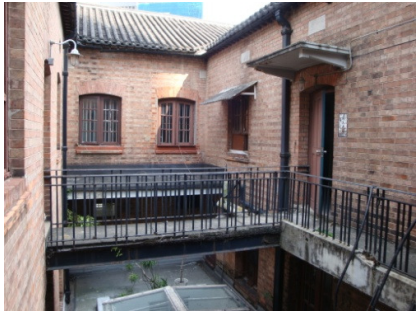
Adverse	Remove walkways and make good brickwork at abutments	Not applicable	High

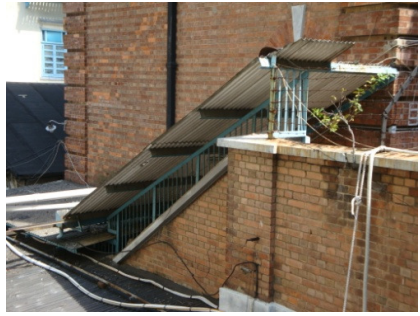
Adverse	Remove canopy and supporting structure	Not applicable	Moderate

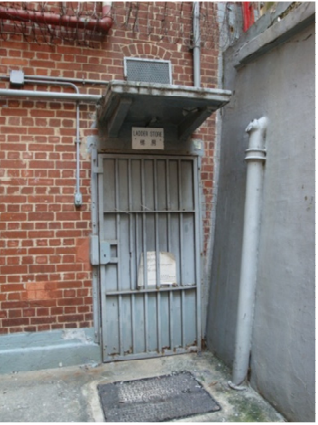
Element no.	Description	Photo ref.	Significance	Proposal	Mitigation	Impact
13.002	Door to Ladder Store

Low	Retain	Not applicable	Neutral
13.003	Security bars at window openings

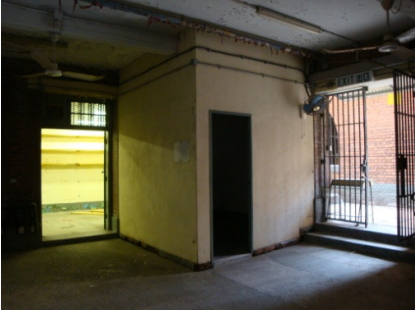
Element no.	Description	Photo ref.	Significance	Proposal	Mitigation	Impact
13.007	Internal partition walls

Low	Remove as part of re-planning of interiors	Record on measured survey drawings	Low
13.008	Fixed signs

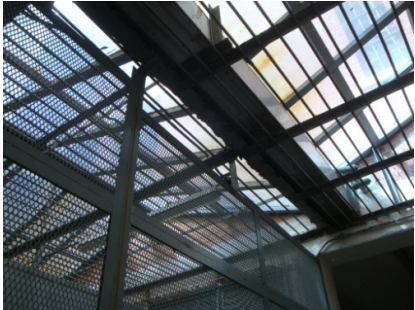
Element no.	Description	Photo ref.	Significance	Proposal	Mitigation	Impact
13.013	Rooflight and security bars over communal cells

Moderate	Remove as part of re-planning of interiors	Record on measured survey drawings	Low
13.014	Granite threshold at external door openings

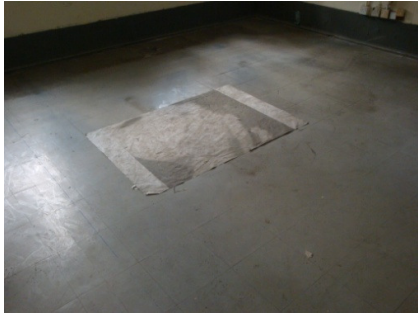
Adverse	Replace	Not applicable	Low

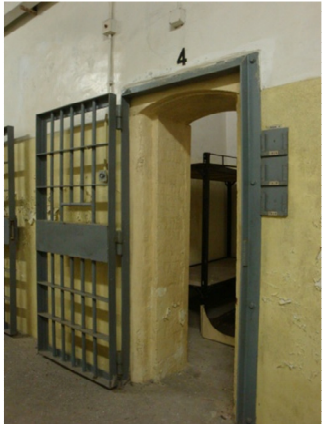
Element no.	Description	Photo ref.	Significance	Proposal	Mitigation	Impact
14.004	Brick reveals with bull-nosed arrisses and segmental arch over (generally north side, alternating with granite surrounds – see previous item)

High	Retain door surround and gate wherever possible	Pin back gate against wall	Low

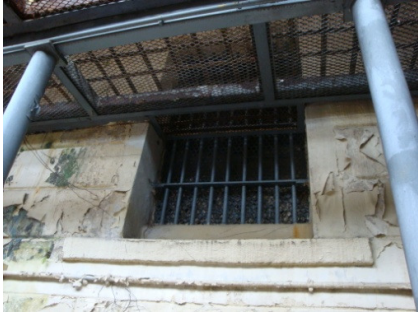
Element no.	Description	Photo ref.	Significance	Proposal	Mitigation	Impact
14.007	Part-blocked windows at Lower Ground Floor - extent of blocking varies.

Moderate	Open up window opening to full extent.	Record existing condition on measured survey drawings. Add further detail during demolition works.	Low
14.008	External granite stair from Lower Ground to Ground Floor level

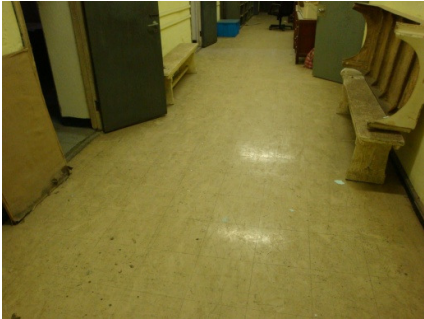
Adverse	Remove vinyl tiles and restore boards if possible; alternatively, replace boards with new timber to match other boarded floors elsewhere on the site.	Not applicable	Low

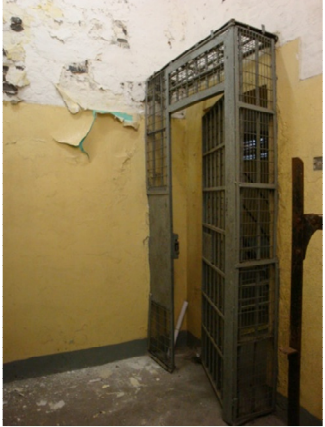
Element no.	Description	Photo ref.	Significance	Proposal	Mitigation	Impact
14.024	Inset security gate and screen in First Floor cells

Low	Remove to suit new use	Remove where necessary.  Record on measured drawings.	Low

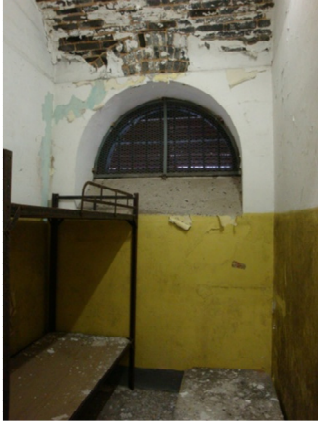
Element no.	Description	Photo ref.	Significance	Proposal	Mitigation	Impact
14.035	Brickwork spandrels below cell windows on south side at Ground Floor

Moderate	Remove to accommodate new cafe	Record on measured survey drawings	Low

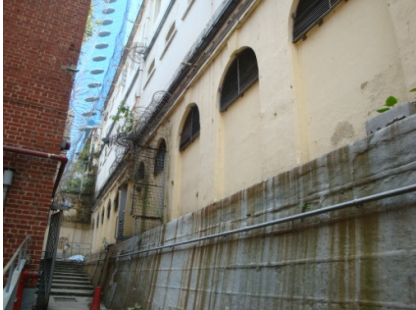
Element no.	Description	Photo ref.	Significance	Proposal	Mitigation	Impact
14.051	Blind arcade, north elevation

Low	Retain insitu	Not applicable	Neutral
14.052	Fence wall, east end of D Hall Yard

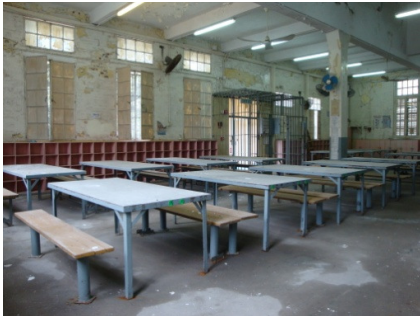
Element no.	Description	Photo ref.	Significance	Proposal	Mitigation	Impact
17.008	Fixed furniture

Moderate	Remove to accommodate gallery space	None	Low
17.009	Security screens

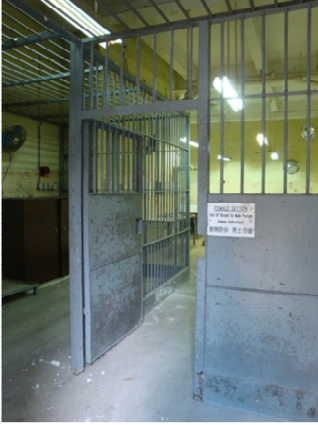
Element no.	Description	Photo ref.	Significance	Proposal	Mitigation	Impact
17.017	Security screen at Ground Floor main entrance

Low	Remove to accommodate gallery space	Record on measured drawings	Low

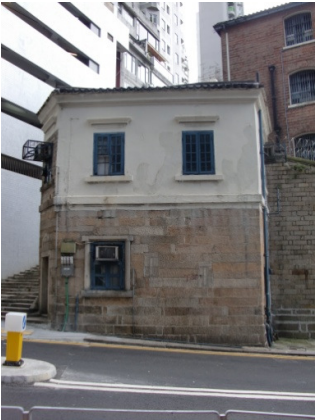
Element no.	Description	Photo ref.	Significance	Proposal	Mitigation	Impact
19.004	External stone wall facing

High	Carry out close inspection of painted areas to determine extent of original granite facing and remove paint media where applicable.	Not applicable	Moderate

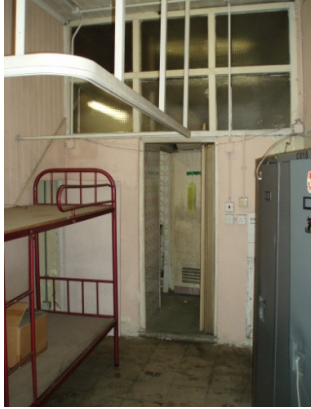
Element no.	Description	Photo ref.	Significance	Proposal	Mitigation	Impact
19.008	Modern partitions

Adverse	Remove	Not applicable	Moderate
