The Jockey Club CPS Limited

Central Police Station Conservation  
and Revitalisation Project:  
*Sixteenth Monthly EM&A Report*  
*(1 February to 28 February 2013)*

Issue Date: March 2013

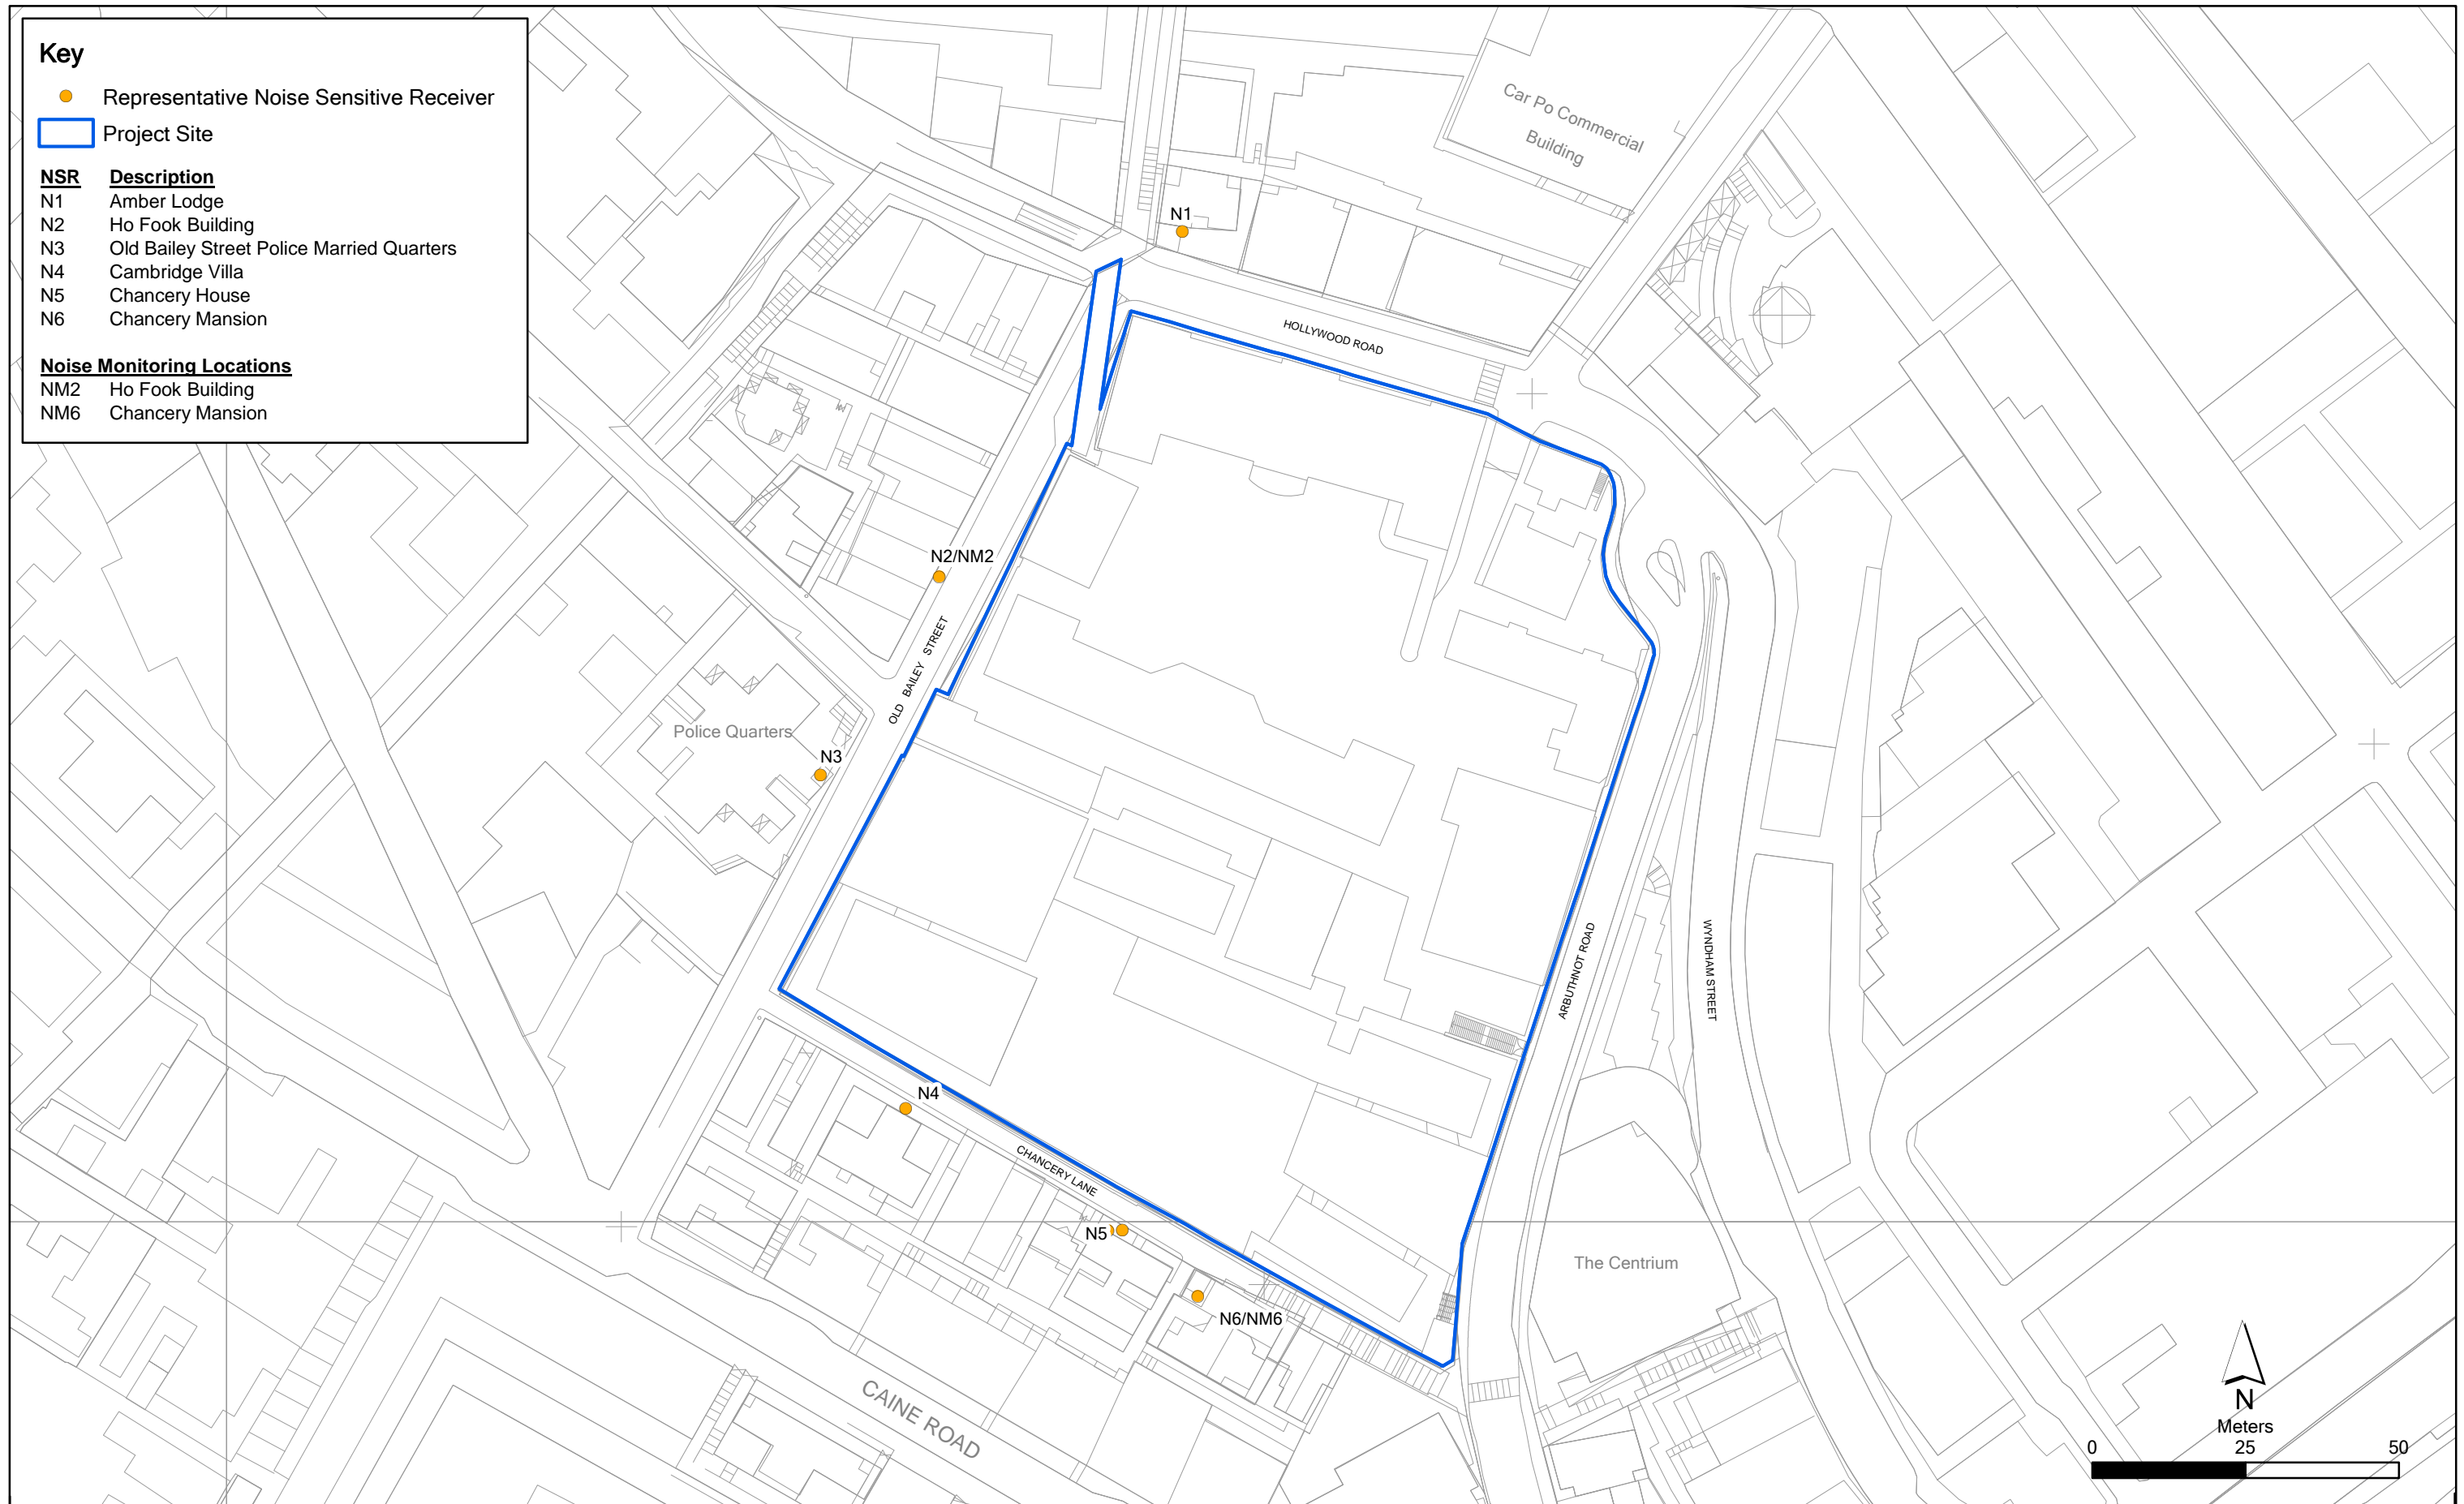
Location of Representative Noise Sensitive Receivers and Noise Monitoring Locations

NSR	Description
N1	Amber Lodge
N2	Ho Fook Building
N3	Old Bailey Street Police Married Quarters
N4	Cambridge Villa
N5	Chancery House
N6	Chancery Mansion

Noise Monitoring Locations	
NM2	Ho Fook Building
NM6	Chancery Mansion

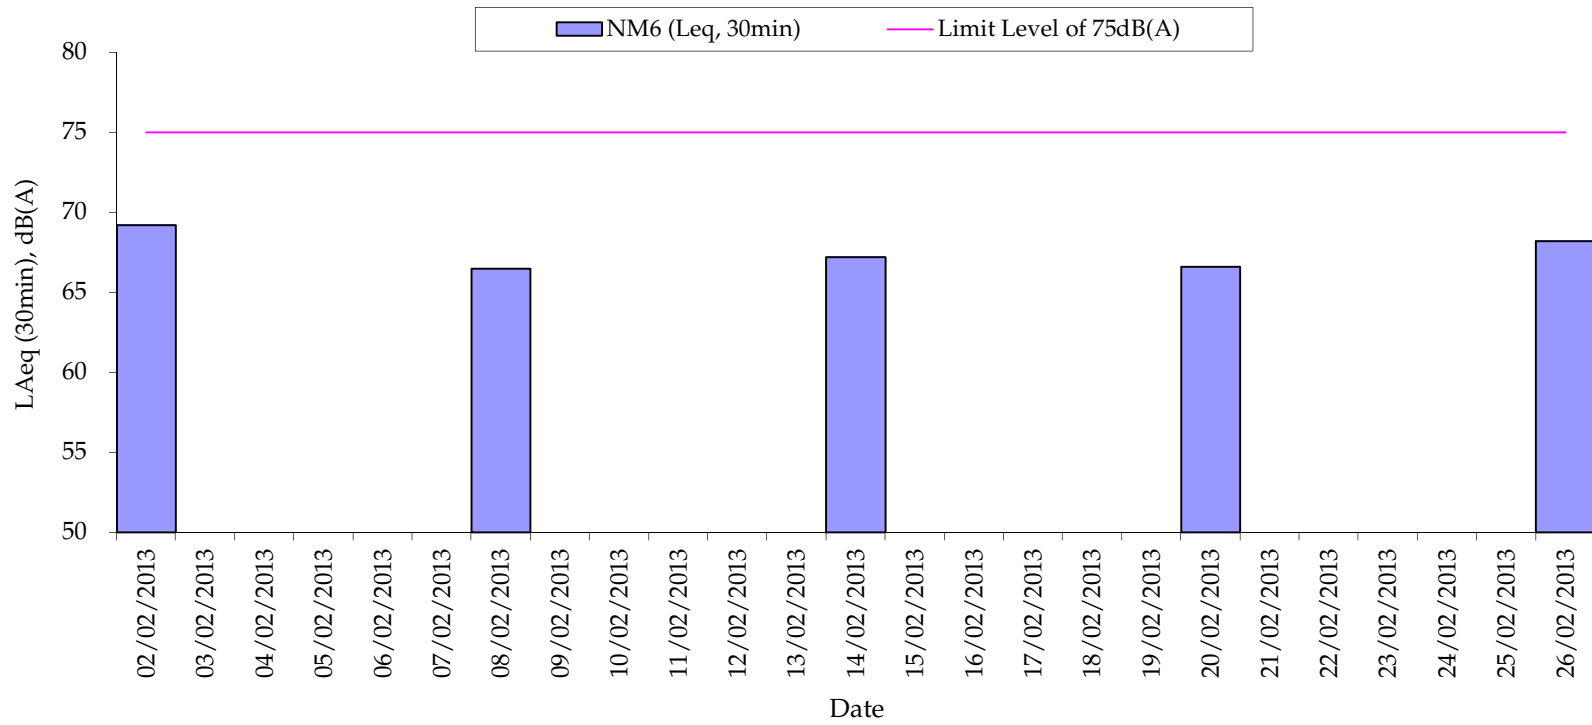
Normal Weekdays Noise Monitoring Results at NM6 - Chancery Mansion (Leq, 30min)

- 75dB(A) was adopted as the Limit Level during normal weekdays in the reporting period

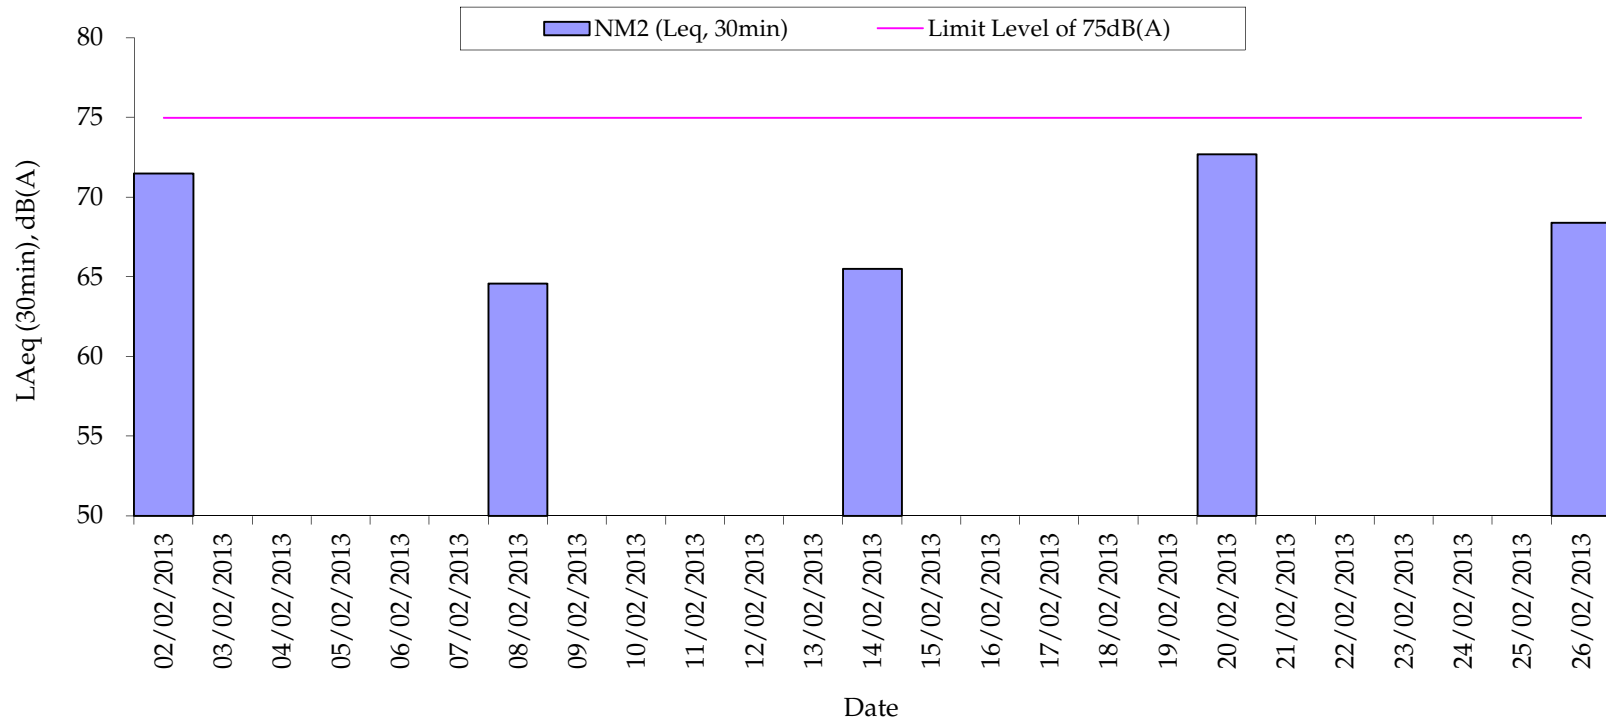
Normal Weekdays Noise Monitoring Results at NM2 - Ho Fook Building (Leq, 30min)

- 75dB(A) was adopted as the Limit Level during normal weekdays in the reporting period

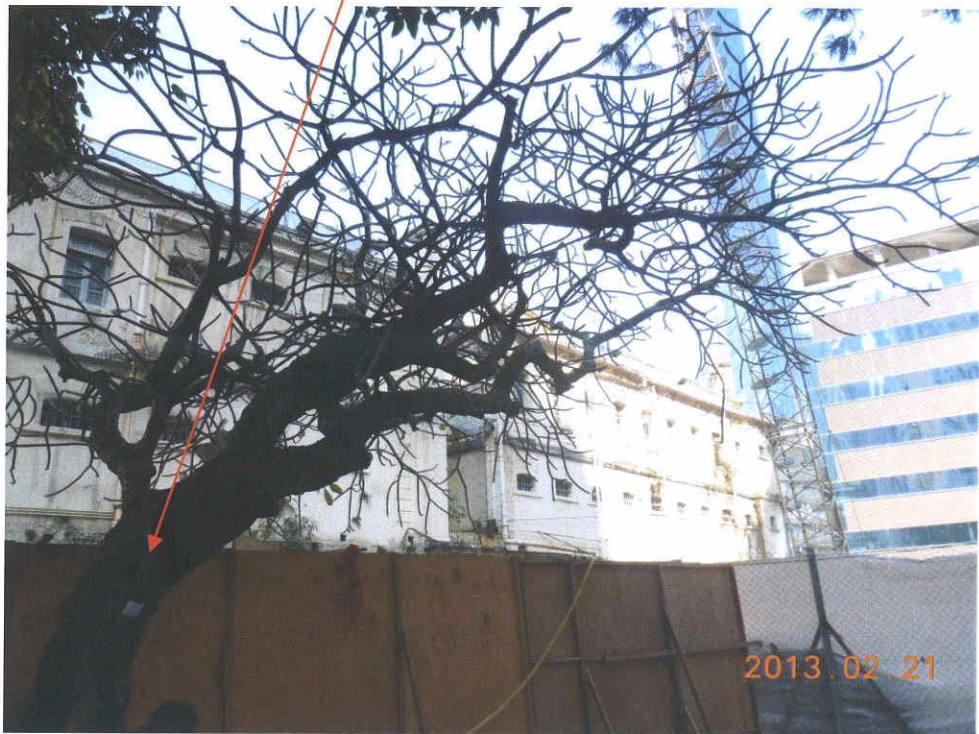
Fig. 4 Most leaves of Tree-8 have fallen at the time of inspection.

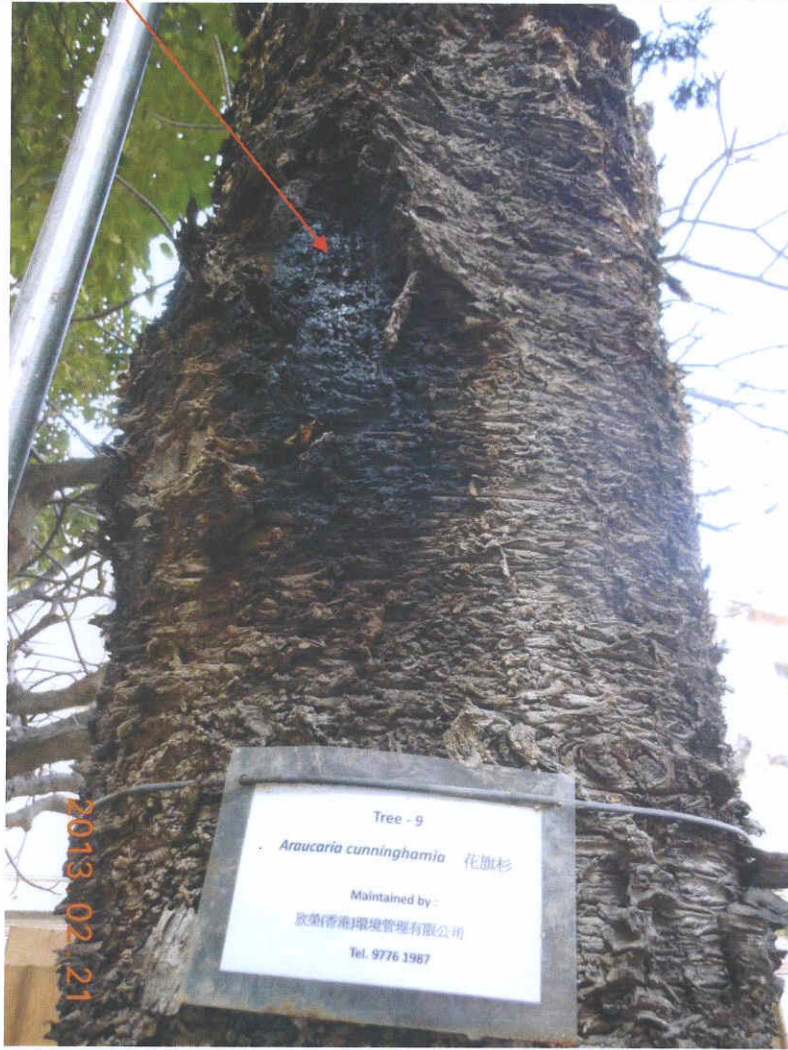
Landscape and visual monitoring has commenced since October 2011 on a monthly basis. Tree inspection was conducted on 21 February 2013 by the arborist during the reporting period. Sap flow was observed on the mid-trunk of Tree-9 and close monitoring by the Contractor was recommended.

Fig. 4 Sap flow appears on the mid trunk, close monitoring at regular intervals is required.

1. Keep close monitoring on the sap flow at regular intervals.

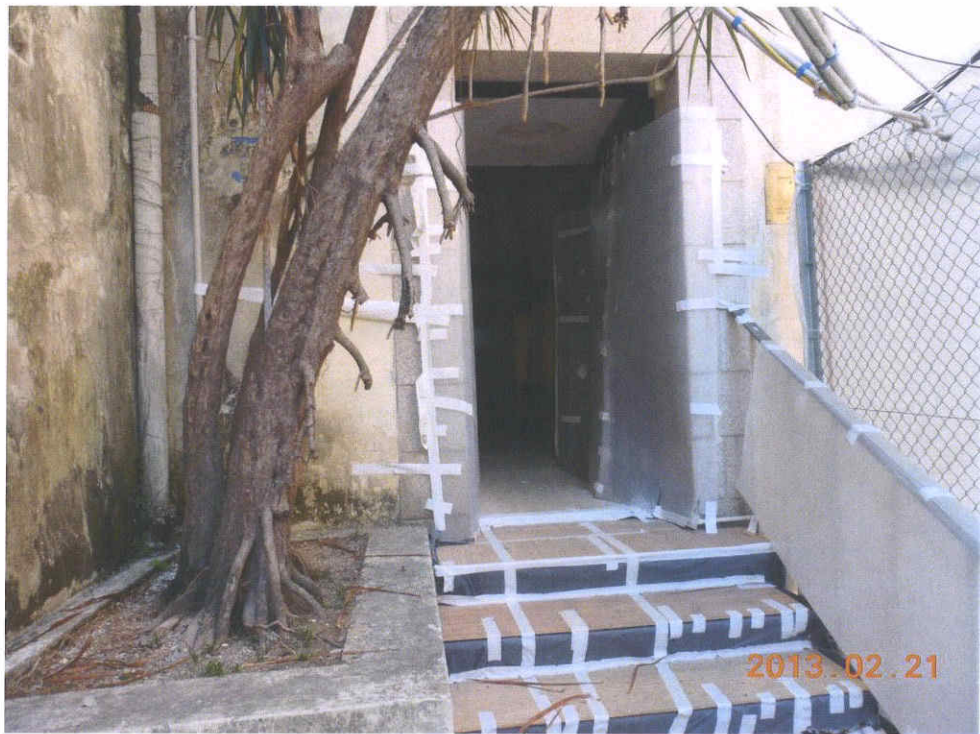
Fig. 4 The wooden door keeps opened at the time of inspection.

1. To keep the wooden door always closed.
