The Jockey Club CPS Limited

Central Police Station Conservation  
and Revitalisation Project:  
*48<sup>th</sup> Monthly EM&A Report*  
*(1 October to 31 October 2015)*

Issue Date: November 2015

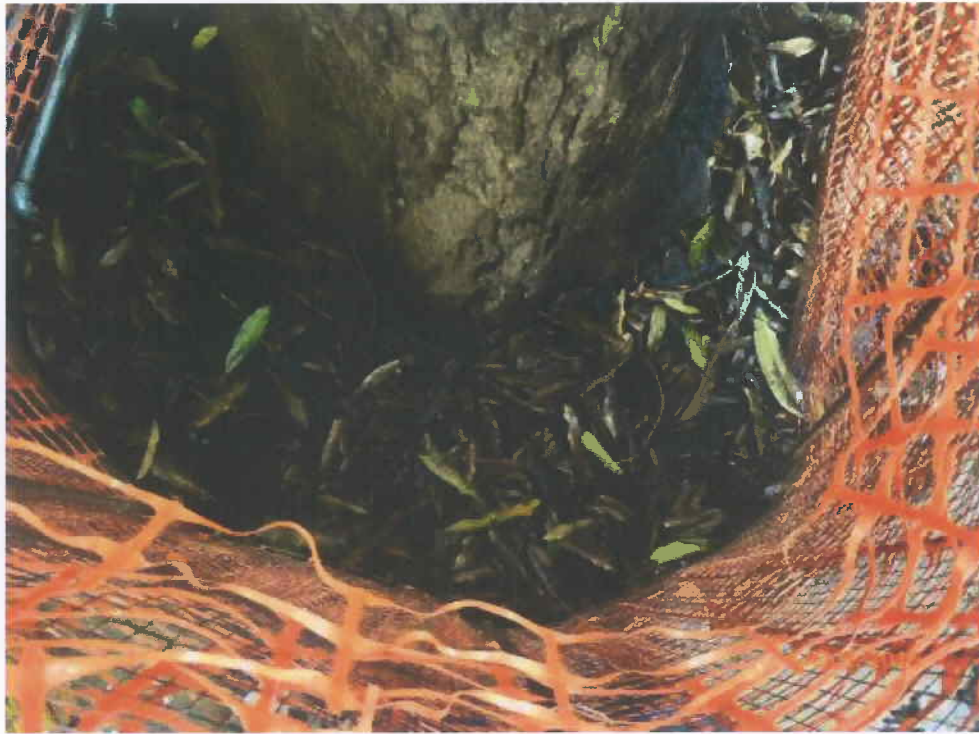
Fig 2. Root collar of Tree-5 is normal. The planter appears clean and tidy.

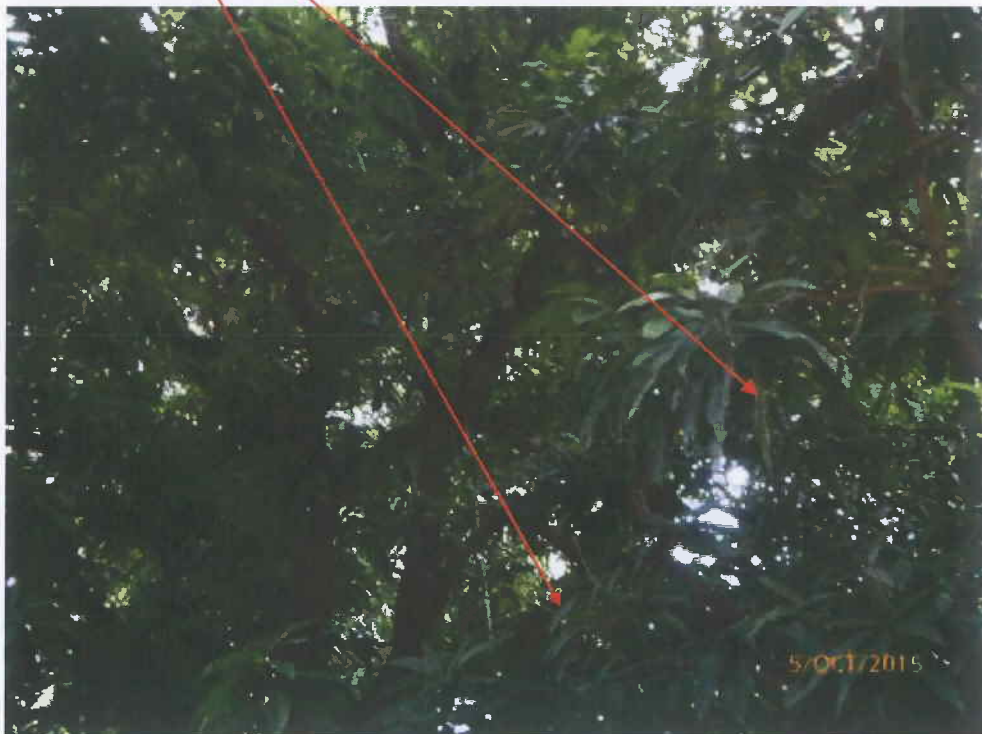
Fig. 7 Signs of the Pest (Mealy Bugs 粉狀介殼蟲) have apparently reduced due to pest control operation on 3<sup>rd</sup> July 2015.

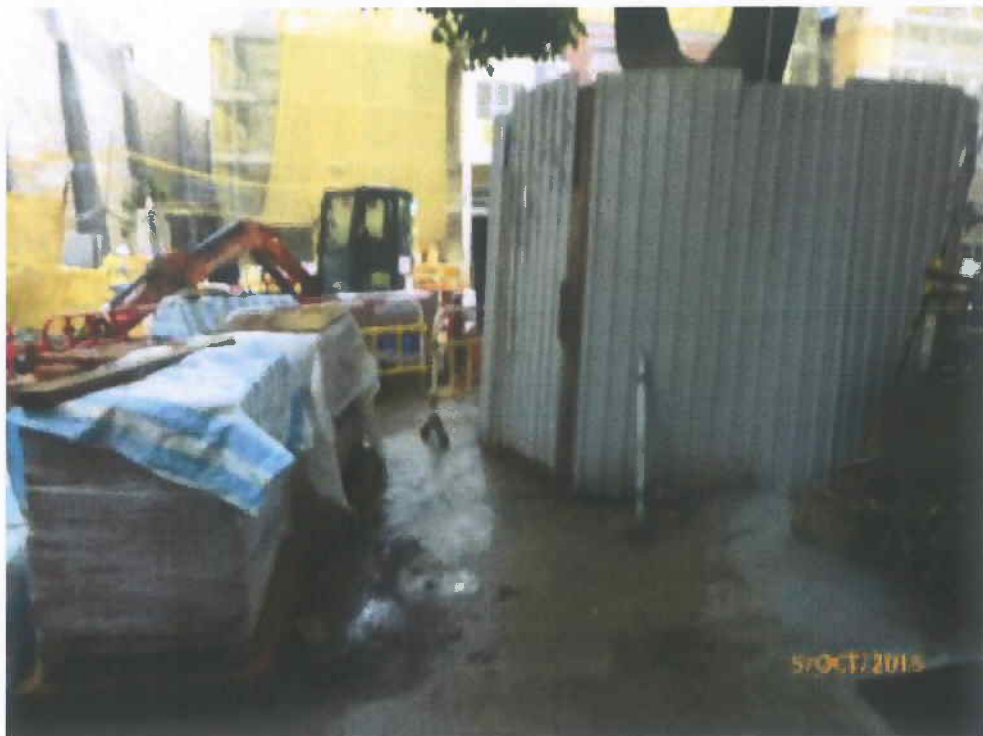
Fig. 7 The planter is surrounded by metallic sheet.

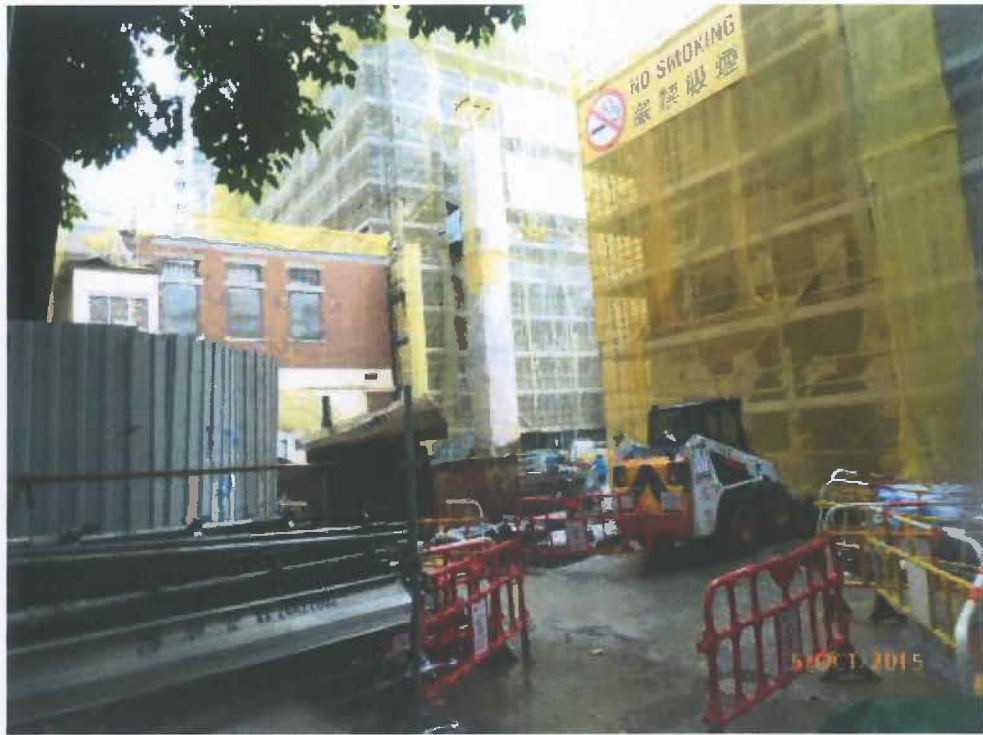
Fig. 8 Many construction items are placed near the planter.

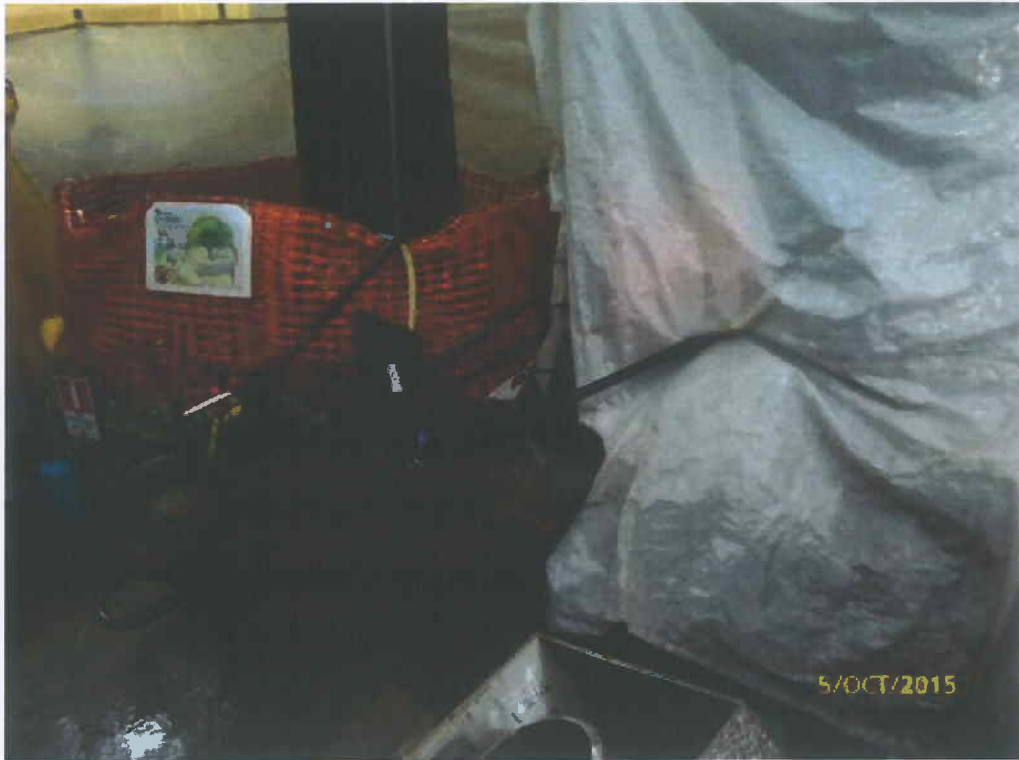
Fig. 8 Many construction items are placed near the planter.

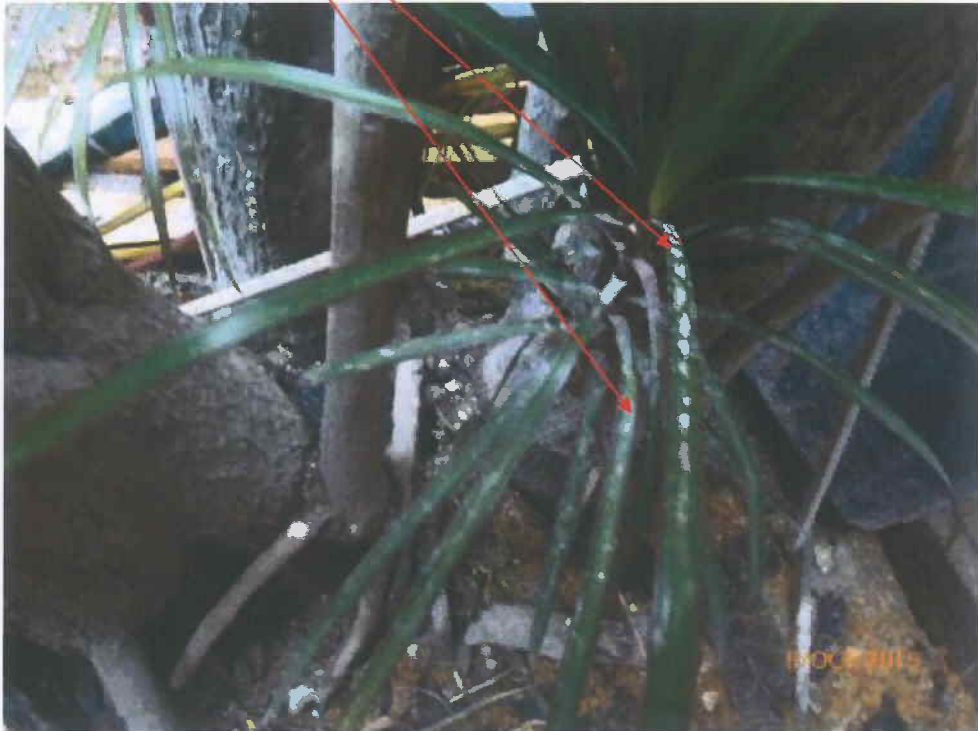
Fig. 2 Lots of cement dust are found on the planter.

1. **To tidy up the planter and to have more protection work for the tree.**
2. **To keep close monitoring on the growth of the tree.**

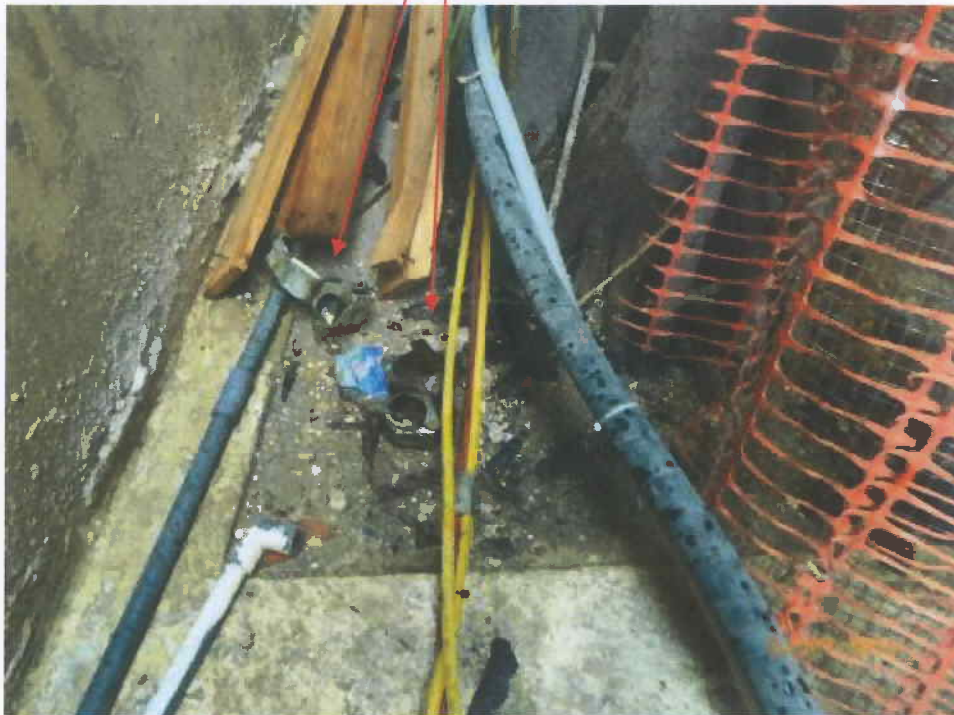
Fig. 3 Lots of construction debris are found on the bottom part of the tree.
