Central Police Station Conservation  
and Revitalisation Project:  
*Eighth Monthly EM&A Report*  
(1 June to 30 June 2012)

Issue Date: July 2012

Reference 0095646

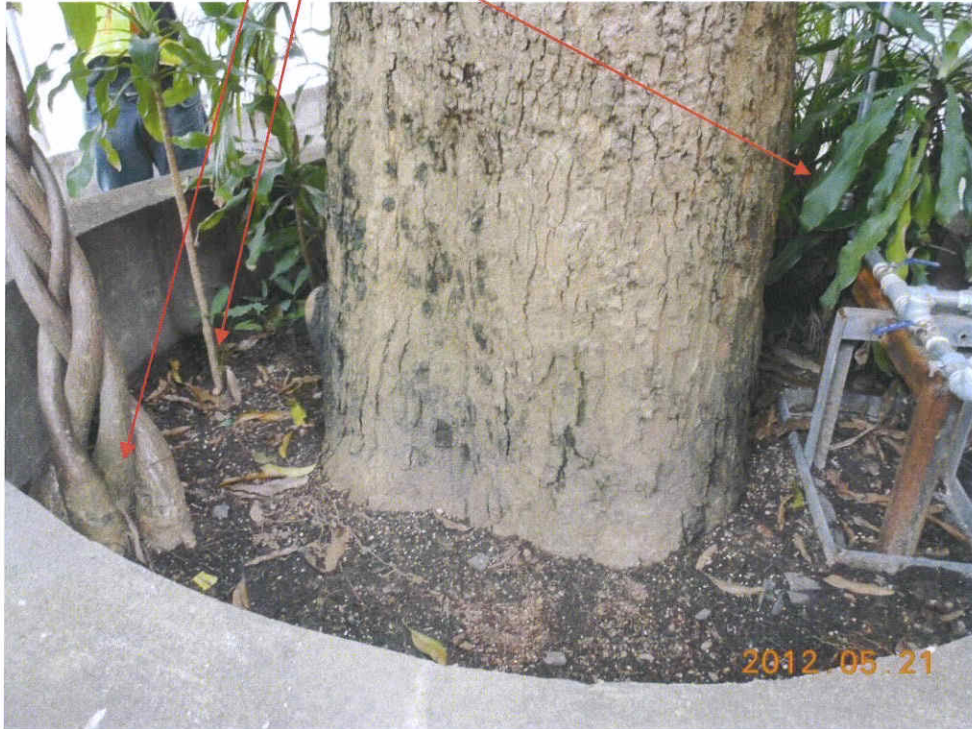
Fig 2. Too many undergrowth were jamming at the same planter during inspection on 21 May 2012.

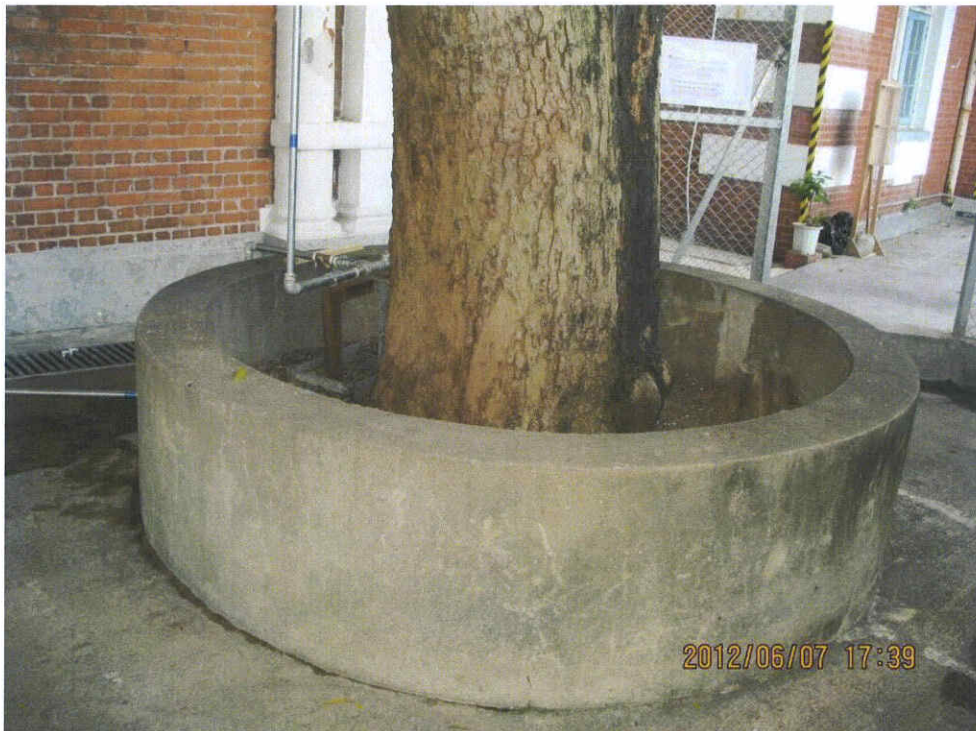
Fig. 3 All the undergrowth had been removed on 7 June 2012.

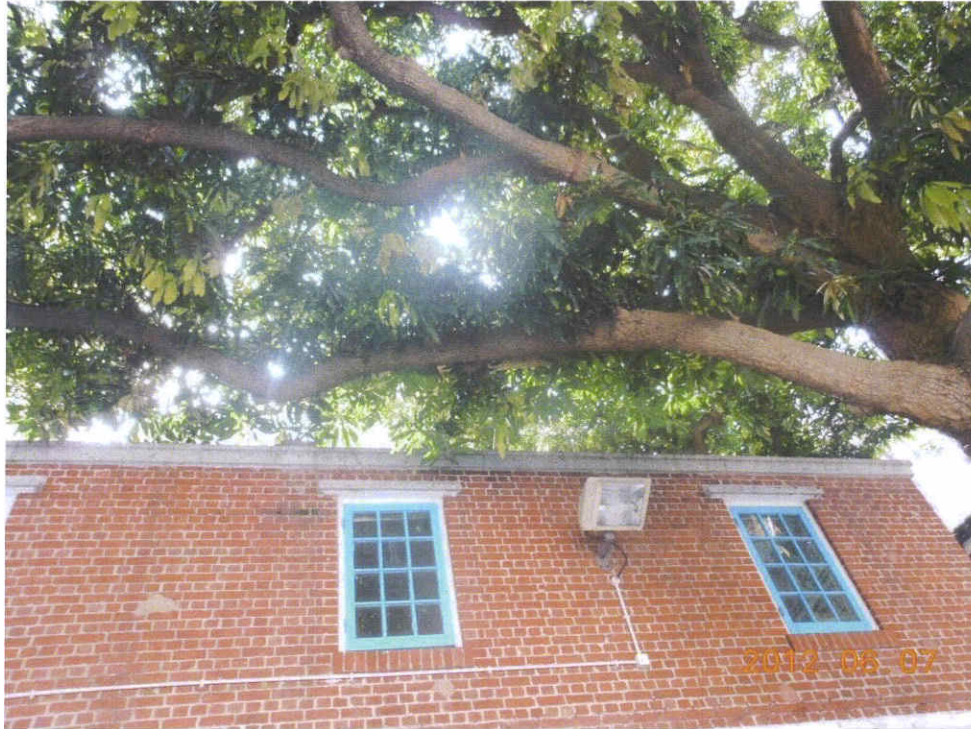
Fig. 4 Some lower branches and leaves are too close to the nearby buildings. Trimming of such branches/leaves is recommended.

1. To trim the lower branches / leaves which are too close to the buildings.

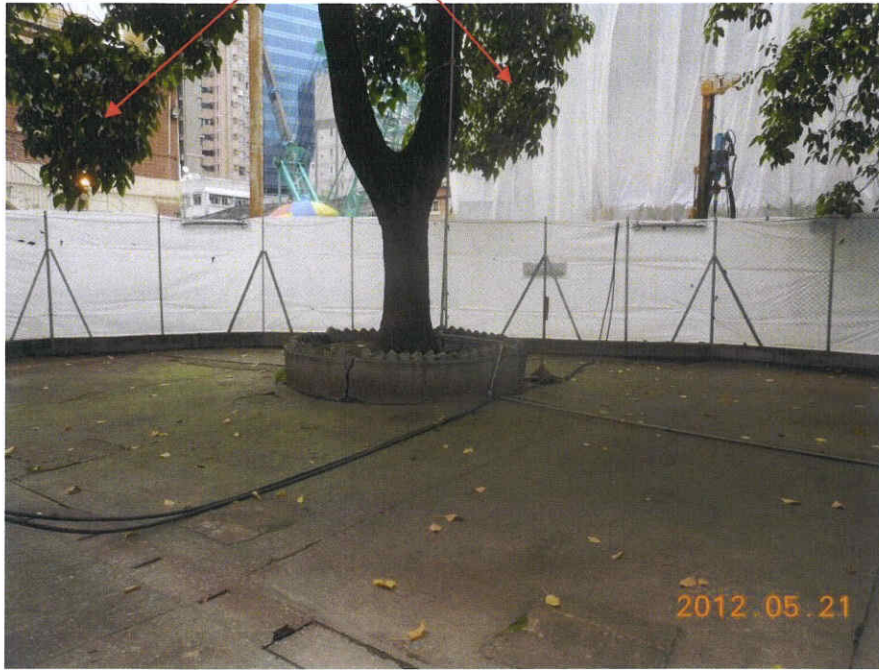
Fig. 6 Overgrown branches/leaves were too close to the wire-netted fence during inspection on 21<sup>st</sup> May 2012.

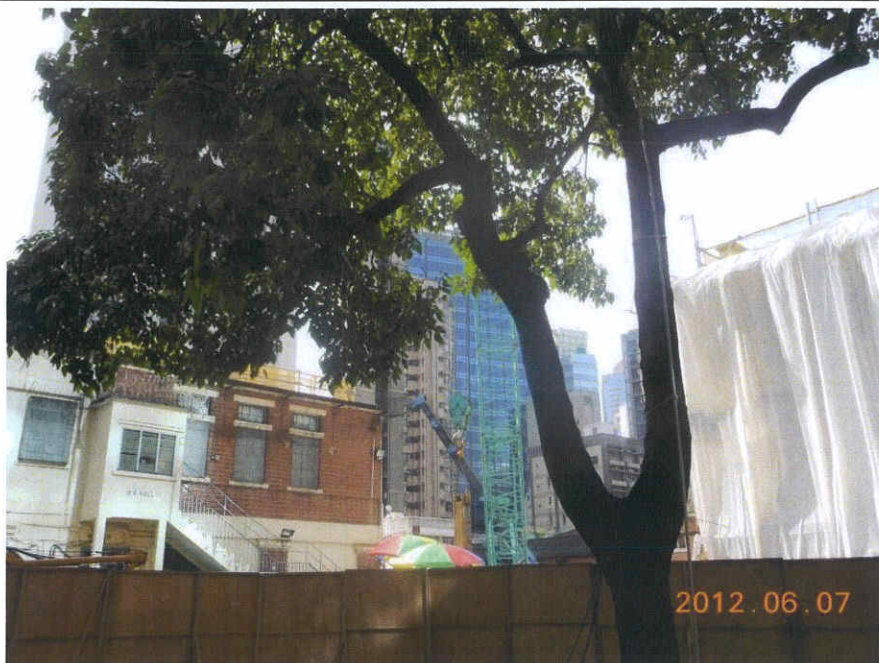
Fig. 7 Overgrown branches/leaves had been pruned on 1<sup>st</sup> June 2012.

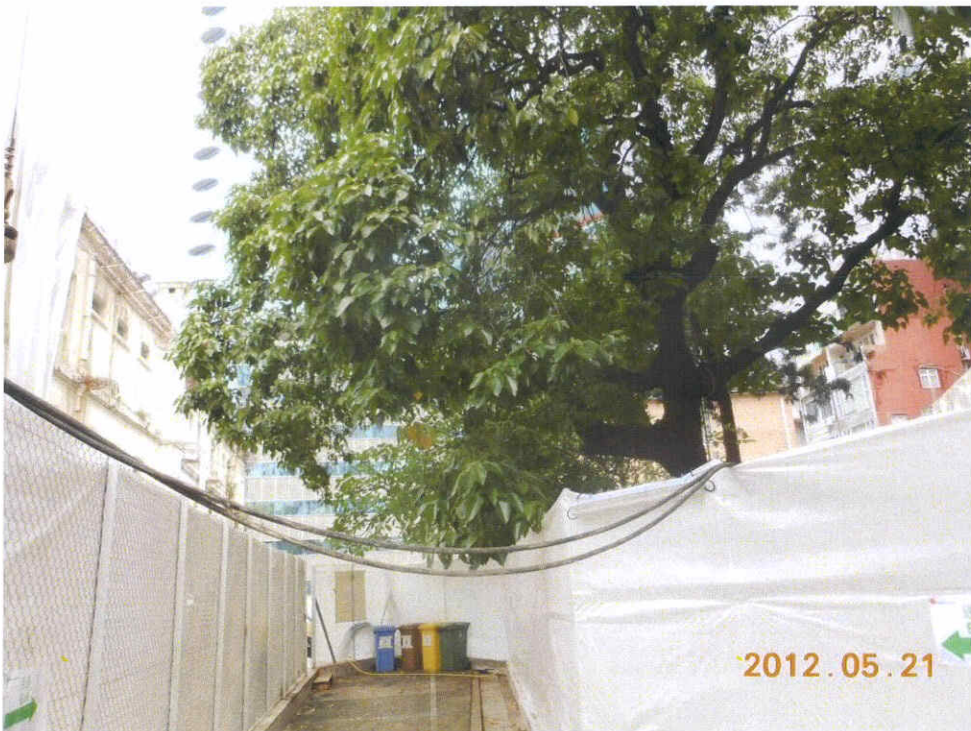
Fig. 5 Overgrown branches /leaves were too close to the fence of the cordon zone during the inspection on 21<sup>st</sup> May 2012.

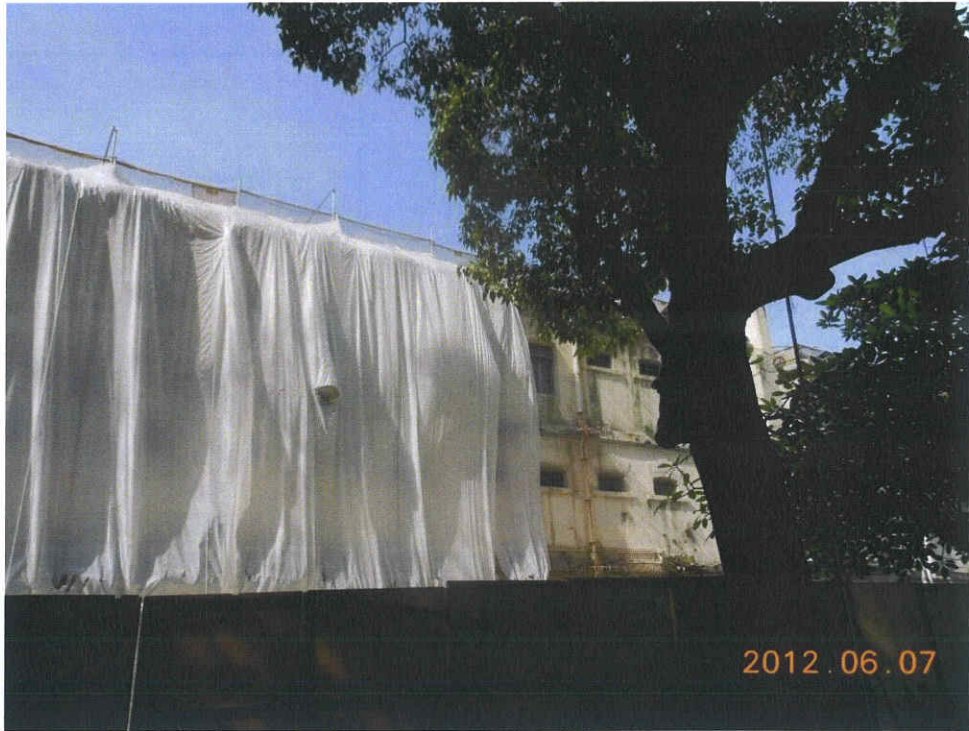
Fig. 6 Overgrown branches/leaves had been pruned on 1<sup>st</sup> June 2012.

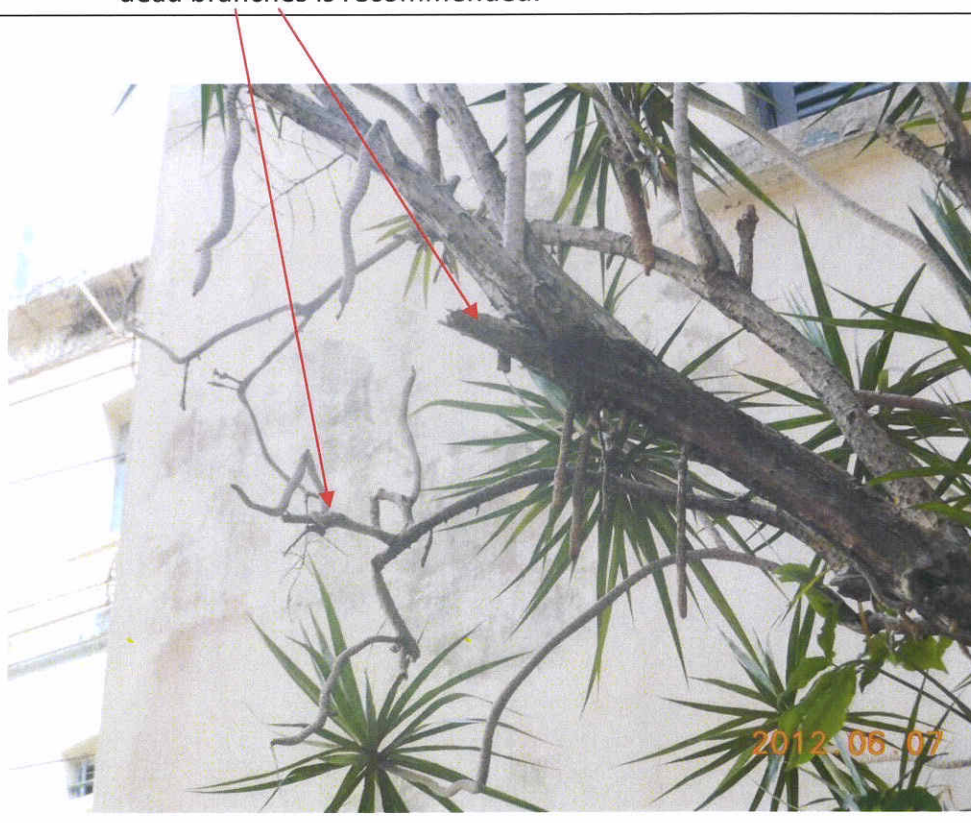
Fig. 5 Some dead branches appear on the tree. Trimming of these dead branches is recommended.

1. To remove the dead branches before typhoon seasons.
