The Jockey Club CPS Limited

Central Police Station Conservation
and Revitalisation Project:
18th Quarterly EM&A Report
(1 February 2016 to 30 April 2016)

Issue Date: November 2016

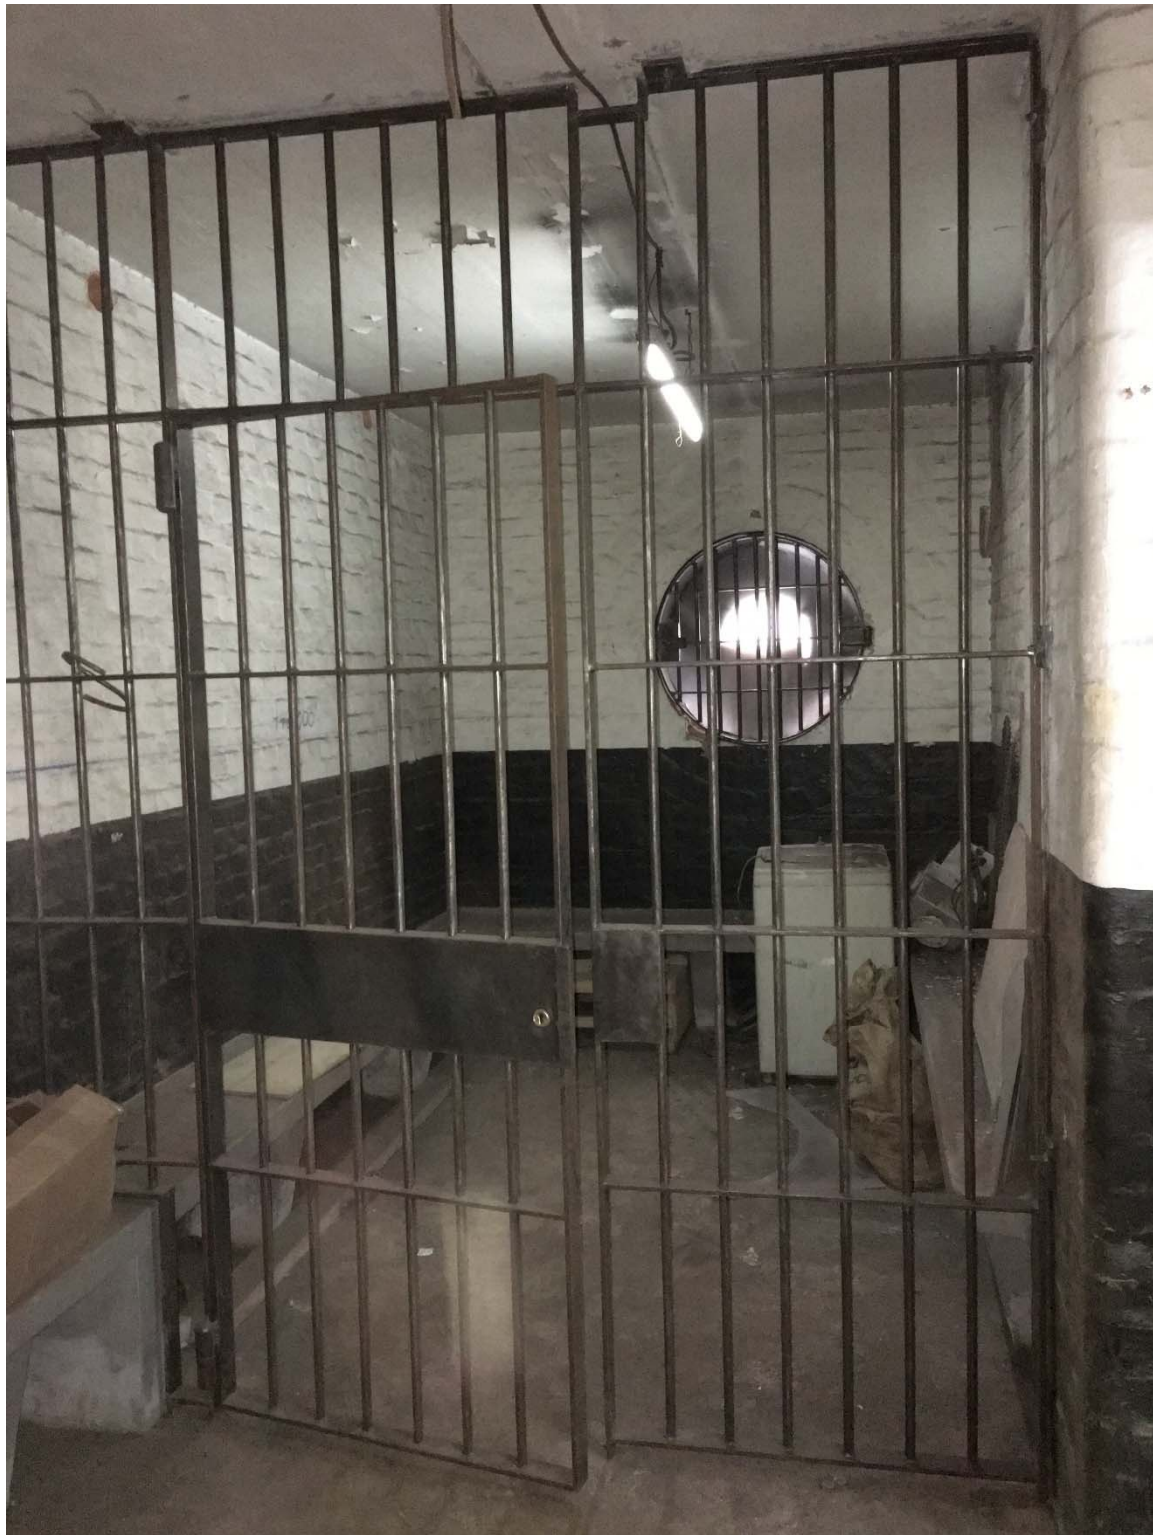
Above, photograph taken on 25th February 2016, the conduits, lighting, mesh and fan on the window, paint on the metal gate were incorrectly removed. Removal of mesh had damaged adjacent brickwork.

- It was observed that the existing paint on metal bars and mesh on the window at Block 9 holding cell were removed incorrectly. The Contractor was informed to follow up.
- Defects on doors at Block 11 were observed. The Contractor was informed to follow up.
- The original timber floorboards at Block 19 were found missing. The Contractor was informed to follow up.
