The Jockey Club CPS Limited

Central Police Station Conservation
and Revitalisation Project:
21st Quarterly EM&A Report
(1 November 2016 to 31 January
2017)

Issue Date: March 2017

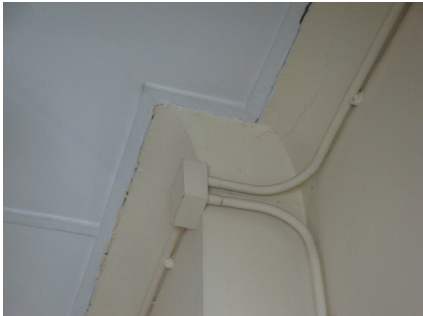
Adverse	Replace with T&G boarding to match existing	Not applicable	High
01.002	Plaster coving at abutments of walls and ceilings

Low	Remove in exceptional cases eg, where adjacent new lift shaft	Cut back neatly to a square edge and ensure remaining section is secure.	Low

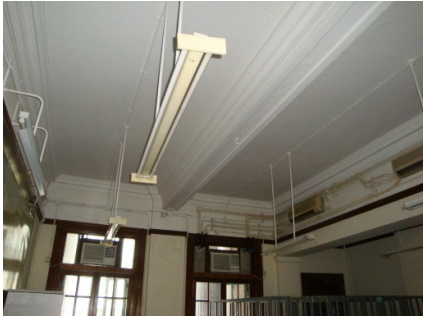
Element no.	Description	Photo ref	Significance	Proposal	Mitigation	Impact
01.009	Plaster ceilings on GF and LG1

Moderate	Install cloud ceilings to accommodate new services	Install fixed grid to minimise damage to ceiling	High
01.010	Timber door frames and architraves

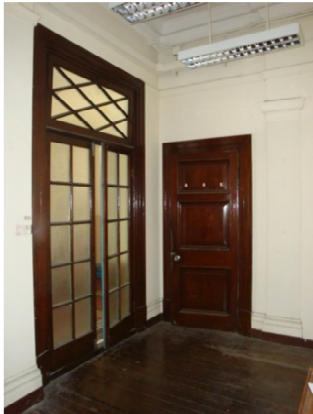
Moderate	Conceal in exceptional cases eg. where adjacent new lift shaft	Retain architrave and door frame in situ. Avoid damage to joinery.	High

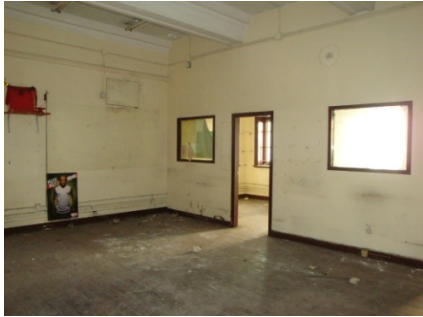
Element no.	Description	Photo ref	Significance	Proposal	Mitigation	Impact
01.011	Concrete floor

Low	Replace where new kitchens and plant rooms to be installed	Carefully remove and retain existing floorboards for re-use. Ensure controlled demolition of concrete structure and removal of debris from building to avoid damage to adjacent surfaces. Protect or carefully remove and set aside adjacent elements such as skirting boards	Low

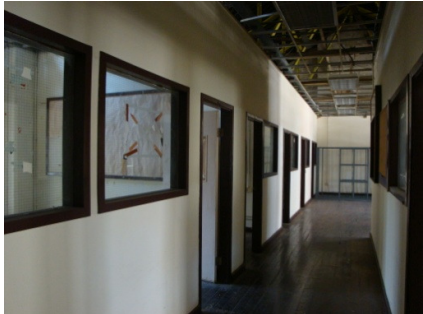
Element no.	Description	Photo ref	Significance	Proposal	Mitigation	Impact
01.029	Modern partitions

Adverse	Remove	Not applicable	High
01.030	Tiled dado

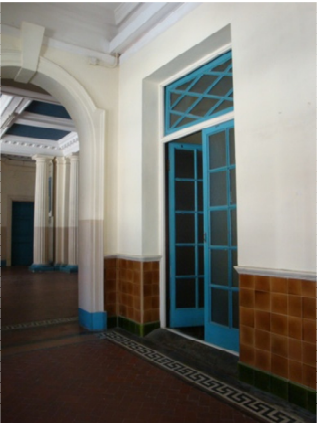
High	Cut away for enlargement of existing windows to form new doorways	Cut back to joint line and adjust tiling pattern to suit new opening. New tiles to match existing sizes and colours.	Moderate

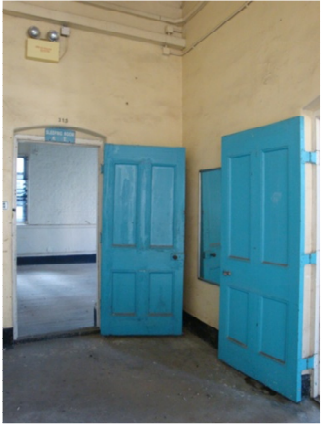
Element no.	Description	Photo ref.	Significance	Proposal	Mitigation	Impact
3.002	Panelled doors

Moderate	Replace where necessary to achieve fire resistance to comply with Code	Re-use where possible. Record design on survey drawings where item cannot be re-used.	Moderate

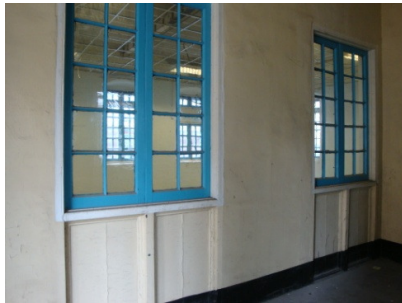
Element no.	Description	Photo ref.	Significance	Proposal	Mitigation	Impact
03.005	Timber spandrel panels below windows

Low	Conceal in exceptional cases eg. where adjacent new lift shaft	Retain frame and spandrel panel where possible. Remove only where necessary in connection with re-planning of interiors. Record on measured survey drawings.	Low
03.006	Timber floors

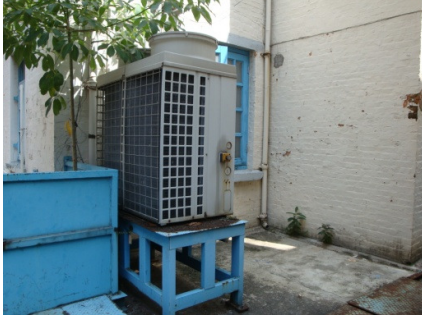
Element no.	Description	Photo ref.	Significance	Proposal	Mitigation	Impact
06.005	Altered doors and windows	 	Adverse	Adverse	Repair or renew as necessary existing frames to match original patterns	Not applicable
06.006	External airconditioning units and other external services

Adverse	Adverse	Remove and make good brickwork	Not applicable

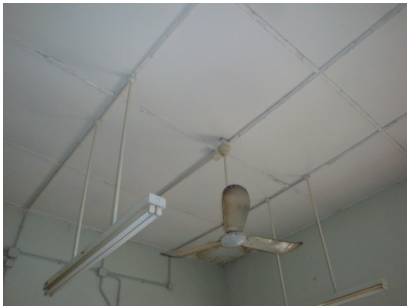
Element no.	Description	Photo ref.	Significance	Proposal	Mitigation	Impact
06.017	Batten and panel ceiling lining

Low	Replace with lath and plaster ceiling	Not applicable	Low
06.018	Exposed roof covering

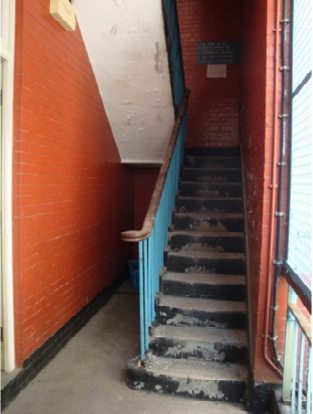
High	Retain	Not applicable	Neutral
08.006	External stair at west end

Moderate	Retain	Repair as necessary. Alter balustrade to achieve reasonable level of operational safety. Restrict access to repairs and maintenance and means of escape.	Low

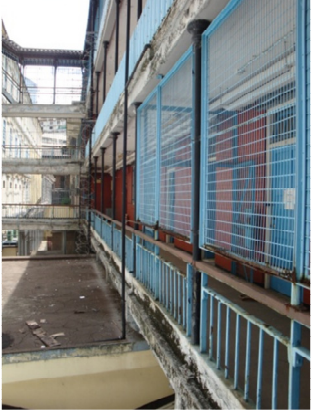
Element no.	Description	Photo ref.	Significance	Proposal	Mitigation	Impact
08.009	Wire mesh screens

Adverse	Remove	Not applicable	Low
08.010	Internal walls and concrete floors

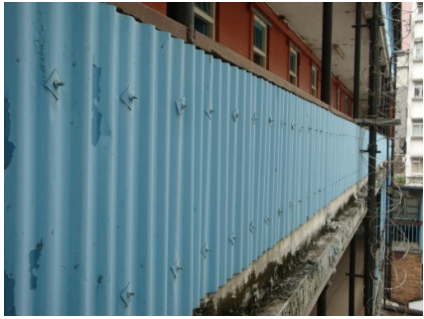
Low	Demolish to make way for new loading bay.	Record on measured survey drawings. Infill existing internal opening leaving reveals exposed. Tooth-in new brickwork at abutments after existing walls removed. Salvage cast iron columns for possible re-use.	Low
08.015	Corrugated steel sheet on balcony balustrades

Adverse	Remove	Not applicable	Low

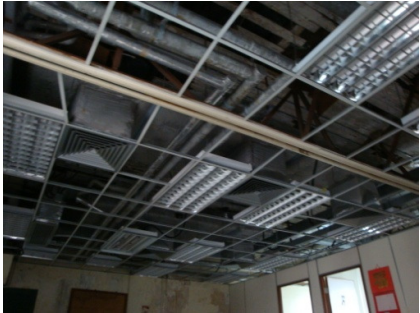
Element no.	Description	Photo ref.	Significance	Proposal	Mitigation	Impact
09.001	Lay-in grid suspended ceiling

Adverse	Remove	Not applicable	High
09.002	Modern partitions

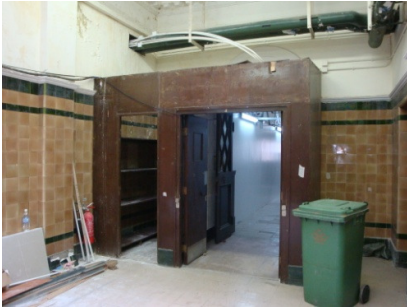
Element no.	Description	Photo ref.	Significance	Proposal	Mitigation	Impact
09.020	Meeting room at G/02-05	 	Moderate	Remove timber panelling from walls and sub divide to form new toilets and lift shaft	Record existing wall linings, and any earlier lining behind, on measured survey drawings.	Moderate
09.021	Lobbies within entrance hall G/12

Adverse	Remove	Not applicable	N/A

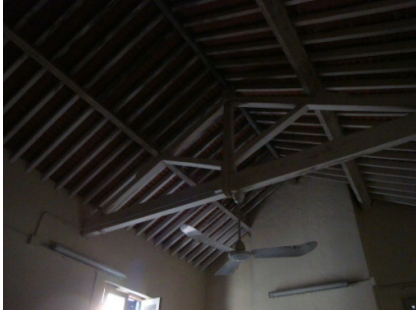
Element no.	Description	Photo ref.	Significance	Proposal	Mitigation	Impact
10.018	Timber roof structure above south-east wing

Moderate	Repair as necessary and retain	Avoid intrusive alteration. Retain open appearance/	Low
10.019	Timber stair

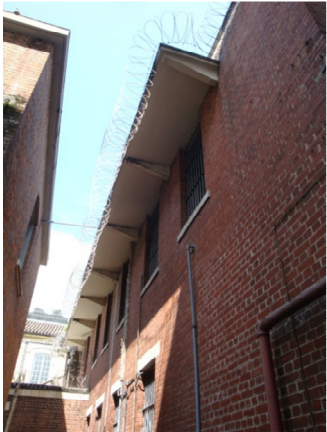
Element no.	Description	Photo ref.	Significance	Proposal	Mitigation	Impact
13.006	Cantilever reinforced concrete canopy

Low	Retain	Not applicable	Neutral

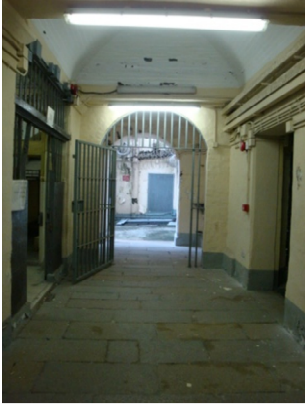
Element no.	Description	Photo ref.	Significance	Proposal	Mitigation	Impact
14.039	Granite pavement in cross-passage between East and West Wings

Moderate	Repair as necessary and retain insitu	Not applicable	Neutral
14.040	Granite threshold at doorway between cross-passage and East Wing

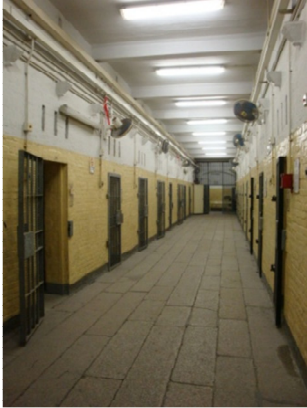
High	Retain insitu	Avoid any services penetrations	Neutral
14.042	Granite floor in central hall at First Floor

Moderate	Retain insitu	Repair where necessary	Neutral

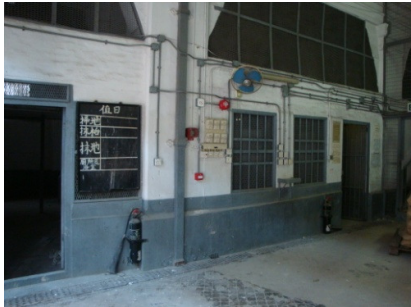
Element no.	Description	Photo ref.	Significance	Proposal	Mitigation	Impact
15.001	Dividing walls at Lower Ground Floor

Moderate	Remove to enable multi-purpose use	Record on measured survey drawings	Low
15.002	Dividing walls at Lower Ground Floor
