Central Police Station Conservation
and Revitalisation Project:
14th Quarterly EM&A Report
(1 February 2015 to 30 April 2015)

Issue Date: July 2015

Annex N	<i>A Summary of Current Condition of Character Defining Elements</i>

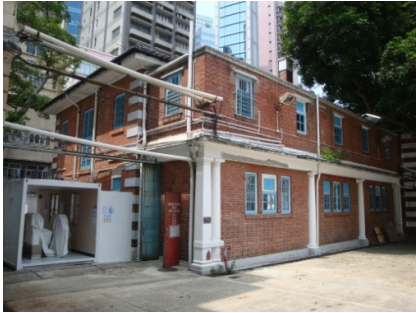
Element no.	Description	Photo ref.	Significance	Proposal	Mitigation	Impact
02.007	Rainwater goods

Adverse	Replace with cast iron in pattern to match original and in correct locations	No applicable	High

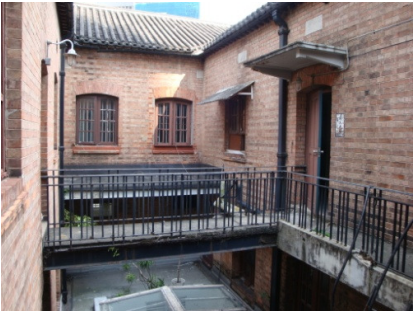
Moderate	Replace with larger sizes/closer spacing to improve performance	Use cast iron to match original pattern Make good all redundant fixing holes	High
09.013	Metal walkways across lightwell

Adverse	Remove walkways and make good brickwork at abutments	Not applicable	High
