The Jockey Club CPS Limited

Central Police Station Conservation
and Revitalisation Project:
15th Quarterly EM&A Report
(1 May 2015 to 31 July 2015)

Issue Date: November 2015

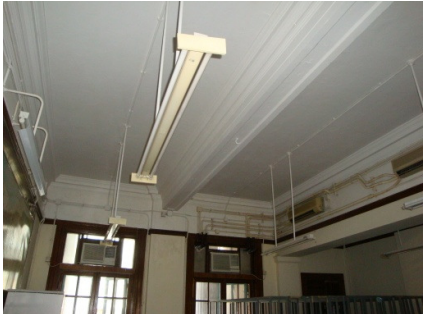
Element no.	Description	Photo ref	Significance	Proposal	Mitigation	Impact
01.009	Plaster ceilings on GF and LG1

Moderate	Install cloud ceilings to accommodate new services	Install fixed grid to minimise damage to ceiling	High
01.010	Timber door frames and architraves

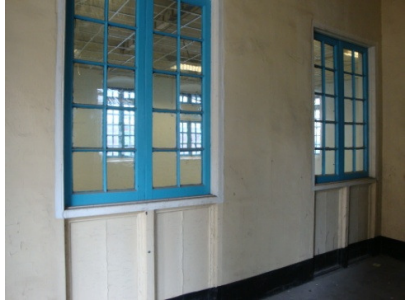
Element no.	Description	Photo ref.	Significance	Proposal	Mitigation	Impact
03.005	Timber spandrel panels below windows

Low	Conceal in exceptional cases eg. where adjacent new lift shaft	Retain frame and spandrel panel where possible. Remove only where necessary in connection with re-planning of interiors. Record on measured survey drawings.	Low
03.006	Timber floors

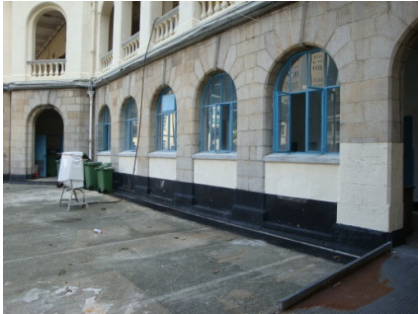
Element no.	Description	Photo ref.	Significance	Proposal	Mitigation	Impact
03.008	Exterior decorations

Adverse	Strip off and redecorate	Sample and analyse existing paint media; select new media to suit substrate and significance	High
03.009	Block existing door openings

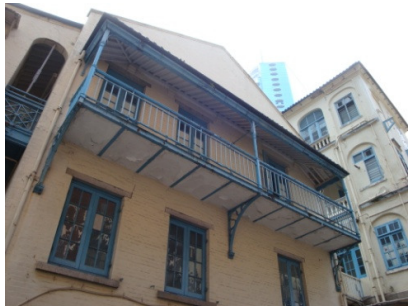
Element no.	Description	Photo ref.	Significance	Proposal	Mitigation	Impact
06.009	Cantilever balconies

High	Retain and repair as necessary.	Avoid highly visible intervention to enhance structural integrity and/or compliance with building codes. Restrict access if necessary to achieve this objective.	Low
06.010	Iron balustrades

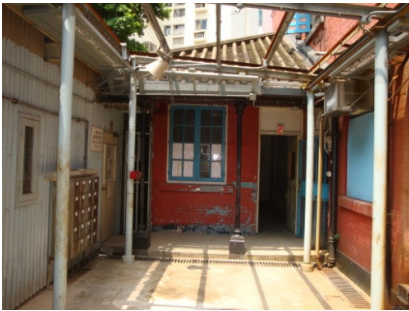
Element no.	Description	Photo ref.	Significance	Proposal	Mitigation	Impact
08.014	Single-storey outbuilding with pitched roof over

Low	Demolish to make way for new loading bay.	<p>Record on measured survey drawings.</p> <p>Infill existing internal opening leaving reveals exposed.</p> <p>Tooth-in new brickwork at abutments after existing walls removed.</p> <p>Salvage cast iron columns for possible re-use.</p>	Low
08.015	Corrugated steel sheet on balcony balustrades

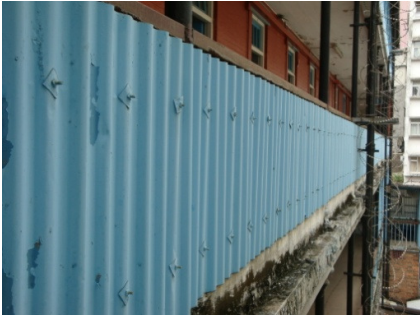
Adverse	Remove	Not applicable	Low

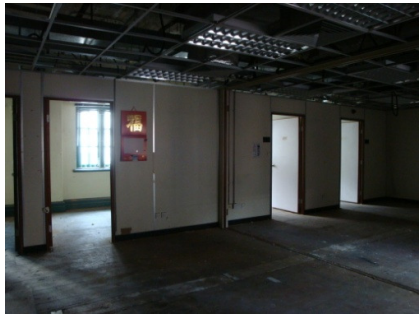
Adverse	Remove	Not applicable	High
09.002	Modern partitions

Adverse	Remove	Not applicable	N/A

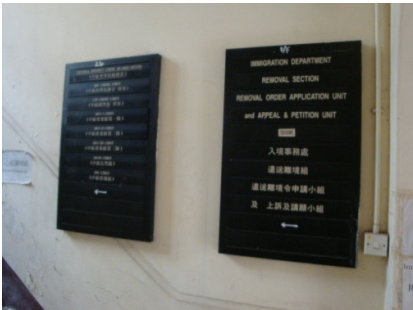
Element no.	Description	Photo ref.	Significance	Proposal	Mitigation	Impact
09.008	Stair balustrades	 	High	Balustrades to be supplemented with additional handrails and supports to mitigate non-compliance with code	New fittings to be of their time and made reversible. Physical intervention to existing stairs and balustrades to be kept to the minimum.	Moderate
09.009	Fixed signs

Low-High	Remove and refix/display in visitors' centre/discard	Record each sign and assess significance individually and treat accordingly	N/A

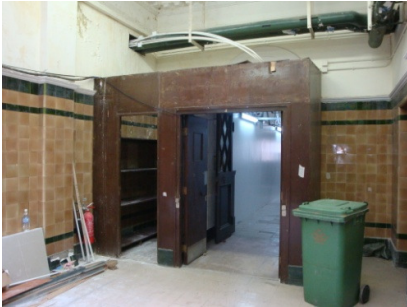
Element no.	Description	Photo ref.	Significance	Proposal	Mitigation	Impact
09.020	Meeting room at G/02-05	 	Moderate	Remove timber panelling from walls and sub divide to form new toilets and lift shaft	Record existing wall linings, and any earlier lining behind, on measured survey drawings.	Moderate
09.021	Lobbies within entrance hall G/12

Adverse	Remove	Not applicable	N/A

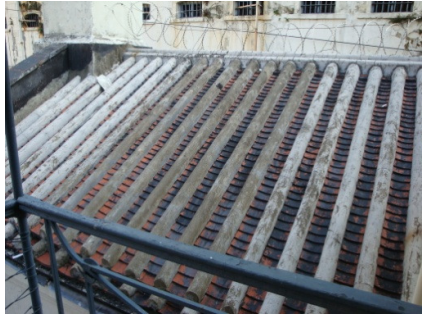
Element no.	Description	Photo ref.	Significance	Proposal	Mitigation	Impact
10.011	Fixed signs	 	Low-High	Remove and refix/display in visitors' centre/discard	Record each sign and assess significance individually and treat accordingly	N/A
10.012	Pitched roofs

High	New penetrations through roofs for ventilation ducts and other services	Arrange new penetrations so that they conform with the geometry of the existing roof. Model the size and shape of the new ducts so that the impact on the roofscape is minimised. Finish the new ducts in a non-reflective material that is neutral in colour and mid-tone.	High

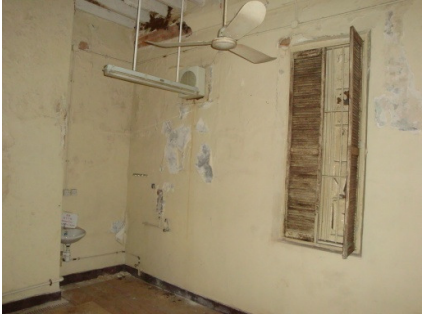
Moderate	Remove partitions	Record partitions on measured drawings	Moderate
10.015	Blocked windows on south elevation of south-east wing

Adverse	Re-open window openings and reinstate window frames and glazing	Not applicable	Moderate

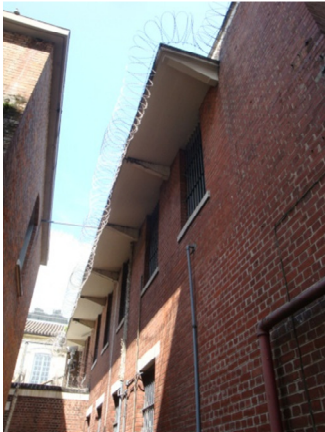
Element no.	Description	Photo ref.	Significance	Proposal	Mitigation	Impact
13.006	Cantilever reinforced concrete canopy

Low	Retain	Not applicable	Neutral

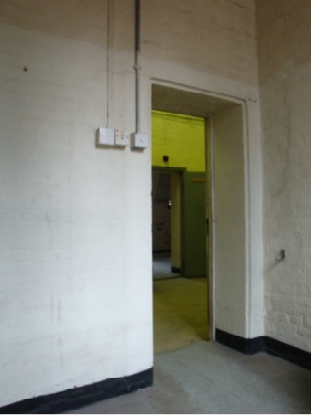
Element no.	Description	Photo ref.	Significance	Proposal	Mitigation	Impact
14.019	Granite surrounds to doorways with lintels over

Moderate	Increase width in selected locations to allow wheelchairs to pass	Record on measured survey drawings. Limit interventions as far as possible.	Low
14.020	Flat ceilings at Ground Floor

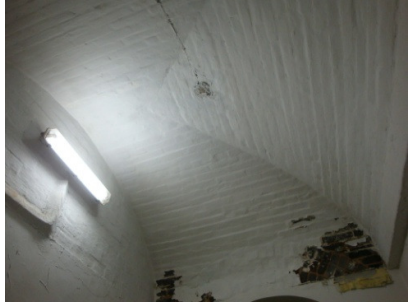
Element no.	Description	Photo ref.	Significance	Proposal	Mitigation	Impact
14.033	Brick vaults above cells

High	Retain insitu	Avoid penetrations for services	Neutral
14.034	Cell walls (later additions)

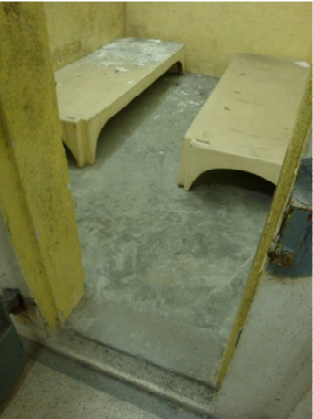
Element no.	Description	Photo ref.	Significance	Proposal	Mitigation	Impact
14.037	Cell floors

Low	Remove to enable piled underpinning	Record on measured survey drawings	Low

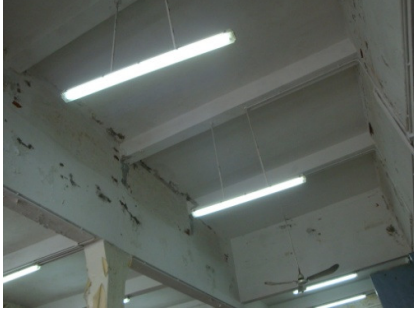
Element no.	Description	Photo ref.	Significance	Proposal	Mitigation	Impact
17.012	Blocked up lantern light

Low	Unblock lantern and fit glazing	Record on measured drawings	Low
17.013	Security gates at Ground openings
