Central Police Station Conservation
and Revitalisation Project:
16th Quarterly EM&A Report
(1 August 2015 to 31 October 2015)

Issue Date: November 2015

Environmental Resources Management

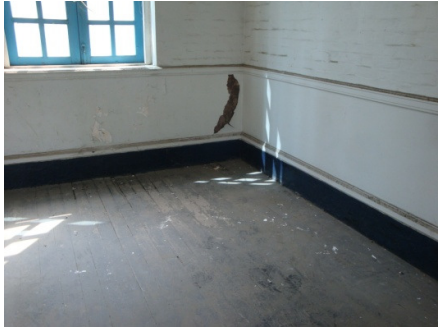
Low	Conceal in exceptional cases eg. where adjacent new lift shaft	Retain frame and spandrel panel where possible. Remove only where necessary in connection with re-planning of interiors. Record on measured survey drawings.	Low
03.006	Timber floors

High	Replace where new kitchens and plant rooms to be installed	Limit extent of removal as much as possible. Carefully remove and retain existing floorboards for re-use. Ensure controlled dismantling of timber structure and set aside for possible re-use. Protect or carefully remove and set aside adjacent elements such as skirting boards	Medium

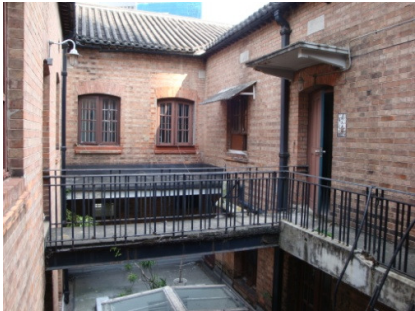
Moderate	Replace with larger sizes/closer spacing to improve performance	Use cast iron to match original pattern Make good all redundant fixing holes	High
09.013	Metal walkways across lightwell

Adverse	Remove walkways and make good brickwork at abutments	Not applicable	High

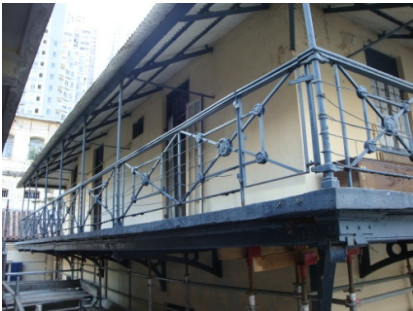
High	Repair as necessary and retain	Lift carefully and refix upon completion of fire-proofing and services installation	Low
10.005	Exterior decorations

Adverse	Strip off and redecorate	Sample and analyse existing paint media; select new media to suit substrate and significance	High

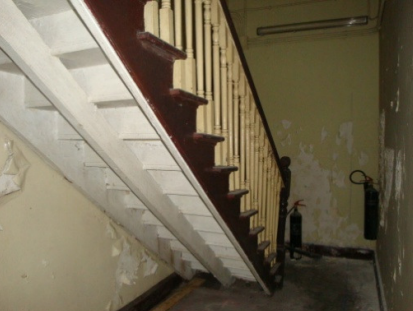
Moderate	Repair as necessary and retain	Avoid intrusive alteration. Retain open appearance/	Low
10.019	Timber stair

Moderate	Underline with fire-resisting lining	Repair as necessary and retain.	Low

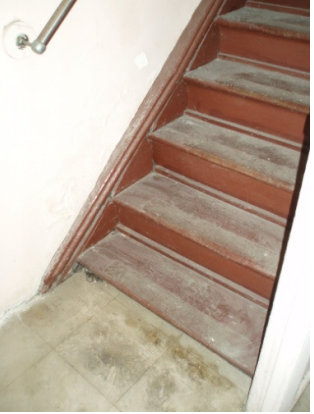
High	Repair and retain insitu	Not applicable	Neutral
19.012	Timber stair

Moderate	Remove	Record on measured surveys drawings	Low
