### Final EM&A Report

**Client :** China International Water & Electric Corporation  
**Project:** Providing Sufficient Water Depth for Kwai Tsing Container Basin and its Approach Channel  
**Contract No.:** CV/2013/04  
**Report No.:** 0394/13/ED/0399C

**Contract No. CV/2013/04  
Dredging Works in Kwai Tsing Container Basin and its Approach Channel  
Verification of Final EM&A Report**

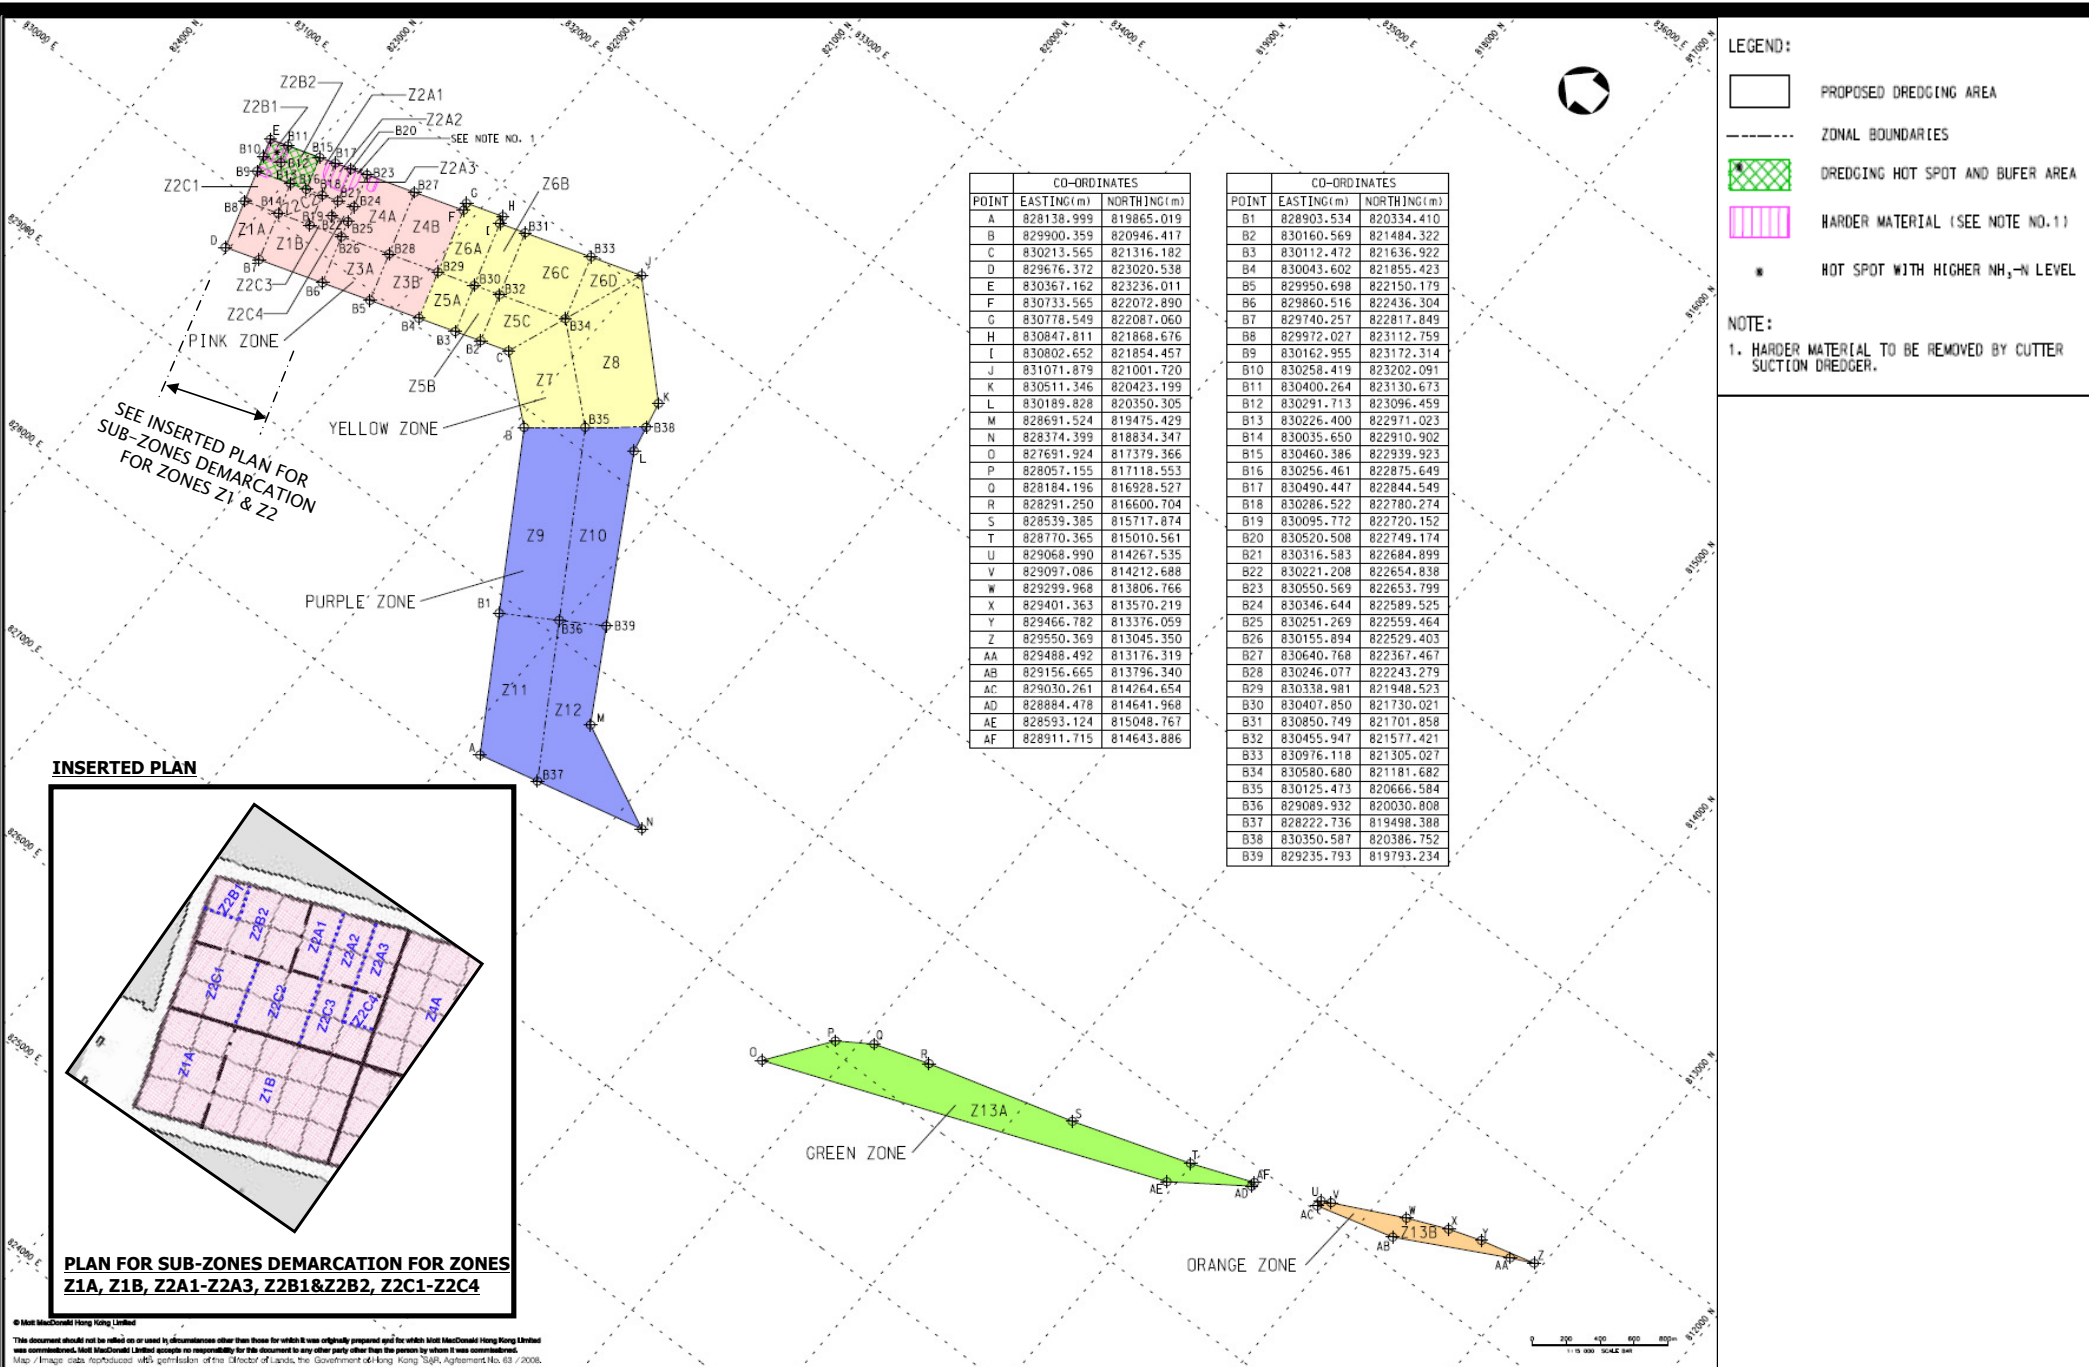
Figure 1

Project General Layout
