**Shatin to Central Link  
Tai Wai to Hung Hom Section**

**Transplantation Proposal for Plant Species of  
Conservation Importance**

**Shatin to Central Link – Tai Wai to  
Hung Hom Section  
[SCL (TAW-HUH)]****Transplantation Proposal for Plant  
Species of Conservation Importance**

November 2012

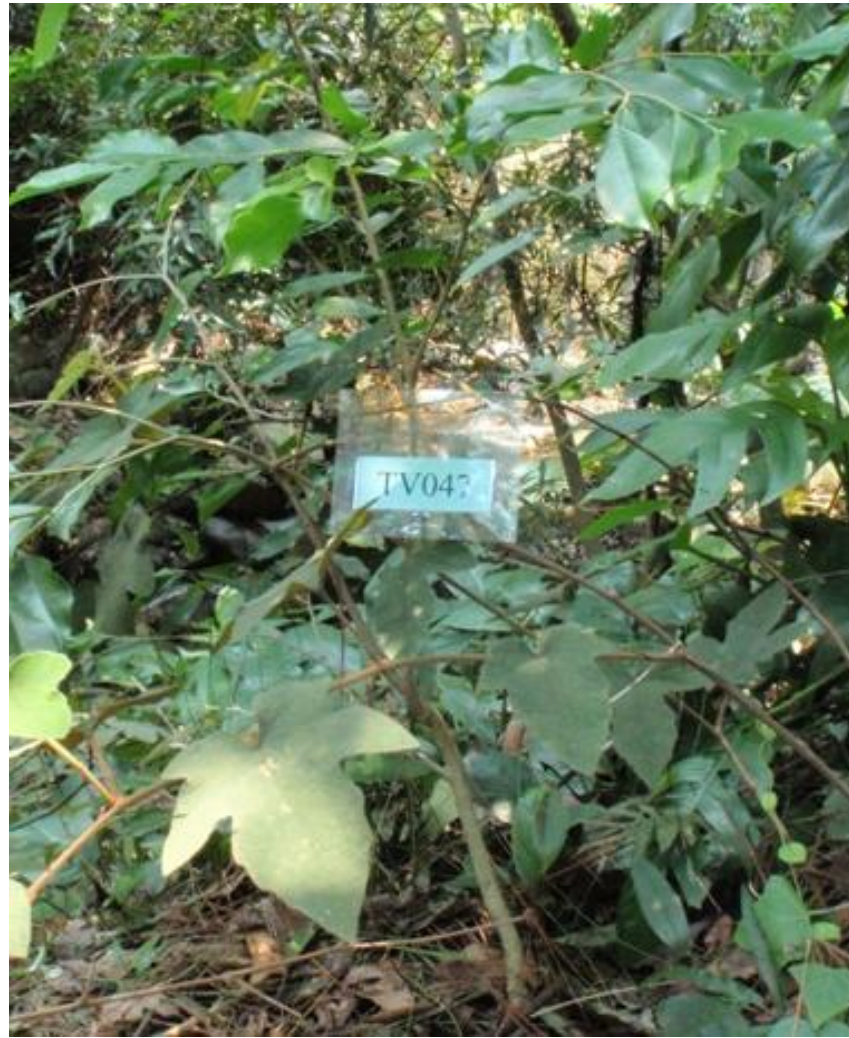
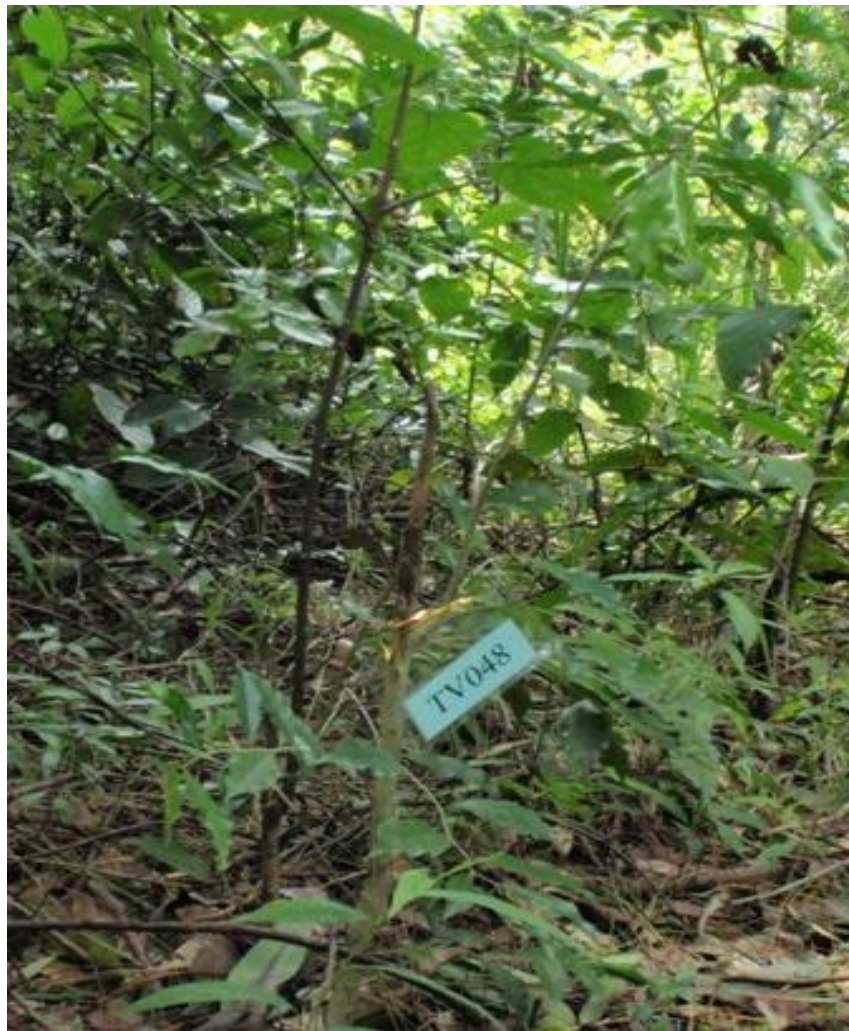
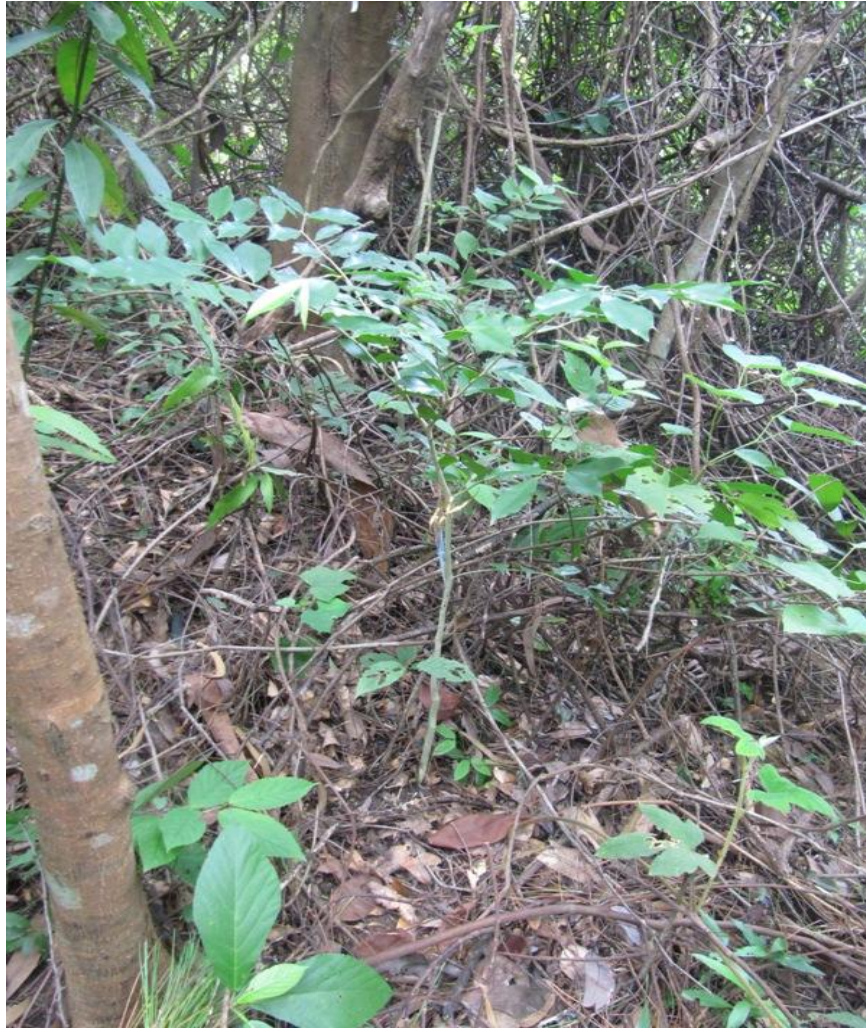
- 5.4.4 Apart from the transplanted individuals, retained individuals of Incense Tree (i.e. TV047, TV048, and TV051) should be fenced off prior to the commencement of construction as they are located in close proximity to the proposed works. Monthly monitoring should also be carried out during the first 12 months in order to check their conditions and report any injuries/damages. For the remainder of construction phase of the Project, monitoring of retained individuals by ITS should be done once every three months. Photographic record of the retained individuals should be taken during every monitoring visit.

- 6.1.1 Prior to the commencement of site clearance works and during the whole of the construction period, protection zone should be set up around the 3 Incense Tree individuals that are to be retained (TV047, TV048, and TV051), and the 14 others that have been transplanted (TV041 – TV046, TV049, TV050, and TV053 to TV058). In locations where site hoarding is not erected, protective fencings with sufficient buffer zone will be provided. Signposts should also be erected to inform the workers about the precautionary measures for protecting the concerned plant individuals and their root system. The Contractor should keep the protection zone clean and tidy without building materials, waste and excess soil. No digging, trenching, compaction, or other soil disturbance should be allowed in the protection zone.

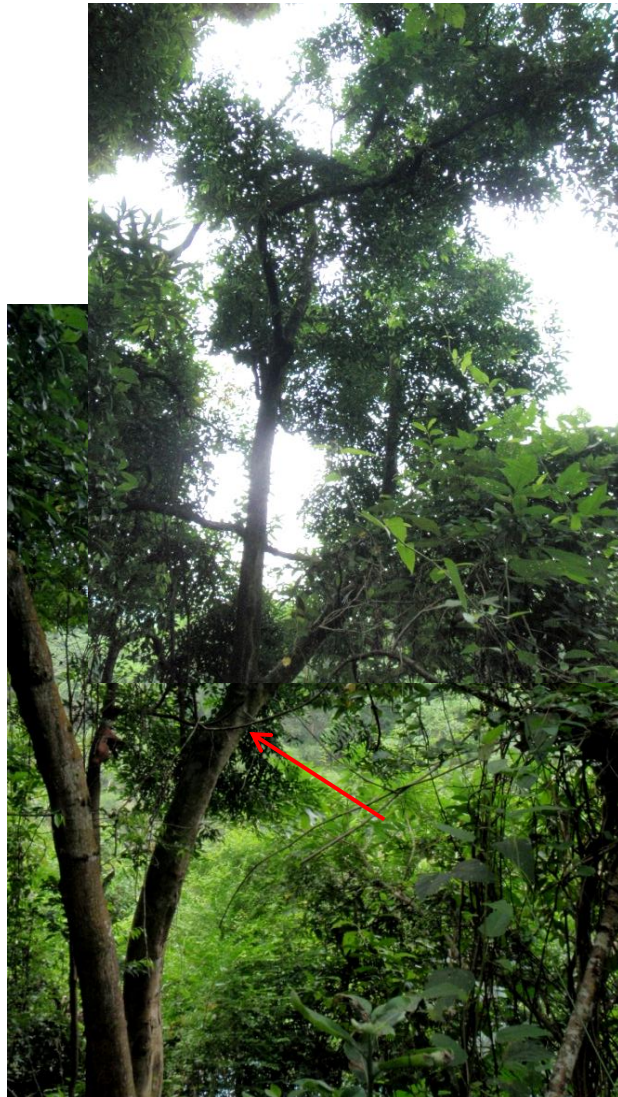
TV052

- 3.1.5 According to the survey assessment results, health conditions of the 15 affected individuals range from poor to good and survival rate after transplantation range from low to medium. A mature individual (TV052) was observed on a steep slope of which the survival rate after transplantation is considered to be low and therefore not recommended for transplantation. The rest of the 14 individuals would be tolerant to, and suitable for transplantation given that receptor site(s) is carefully selected, and appropriate transplantation procedures and post-planting care are adopted. **Table 3.1** summarizes the proposed treatment for the identified individuals. Details on the vegetation assessment and recommendation are provided in **Appendix B**.

TV 052	1200	25	500	Poor	Poor	Low	Y	Fell	On steep slope, lateral limb and bark crack at the lower part of trunk, rooted near a drain
TV 053	70	0.5	70	Fair	Fair	Low	Y	Transplant	On steep slope
TV 054	150	1.0	100	Fair	Fair	Low	Y	Transplant	On steep slope
TV 055	250	2.0	100	Fair	Fair	Low	Y	Transplant	On steep slope, rooted in a concrete retaining structure
TV 056	150	1.0	100	Fair	Good	Med - Low	Y	Transplant	On slope
TV 057	160	1.0	150	Fair	Good	Med - Low	Y	Transplant	On slope
TV 058	250	1.4	150	Fair	Good	Med - Low	Y	Transplant	On slope

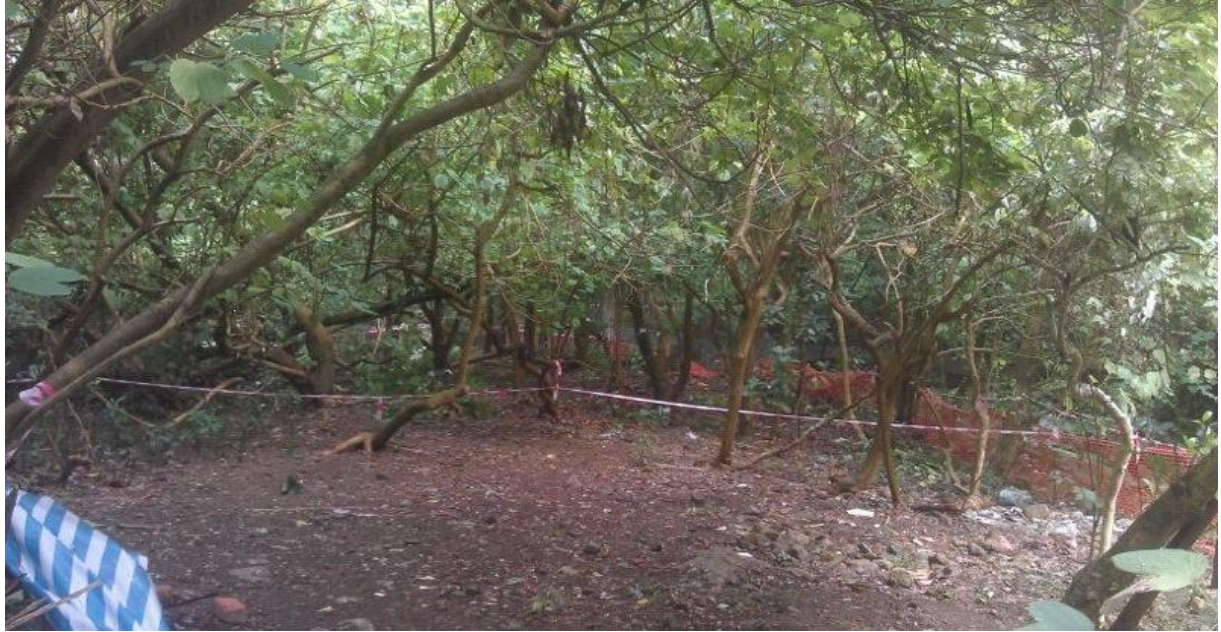
- 4.1.1 In order to provide consistent habitat characteristics (i.e. soil condition, topography, dominant plant species, degree of exposure to wind/sunlight, overhead/ground space for tree growth, and degree of human disturbance) allowing quick adaptation, the affected individuals are proposed to be transplanted within the project boundary of the HIK Portal. Indicative location of the proposed tentative receptor site is shown in **Figure C11033/C/SCL/ACM/M51/003** and a photograph is presented in **Appendix D**.

- 4.1.2 The proposed tentative receptor site is located at the west of Tei Lung Hau and approximately 12 m away from the proposed cut and cover area. The site is currently sparsely vegetated with shrubs and small trees such as *Bauhinia* spp. The receptor site was selected and verified by the ITS on the suitability for receiving the transplanted individuals.

- 4.1.3 The receptor site will be reassessed by the ITS prior to the commencement of transplantation taking into account the latest site condition. Habitat characteristics, as mentioned in **Section 4.1.1**, of the alternative sites should be similar to that of their original locations. Should any changes in the location of receptor site be proposed afterwards, the Director of Environmental Protection (DEP) will be informed for prior consideration.
