Ref No.: 100440EN121562

Contract No. EP/SP/58/08
Sludge Treatment Facilities
Environmental Monitoring and Audit Report
For
December 2012

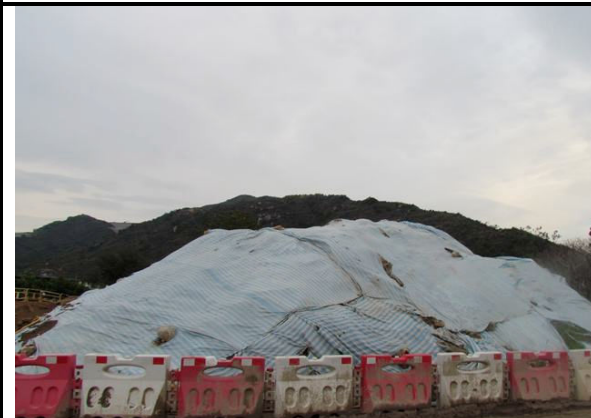
1. Photographic Record of the PFA Treatment	2. Photographic Record of Protection to the Fell / Retained Trees

<p>The PFA excavated has been dehydrated under sunlight, and will be buried back to its original position inside the site boundary. Capping of the PFA is established to prevent spreading in air.</p>	<p>T758 is confirmed to be retained on site. Proper tree protection should be applied to protect T758. Amendment to the tree felling application will be submitted.</p>

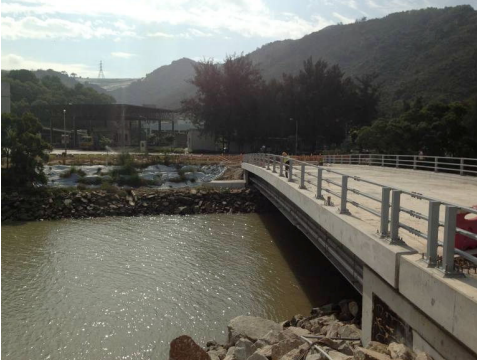
<p>3. Photographic Record of the Original Transplant Trees Location</p>

<p>The new tree plantings will be proposed on the either side of the bridge at portion 6 to fulfil the EIA requirement.</p>	
<p>4. Photographic Record of the Compensatory Tree Locations</p>

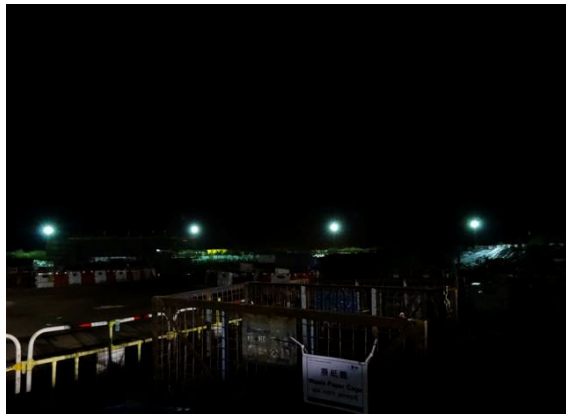
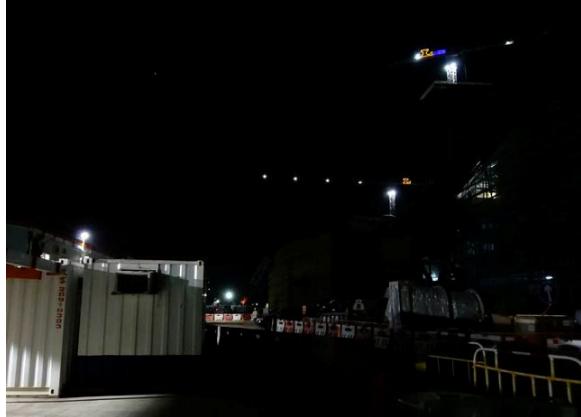
<p>The lighting during night-time working is confined within the working area within the site boundary. Periphery area and the sensitive receivers are not affected by the lighting during night-time working.</p>	<p>The lighting during night-time working is confined within the working area within the site boundary. Periphery area and the sensitive receivers are not affected by the lighting during night-time working.</p>

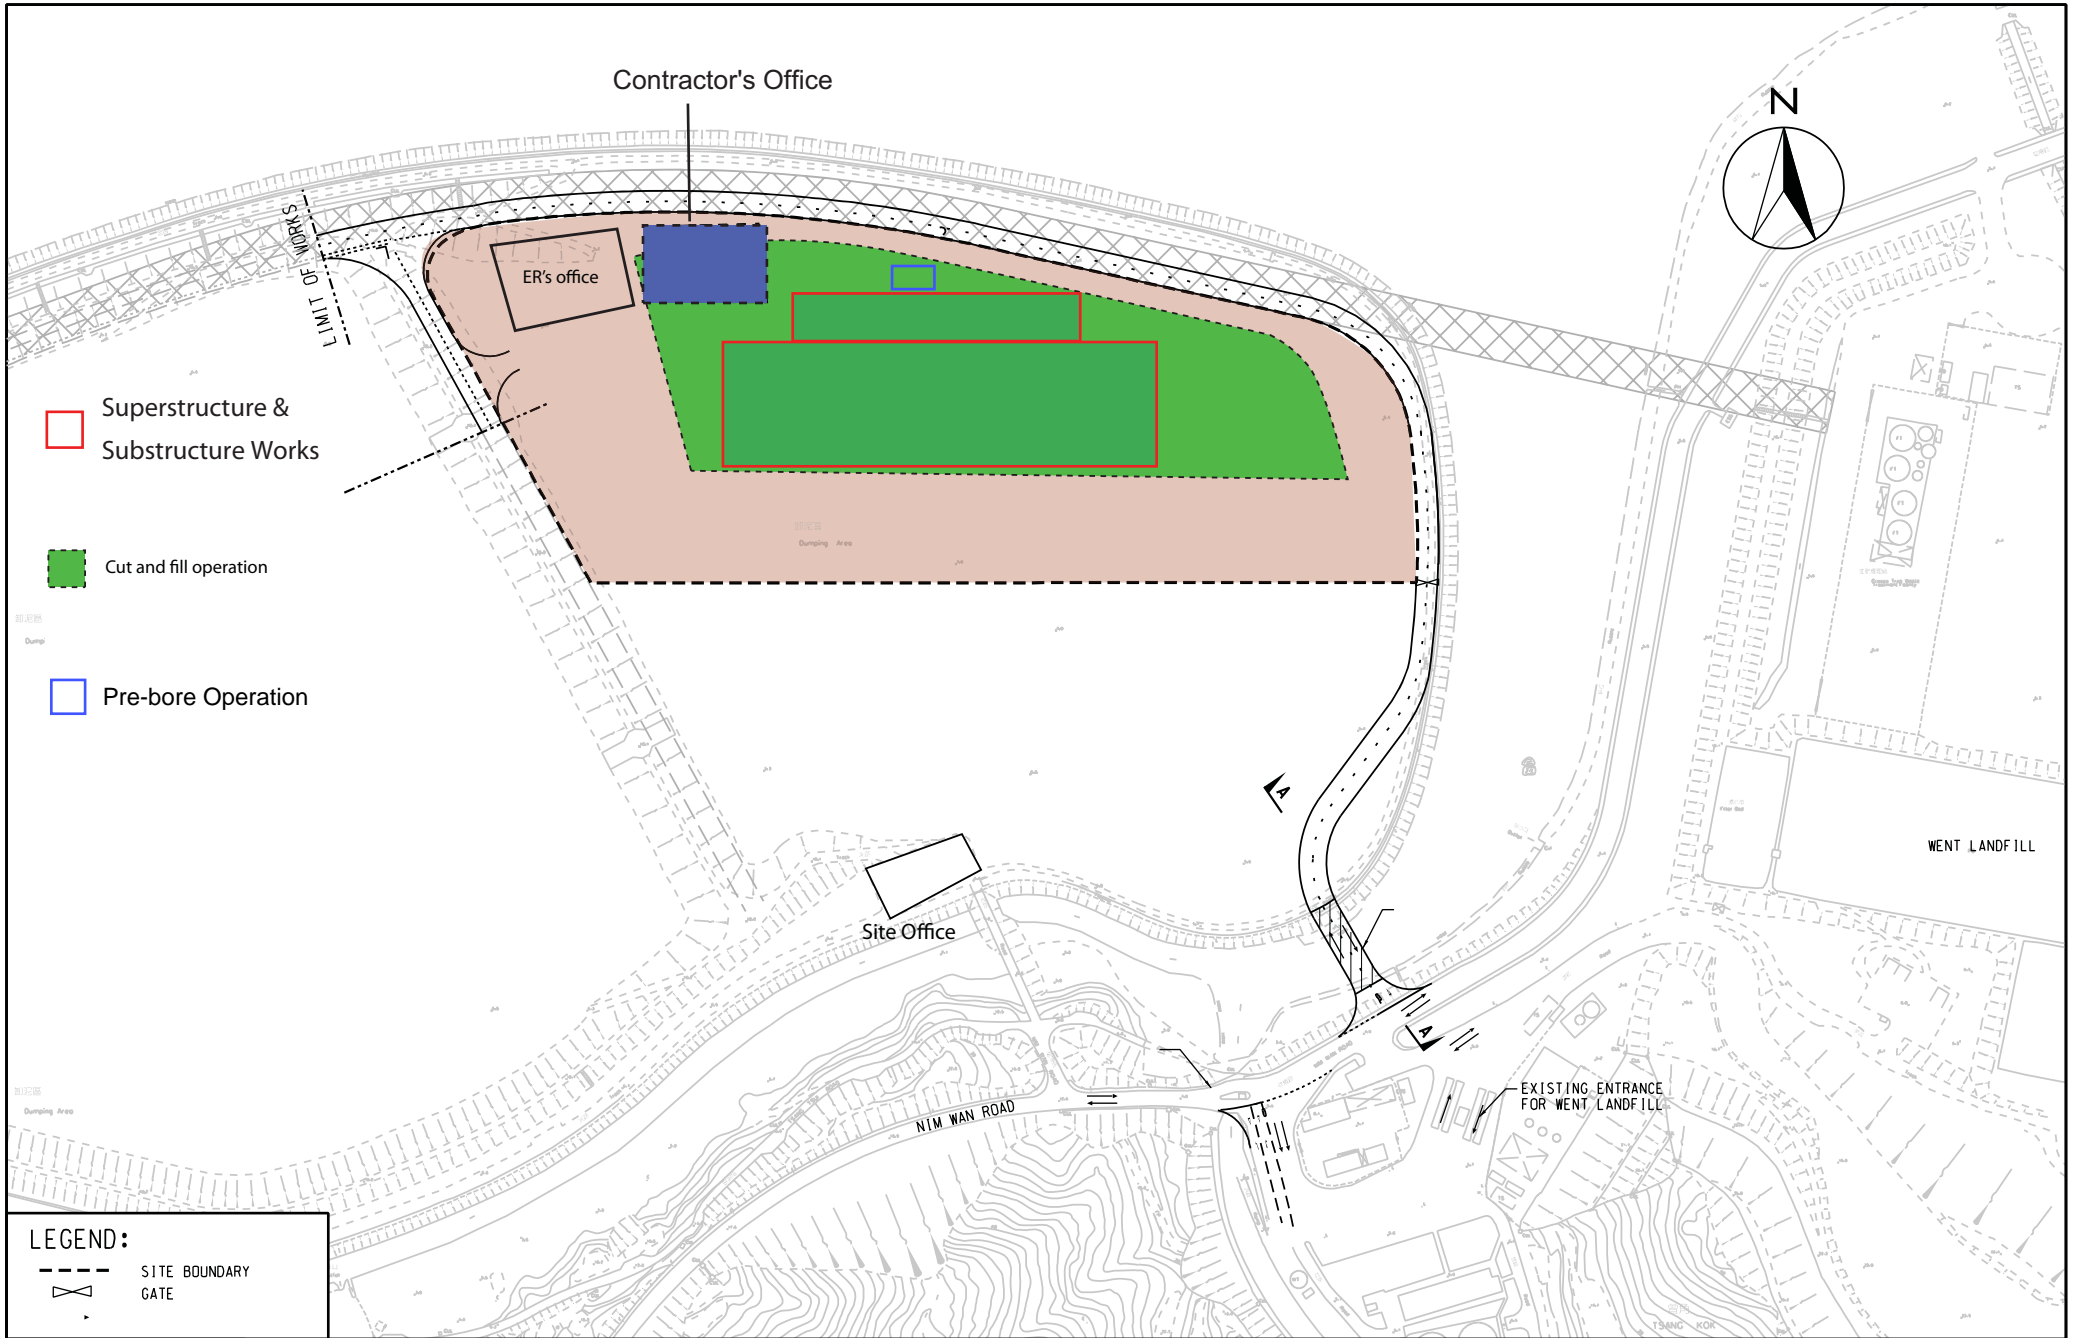
Construction Works Area

Works area is shown in Figure 1.1
