Ref No.: 100440EN130011

**Contract No. EP/SP/58/08**  
**Sludge Treatment Facilities**  
**Environmental Monitoring and Audit Report**  
**For**  
**January 2013**

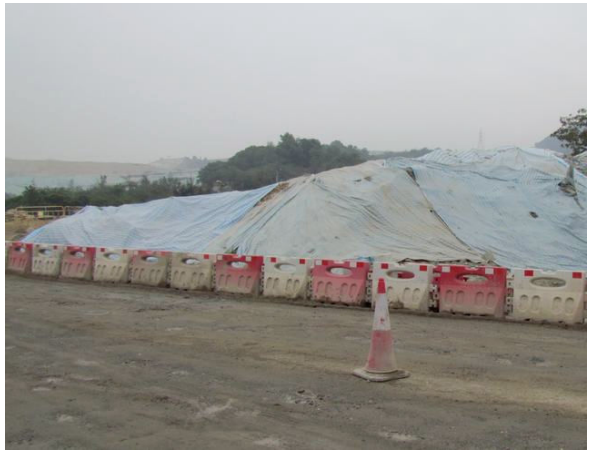
1. Photographic Record of the PFA Treatment	2. Photographic Record of Protection to the Fell / Retained Trees

<p>The PFA excavated has been dehydrated under sunlight, and will be buried back to its original position inside the site boundary. Capping of the PFA is established to prevent spreading in air.</p>	<p>T758 is confirmed to be retained on site. Proper tree protection should be applied to protect T758. Amendment to the tree felling application will be submitted.</p>
3. Photographic Record of the Original Transplant Trees Location

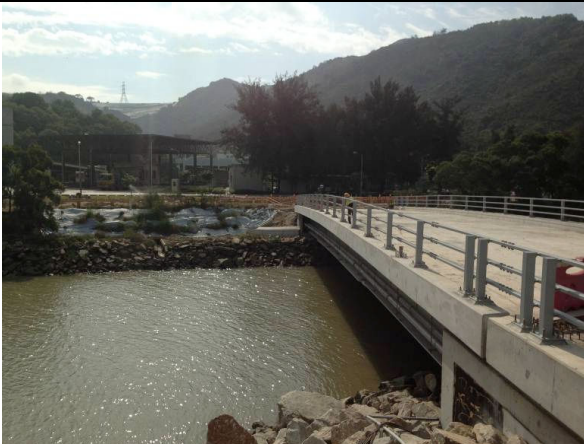
<p>The new tree plantings will be proposed on the either side of the bridge at portion 6 to fulfil the EIA requirement.</p>

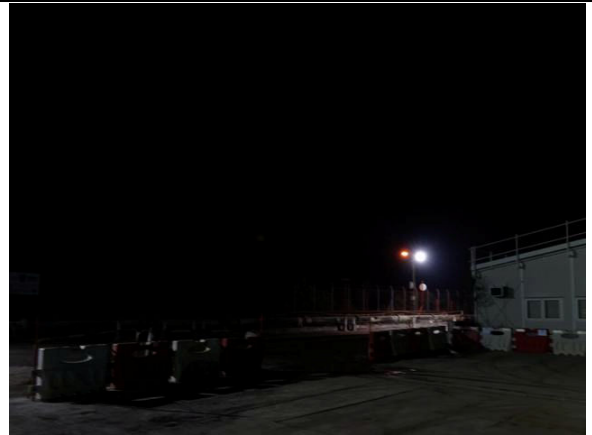
5. Photographic Record of the Night-Time Working

The lighting during night-time working is confined within the working area within the site boundary. Periphery area and the sensitive receivers are not affected by the lighting during night-time working.
