Ref No.: 100440EN130109

**Contract No. EP/SP/58/08**  
**Sludge Treatment Facilities**  
**Environmental Monitoring and Audit Report**  
**For**  
**February 2013**

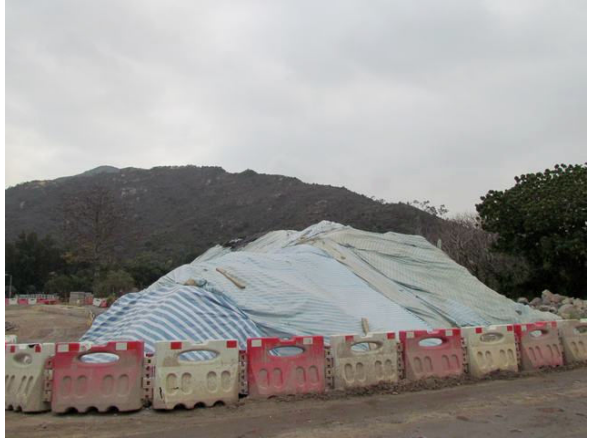
1. Photographic Record of the PFA Treatment	2. Photographic Record of Protection to the Fell / Retained Trees

<p>The PFA excavated has been dehydrated under sunlight, and will be buried back to its original position inside the site boundary. Capping of the PFA is established to prevent spreading in air.</p>	<p>T758 is confirmed to be retained on site. Proper tree protection should be applied to protect T758. Amendment to the tree felling application will be submitted.</p>

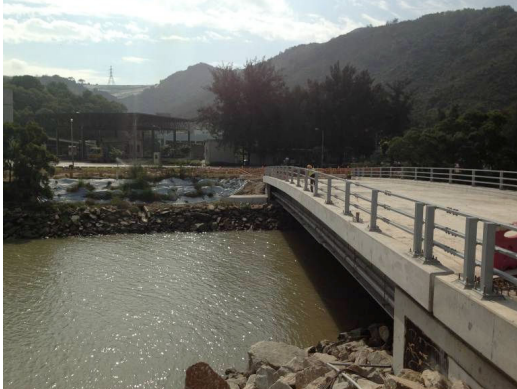
<p><b>3. Photographic Record of the Original Transplant Trees Location</b></p>

<p>The new tree plantings will be proposed on the either side of the bridge at portion 6 to fulfil the EIA requirement.</p>	
<p><b>4. Photographic Record of the Compensatory Tree Locations</b></p>

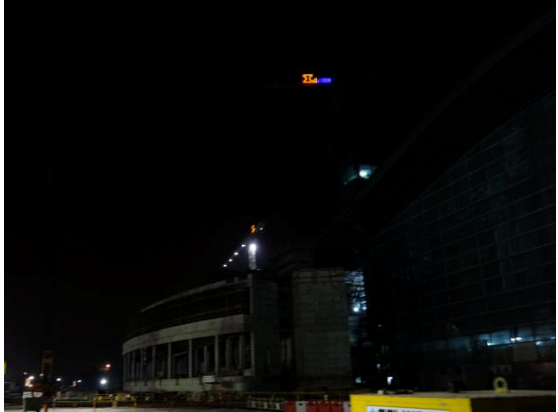
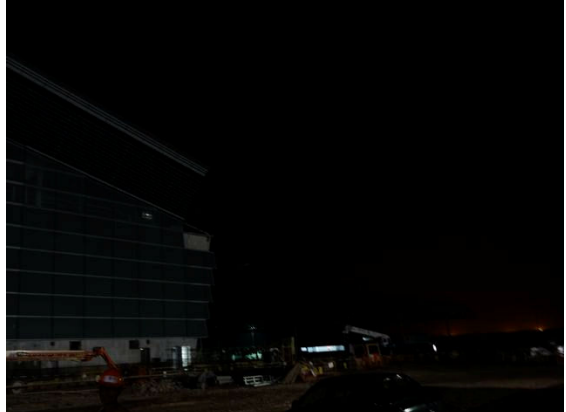
<p>The lighting during night-time working is confined within the working area within the site boundary. Periphery area and the sensitive receivers are not affected by the lighting during night-time working.</p>	<p>The lighting during night-time working is confined within the working area within the site boundary. Periphery area and the sensitive receivers are not affected by the lighting during night-time working.</p>
