Ref No.: 100440EN130280

Contract No. EP/SP/58/08
Sludge Treatment Facilities
Environmental Monitoring and Audit Report
For
March 2013

Date : 10 April 2013

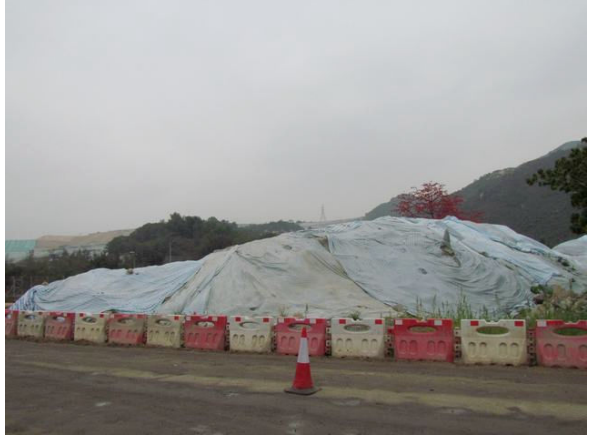
1. Photographic Record of the PFA Treatment	2. Photographic Record of Protection to the Fell / Retained Trees

Topsoil found within the project site is PFA. Suitable topsoil will be imported for planting during landscape planting phase. All PFA excavated during the tree felling works has been retained in the site confinement. The PFA has been under dehydration and concealed properly to prevent spreading in the air. Backfill of PFA to its original location inside site area is under progress.

<p>The PFA excavated has been dehydrated under sunlight, and will be buried back to its original position inside the site boundary. Capping of the PFA is established to prevent spreading in air.</p>	<p>T758 is confirmed to be retained on site. Proper tree protection should be applied to protect T758. Amendment to the tree felling application will be submitted.</p>

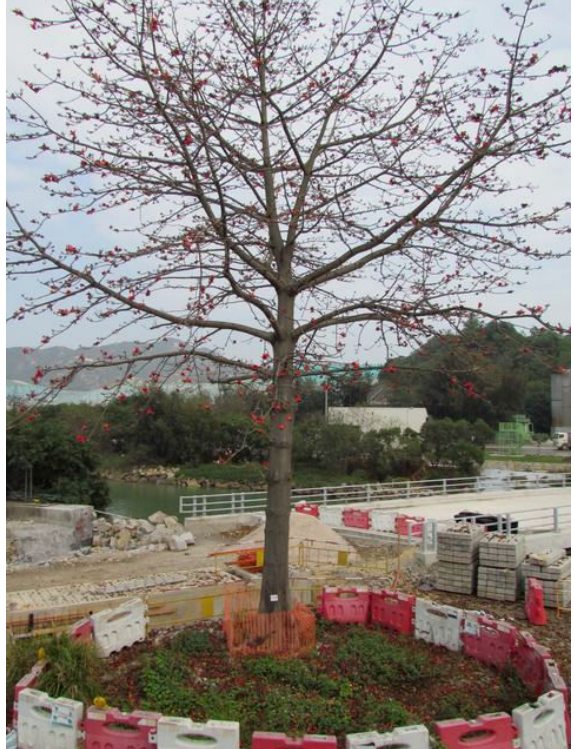
CM2 - Existing trees to be retained on site should be carefully protected during construction. The Tree felling work approved under the Phase 1 and 2 tree felling application has been completed. Proper procedures of tree felling have been observed. The tree felling works should not cause damages to the existing trees on site. T758 has been confirmed to be retained on site. Proper tree protection should be set up for T758.

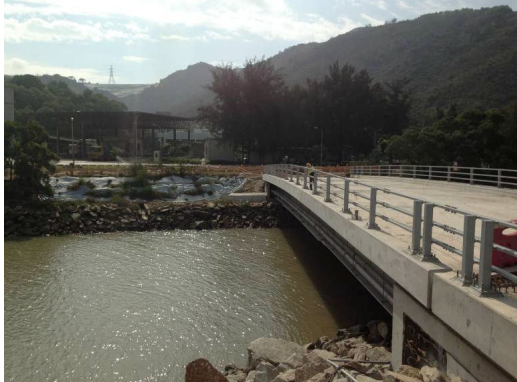
<p>3. Photographic Record of the Original Transplant Trees Location</p>

<p>The new tree plantings will be proposed on the either side of the bridge at portion 6 to fulfill the EIA requirement.</p>	
<p>4. Photographic Record of the Compensatory Tree Locations</p>

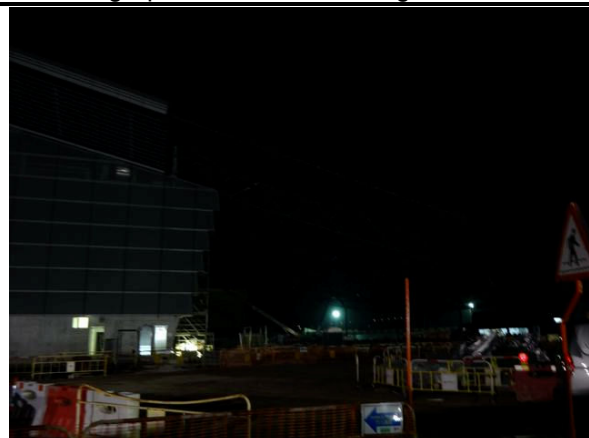
<p>The lighting during night-time working is confined within the working area within the site boundary. Periphery area and the sensitive receivers are not affected by the lighting during night-time working.</p>	<p>The lighting during night-time working is confined within the working area within the site boundary. Periphery area and the sensitive receivers are not affected by the lighting during night-time working.</p>

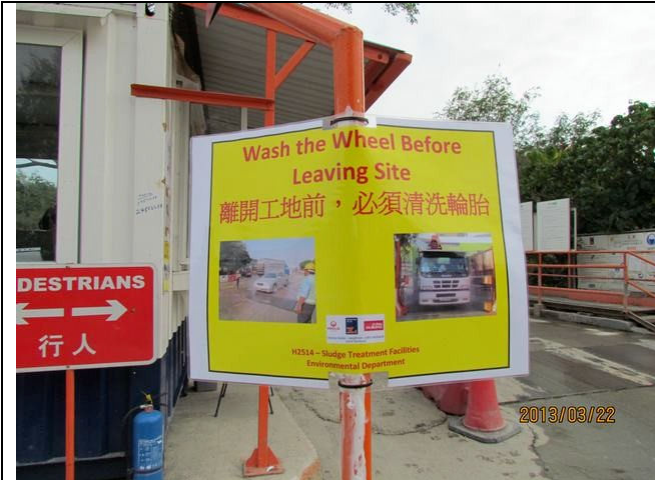
Photo 1. Reminder notice was posted to remind all site personnel with cars for wheel washing before they leave.

Details of Action(s) Taken	1. Review watering frequency. 2. Issue notices reminding the necessity of wheel washing before leaving the site.
Follow up by	Leighton and ET
Date	
Details of Follow up Action(s)	1. Watering frequency has been reviewed at site exit and no fugitive dust was observed. 2. A Bob Cat with sweeper was used to clean out the mud deposited on the paved road instead of water truck. 3. No observation of vehicles leaving the site without wheel washing in consecutive site inspection on 7 th and 15 th March 2013.
Remarks	---

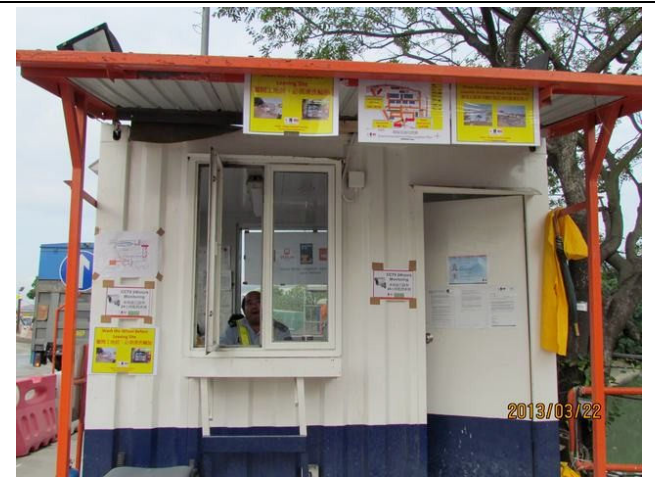
Photo 2. The notices were posted at the site exit to remind all vehicle drivers to stop and ensure that their cars were properly cleaned.

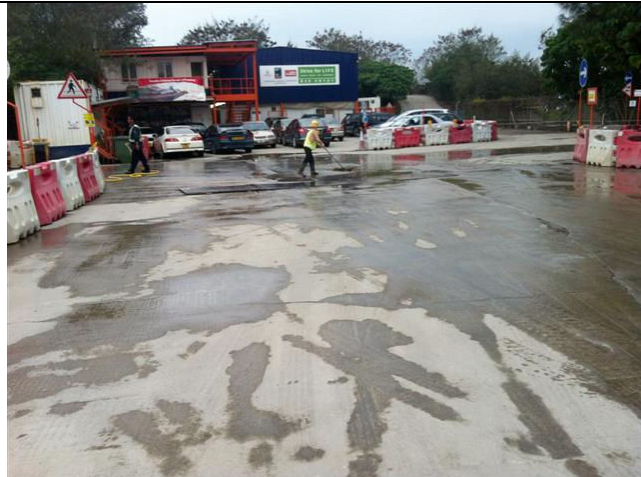
Photo 3. The floor area was watered by site workers at the exit point.

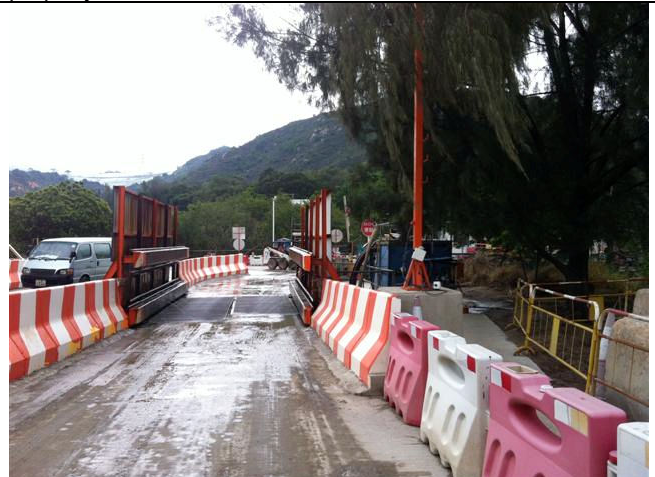
Photo 4. The Contractor had provided a workable and effective wheel washing system at the exit point of the site, comprising high pressure water jets.

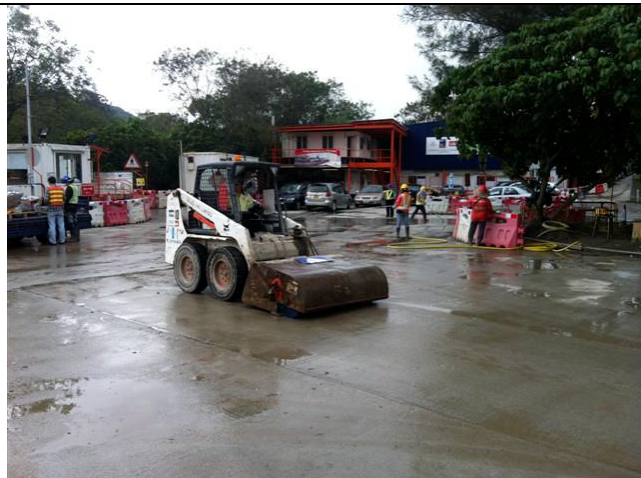
Photo 5. A Bob Cat with sweeper was used to clean out the mud deposited on the paved road instead of water truck.

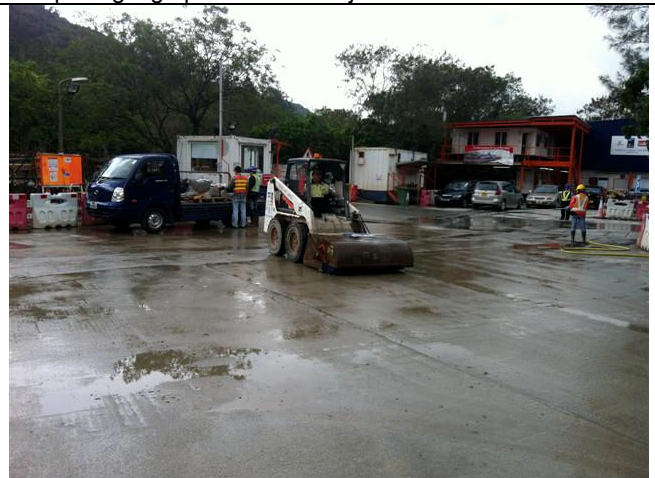
Photo 6. The floor area of the site exit point had been paved.
