Contract No. EP/SP/58/08

Sludge Treatment Facilities

Environmental Monitoring and Audit Report

April 2013

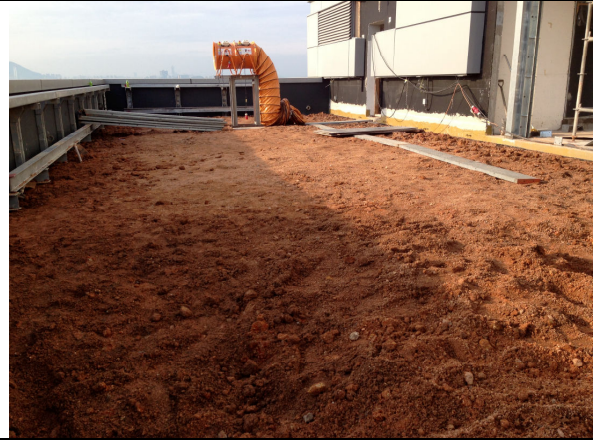
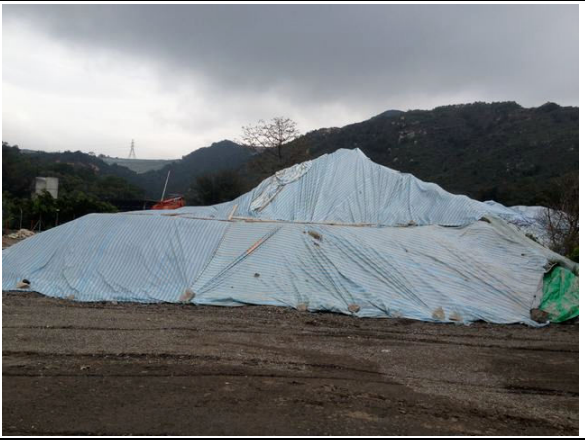
1. Photographic Record of the PFA Treatment

Topsoil found within the project site is PFA. Suitable topsoil already imported for planting. All PFA excavated during the tree felling works has been retained in the site confinement. The PFA has been under dehydration and concealed properly to prevent spreading in the air. Backfill of PFA to its original location inside site area is under progress.

Suitable topsoil already imported for planting.	Capping of the PFA is established to prevent spreading in air.
2. Photographic Record of Protection to the Fell / Retained Trees

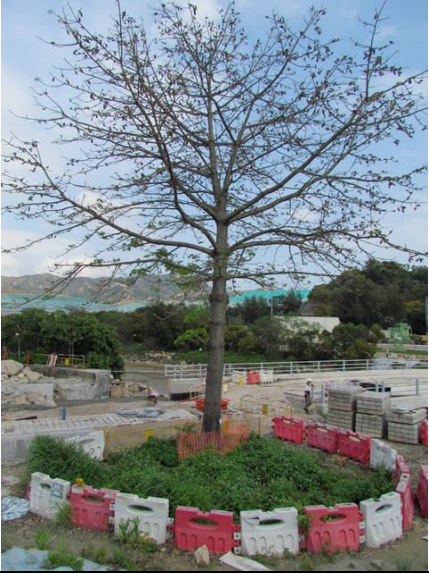
T758 is confirmed to be retained on site. Proper tree protection should be applied to protect T758. Amendment to the tree felling application will be submitted.

CM2 - Existing trees to be retained on site should be carefully protected during construction. The Tree felling work approved under the Phase 1 and 2 tree felling application has been completed. Proper procedures of tree felling have been observed. The tree felling works should not cause damages to the existing trees on site. T758 has been confirmed to be retained on site. Proper tree protection should be set up for T758.

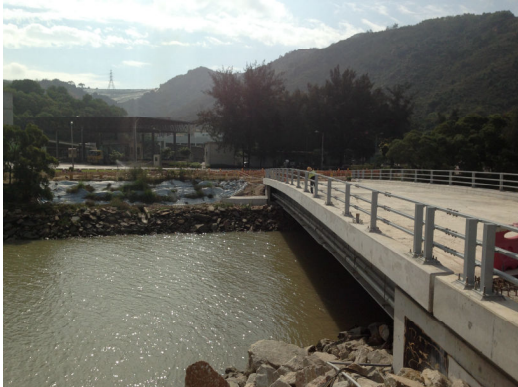
<p>3. Photographic Record of the Original Transplant Trees Location</p>

<p>The new tree plantings will be proposed on the either side of the bridge at portion 6 to fulfill the EIA requirement.</p>	
<p>4. Photographic Record of the Compensatory Tree Locations</p>

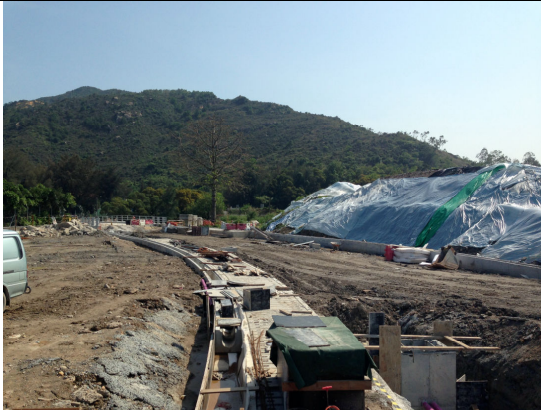
<p>More compensatory trees will be added for the dead transplant trees, which should be reflected in the tree felling resubmission. Final locations of the compensatory planting to be verified on site by the contractor. These shall be reflected in the revised compensatory proposal as well.</p>	
<p>5. Photographic Record of the Night-Time Working</p>

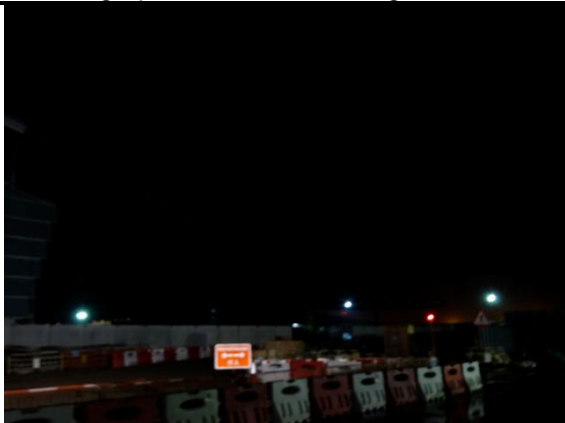
<p>The lighting during night-time working is confined within the working area within the site boundary. Periphery area and the sensitive receivers are not affected by the lighting during night-time working.</p>	<p>The lighting during night-time working is confined within the working area within the site boundary. Periphery area and the sensitive receivers are not affected by the lighting during night-time working.</p>
