Ref No.: 100440EN130517

Contract No. EP/SP/58/08
Sludge Treatment Facilities
Environmental Monitoring and Audit Report
For
May 2013

Date : 07 June 2013

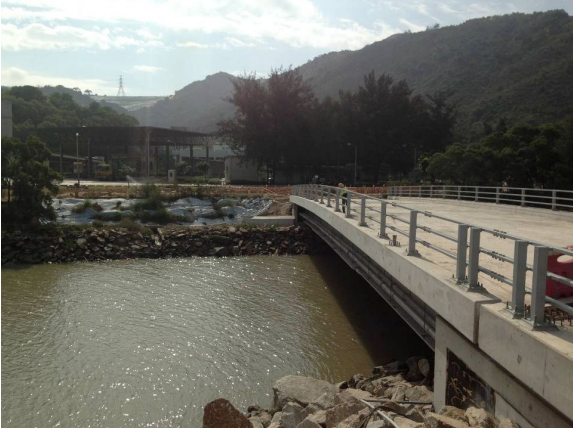
<p>3. Photographic Record of the Original Transplant Trees Location</p>

<p>The new tree plantings will be proposed on the either side of the bridge at portion 6 to fulfill the EIA requirement.</p>	
<p>4. Photographic Record of the Compensatory Tree Locations</p>

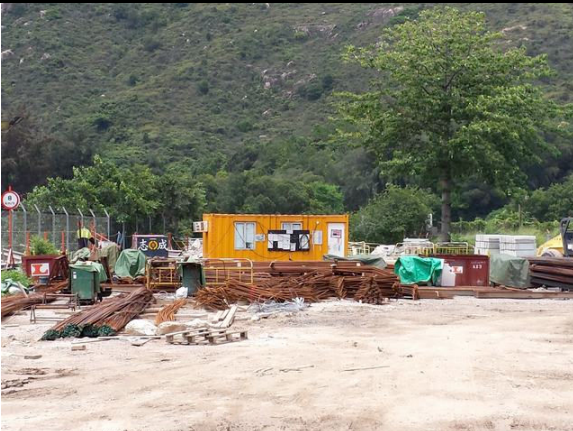
<p>More compensatory trees will be added for the dead transplant trees, which should be reflected in the tree felling resubmission. Final locations of the compensatory planting to be verified on site by the contractor. These are reflected in the revised compensatory proposal as well.</p>	
<p>5. Photographic Record of the Night-Time Working</p>

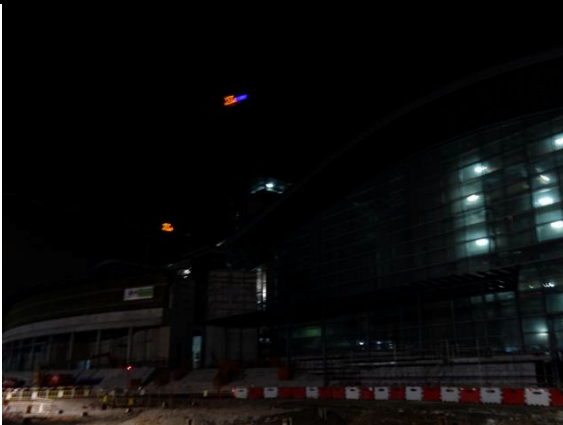
<p>The lighting during night-time working is confined within the working area within the site boundary. Periphery area and the sensitive receivers are not affected by the lighting during night-time working.</p>
