Ref No.: 100440EN130518

Contract No. EP/SP/58/08
Sludge Treatment Facilities
Environmental Monitoring and Audit Report
For
June 2013

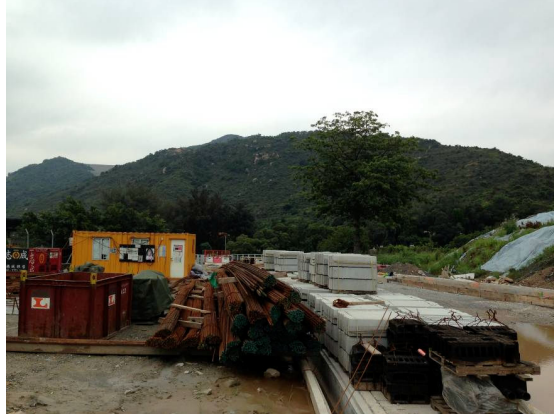
3. Photographic Record of the Original Transplant Trees Location

The transplant trees will be transplanted back into the site once the transplant area is suitable.

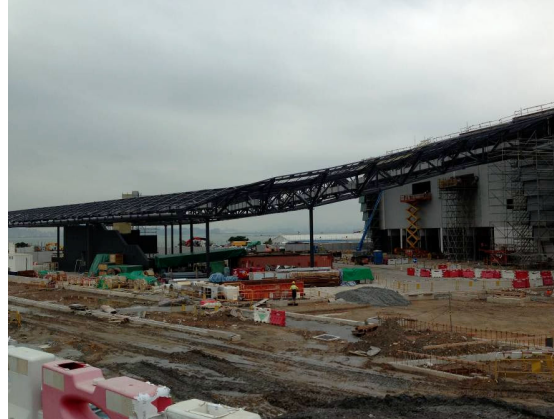
4. Photographic Record of the Compensatory Tree Locations

More compensatory trees will be added for the dead transplant trees, which should be reflected in the tree felling resubmission. Final locations of the compensatory planting to be verified on site by the contractor. These are reflected in the revised compensatory proposal as well.

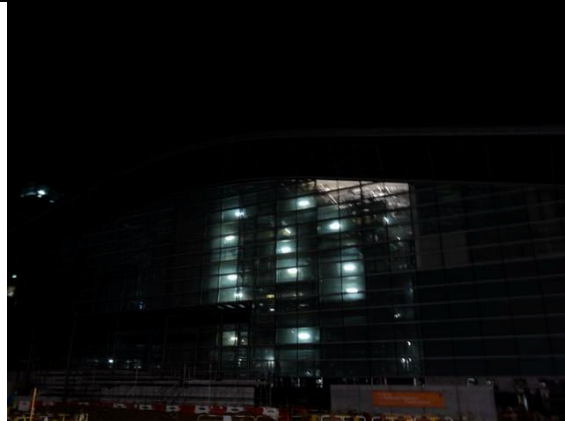
5. Photographic Record of the Night-Time Working

The lighting during night-time working is confined within the working area within the site boundary. Periphery area and the sensitive receivers are not affected by the lighting during night-time working.

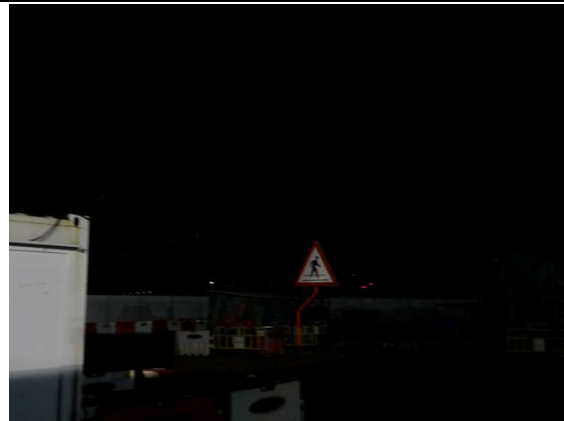
The lighting during night-time working is confined within the working area within the site boundary. Periphery area and the sensitive receivers are not affected by the lighting during night-time working.
